Taum Sauk Upper Dam Breach FERC No. P-2277

Technical Reasons for the Breach
of December 14, 2005

FERC Independent Panel of Consultants (IPOC)

May 24, 2006

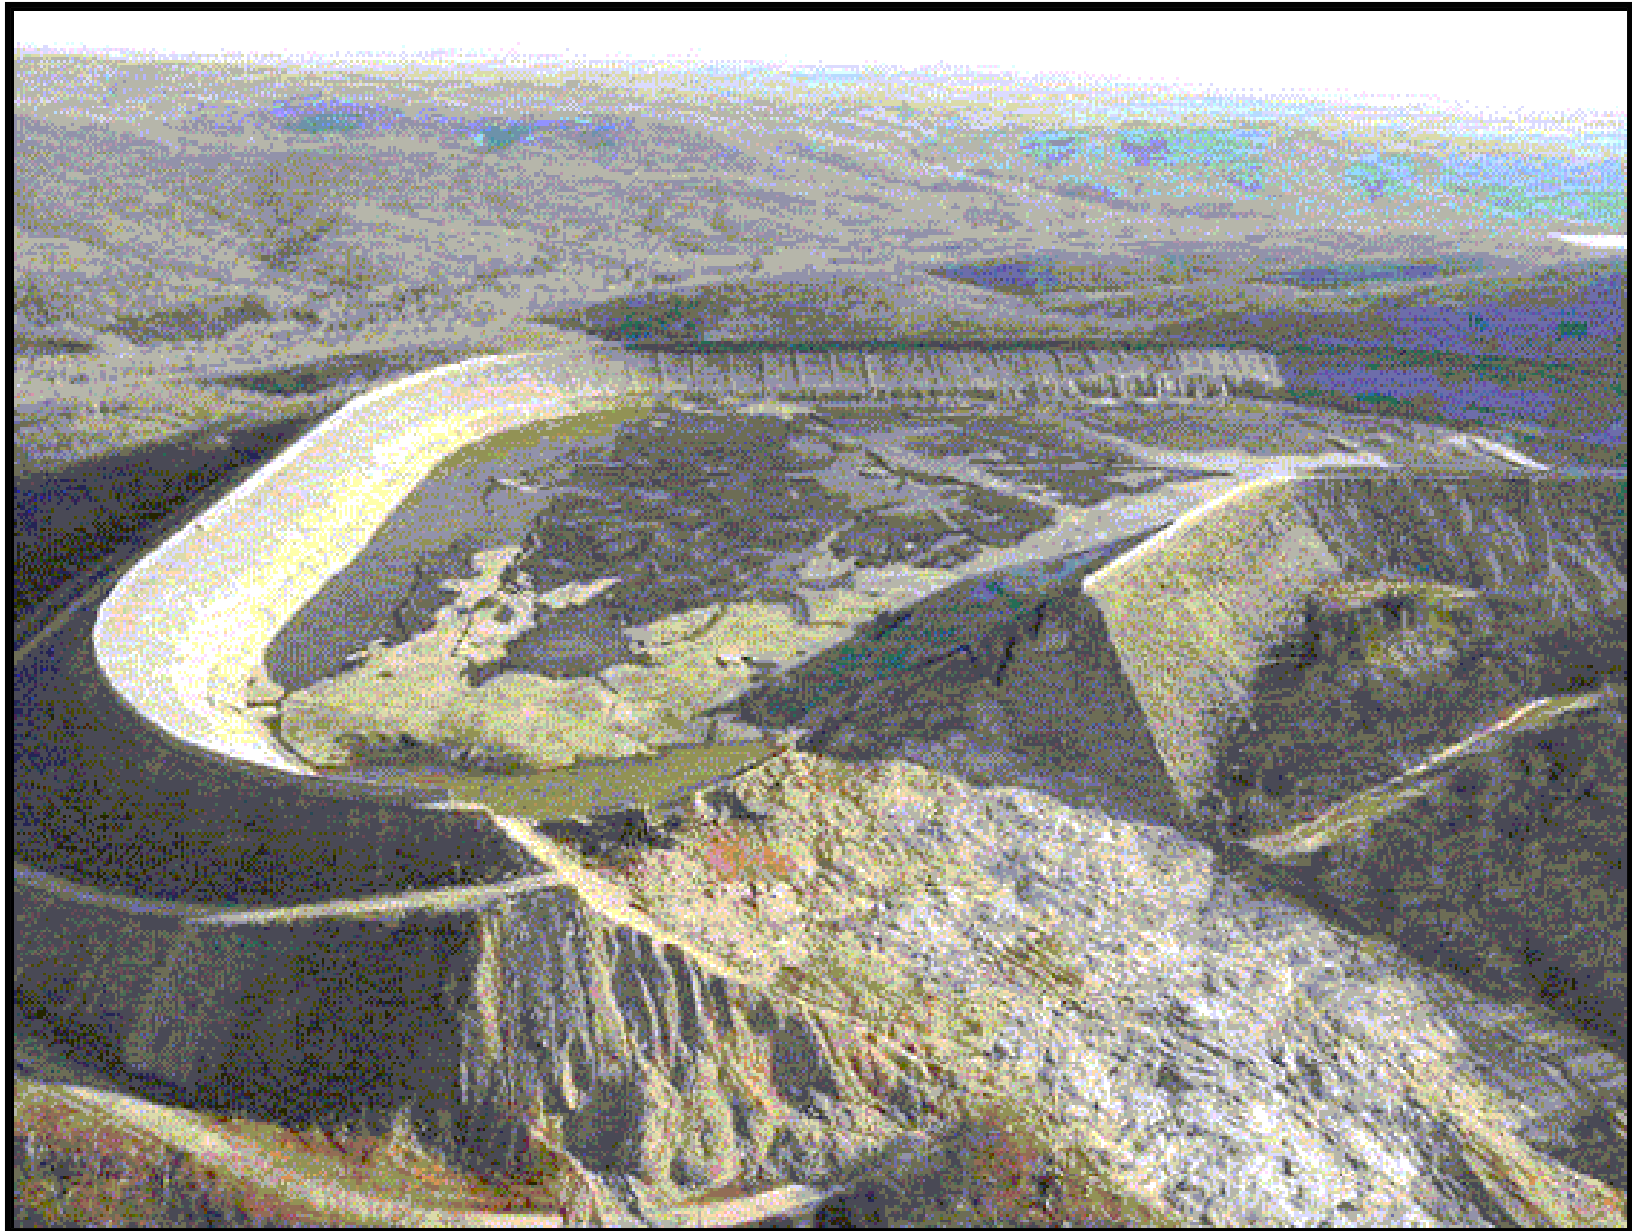
Figure 6-1

On December 14, 2005, an uncontrolled release of water from the upper reservoir occurred at the Taum Sauk Pumped Storage Project resulting in the damage shown in Figures 6-1 and 6-2. The time history of the reservoir transducers and the penstock transducer just before, during, and after the breach is shown in Figure 6-3. It is shown on Figure 6-3 that the full breach developed within about 25 minutes from the initial dropping of the reservoir level.

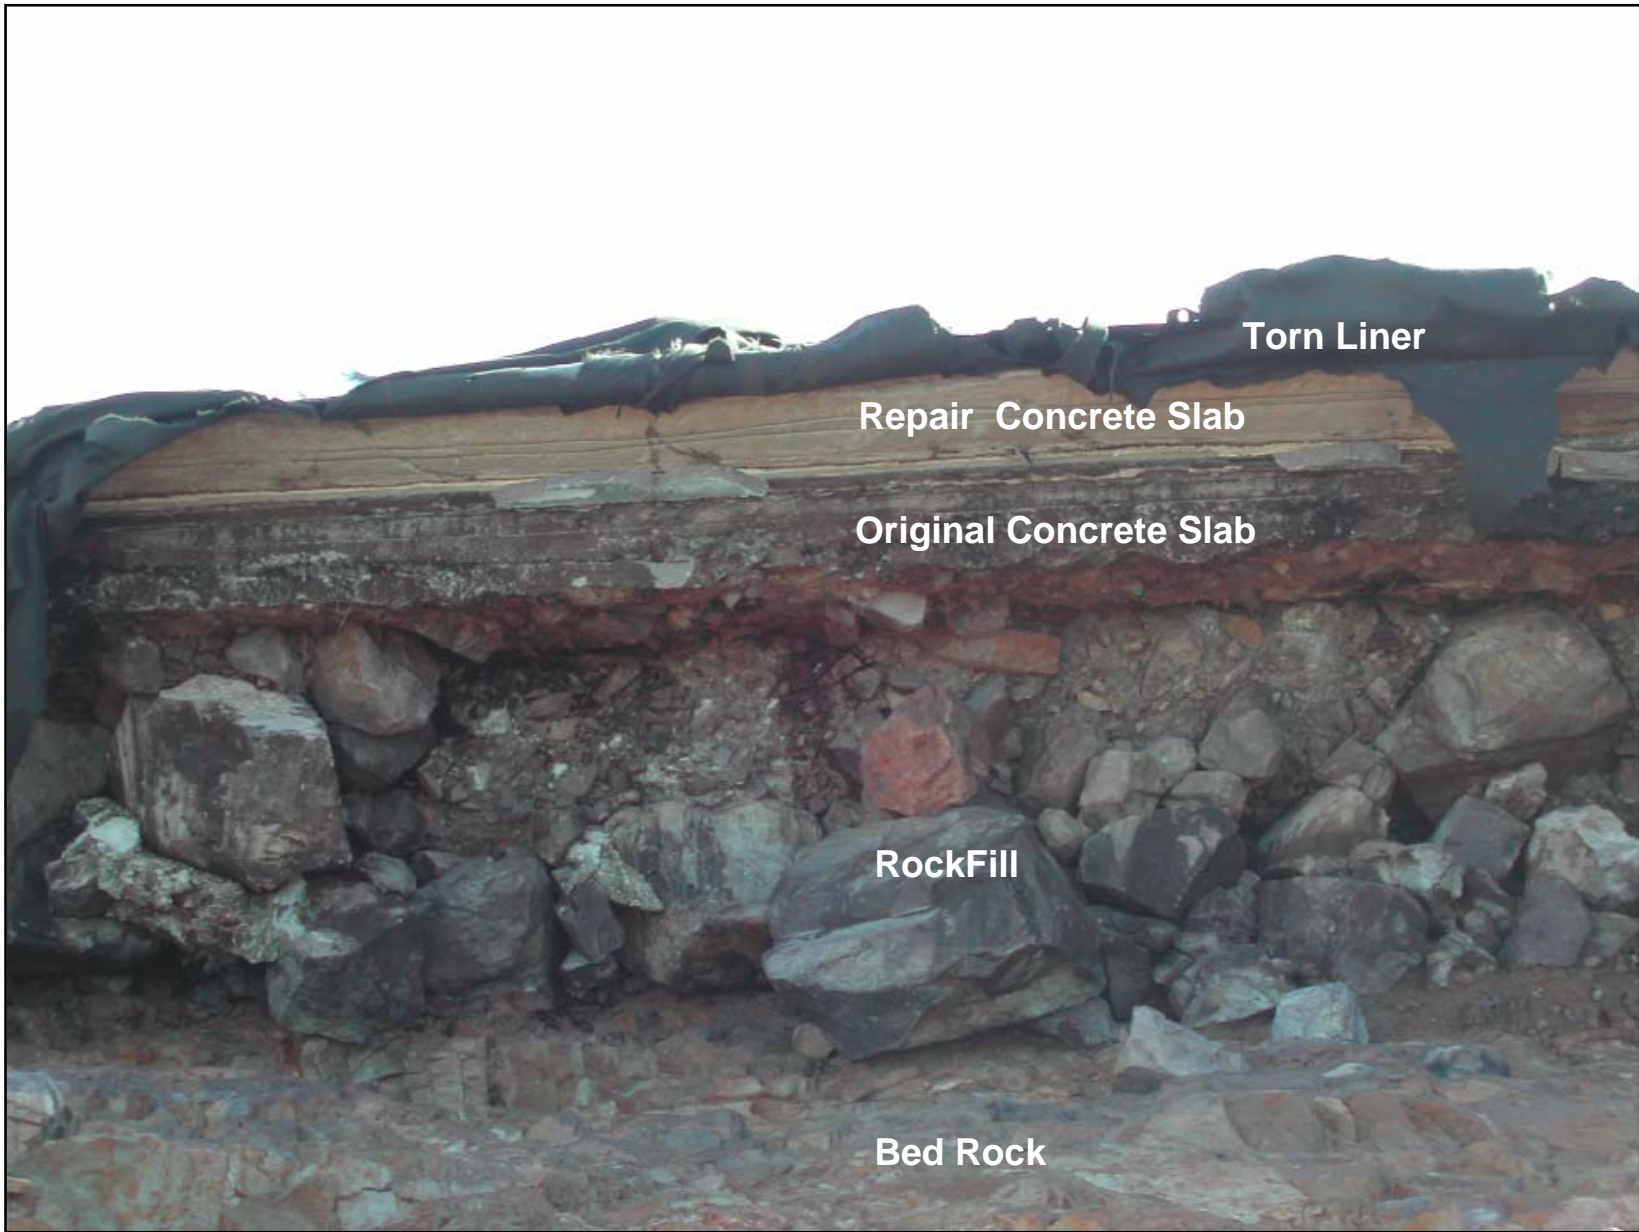
Figures 6-6, 6-7, and 6-8 show three views of the area under the base of the bottom of the face slab and plinth. The most glaring issue revealed by Figure 6-6 for example is that it appears that the plinth was not taken down to the rhyolite bedrock shown at the bottom of the photo. This is not considered good practice today and it was not good practice in 1963. Figures 6-7 and 6-8 show similar construction along the plinth area. This observation makes it consistent to rationalize the blow outs and holes that had to be repaired upstream of Panels 90-95 in 1963 and 1964. It definitely appears from these inspections that the plinth was not extended to bedrock for this dam, at least in the breach area.

Rockfill between top of rock and base of plinth

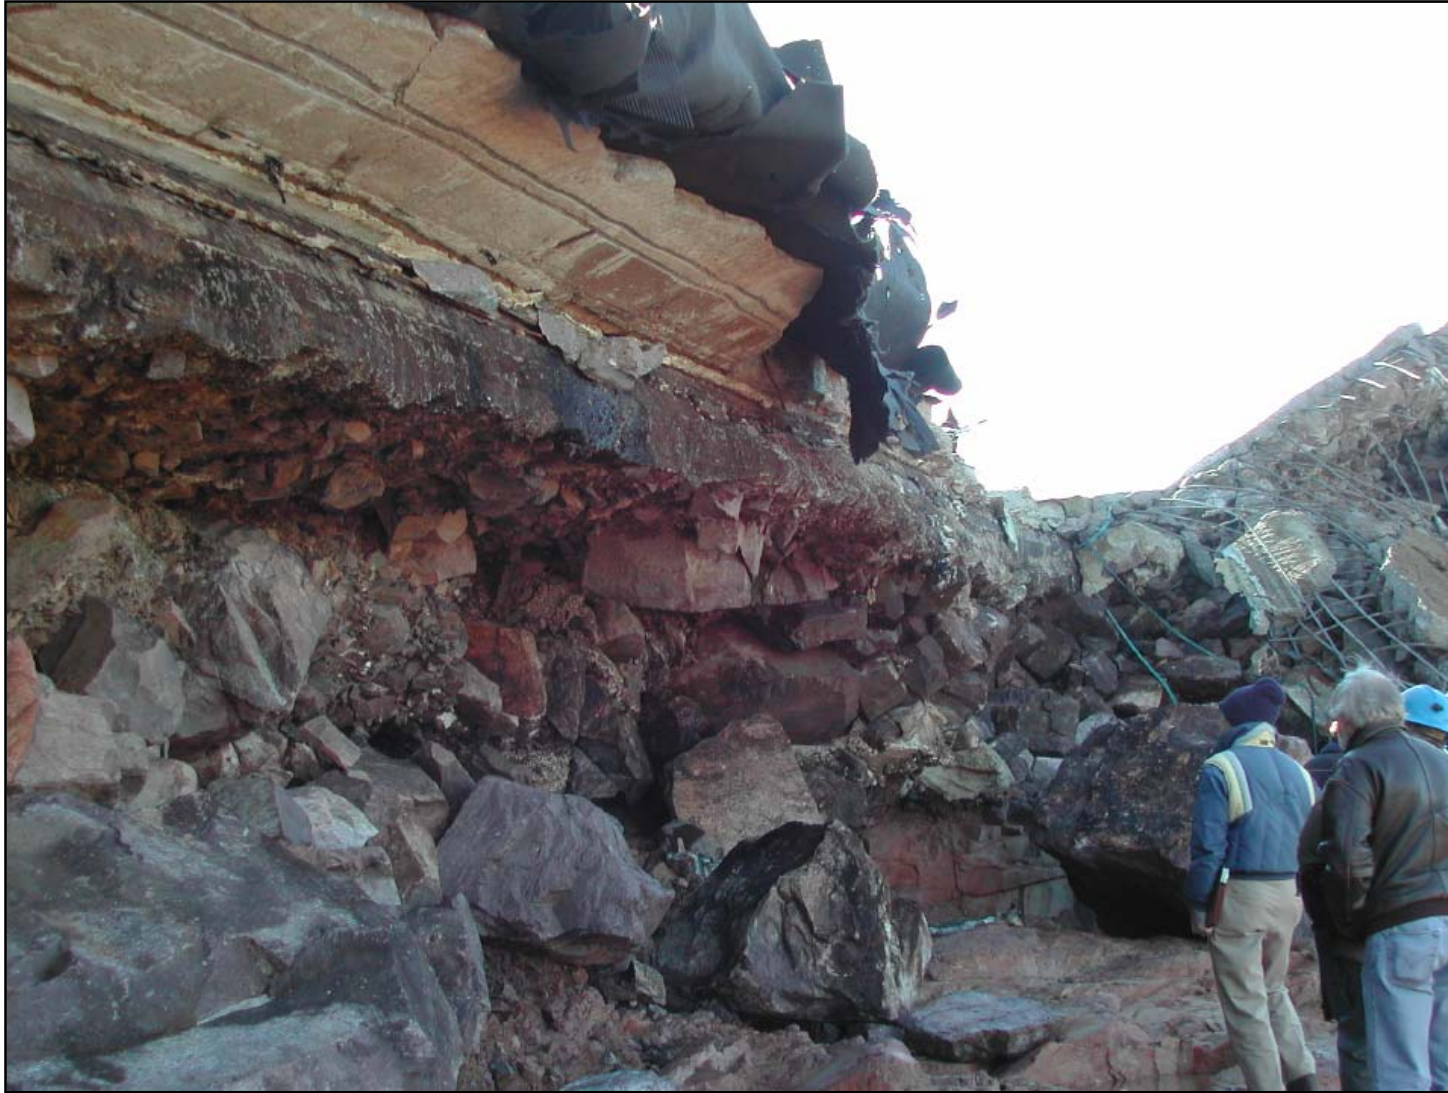
Figure 6-7

Rockfill between top of rock and base of plinth,
note reddish grout in rockfill beneath the plinth

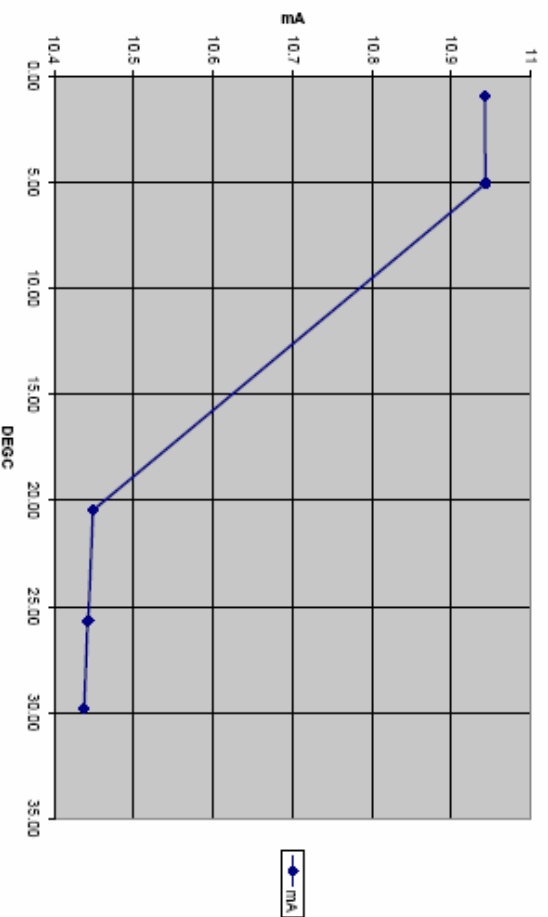
Figure 7-2

**Pressure Transducer Temperature Sensitivity
(TX2 Output Shift Represents +7.11 Ft. of Water Level
at 5 degrees compared to 20 degrees)**

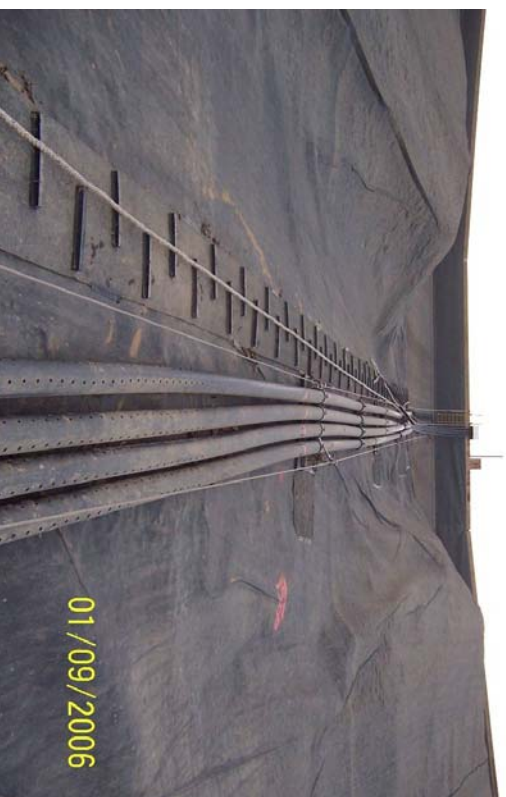
Figure 7-5

Note, straightening of protective pipes between dates of above photos.

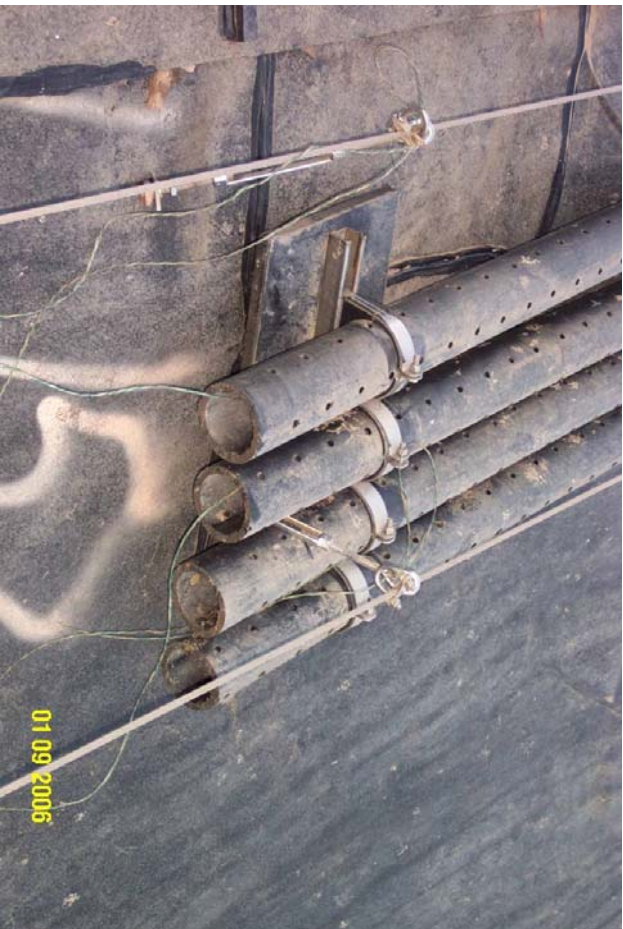
Figure 7-7

To avoid penetrations of the liner material and the creation of possible leakage paths, the protective pipes were supported on plastic plates that were connected by eye bolts to two stainless steel guide cables. The cables were secured only at the bottom and top of the reservoir. Figures 7-7 and 7-8 show these support systems as found after the breach event.

Protective pipe base plates are not anchored to reservoir.
Left guy cable has come loose from base plate in top photo.

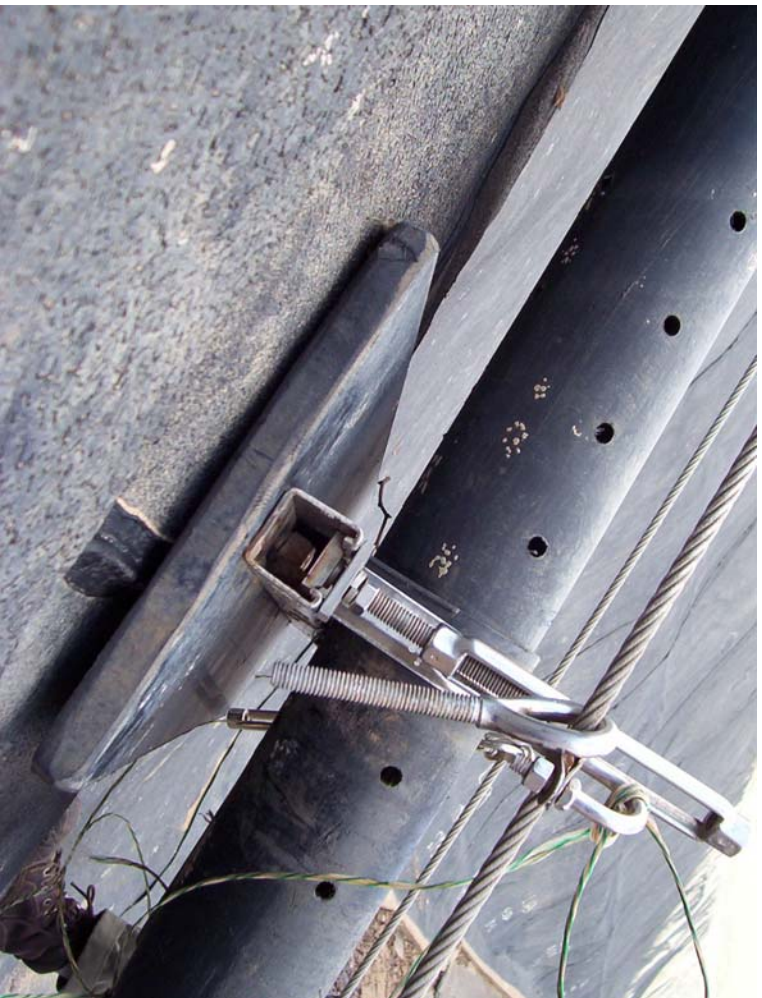
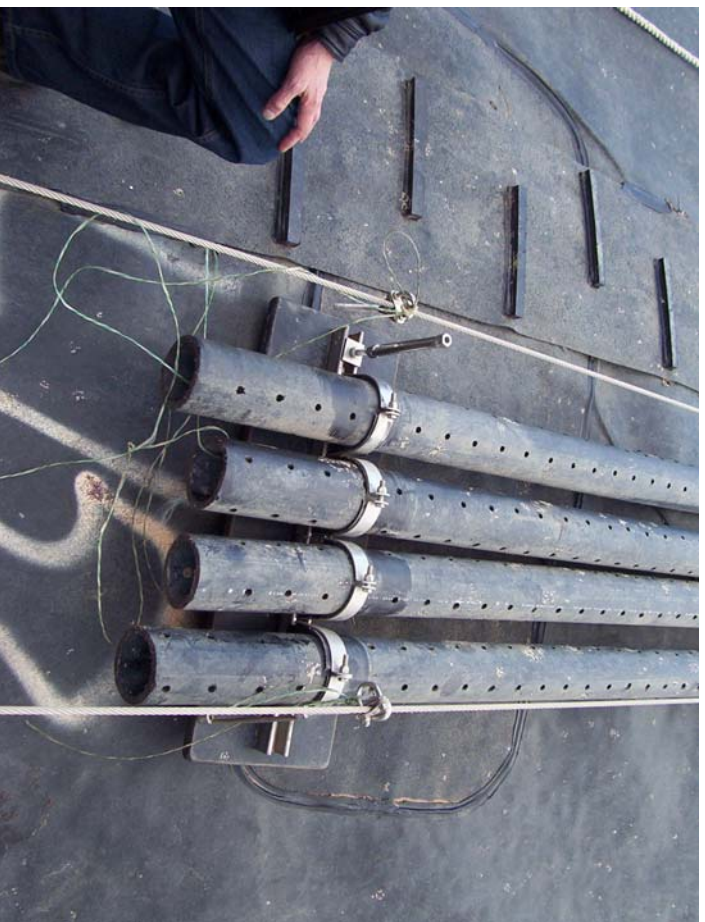
Figure 7-8

Protective pipe support system as found. Note eye bolt unthreaded from turnbuckle. Also note lock washer in place at connection to U channel but lack of lock washer at turnbuckle.

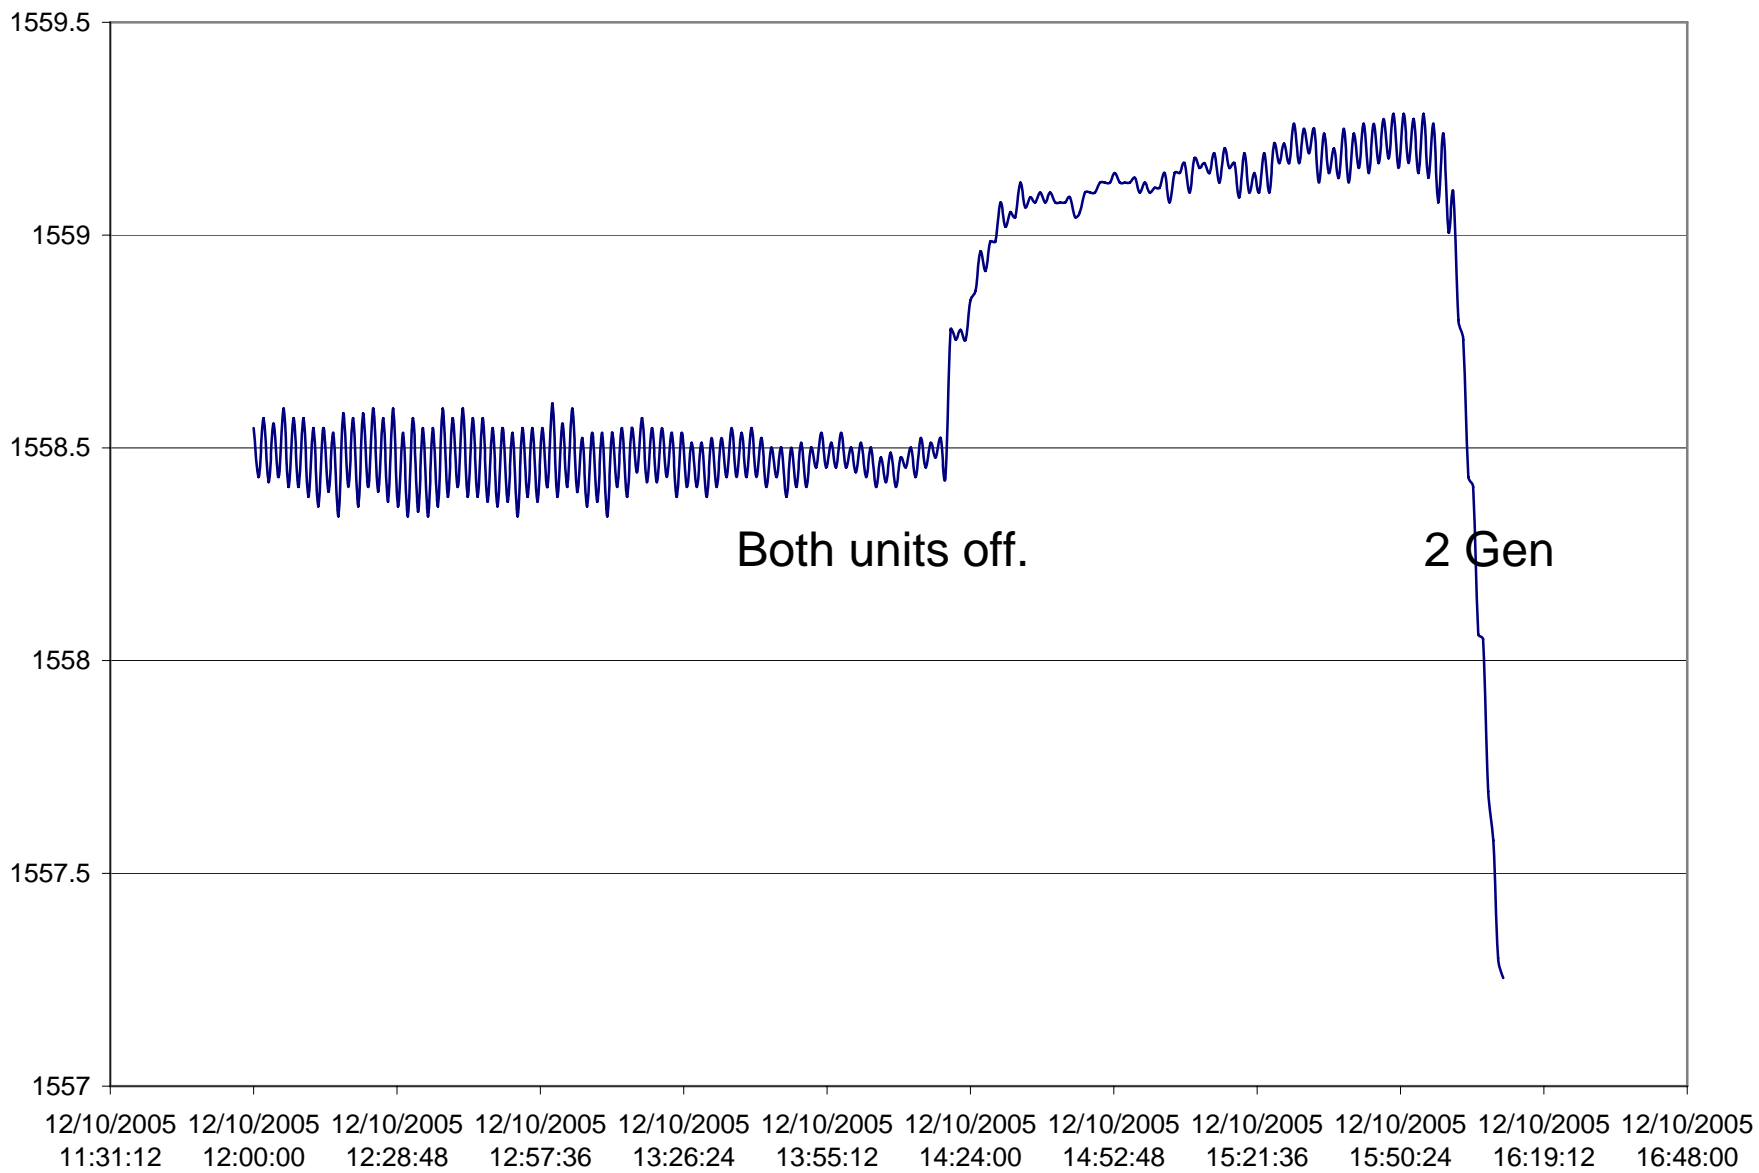
Figure 7-23 shows an interesting pattern of water level readings for December 10, 2005 with both units off followed by both units generating. We don't know if these level fluctuations are due to transducer movement or other causes. The left portion of the plot seems to be damping out until the disturbance around 14:24. The subsequent fluctuations appear to be building in amplitude until the two generators began operation.

Erratic level indications on Dec. 10th.

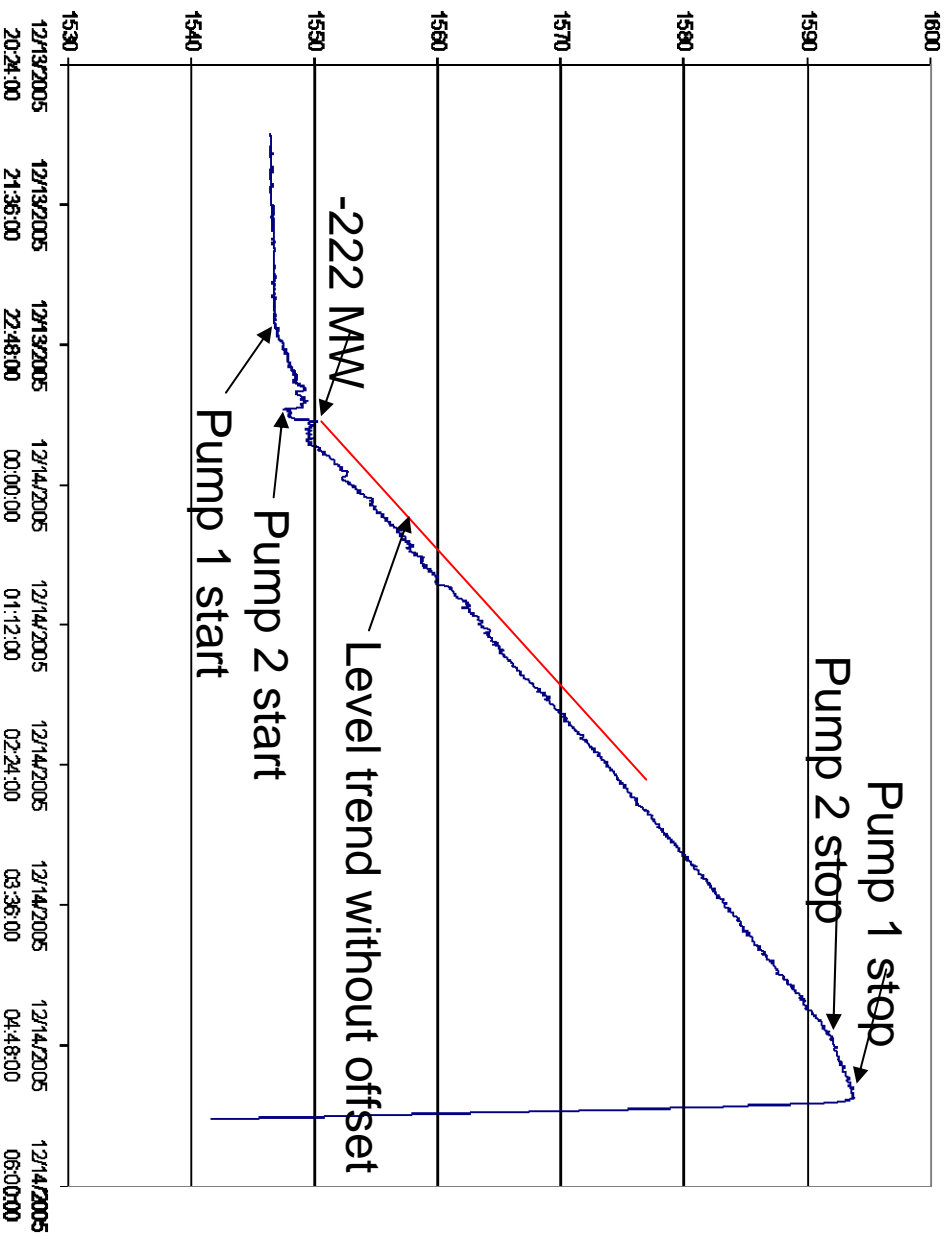
Figure 7-24 shows the water level readings from the start of both pumps on December 13, 2005 through the reservoir failure on December 14, 2005. The – 222 MW arrow shows the indicated water level when pump 2 completed its start sequence. The water level indication remained level for about 12 minutes rather than immediately beginning the more rapid rate of rise that it should have. At that level of Elev. 1550, two pumps were producing a level rise of about 10 feet per hour or about 2 feet in those 12 minutes. While there were smaller subsequent level indication fluctuations, they did not restore the level readings back to the trend line shown.

The most logical explanation is that during those twelve minutes the transducers were moving up at about the same rate as the water level, hence showing no level change during the interval. The line labeled “Level trend without offset” shows where the water level indications should have been without the offset. It should be noted that the level indication at the beginning of the plot is not necessarily accurate given the many indications of prior transducer movement and erratic readings. It is also possible that generating mode flows past the transducers may have tended to bring the protective pipes back to near their original positions resulting in some periodic level error corrections.

**Level indications after pump 2 start shows an offset.
-222 MW = Completion of pump 2 start sequence.**
