Transmission Facility Outages During the Northeast Snowstorm of October 29–30, 2011

Causes and Recommendations

Federal Energy Regulatory Commission *and* the North American Electric Reliability Corporation

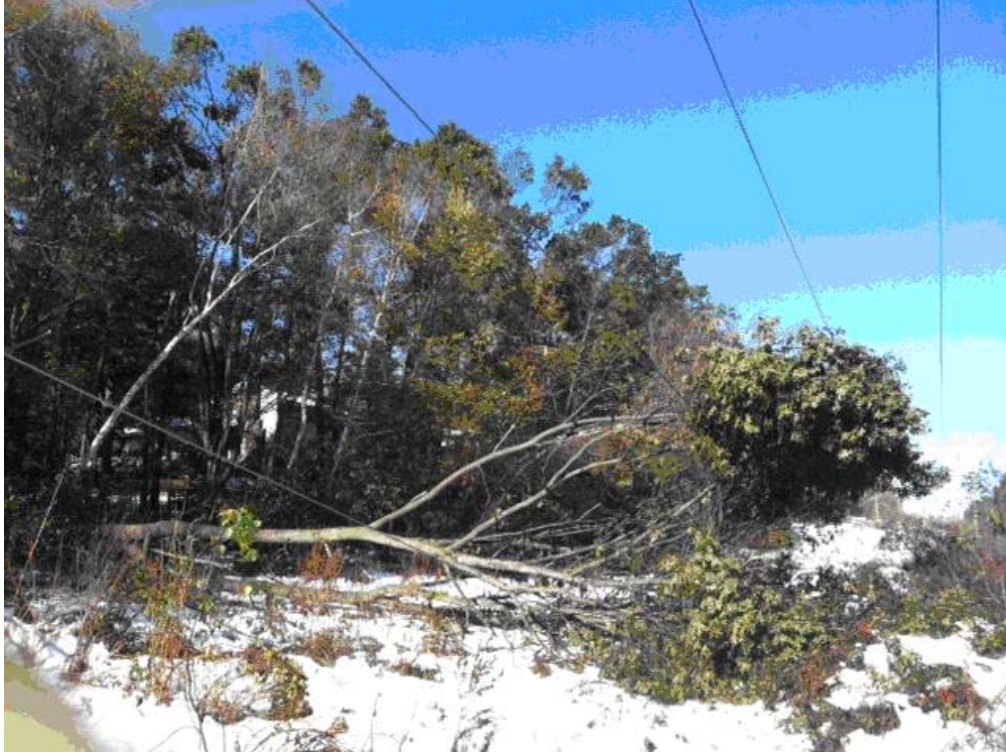
Figure 13: Trees Fallen on 115kV Line in Connecticut

The 115 kV line in the photograph below was forced out of service when several trees, each over sixty feet tall and located twenty to thirty feet outside of the utility's full right-of-way, uprooted and fell onto three separate spans of the line. Transmission lines are not always located in the middle of a right-of-way, but instead often are closer to an edge of the right-of-way. Thus, as is the case here, a tree may be outside the boundaries of a 130 foot wide right-of-way but still less than sixty-five feet from a conductor.

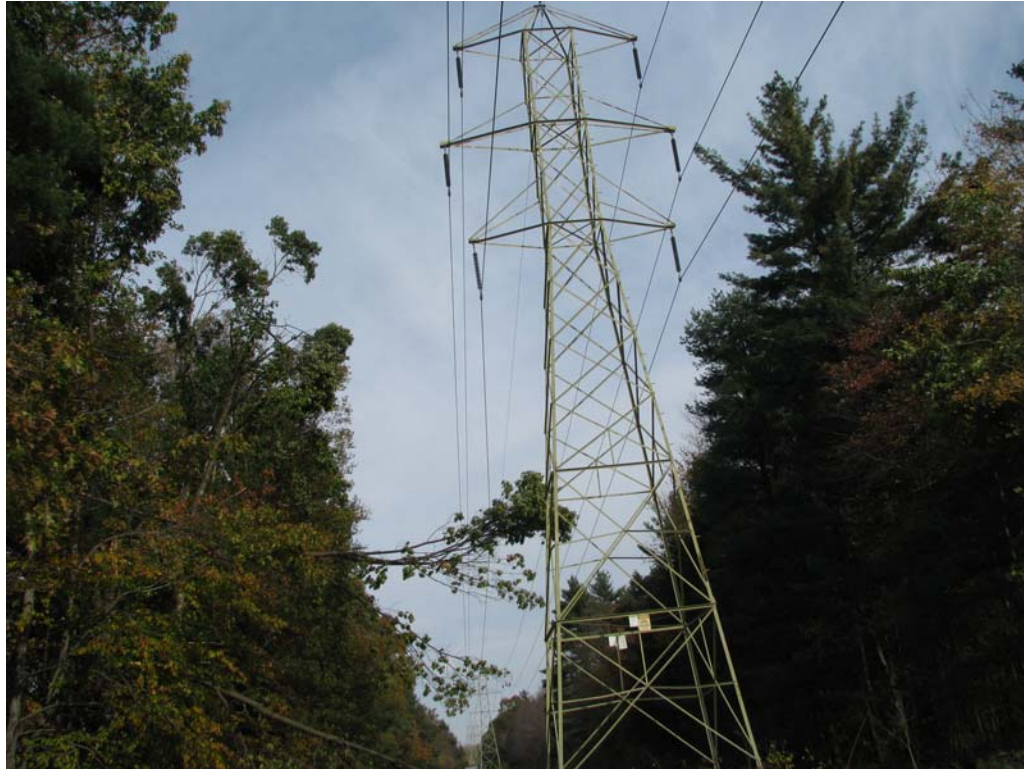
Figure 14: Tall Tree Fallen on an 115kV line in Massachusetts

The line in the photograph below is a 115 kV line in Massachusetts that went out of service when a seventy-five foot tall tree located outside of the 100 foot wide maintained right-of-way, but inside the 200 foot wide full right-of-way, fell onto the line. Because the transmission line was not centered on the right-of-way, the base of the tree, while outside the maintained right-of-way, was only about 30 feet from the nearest conductor.

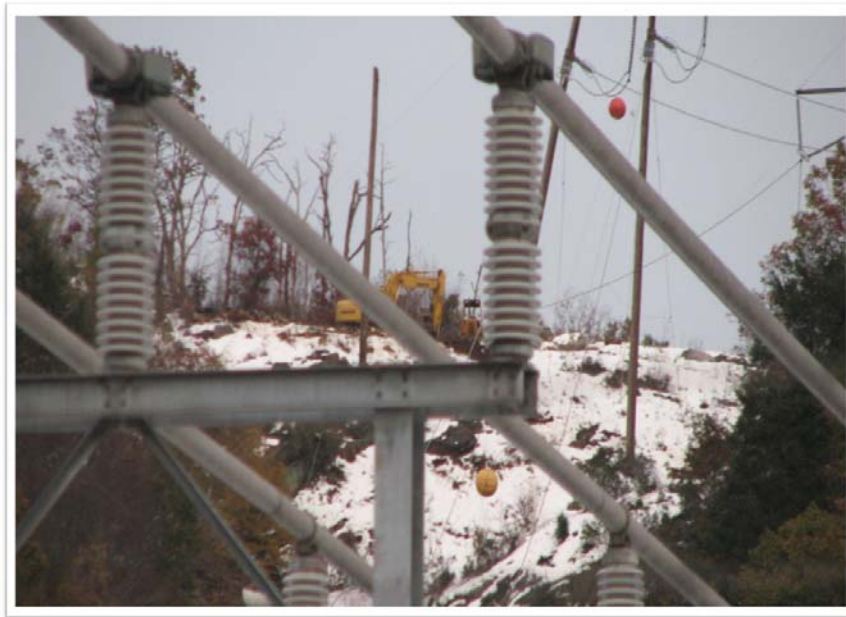
Figure 15: Structure Failure on a 345kV Line in Connecticut

Extreme weather conditions caused several transmission facilities to break, resulting in transmission line outages. Temperatures during the snowstorm hovered around 32 degrees, which is conducive to the accumulation of ice and snow on transmission lines. The weight of the accumulated ice and snow on conductors, and, in one case, high wind conditions, caused a number of structures — including static wires,⁶⁶ conductors, insulators,⁶⁷ and cross-arms⁶⁸ — to break, resulting in six transmission line outages and approximately 32,000 customer outages. Although a number of the transmission structures that failed were several decades (or even more than fifty years) old, it does not appear, based on data obtained during the inquiry, that these structures were in need of repair before the storm. Data reviewed by staff also indicates that the affected structures had been maintained according to utility plans, which staff finds are consistent with typical utility practice.

The 345 kV line shown in the photograph above was forced out of service when the weight of ice and heavy, wet snow on conductors damaged a structure and broke a conductor, static wire, cross-arms, guy-wires,⁶⁹ and insulators. This photograph shows (in the background) a wood pole where cross-arms and guy-wires have broken and the conductor has fallen to the ground.
