9.0 OPERATION AND CONTROL AT TAUM SAUK

9.1 INSTRUMENTATION

9.1.1 Instrumentation and Controls System

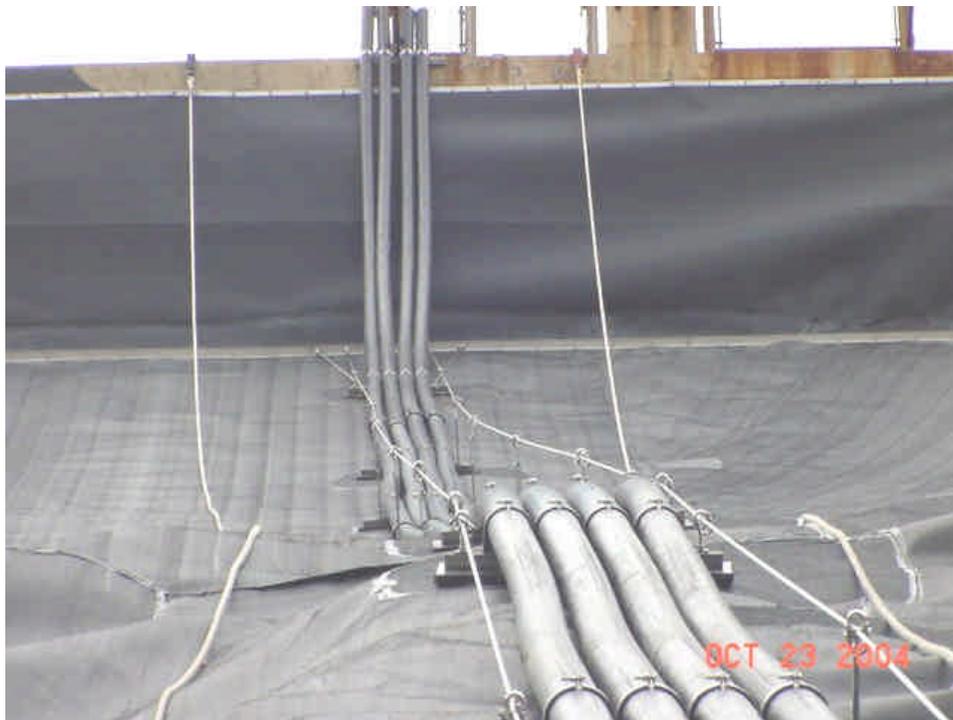
FIGURE 9-1

As outlined above, field changes were required because initial design was inadequate. The original design (Appendix H - Drawing # 8304-X-155099 Rev. 4) called for eye-bolts to attach the clamp baseboard/spacer to the guide cables. In the field, it was noted that once the guide cables are tensioned, the distance from the baseboard to the cable was quite variable. See *Figure 9-1* for an understanding of the turnbuckle locations.

TURNBUCKLE-GUIDE CABLE-INSTRUMENT CONDUIT SYSTEM

Since it would have been difficult and time-consuming to set the length of each eye-bolt to match the curvature of the embankment, the design was changed to accommodate turnbuckles in most clamp locations so that they could be field-adjusted as needed. The bottom anchor for the guide cable was changed to a turnbuckle also. We consider both changes to be a significant deviation from the original design. RIZZO's findings indicate that these field changes were poorly documented.

Overall, the substitution of a turnbuckle in a location where a bolt was originally specified was not adequate. From a generic perspective, the mechanism of bolted connections is such that the nut is held in place by the friction of the nut on the part being connected. The friction acting on the threads is not credited as there is an inherent gap between the threads of the bolt and of the nut that allows the nut to turn. This gap allows a slight vibration to release the friction in the thread-to-thread interface. In other words, to rely only on thread-to-thread friction to maintain the integrity of a bolted connection is not adequate and not consistent with function of the bolted connection.

At Taum Sauk, the turnbuckles were tightened, but no locking device, such as a locking nut or spot weld, was used to secure the fixity of the connection against vibratory effects. Thus, over time, the turnbuckle loosened and eventually was unscrewed completely. As can be seen in several photos available in the AmerenUE records, several turnbuckles were installed using less than one inch of thread.

Firstly, as the water flows around the turnbuckles, turbulence initiates a vibration in the turnbuckles. This, combined with the tension in the threads, can loosen the turnbuckles. *Figure 9-1*, taken immediately after the installation of the HDPE pipes and supports, shows that many of the turnbuckles were installed with little or no male thread protruding from the female thread. This means that as a few as a dozen revolutions of the turnbuckle could have failed the connection.

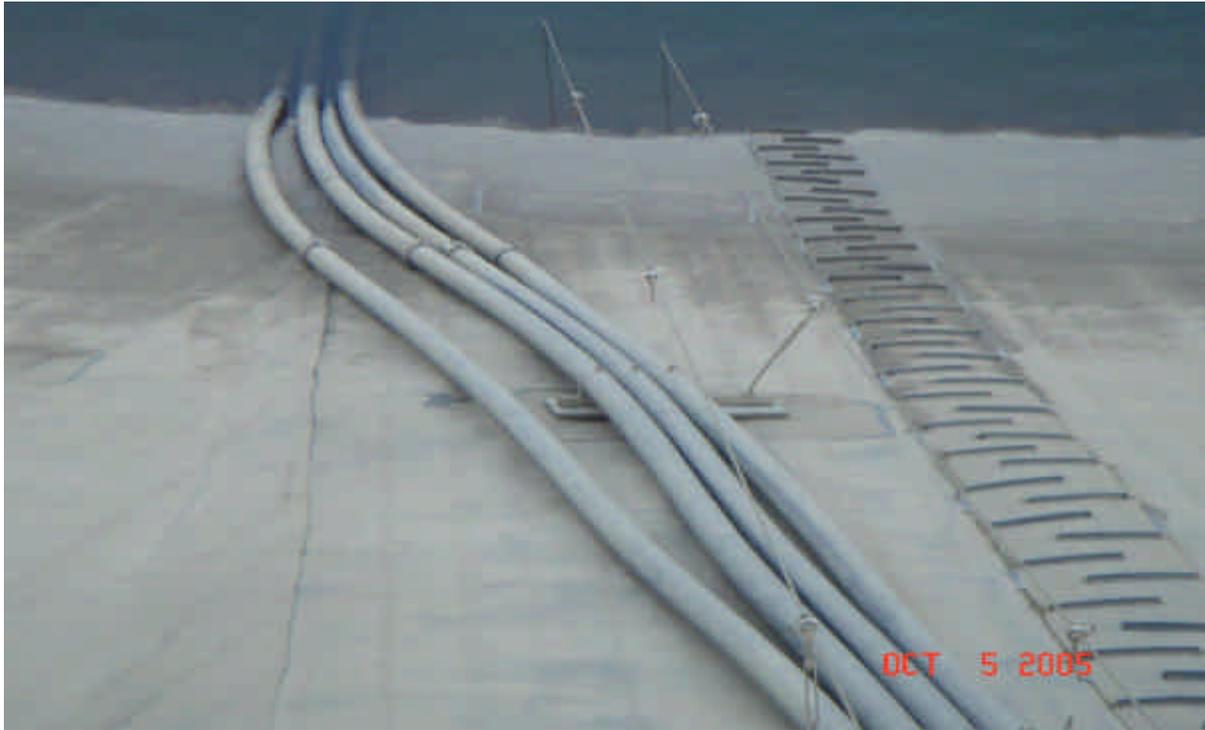
FIGURE 9-2

As may be seen in *Figure 9-1*, the bottom portion of the turnbuckle is connected to a horizontal steel member, called a Unistrut. A Unistrut is a U-shaped member with flanges that allow for a clamp to grasp the member. We observe on *Figure 9-2* that the Unistrut assembly failed to function as intended. The nut-Unistrut assembly became disengaged when the lateral displacement of the Unistrut became more pronounced (over one or two feet) as may be seen on *Figure 9-2*. It is RIZZO's opinion that the side to side movement of the instrumentation conduit allowed momentum to build up enough to create impact forces on the Unistrut-clamp connection. These impacts caused the clamps to slide off the Unistrut, leaving the instrumentation conduits to act as four individual elements instead of the much stiffer arrangement provided by the intended configuration.

LAYOUT OF INSTRUMENTATION CONDUITS AND UNISTRUTS

It has been postulated that movement of the instrumentation conduits in a back and forth swaying motion contributed to the failure of the turnbuckle-Unistrut-guide cable support system. This postulated behavior is difficult to quantify as it is not practical to ascertain the exact speed of the water flow in the vortex that forms around the “morning glory” inlet shaft. Indeed, the bottom surface of the Upper Reservoir around the “morning glory” was depressed to counter the possibility of vortex action during the generation cycle. In discussion with AmerenUE management, we understand anecdotally that vortex action occurs, possibly in the pumping mode as well. This is a difficult analytical problem to assess as regards the impact on the instrumentation conduits; therefore, we can only comment that no records or calculations were found that would document that this effort was undertaken.

Figure 9-2 shows the lateral displacement noticed in the conduits about two months before the overtopping failure of the Reservoir. Plant operators were aware that this lateral displacement would have the effect of raising the gage instruments and lowered the pump auto stop elevation by two feet after this observation. It is RIZZO's opinion that that this was not sufficiently conservative considering the level of uncertainty involved.
