Operational Failure Modes

Key Concepts

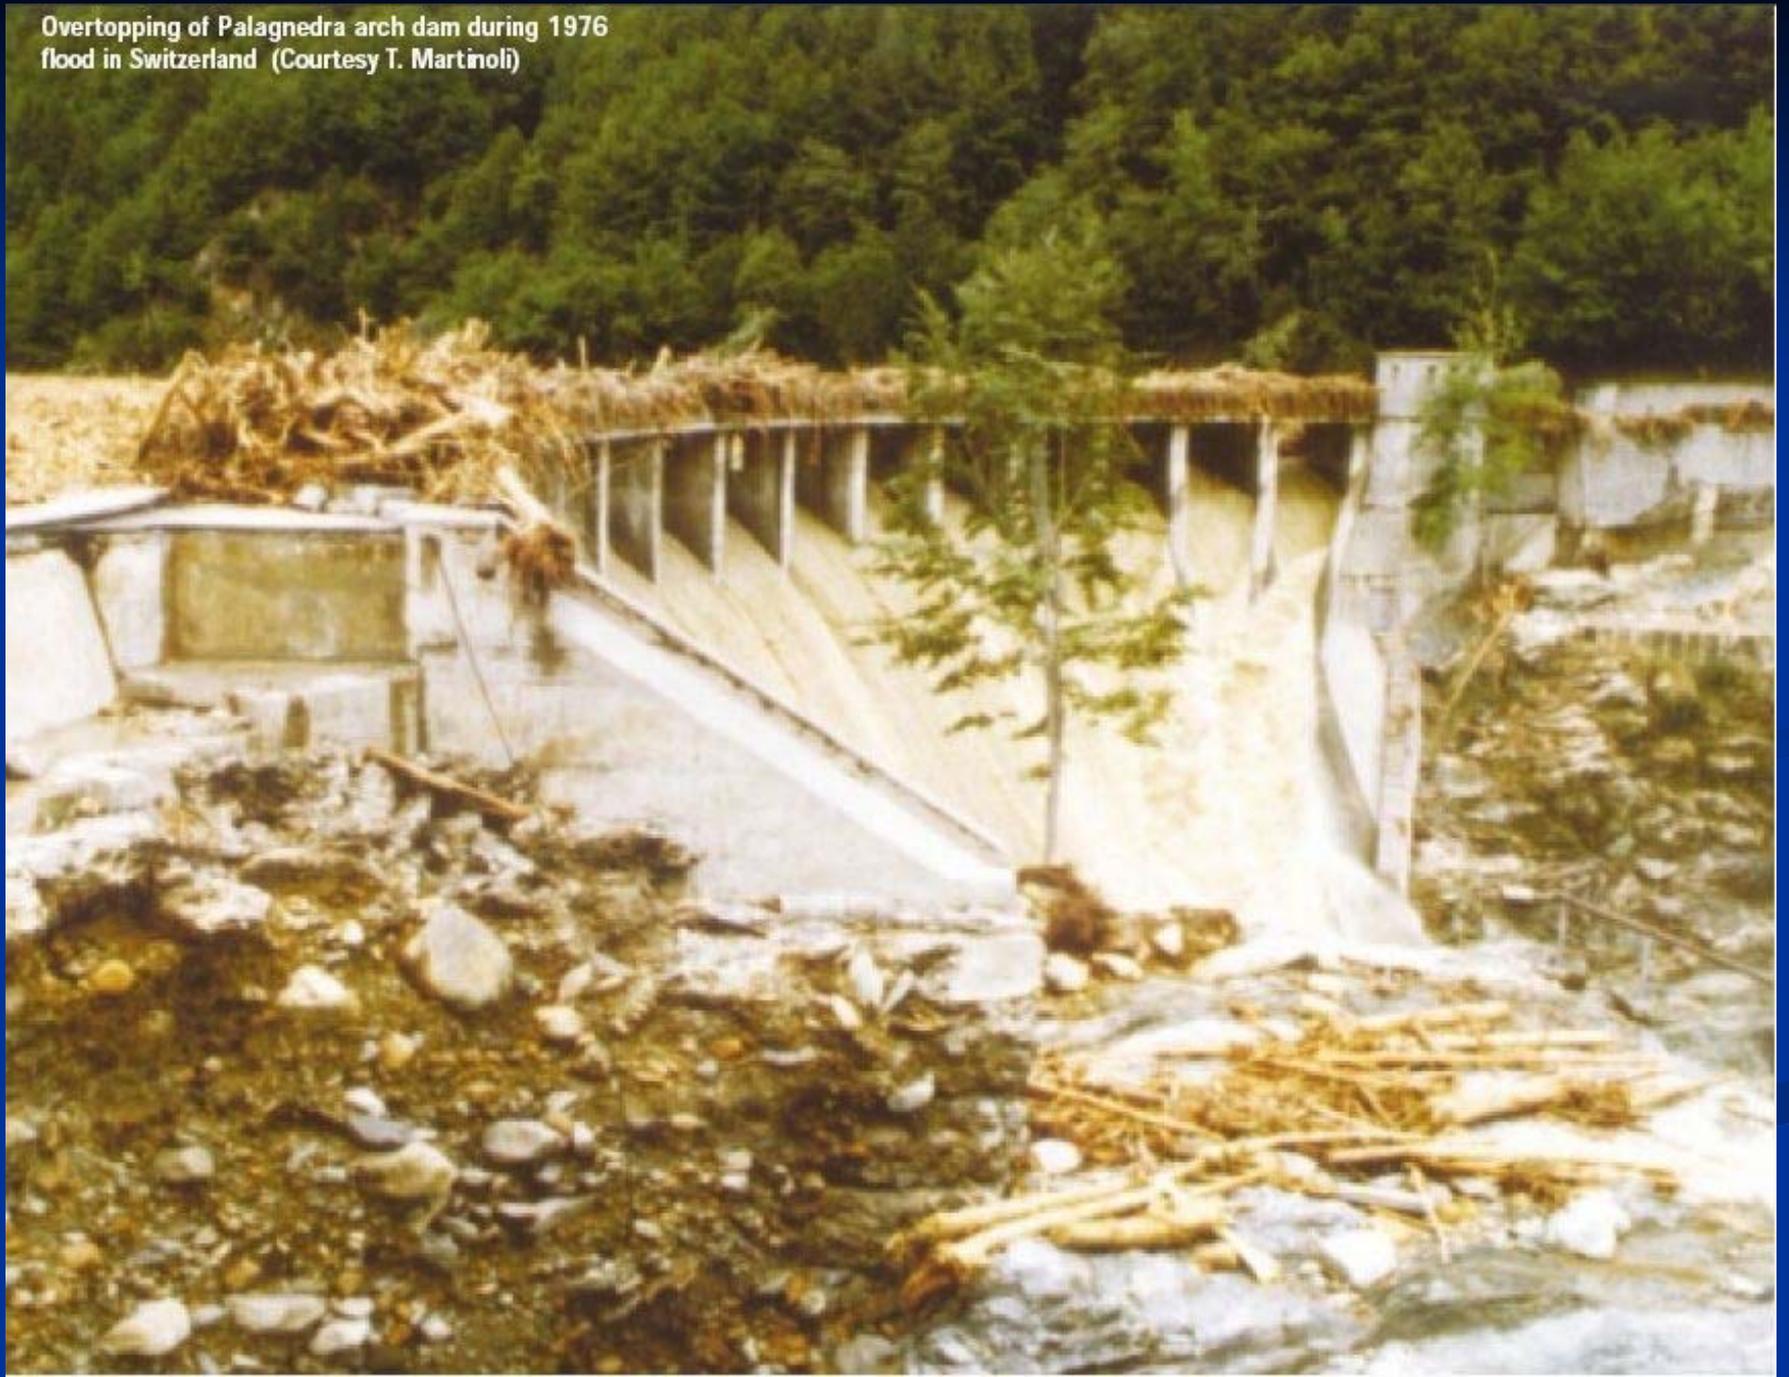
Overtopping of Palagnedra arch dam during 1976 flood in Switzerland (Courtesy T. Martinoli)

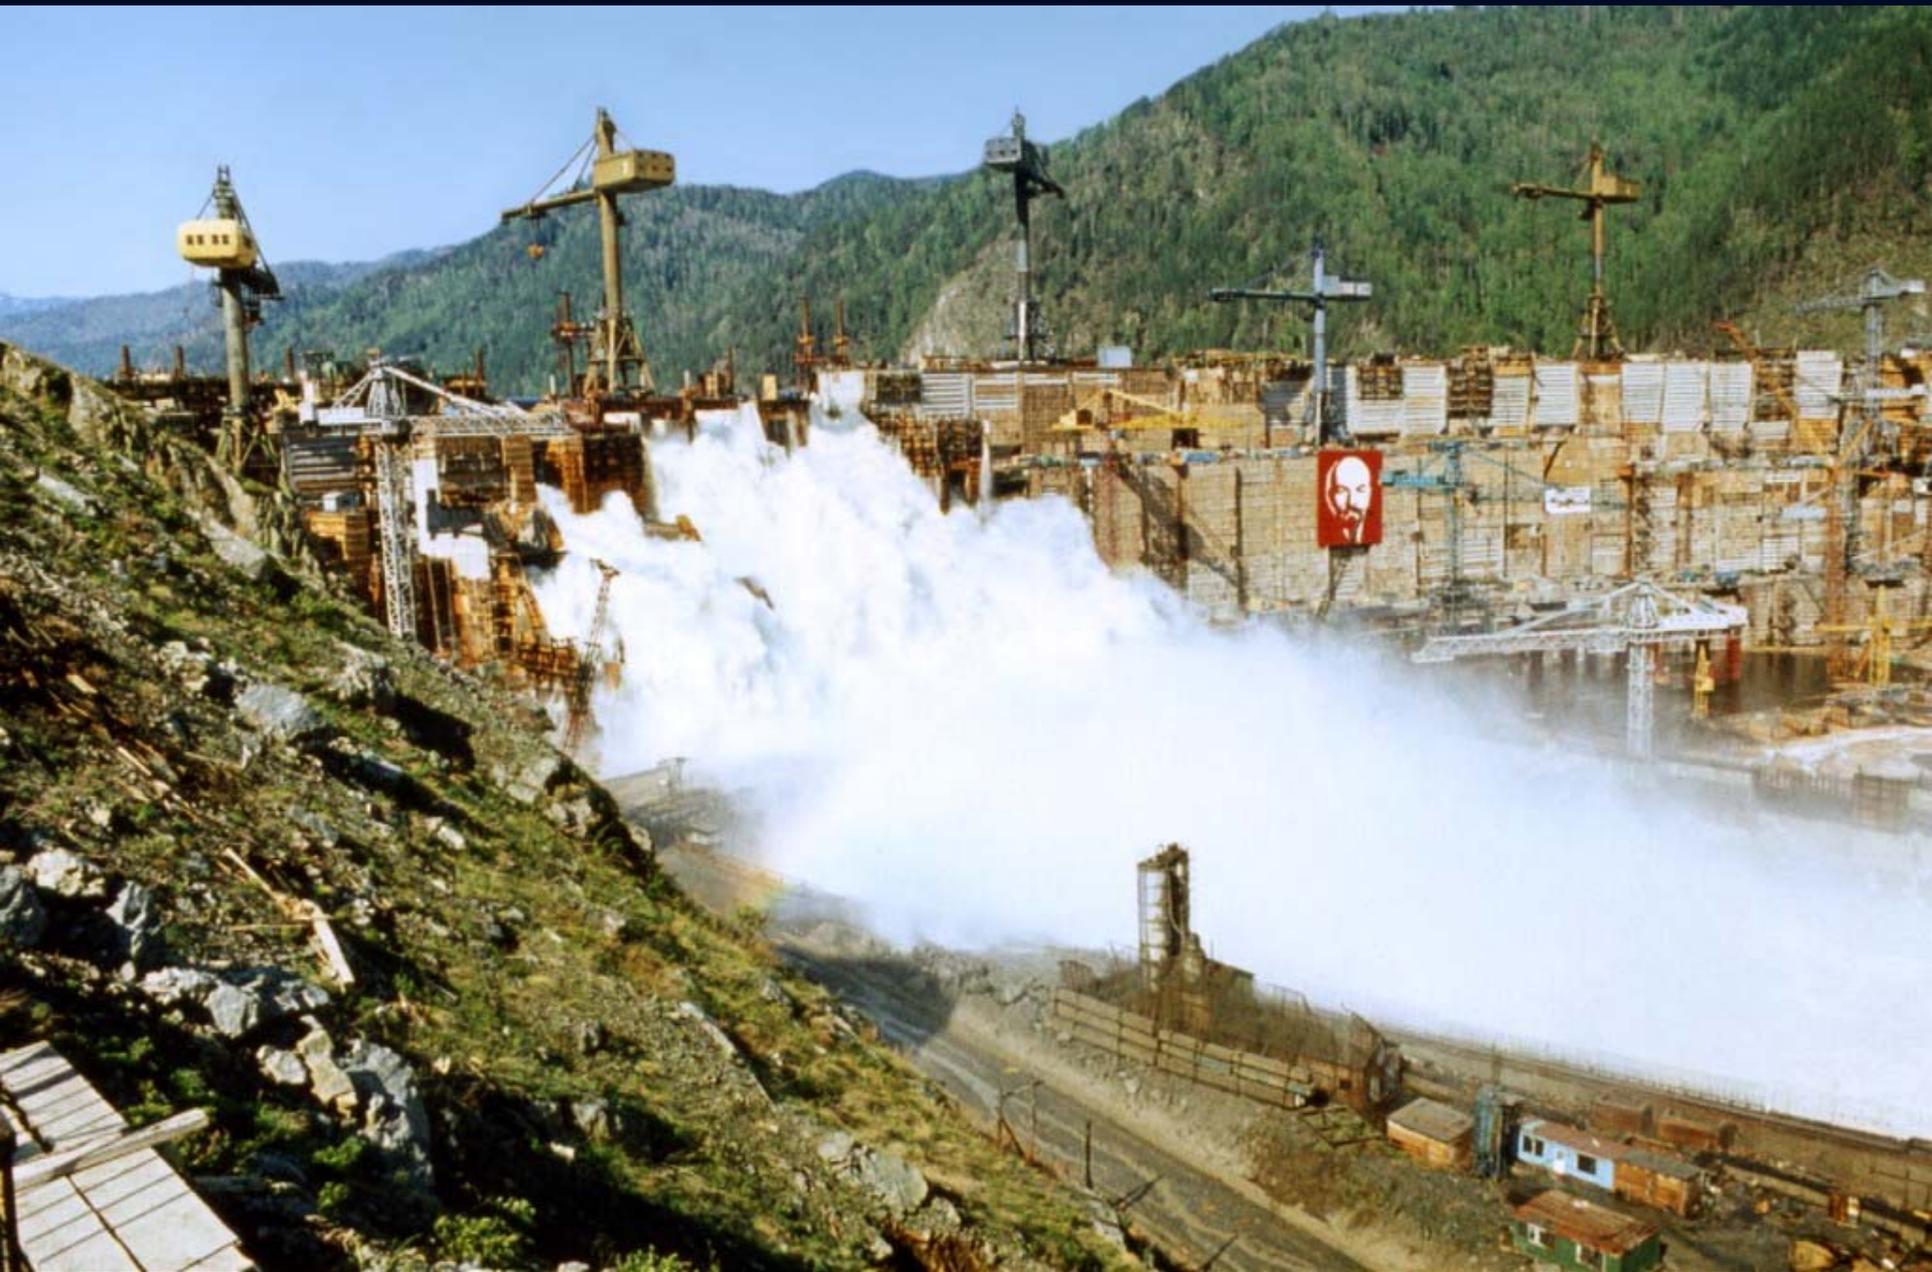
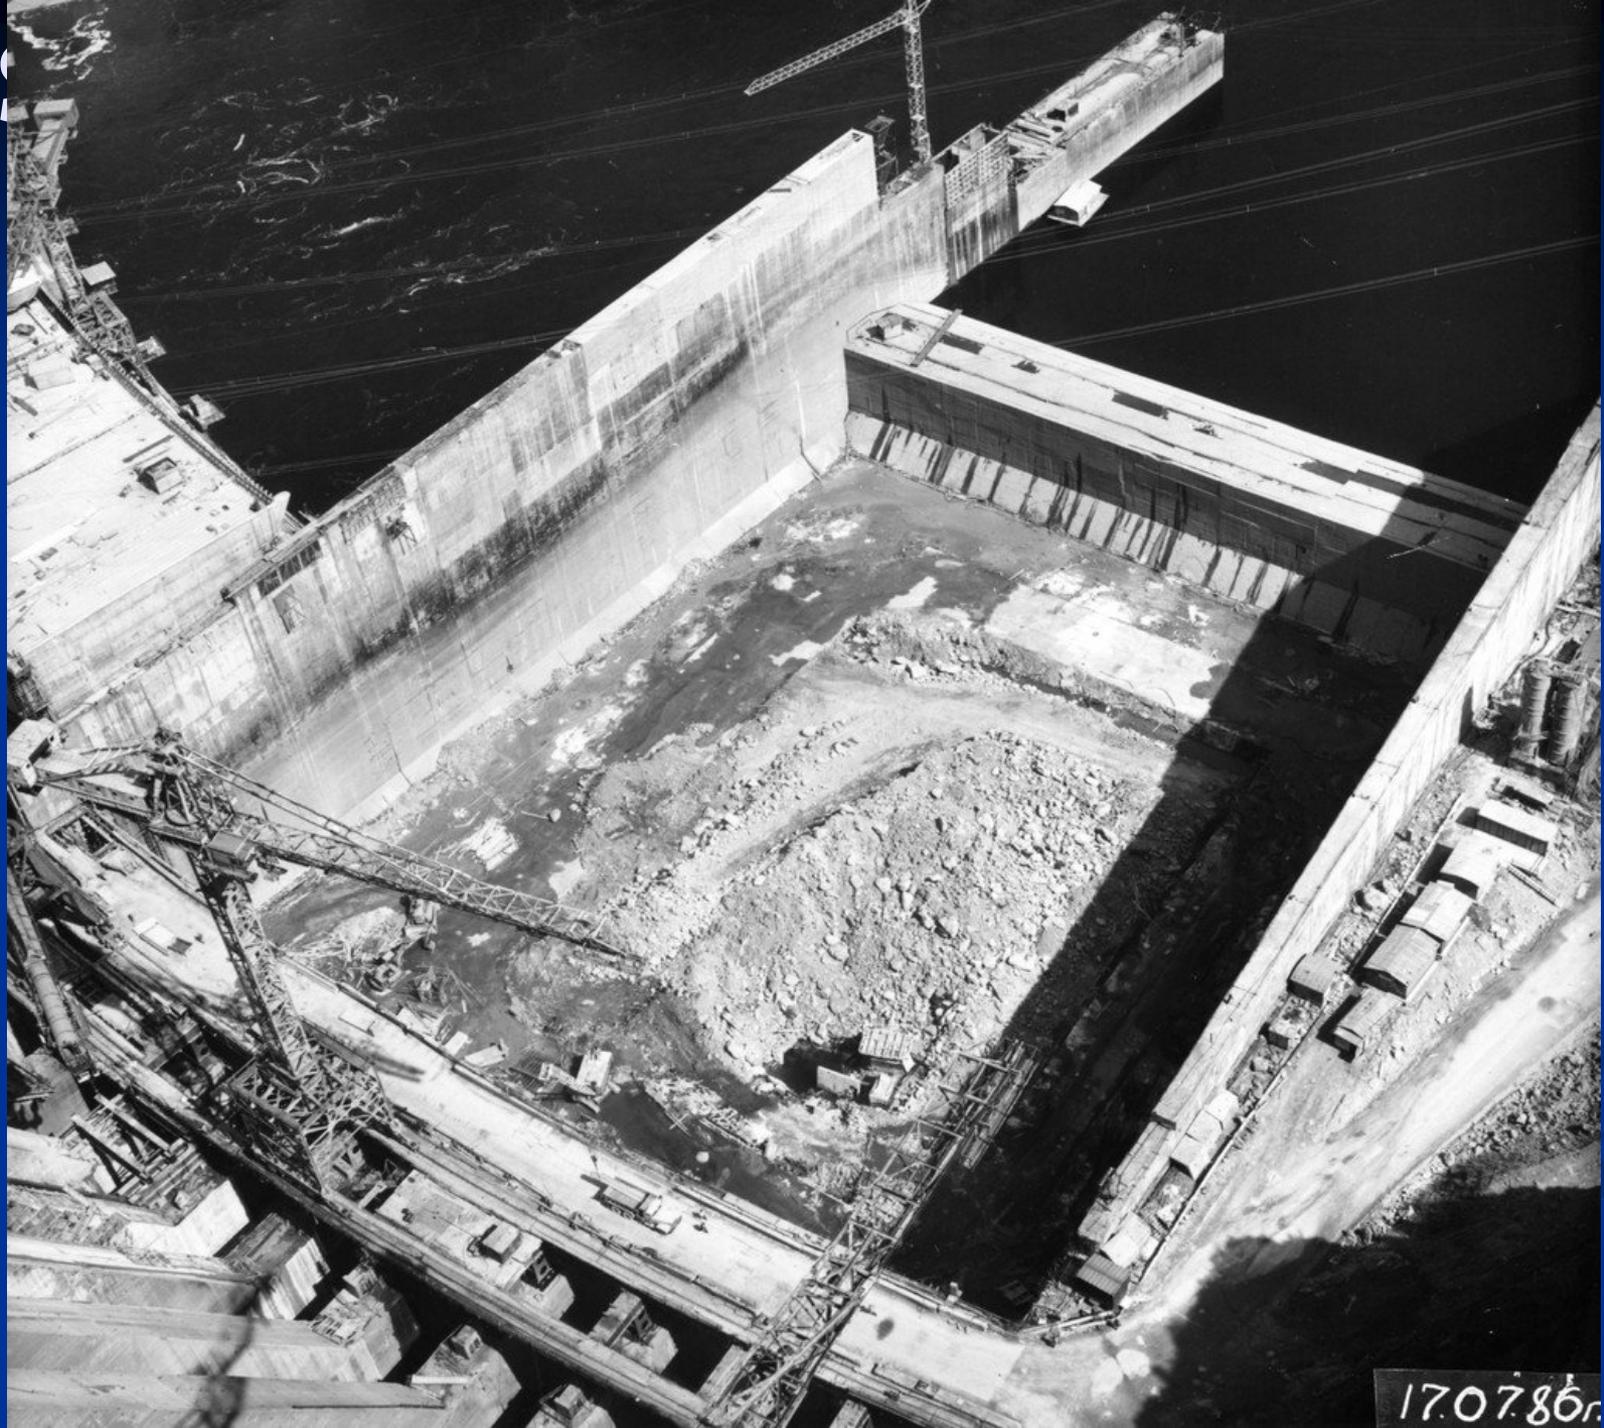
- During construction the spillway was used to pass water
- During construction a flood resulted in 4500 m³/s being discharged through the spillway
- The spillway stilling basin was severely damaged while passing 4500 m³/s - 7m of the foundation was eroded
- The flood also overtopped the partially constructed dam cracking the dam-foundation interface and some concrete monoliths
- The damage to the spillway was repaired
