**SIEMENS' REPORT
MARCH 24, 2006
AmerenUE**

AmerenUE Taum Sauk Incident Instrumentation and Controls Root Cause Investigation Report

March 24, 2006

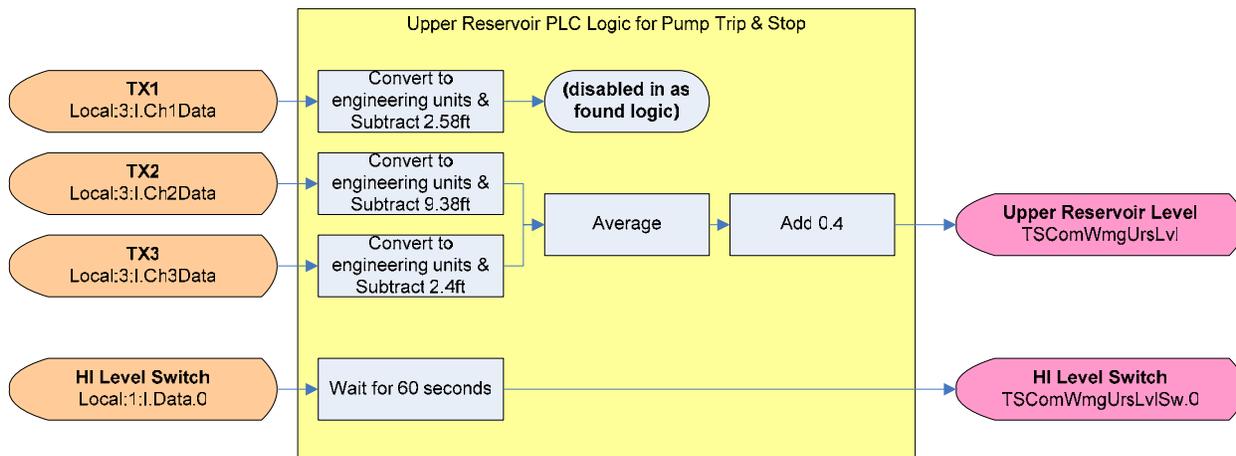
Figure 6: Upper Reservoir PLC Logic Diagram

The upper reservoir PLC is to read the three level transmitter signals through channel 1, 2 and 3 of the analog input card in slot 3. In the as found logic, the level transmitter signals are converted from 0.10000 integer range into actual engineering units. After this conversion, constants are subtracted. These constants were determined during the initial installation of the system in November 2004. The as found logic forms the average value of the two transmitters TX2 and TX3 and adds a constant of 0.4 to the average value. Transmitter TX1 is not used. The PLC also reads the HI level switch through channel 0 of the digital input card in slot 1. If the value becomes a 1 (e.g. the contact is closed), the PLC is to wait for 60 seconds before it makes this value available to other PLCs.

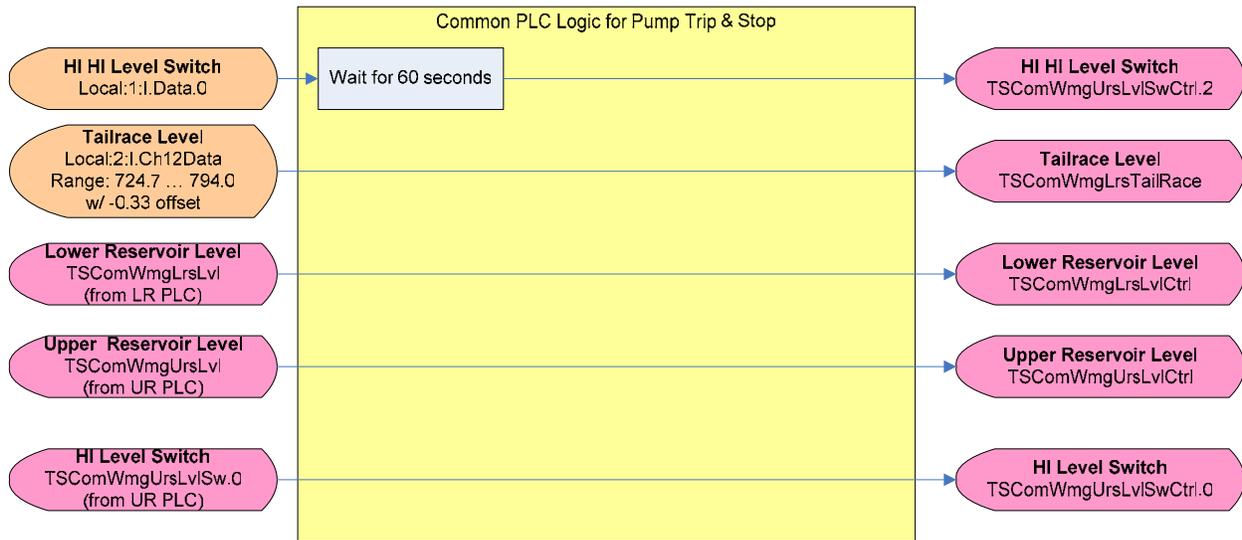
Figure 7: Common PLC Logic Diagram

The common PLC reads the HI HI level switch through channel 0 of the binary input card 1. The cable for the HI-HI signal is wired through the phone system from the UR PLC cabinet in the UR gauge house to the common PLC. The HI HI level signal needs to be active for 60 seconds before it is made available to other PLCs. The tailrace level transmitter is connected to the common PLC. The conversion to engineering units is performed in the input card. The common PLC is also to receive the UR level average, the LR average from the LR PLC and the HI signal from the UR PLC. It does not perform any logic or conversions with these values; it passes them to other PLCs.

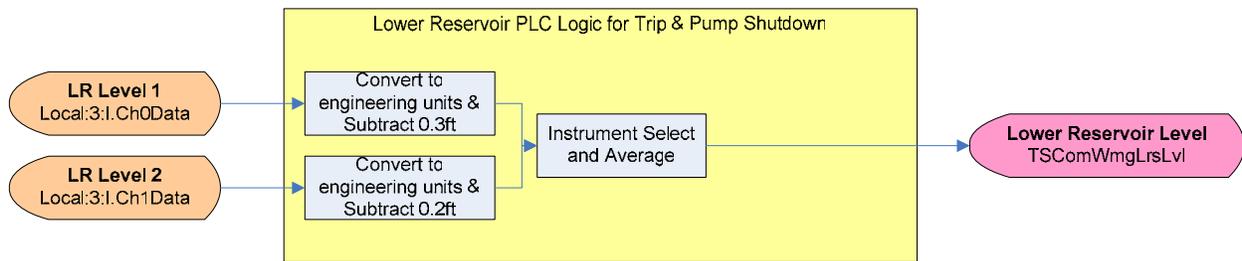
Figure 8: Lower Reservoir PLC Logic Diagram

The lower reservoir PLC is to read the LR level transmitters and converts the values into engineering units. Then it performs an average calculation of these two values. The operators can also choose to use either one of the two values instead of the average. According to the operator logs, transmitter #2 was not operational on 12-Dec-05, so transmitter #1 was selected as the sole source.

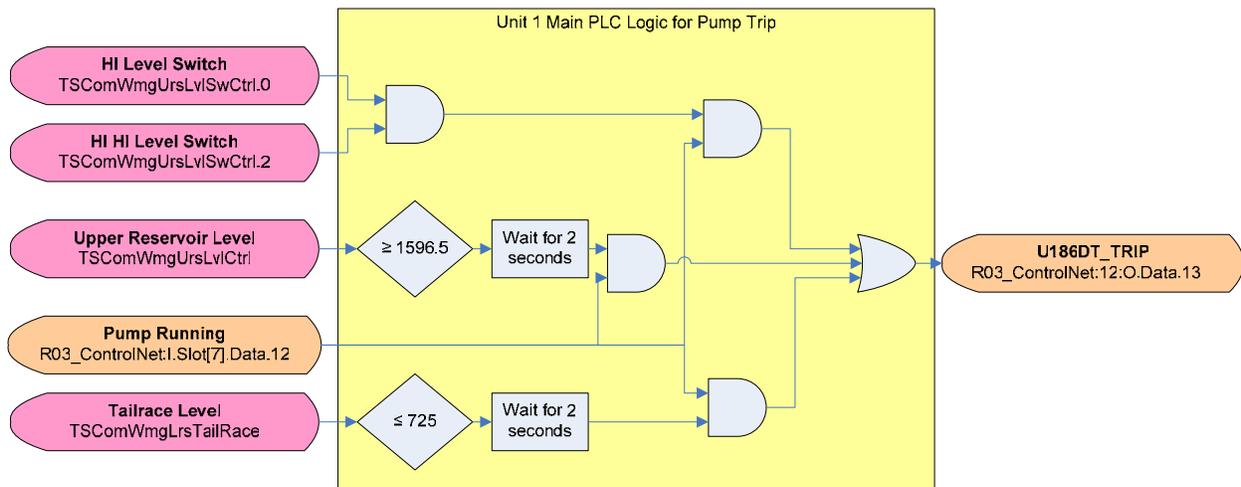
Figure 9: Unit 1 Main PLC Logic for Pump Trip

The Unit 1 main PLC performs the trip logic as outlined in the above sketch. Either a combination of the HI and HI-HI level switch, an indicated upper reservoir level of greater or equal than 1596.5 feet or a tailrace level of less or equal than 725 feet for more than 2 seconds is to trip the pump. The trip levels for the tailrace level (725 feet) and for the upper reservoir level (1596.5 feet) are coded into the PLC program and therefore not changeable by the operator.

The trip is performed by energizing the coil of relay 186DT which triggers an input signal of the governor PLC. This is to cause the governor PLC to trip the pump and to close the wicket gates. Since the historical process data indicates that the inputs for the trip signals were never satisfied (e.g. HI-HI alarm was never present, the maximum indicated upper reservoir level was 1593.72 which is below 1596.5 feet and the lowest tailrace level logged in the process data archive was 730.0 which is above 725.0 feet) during the incident, it is likely that relay 186DT was never energized and the trip circuit was therefore not further analyzed.

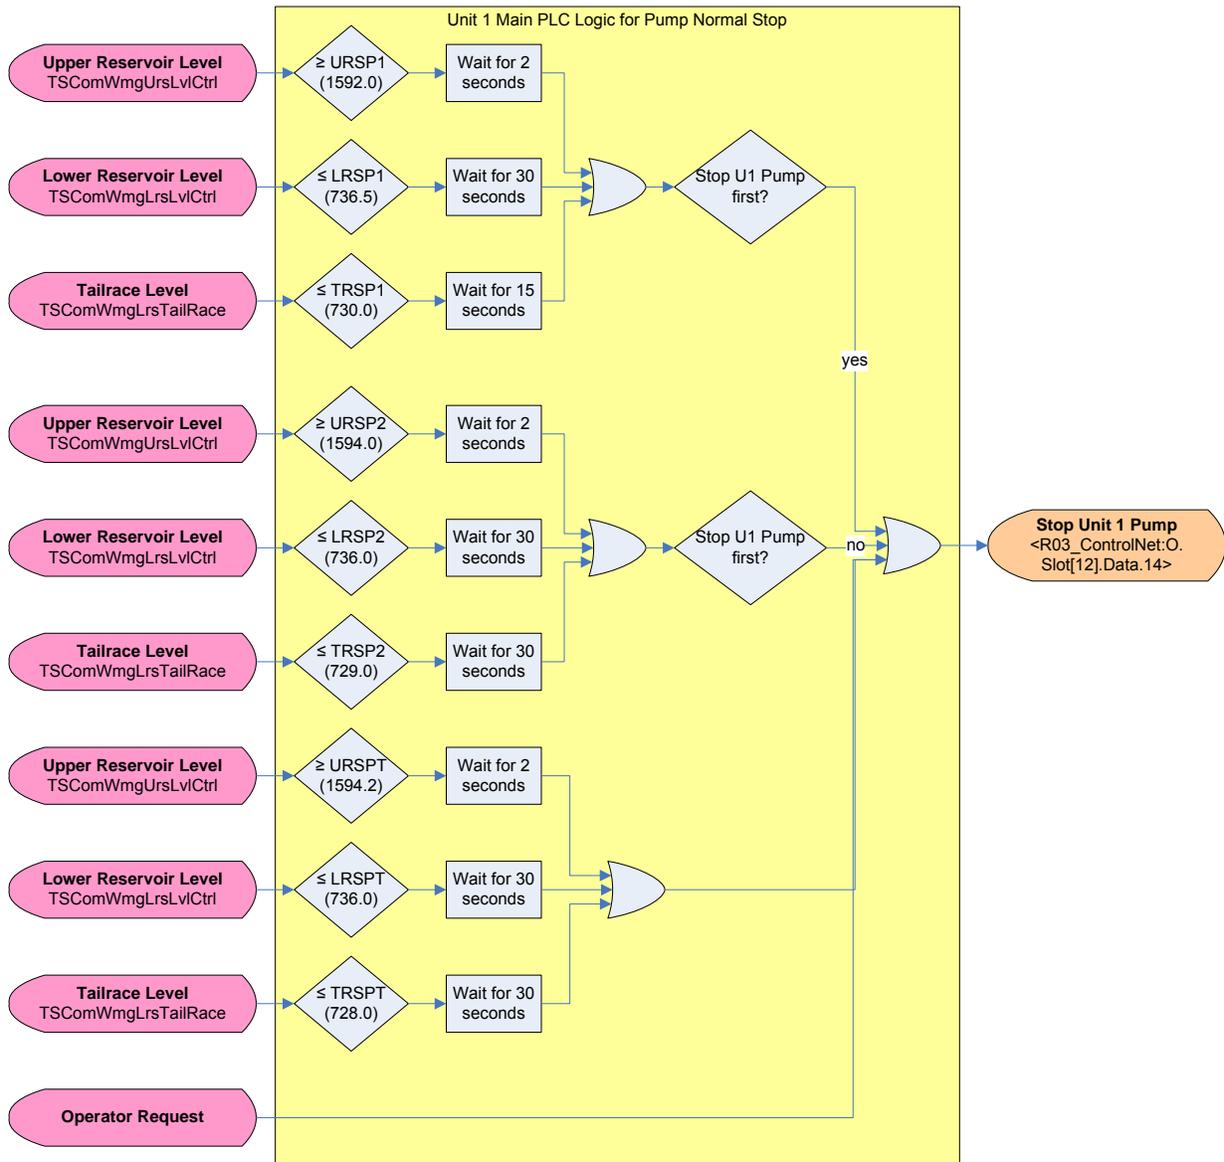
Figure 10: Unit 1 Main PLC Logic for Pump Stop

The logic for normal pump stop implemented in unit 1 main PLC is intended to stop pump #1 if the operator selectable set points for pump stop are exceeded. The effective set of setpoints is determined based on whether unit 1 is the first or the second unit to be shut down. The third set of setpoint is to shut down unit 1 regardless whether it has been selected to be shut down first or second. In any case, the signals need to exceed those setpoints for a pre-programmed period of time.

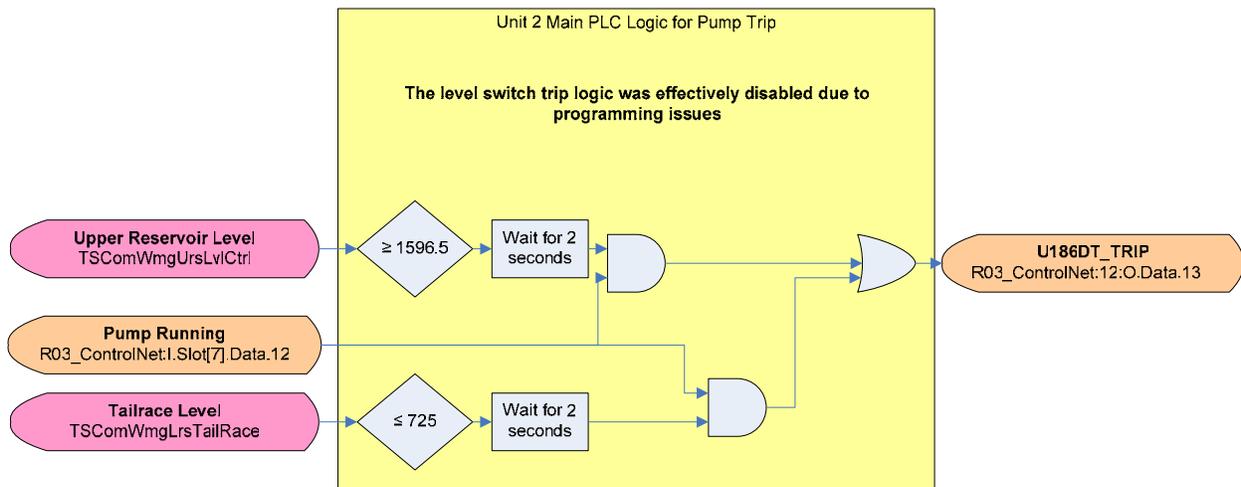
Figure 11: Unit 2 Main PLC Logic for Pump Trip

The trip logic implemented in the unit 2 PLC considers only the tailrace level and the upper reservoir level. The signals for the HI and HI-HI probes are not transmitted into the PLC. The logic for receiving the probe signal addresses the level transmitters; this appears to be in error. A review of the unit 2 main PLC program indicated a possible spelling error which led to this situation.

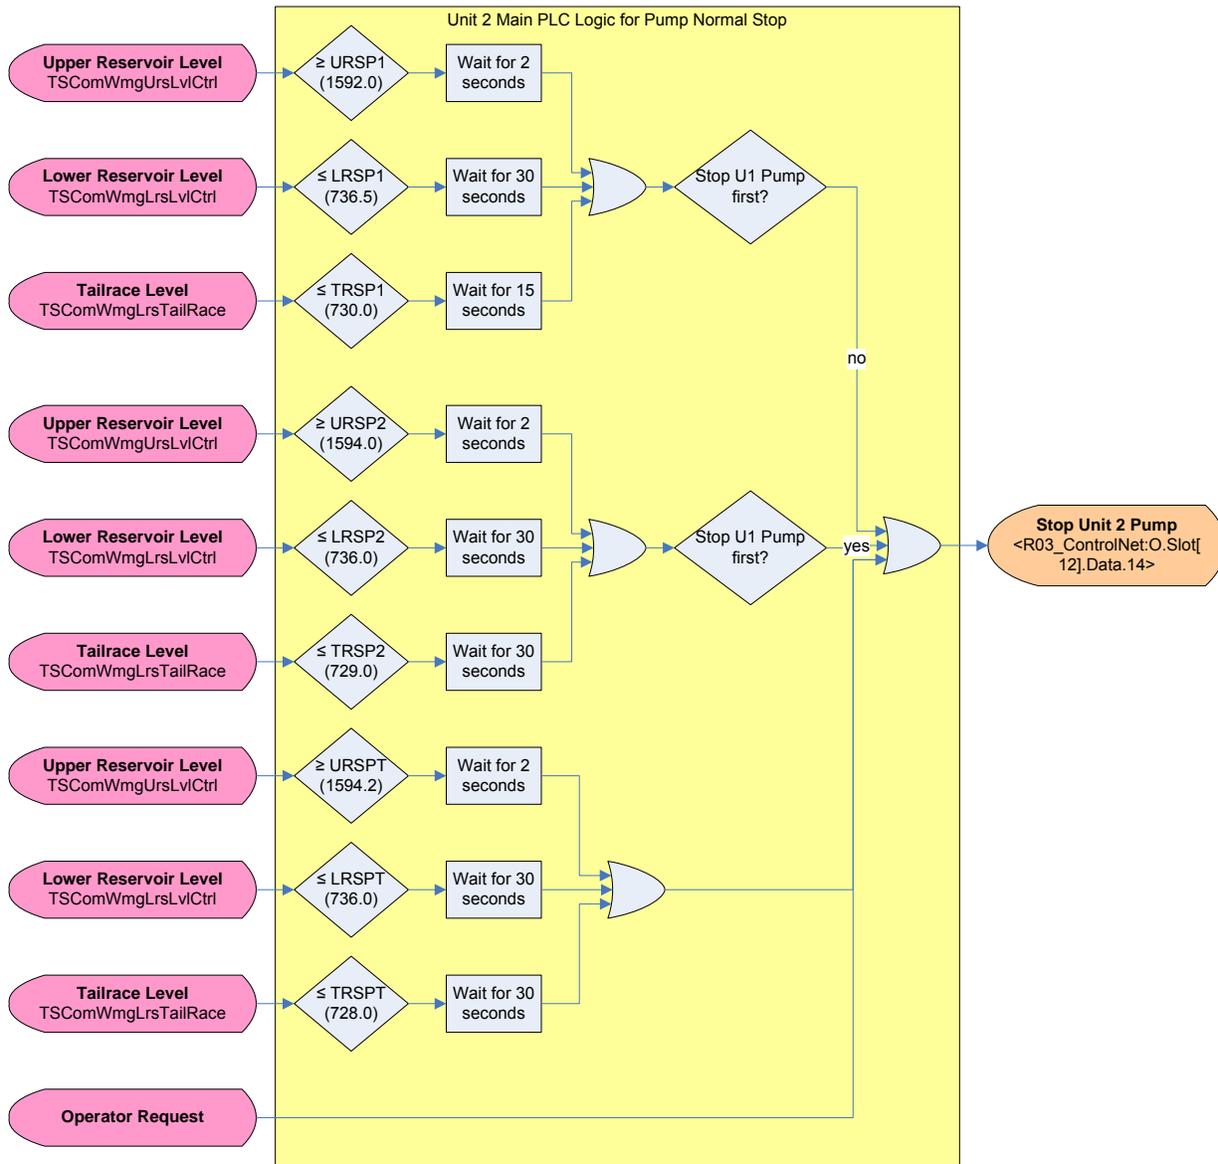
Figure 12: Unit 2 Main PLC Logic for Pump Stop

The logic for normal pump stop implemented in unit 2 main PLC is intended to stop pump #2 if the operator selectable set points for pump stop are exceeded. The effective set of setpoints is determined based on whether unit 2 is the first or the second unit to be shut down. The third set of setpoint is to shut down unit 2 regardless whether it has been selected to be shut down first or second. In any case, the signals need to exceed those setpoints for a pre-programmed period of time.

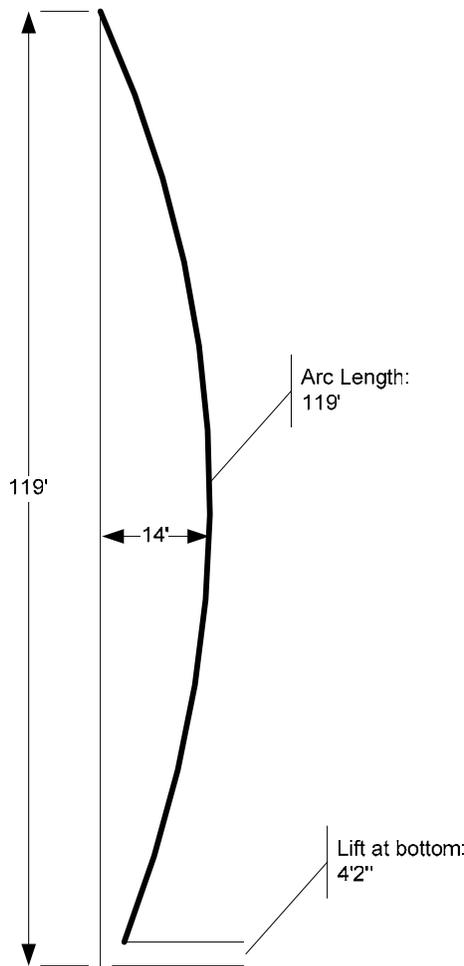
Figure 14: Instrument Pipe Bow Sketch

transmitter above its original elevation of 1500 feet and made it read a lower than actual level. Pipes in the photo marked as 16-Dec-05 were substantially straighter than those in the photos marked 15-Dec-05 and as observed by Siemens on 12-Jan-06, the pipes appeared to be further straightened. As reported to Siemens by Ameren engineers, these pipes straightened on their own. Ameren provided Siemens what they represented to be a rough calculation based on the 15-Dec-05 pipe position showing a rise in transmitter elevation of at least 2.54 feet at the time of the event (see sketch below). This rise would result in an analog reading of at least 2.54 feet low. Based on the straightening observations and the fact that the pipes were buoyant it is reasonable to assume that the pipes were even more curved at the time of the event causing an even larger corresponding error. Ameren engineers performed further analysis which considered the number of failed clamp/unistrut assemblies. Based on this analysis, the maximum lift could have been significantly higher. However based on the historical data analysis, a lift of more than 4 feet seems to be unlikely (see chapter 5.2.3).

The analog transmitter calibration was checked during the initial filling of the upper reservoir and an adjustment factors were put into the PLC code to compensate for the error in elevation placement or signal output of the transmitters. Another adjustment factor of 0.4 ft was added to the PLC's level calculation to recalibrate the transmitters on 9/27/05. This 0.4 feet may take into account some of this bend since just 1 week later on 10/03/05 the breakage of supports and bowing of the pipes was reported by Ameren to have been noticed.

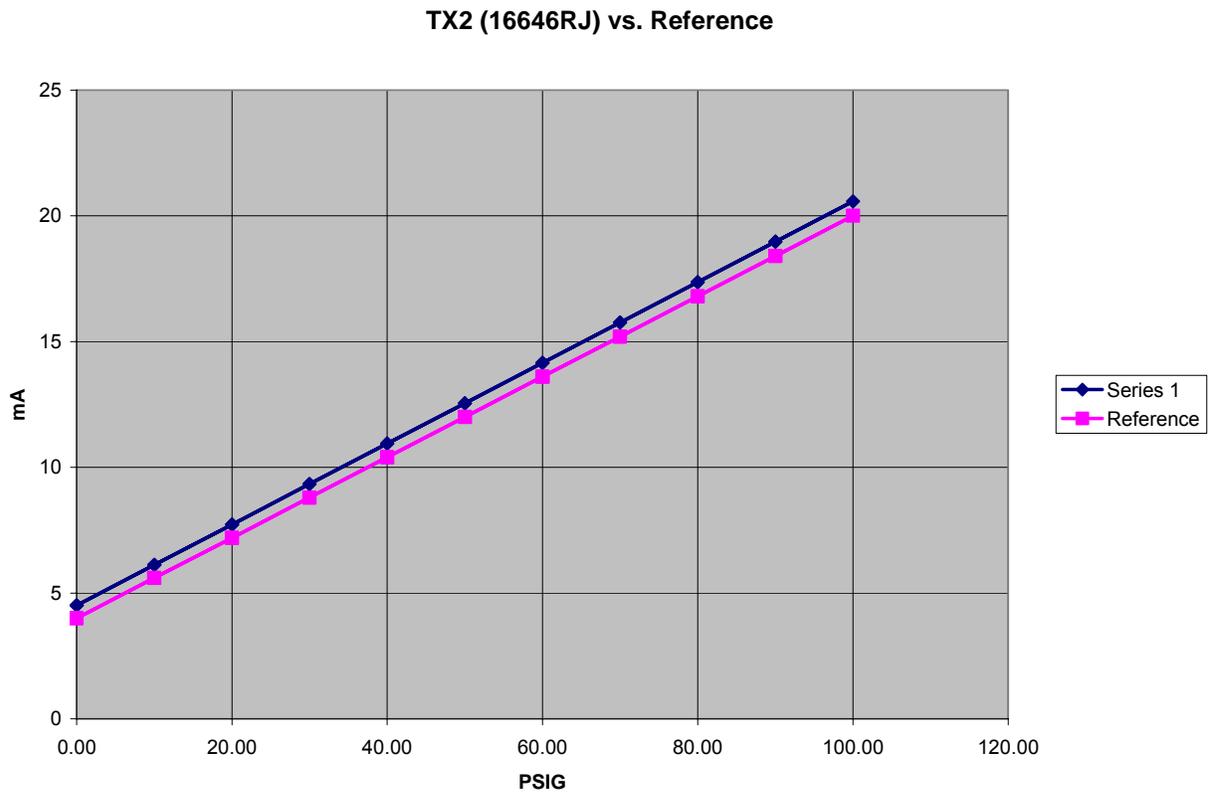
Figure 17: TX2 (16646RJ) vs. Reference

TX2 relates to the reference transmitter with a correlation coefficient of 0.99999994. This means that it is very linear. The average difference between TX2 and the reference transmitter is 0.545338 mA which equates to approx. 7.86 feet of water level at 5 degree Celsius.

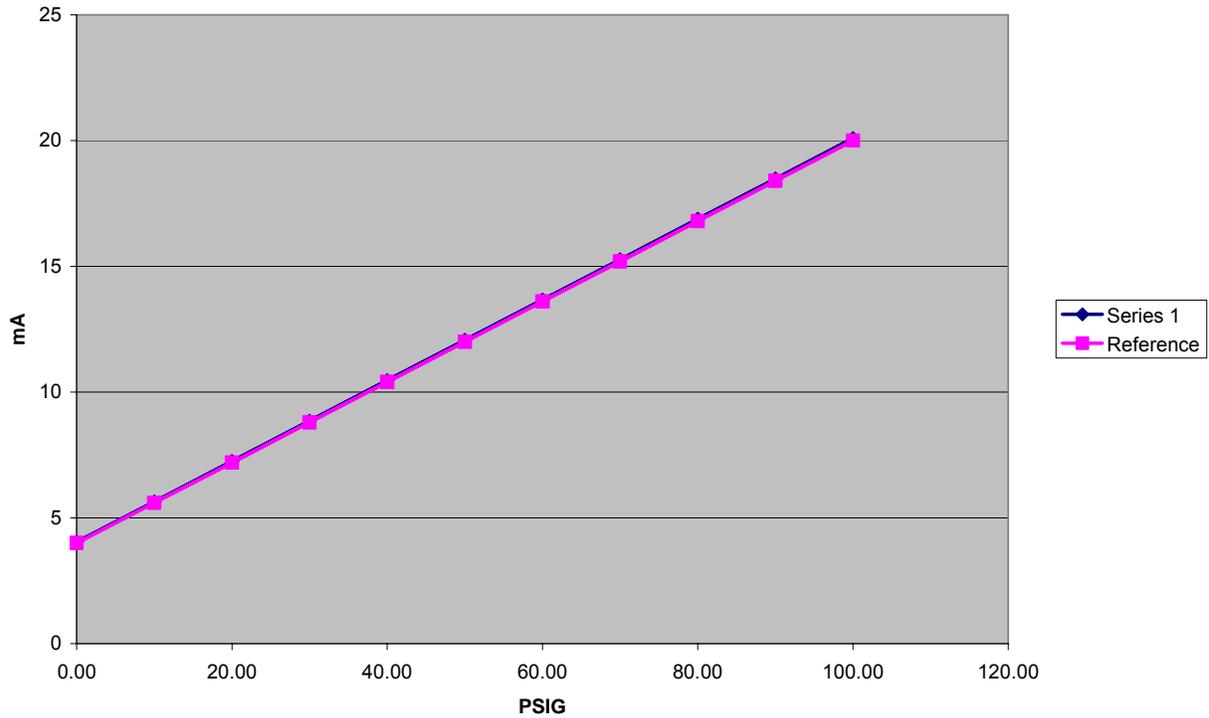
Figure 18: TX3 (16647RJ) vs. Reference

TX3 relates to the reference transmitter with a correlation coefficient of 0.99999996. This means that it is very linear as well. The average difference between TX3 and the reference transmitter is 0.059567 mA which equates to approx. 0.85 feet of water level at 5 degree Celsius.

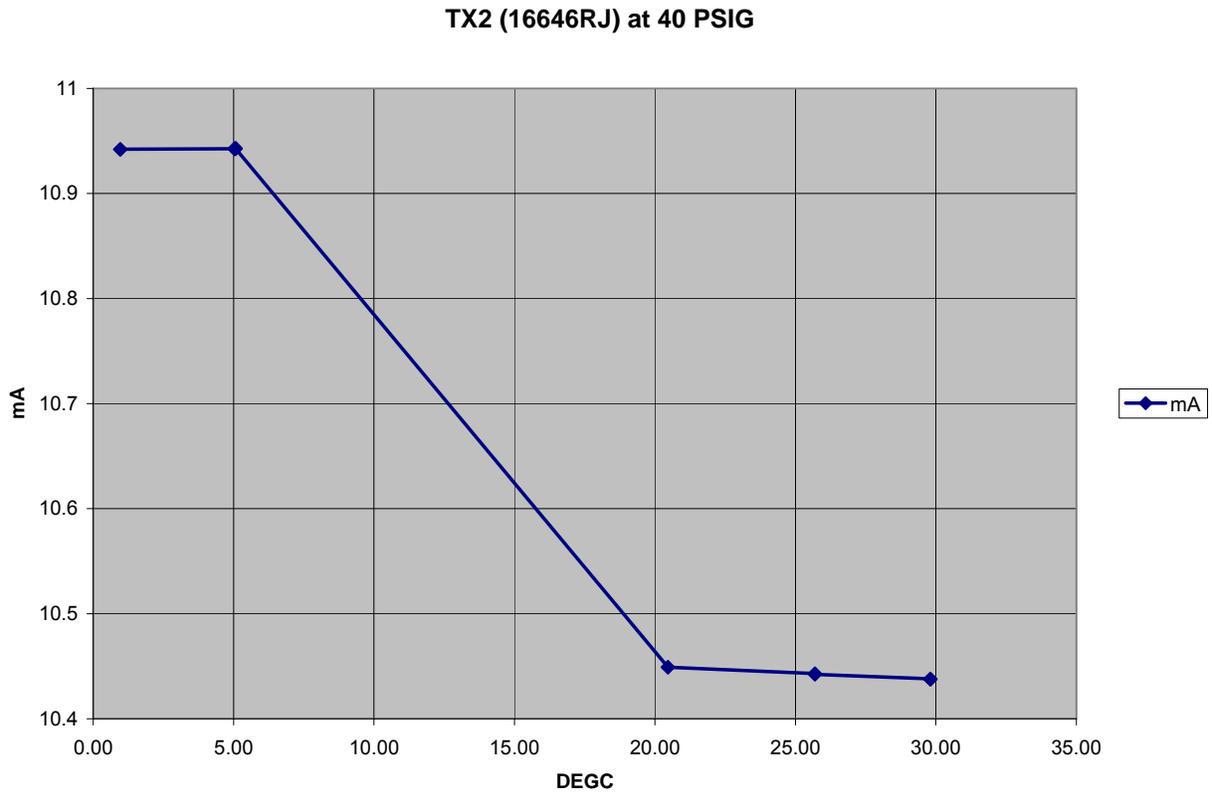
Figure 19: Temperature Sensitivity of TX2

One can see that there is a 0.5 mA step change between 5 degrees Celsius and 20 degrees Celsius. This 0.5 mA change equates to approx. 7.11 feet of water level (at 5 degrees Celsius).

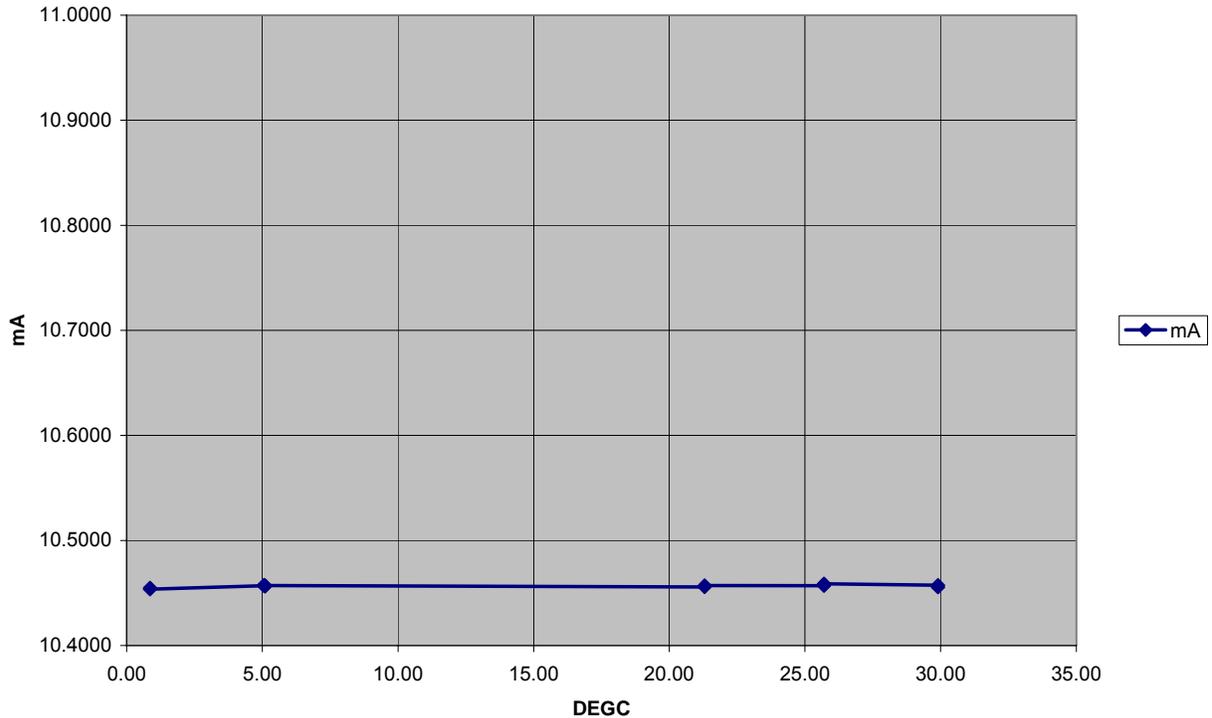
Figure 20: Temperature Sensitivity of TX3

TX3 is less sensitive to temperature changes.

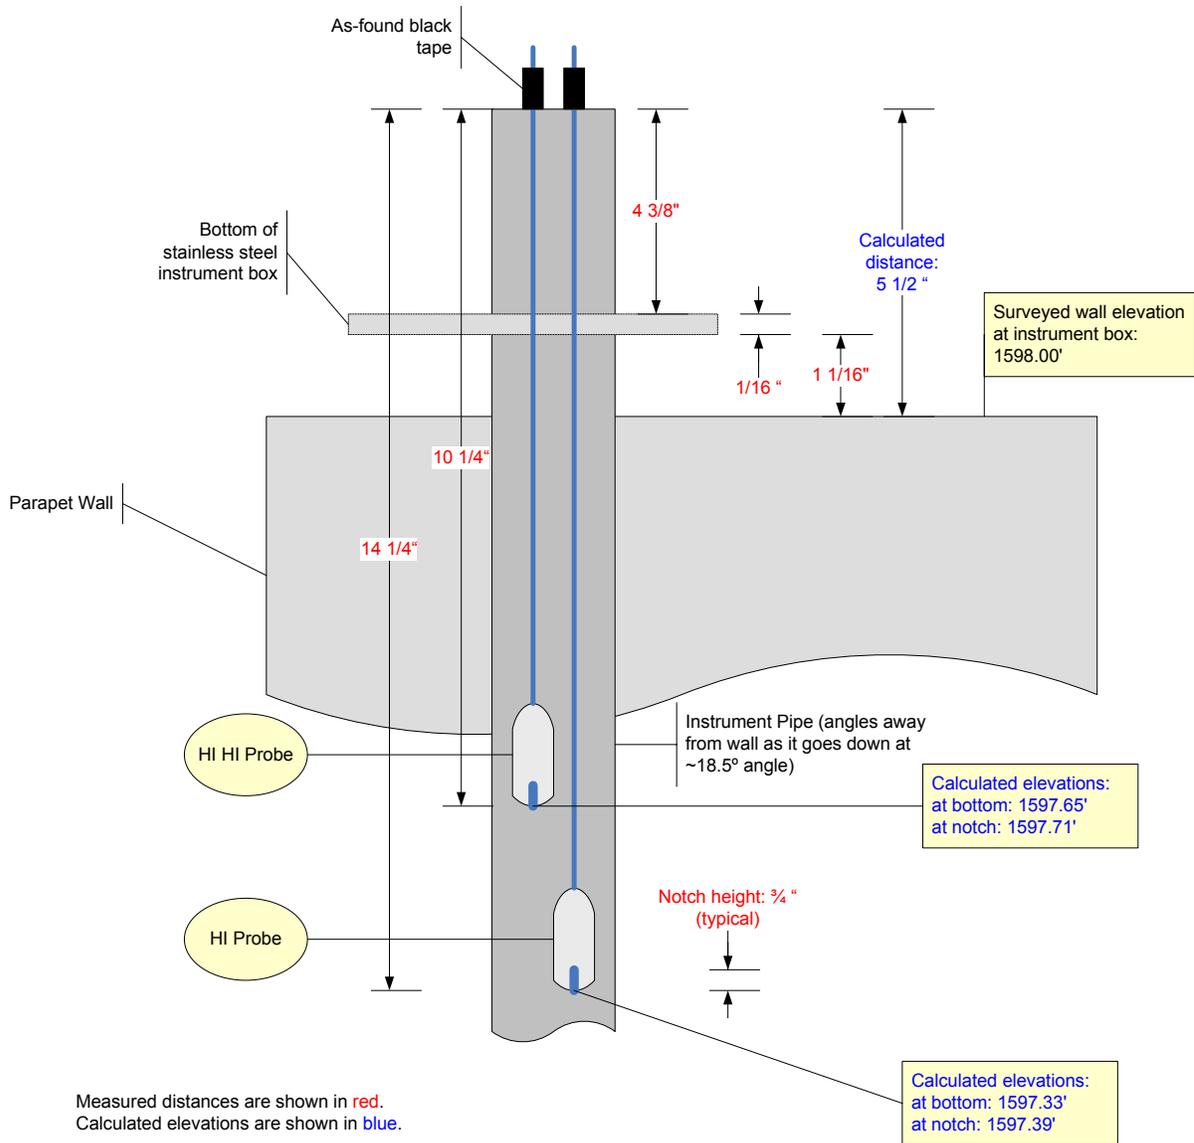
Figure 21: Level Probe Elevation Calculation

The elevation reported of the top of the parapet wall at the instrument box is 1598.0 feet, however the elevation of the lowest part of the wall was only 1597.0 feet (according to drawings provided by Ameren), 0.3 and 0.7 feet below where the Hi and Hi-Hi sensors were located respectively. If this is the case, water would have passed over the lower portions of the parapet wall before these probes would have sensed water. No reference markings showing wall elevation and low point wall elevation were found near the location where the sensors would be adjusted.

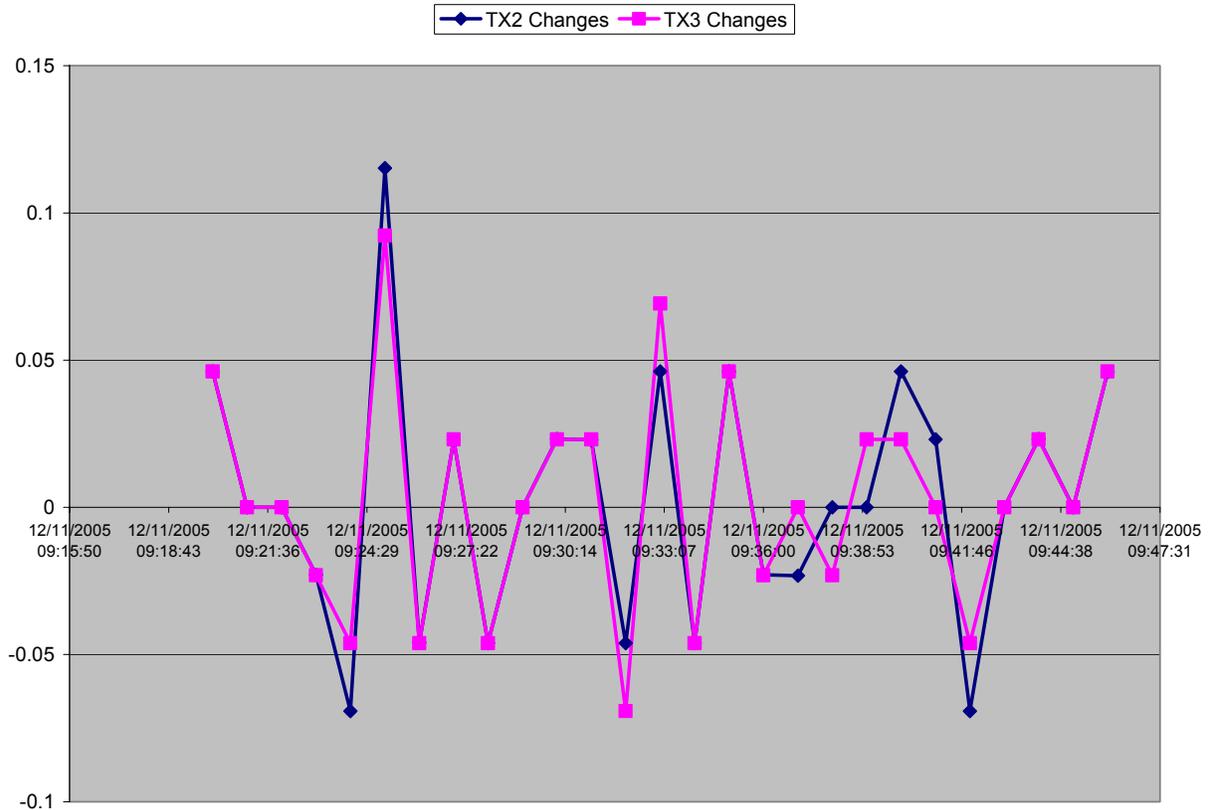
Figure 24: Individual UR Transmitter Reading Changes on 11-Dec-05

Several time intervals with different reservoir levels were reviewed. In all cases, a signal variation of $\pm 0.1 - 0.15$ feet was observed.

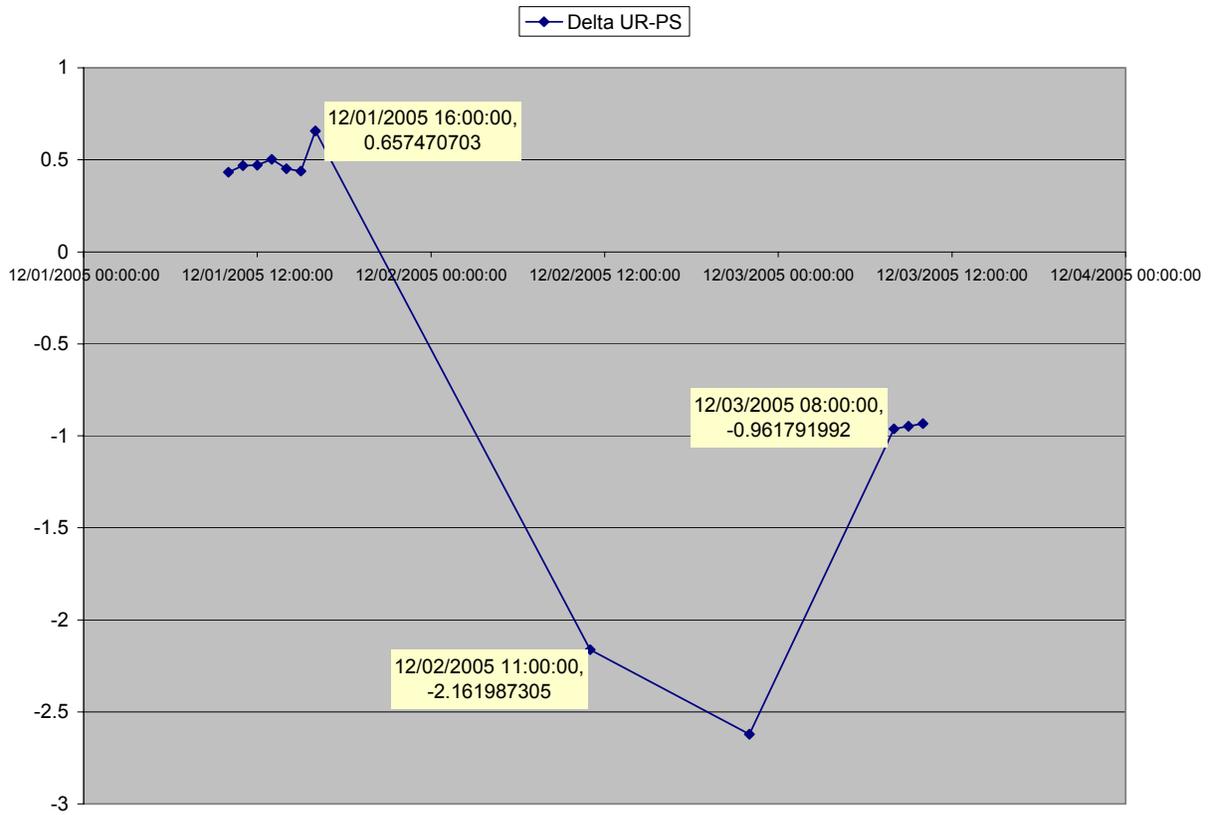
Figure 29: Difference between UR Transmitter Average and PS Transmitter between 1-Dec-05 and 3-Dec-05

Note the change in between 1-Dec-05 16:00, 2-Dec-05 11:00 and 3-Dec-05 08:00. This sudden change can not be explained by a change of environmental conditions. One assumption could be that the location of the UR level transmitters may have shifted during that time period.
