GOUHOU DAM PAPER

BREACHING OF THE GOUHOU CONCRETE FACE SAND AND GRAVEL DAM

ZUYU CHEN

Institute of Water Conservancy and Hydroelectric Power Research

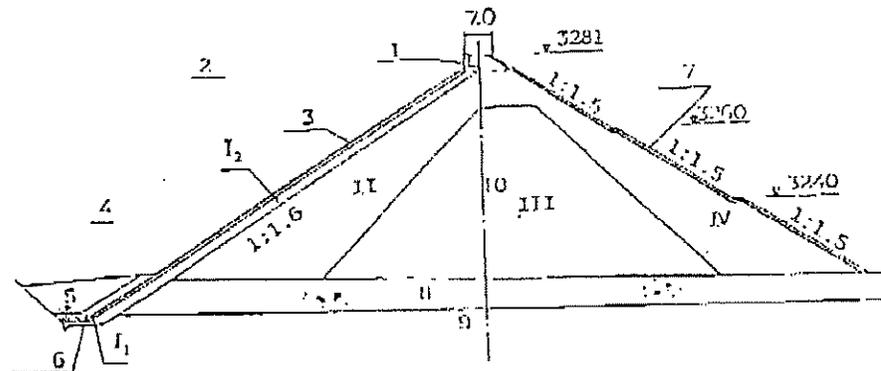
Fig. 1 Cross section of the dam

1. Crest wall; 2. Normal water level; 3. Face slab; 4. Dead water level; 5. Random fill; 6. Clay.
7. Dry packed rock; 8. Alluvium; 9. Bed rock; 10. Dam axis

The dam was divided into four zones as shown in Fig. 1. Main features of the four parts are indicated in Table 1 from which one may find that no serious restrictions to the gradings of difference zones were given. Since large pebbles were rare, the dam was essentially a uniform sand and gravel one (Hong, 1990).

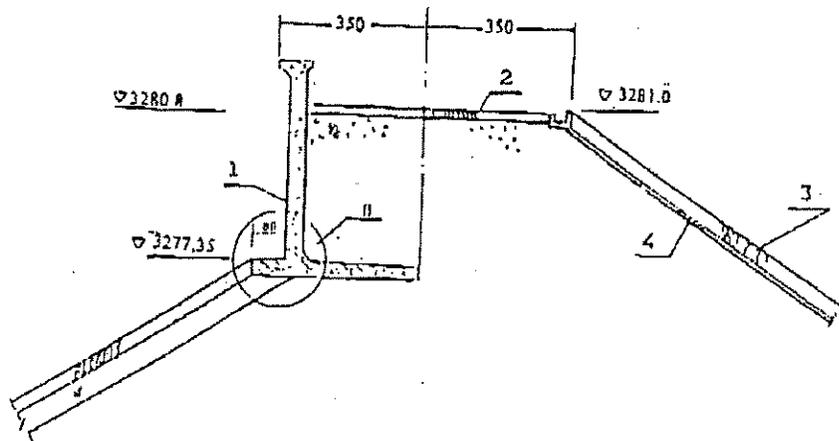
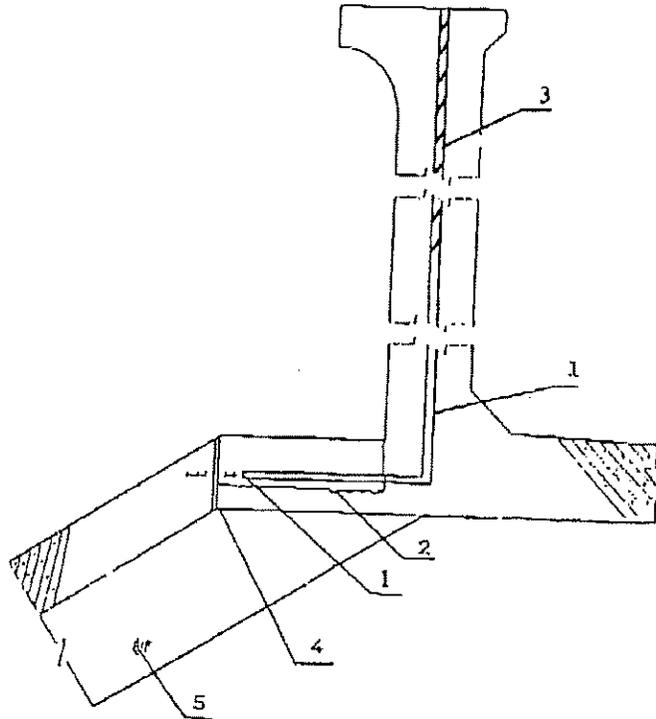
Fig. 2 The crest wall

Following the common practice of CFRDs, an L-type crest wall was provided to save the volume of rockfill and facilitate concrete placement of slabs by the slip form.

were connected with the face slab by rubber water stop. The elevation of the horizontal slab was 3277.35m. To accommodate possible settlement of the dam, transverse joints are provided at 6m spacing.

1. Reinforced concrete; 2. Pavement; 3. Masonry; 4. Transition.

1. Rubber water stop; 2. Top of the intact concrete; 3. Timber soaked by oil; 4. Timber Fill; 5. Transition.

(4) This dam has an important feature that the normal water level is above the horizontal slab of the crest wall. The reason of the cracking of the crest wall slab is still a question of much needed study. However, correcting the cracking by cement mortar is by all means wrong. As an important part of the dam structure, the crest wall is subjected to very complicated working conditions including settling of the foundation, rotating due to earth pressure, etc. Details of the crest wall must be carefully studied to assure safe performance of the wall.

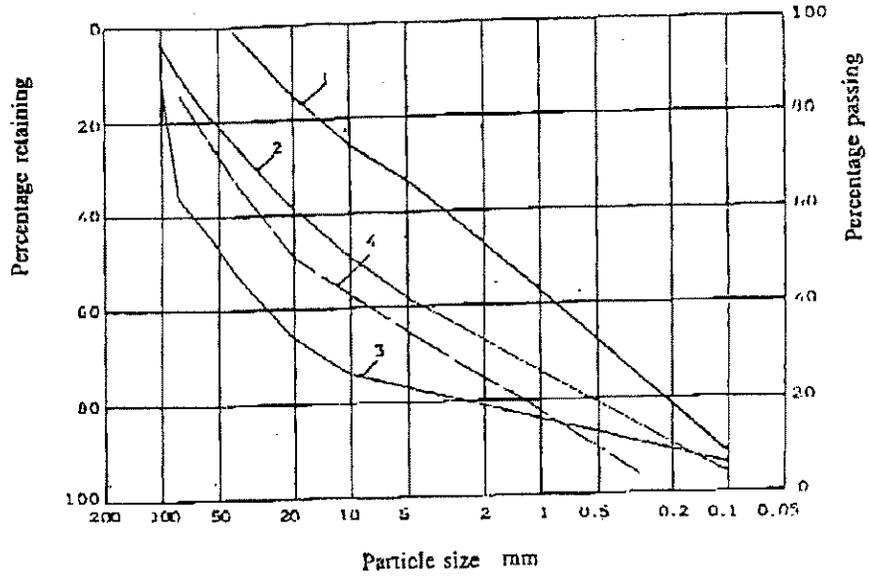
Fig. 6 Gradations of the fills

The lack of adequate drainage of the dam has aroused common concern about the grading of the fill material. All available field gradation test results have been collected. They include the SS gradings obtained from the borrow pit and the dam body. The tests were carried out by the contractor for quality inspection purpose. The smallest, average and greatest contents of fines (particles less than 5mm) are 23.5%, 41.7%, 66.8%; and those of silt (particles less than 0.1mm) are 0.3%, 4.3%, 8.3% respectively. Fig. 6 gives three curves that represent the finest, coarsest and average gradations of the samples.

1,2,3: Selected gradings of 55 samples. 1, finest; 2, average; 3, coarsest. 4, Average of 8 samples taken from exploratory pit of borrow area.

(3) The permeability of the fill material is a problem of common concern. The design of the dam was based on the test data taken from the borrow pit, which gave a value of 1.48×10^{-1} cm/s. The available 56 gradings of the fill material exhibit big variance as can be seen in Fig. 6. The average of the 55 samples taken from the dam was finer than that of the 8 samples taken from the borrow pit during design stage. Some risk analysis might be desirable in assessing the reliability of the field test data if the number of tests is not large enough and the locations of the samples are not reasonably representative.

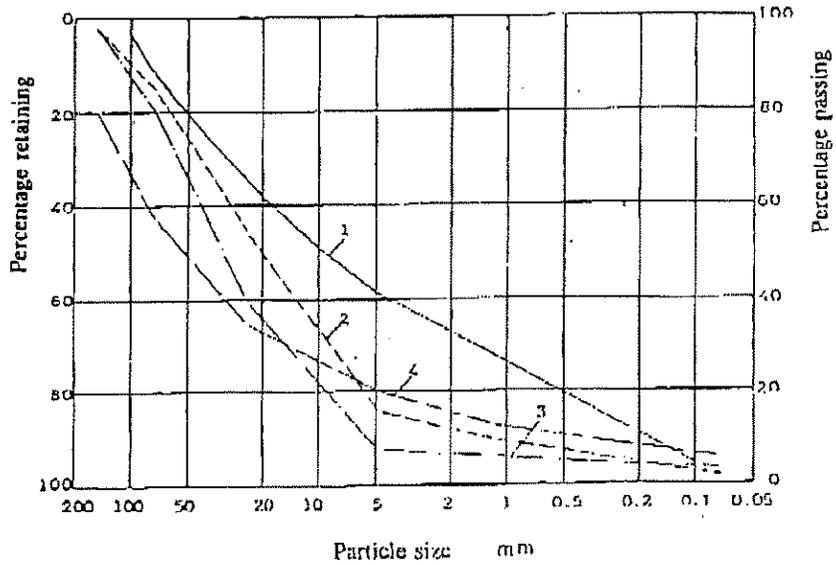
Fig. 7. Comparisons of gradings.

(2) The Qiapoqia River is a small creek with a natural runoff not more than $0.8 \text{ m}^3/\text{s}$ at the time of failure and it was found that the reservoir water level kept rising instead of lowering before failure. This means the maximum seepage into the dam body would not exceed $0.8 \text{ m}^3/\text{s}$, an order of magnitude several CFRDs have also experienced without failure. Compared with the gradings of the then existing three CFRDs in the world (Fell, R. et. al., 1992, Fig.7), the Gouhou fill material was

1. Gouhou (based on 55 gradings; 2. Crotty; 3. Salvagina; 4. Golillas

relatively fine. However, unlike the three dams, special free drainage zone was absent. The designers have given similar discussions (Chu, 1992).
