## 2.0 SUMMARY DESCRIPTION OF THE TAUM SAUK PLANT

The Taum Sauk Plant is located in Reynolds County, Missouri, on the East Fork of the Black River, approximately 90 miles southwest of St. Louis, Missouri. It is a reversible pumped storage project used to supplement the generation and transmission facilities of AmerenUE, and consists basically of a ridge top Upper Reservoir, a Shaft and Tunnel conduit, a 450-MW, two-unit pump-turbine, motor-generator plant, and a Lower Reservoir as illustrated on **Figure 2-1**.

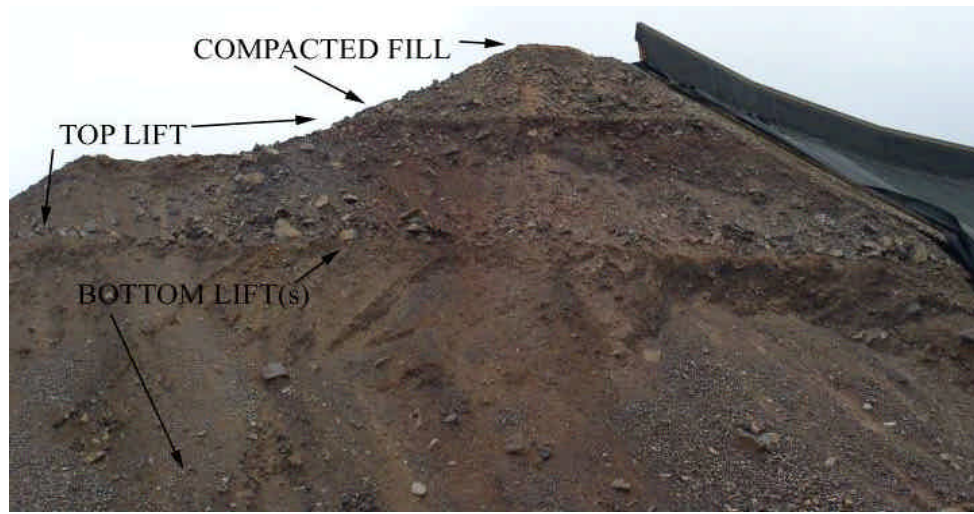
**FIGURE 2-7**

The fines content issue stands out on the slopes of the Breach Area as illustrated below on **Figure 2-7**, which is a photo of the north side of the Breach Area. This is supposed to be a rockfill, but it is apparent that fines were left in place and comprise a significant percentage of the overall embankment. We submit that this was not the original designer's intent and that the shear strength and drainage properties of this finer material acts negatively on the performance of this type of dam and dike construction.

**VIEW OF NORTH SIDE OF BREACH AREA**

| REFERENCE | SPECIFICATION OR LANGUAGE | POST EVENT OBSERVATION |
|---|---|---|
| Spec. EC-311<br>IV-b-7, Sec. D<br>Rev. Mar. 1, 1961. | "All rock within this area shall be thoroughly sluiced to prevent the accumulation of fines in the upper portions of the face fills." | Specification not satisfied.<br>See <b>Figure 2-7</b> . |
| Spec. EC-311<br>IV-b-7, Sec. D<br>Rev. Mar. 1, 1961. | "The criterion for determination of adequate sluicing by visual inspection shall be that the entire height of the progressing face and side slopes shall have the appearance of clean rock, and that no areas of concentrated fines, dirt or mud are in evidence." | Specification not satisfied.<br>See <b>Figure 2-7 and Figure 4-3</b> (presented later). |

| <b>REFERENCE</b> | <b>SPECIFICATION OR LANGUAGE</b> | <b>POST EVENT OBSERVATION</b> |
|---|---|---|
| Spec. EC-311<br>IV-b-8, Sec. E<br>Rev. Mar. 1, 1961. | “The jetting shall accomplish, principally, the following:<br>a) Wash surface zones of fines away.<br>b) Excavate pockets of spalls and distribute the spalls into voids between larger rocks in contact.” | Specification not satisfied. See <b>Figure 2-7 and Figure 4-3</b> (presented later). |
