3.0 SUMMARY DESCRIPTION OF THE SITE GEOLOGY

3.3 GEOLOGIC MAPPING OF THE BREACH AREA

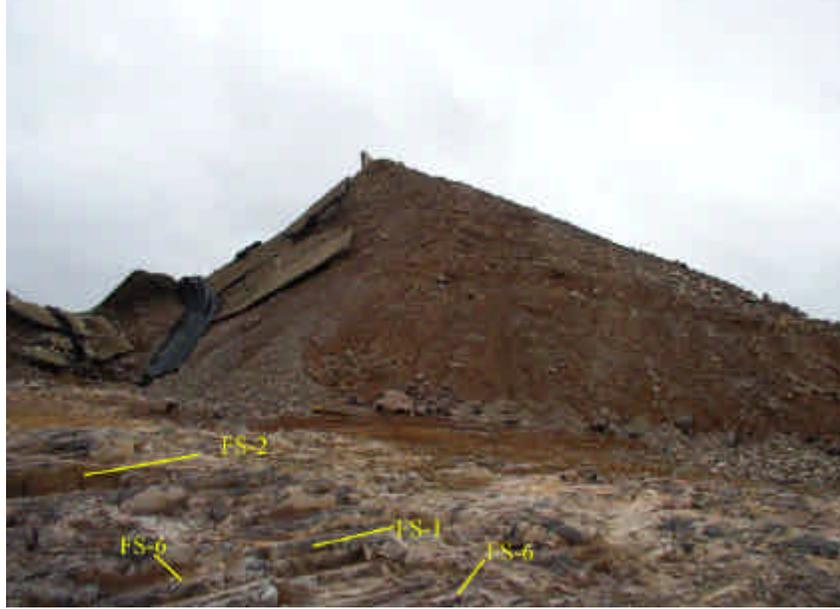
FIGURE 3-4
FRACTURE SETS FS-1, FS-2, AND FS-6

Figures 3-4 through *3-7* show some of the prevalent fracture sets in the breach area foundation.

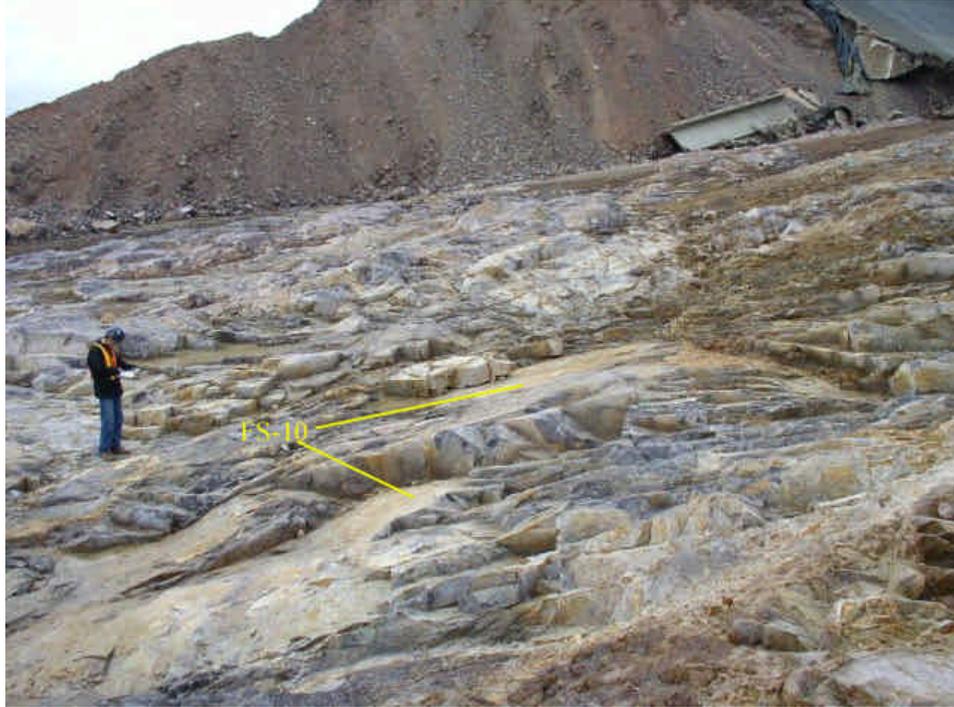
FIGURE 3-6

FRACTURE SET FS-10

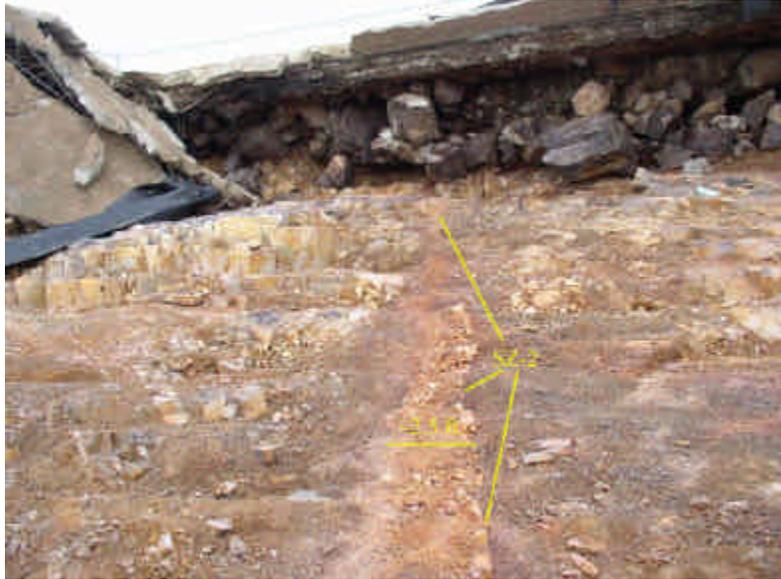
FIGURE 3-7

In addition to fractures, shear zones and faults exist with the breach area. Five roughly east-west striking, steeply dipping shear zones are noted and presented on *Plate 3-1*. These shear zones are linear, very continuous, and cut all other features. Rock within these shear zones is very broken. *Figure 3-7* shows shear zone SZ-2 from *Plate 3-1*. A sense of offset on this feature could not be determined.

SHEAR ZONE SZ-2

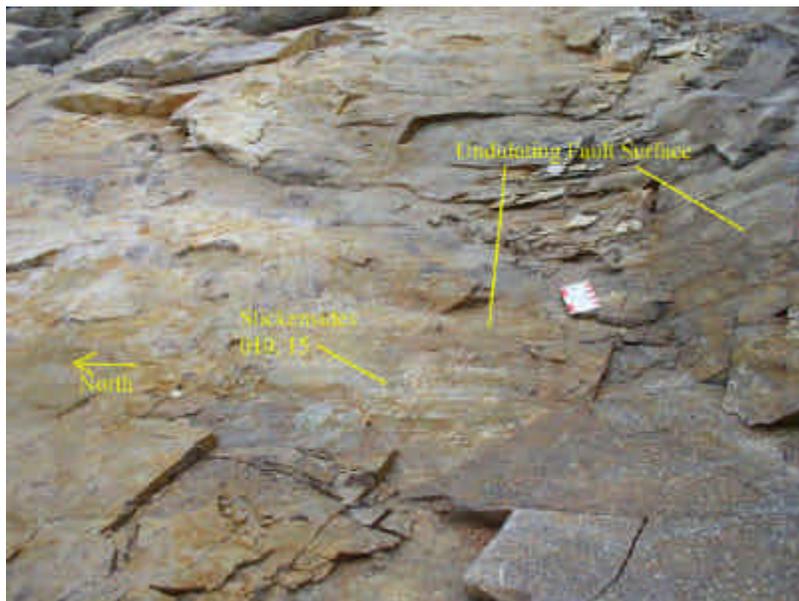
FIGURE 3-8

Two fault zones with slickensides were mapped in the breach zone area. These faults strike N80-85E, exhibit shallow dip (20-30 degrees) to the NNW, and have slickensides that rake north to N10E and dip 15-20 degrees (*see Figure 3-8*).

LOW ANGLE FAULT WITH SLICKENSIDES

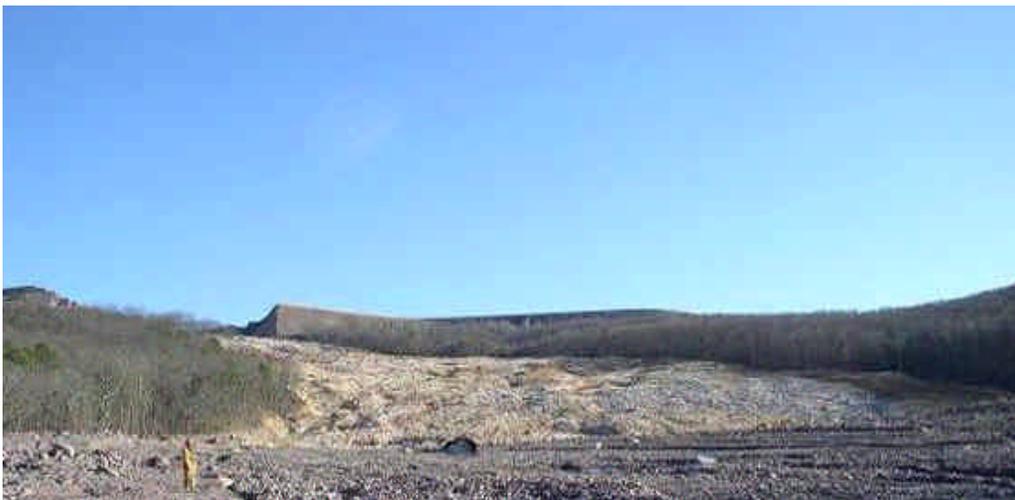
FIGURE 3-11

The zone of depletion of the debris (the zone where the displaced material was below the original ground surface) is the area from the downstream toe of the Rockfill Dike to the break in slope. This area is characterized as having a few remnant patches of residual soil, no vegetation and no material derived from the Rockfill Dike (or facing concrete). Only a small concrete block is observed close to the top. *Figure 3-11* shows this area as it is seen from the slope break to the initiation area.

ZONE OF DEPLETION FROM THE INITIATION AREA TO THE SLOPE BREAK

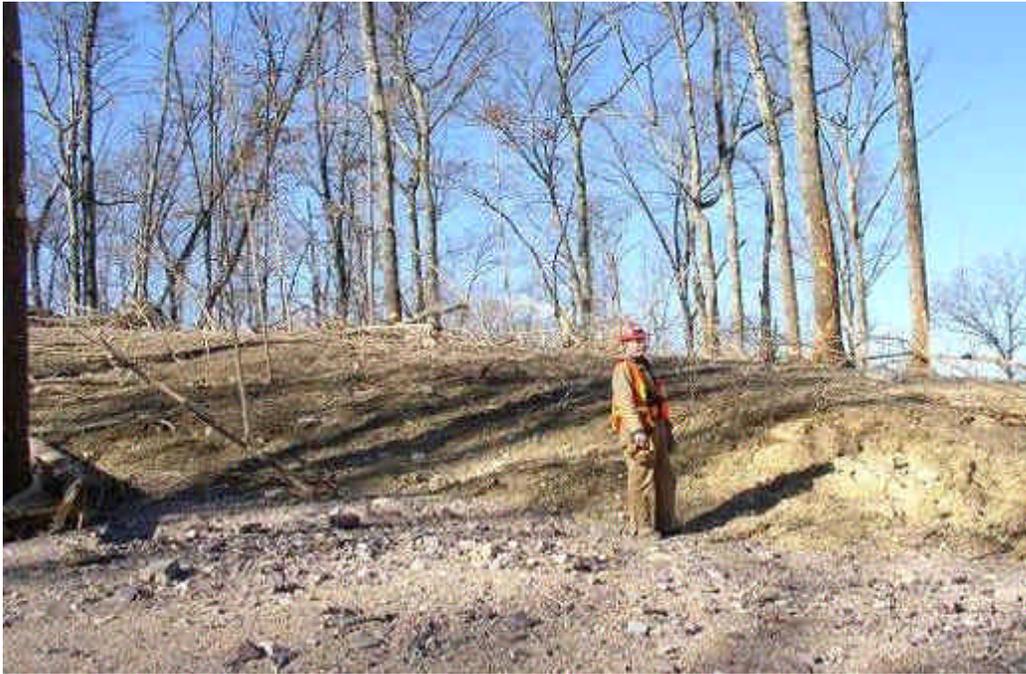
FIGURE 3-12

Once the availability of the source of material ended, i.e., when the Dike was fully breached, there was some local remobilization based on the fact that plugs of debris and banks were cut as much as 6 inches and boulders were remobilized from their original position. The height of the mix flow is shown to be at least 10 feet high, from overbank flows, based on marks left by rocks on trees left standing on the hillsides, where almost all minor vegetation was partially removed (*Figure 3-12*).

**FACIES S1/S3 DEPOSITS OVER SLOPE IN SW OF SECTION 1,
WITH MARKS ON TREES CAUSED BY ROCK PARTICLES**

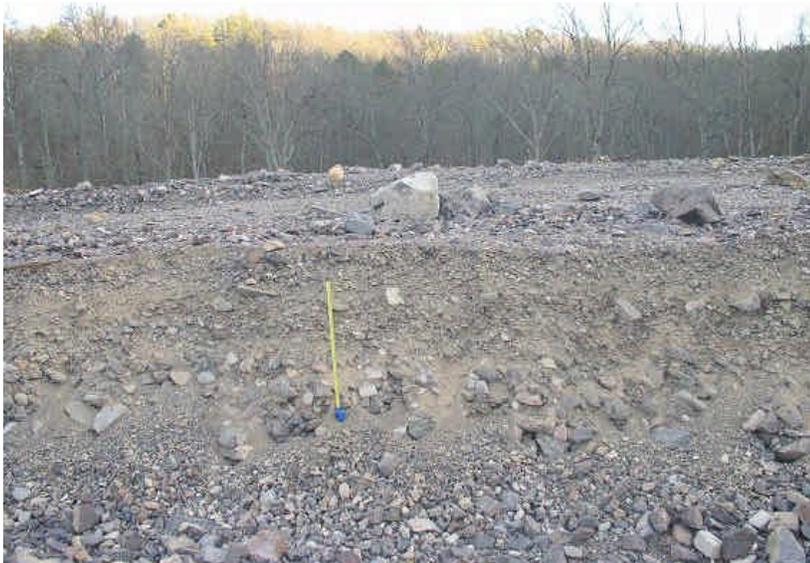
FIGURE 3-16

STRUCTURED DEPOSITS IN A DEBRIS PLUG CUT

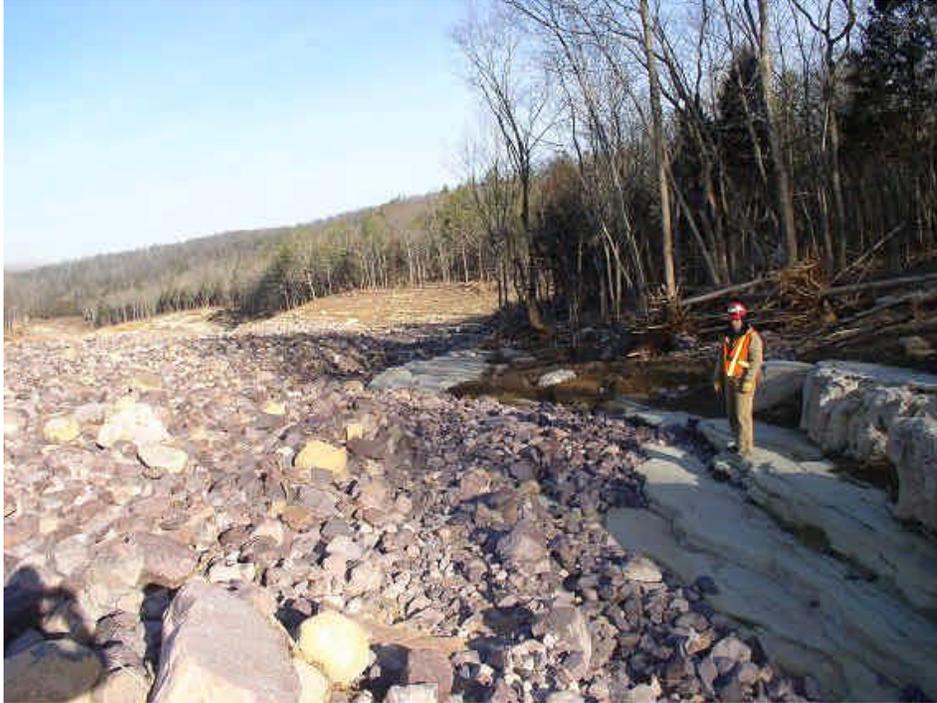
FIGURE 3-17

WELL-SORTED FACIES S4/S5 SHEET DEPOSIT, SECTION 6
