## 8.0 ANALYSIS OF UPPER RESERVOIR BARRIERS

### 8.1 OVERTOPPING ANALYSIS

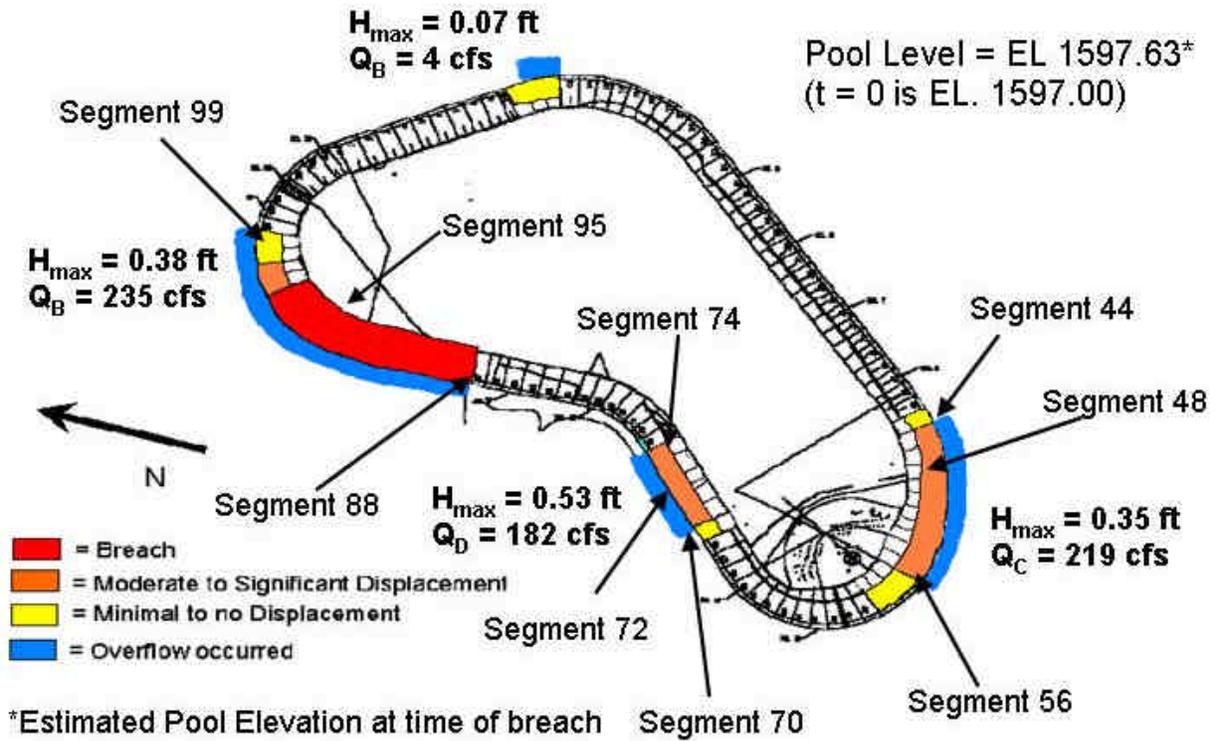
FIGURE 8-1  
OVERTOPPING ZONES

The results of the overtopping analysis shown on *Figures 8-1 and Figure 8-2* indicate that the total flow near Parapet Wall Segment 95, where the Breach occurred, is estimated to be 235 cfs at  $t \sim 10$  minutes, 20 seconds. The total flow over Wall Segment 95 (60 feet long) having an average top Elevation of 1597.25 is 38.1 cfs, or 0.64 cfs/ft. The overtopping flow rapidly infiltrated into the Rockfill Dike, resulting in a rapid rise in the phreatic surface and the pore pressure on the critical Dike/foundation interface.

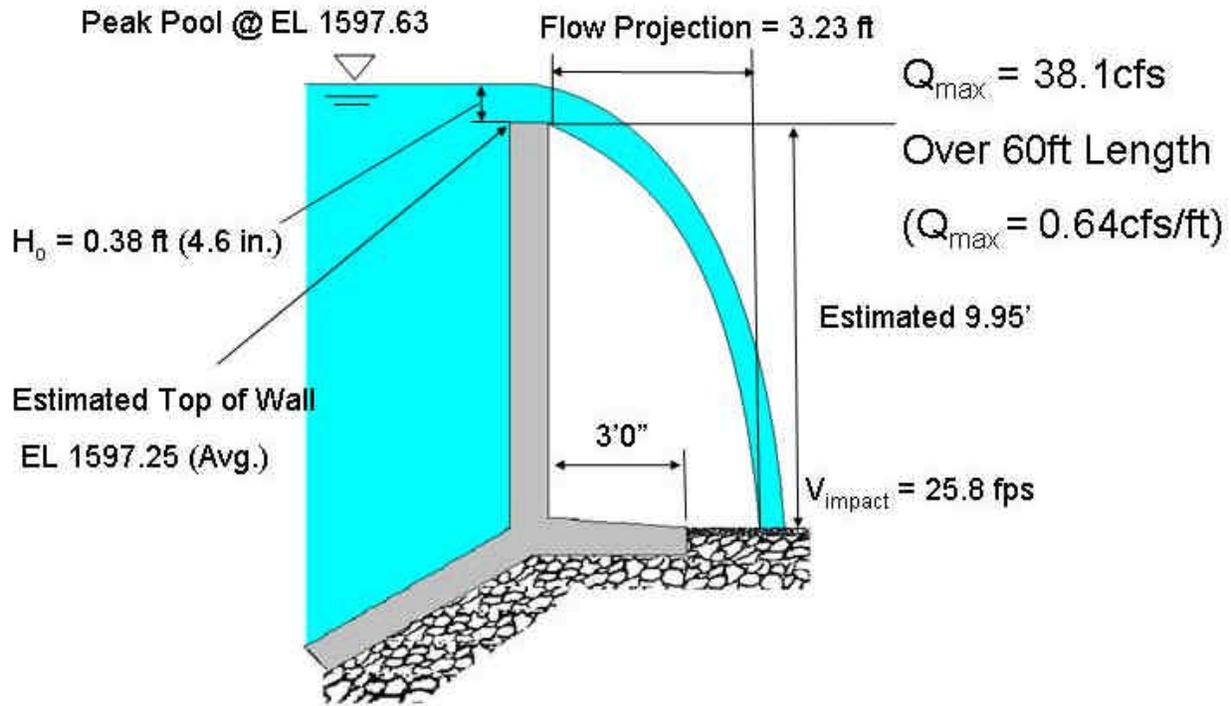
**FIGURE 8-2**

### WEIR FLOW PROJECTION – WALL SEGMENT 95

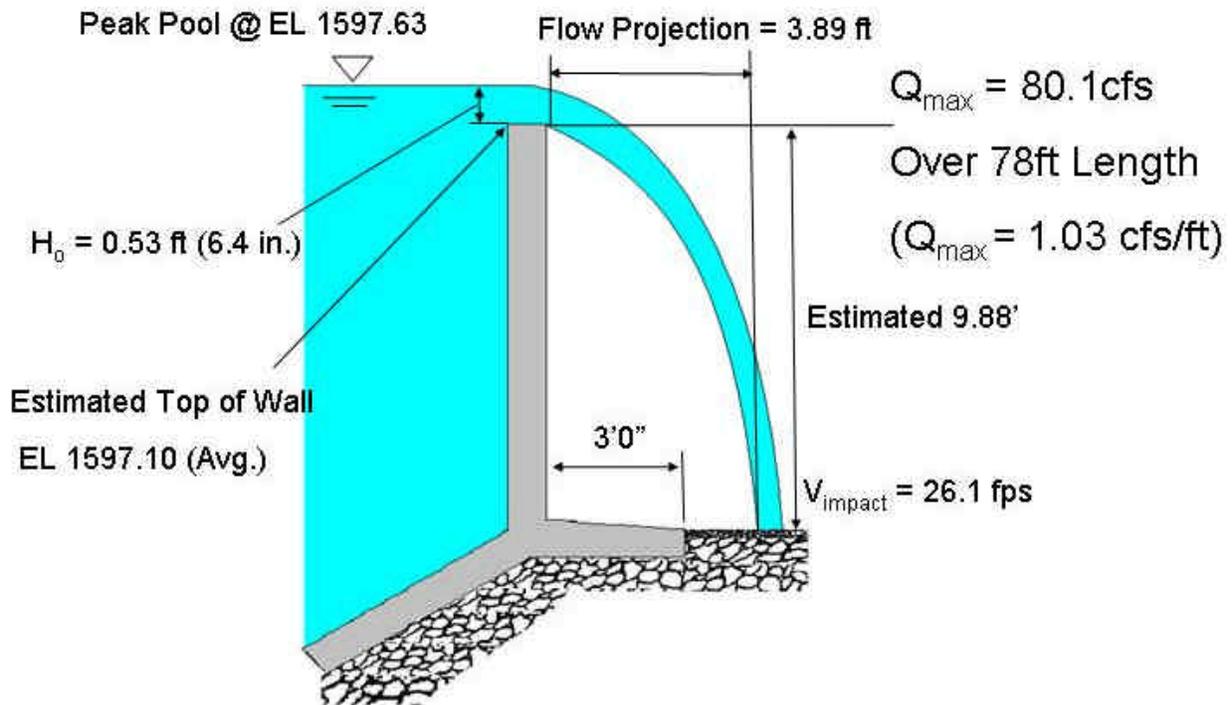
FIGURE 8-3

The total flow over Wall Segment 72 (78 feet long) having an average top Elevation of 1597.10 is 80.1 cfs, or 1.03 cfs/ft. This is slightly greater than at the Breach Area but over a more concentrated zone. In the southwest corner as shown on *Figure 8-4* for Parapet Wall Segment 48, the flow is estimated to be 33.1 cfs over a length of 60 feet or about 0.55 cfs per foot. These

WEIR FLOW PROJECTION – WALL SEGMENT 72

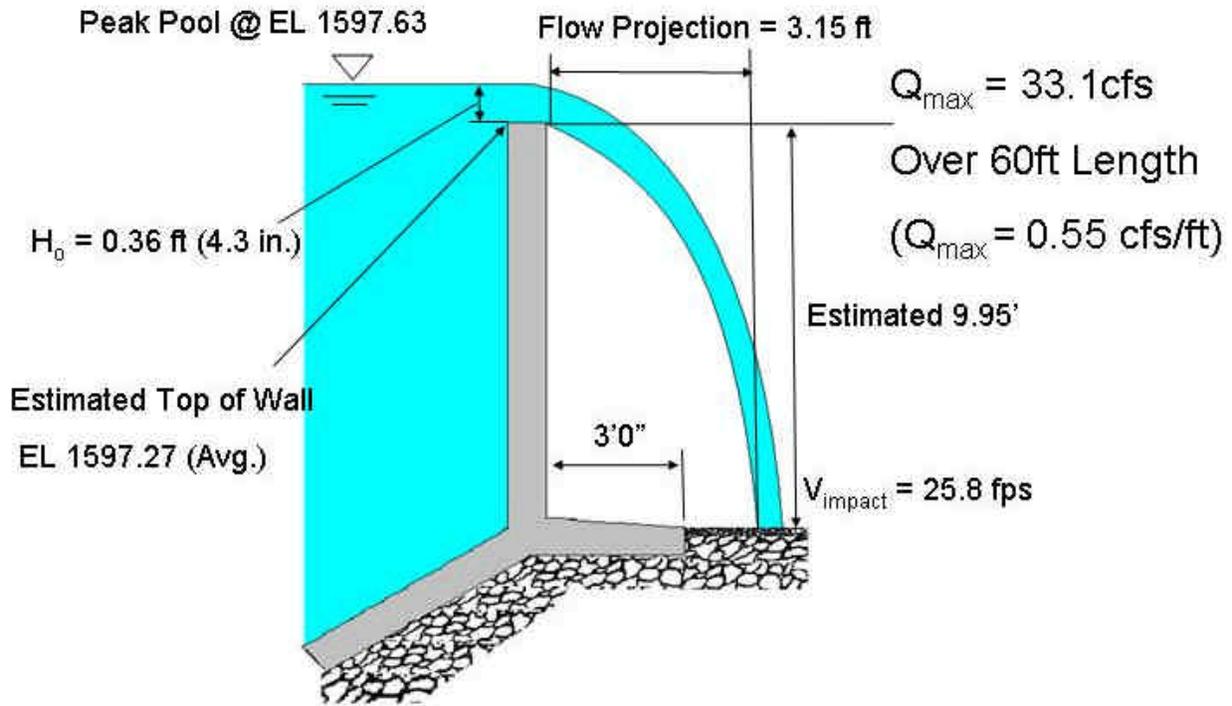
FIGURE 8-4

WEIR FLOW PROJECTION – WALL SEGMENT 48

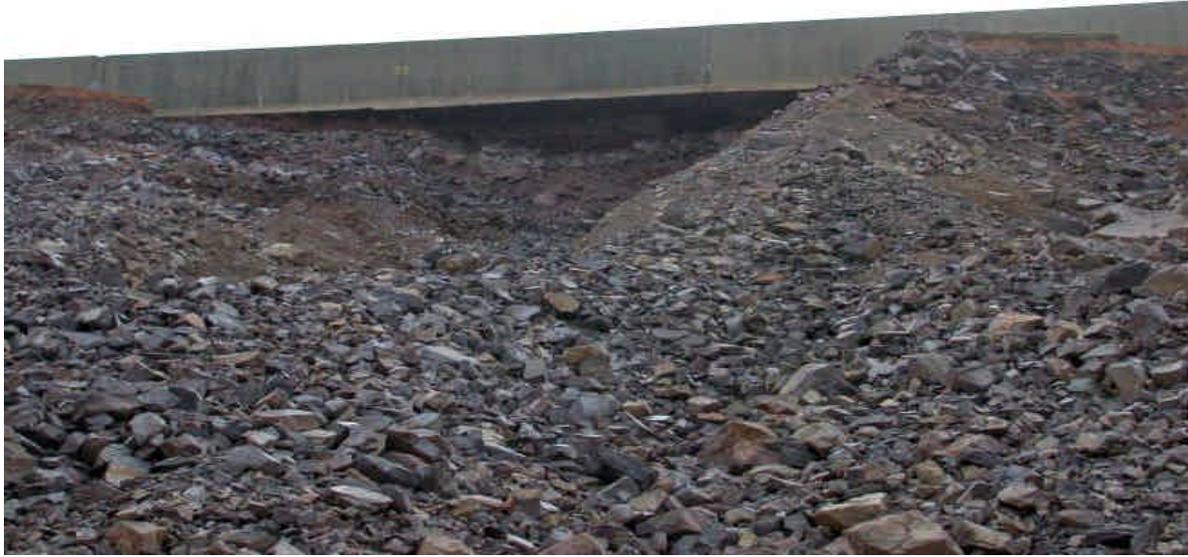
**FIGURE 8-5**

flows caused Parapet Wall Segment Nos. 72 and 48 to be undermined as illustrated below on *Figure 8-5* and *Figure 8-6* respectively.

**PARAPET WALL SEGMENT 72 UNDERMINING**

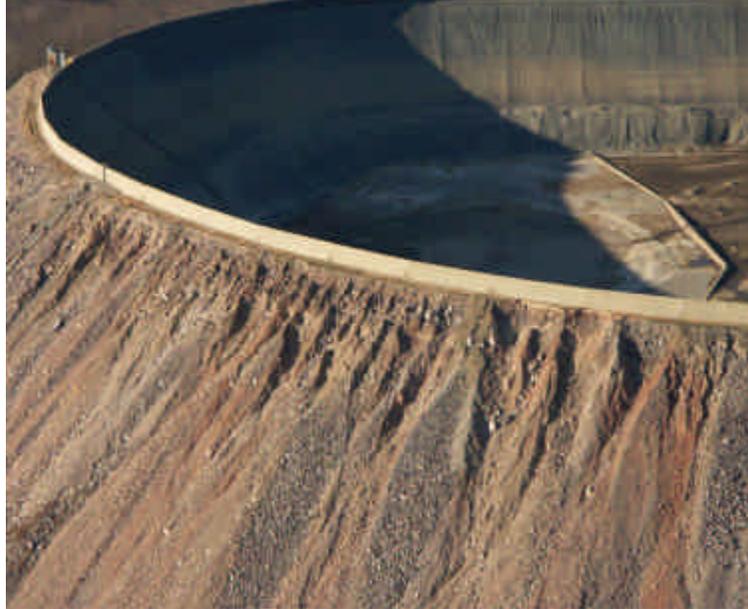
**FIGURE 8-6**

**PARAPET WALL SEGMENTS 44 TO 56 UNDERMINING**

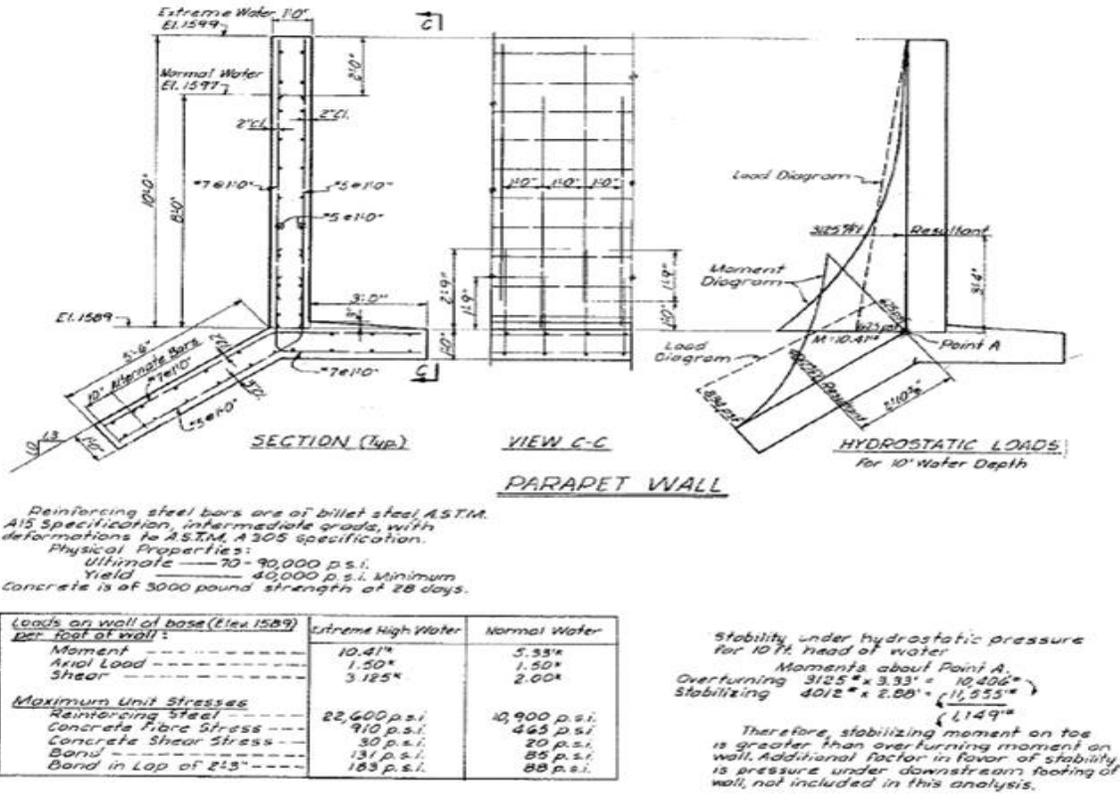
FIGURE 8-7

We have a few comments on this analysis. Firstly, the designer summed moments about Point A at the downstream bottom corner of the vertical stem of some of the acting forces - not all. Theoretically, one can sum moments about any point so long as all forces and moments are considered. Practitioners normally sum moments about the downstream toe, i.e., about the lower right hand corner of the base and all of the forces and moments would be considered.

Secondly, the originating analyst ignored the weight of the concrete and the soil pressure, and thirdly, the analyst ignored any uplift pressure that might develop under the foundation when the water level is in the range of El. 1598.

Our conclusion on this matter is that the original analysis would not be acceptable in a modern regulatory environment.

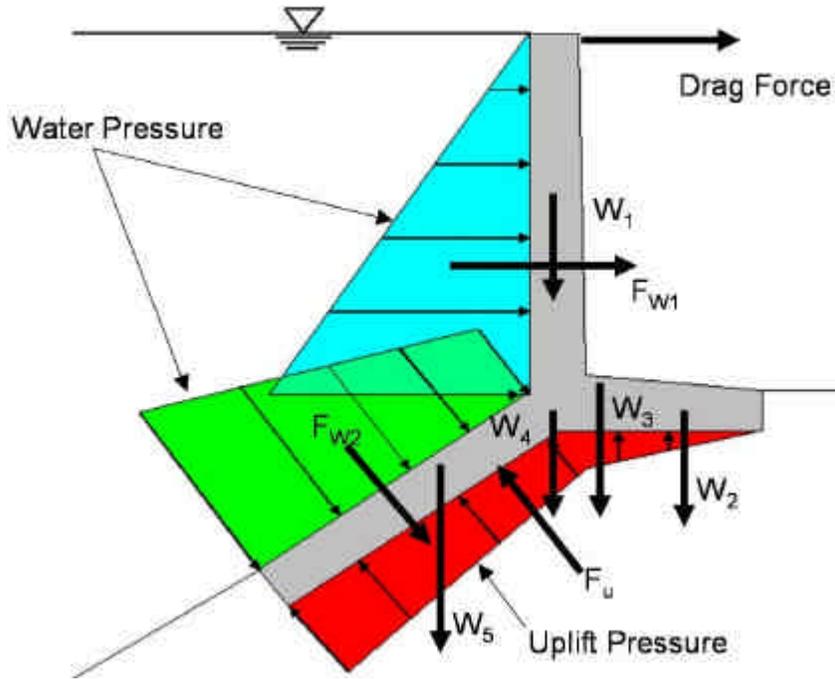
**FIGURE 8-8**

The forces considered for this analysis are illustrated below on **Figure 8-8** with the results shown on **Figure 8-9**. The results indicate that the Wall was stable against overturning for all practical purposes under the given water level and so long as no undermining had developed.

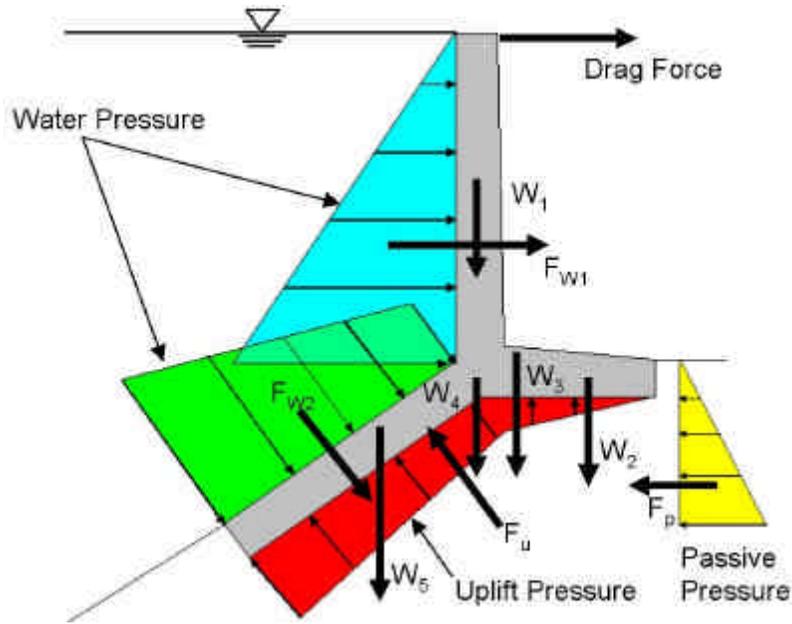
**FIGURE 8-10**

The forces considered for the sliding analysis are illustrated below on *Figure 8-10* with the results shown on *Figure 8-11*. The results indicate that the Wall was stable against sliding for all practical purposes under the given water level and so long as no undermining had developed.

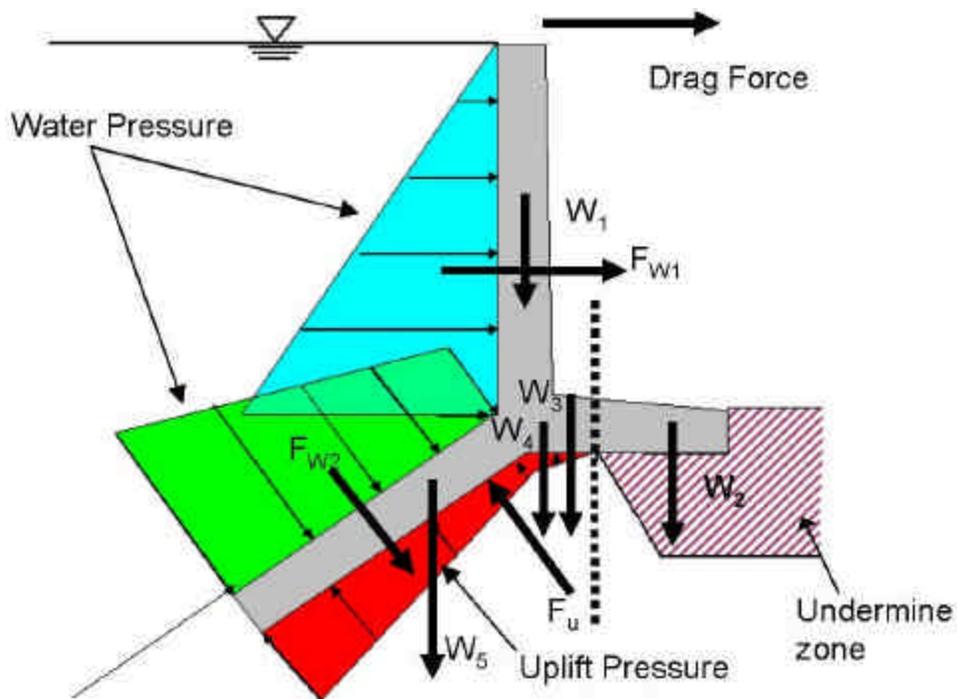
**FIGURE 8-12**

The forces considered for this analysis are illustrated below on *Figure 8-12* with the results shown on *Figure 8-13*. The results indicate that the Wall becomes unstable when undercutting penetrates about three feet under the wall. This analysis is two dimensional, and therefore for the Wall segment to actually fail, the entire 60 feet long Wall Segment would have to be undermined to this degree. We observe that Wall Segment 72 shown on *Figure 8-5* was probably “saved” by three dimensional action and the Wall Segments 44 to 56 shown on *Figure 8-6* were not undermined enough to result in an unstable situation.

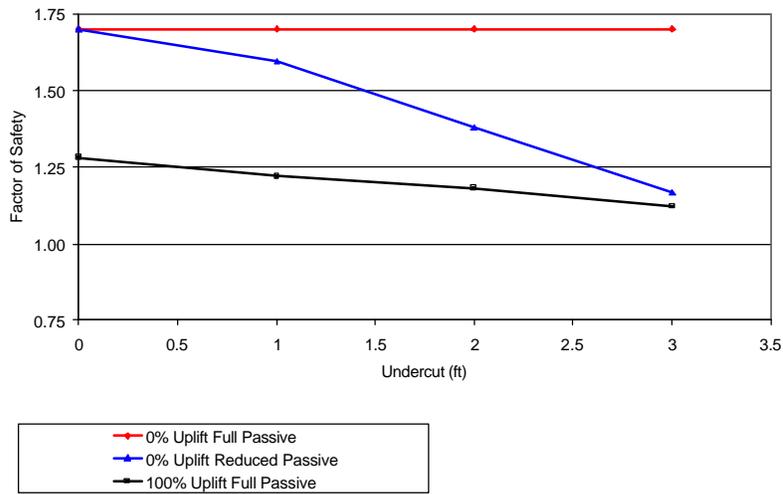
**FIGURE 8-14**

The forces considered for this analysis are illustrated are the same as shown on *Figure 8-10* for the overturning analysis and the results shown below on *Figure 8-14*. The results indicate that the Wall will probably fail first due to overturning (before sliding) when undermining occurs, primarily because of the upstream sloping base.

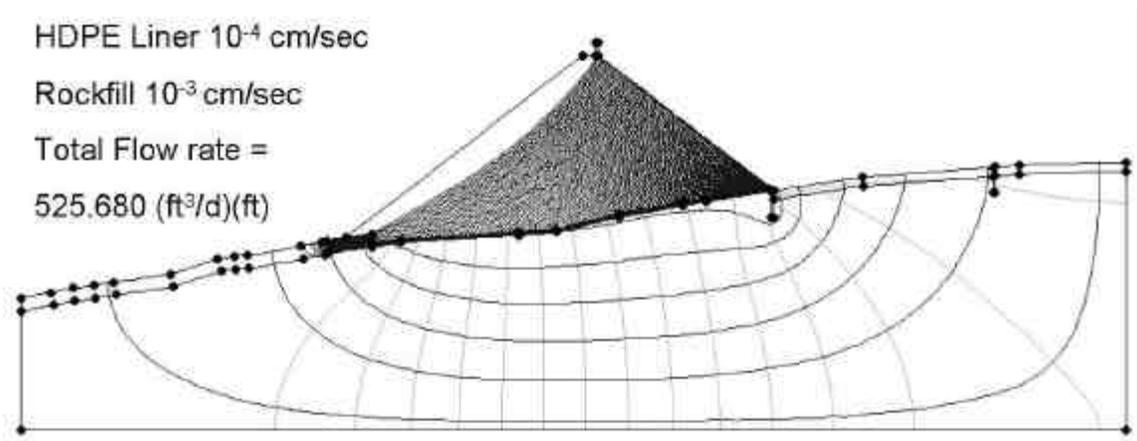
**FIGURE 8-16**

A comment pertaining to the calibration runs is that the overall calibration check is somewhat crude as the accuracy of the leakage rate available is limited. Specifically, the available leakage rates are such that one cannot distinguish water lost through the Dike from that lost through the bottom of the Upper Reservoir bottom or that lost through evaporation. Also, the configuration of the Dike varies significantly around the perimeter of the Upper Reservoir, whereas we considered only the geometry at the Breach Area as being reasonably indicative of all cross sections. Therefore, we are able to conclude only that our chosen parameters are in the proper range, but parametric runs as described below are necessary to fully understand the range of possible behavior of the Dike.

A secondary observation with this model is that there are certain zones in the Dike, such as at the upstream toe, where the gradient may have been relatively high. This would suggest the possibility of fines transport within the Dike itself, i.e., movement of fines from the toe area toward the center of the Dike. Except for the small zone at the extreme downstream toe, the gradients were too low to move the fines through the Dike entirely. This observation is consistent with reports by AmerenUE that major quantities of fines were not observed in the Pump-Back Pond at the southeast corner of the Upper Reservoir, the sink for the toe drainage ditch. RIZZO personnel observed only minor quantities of fines buildup in portions of the drainage ditch, e.g., in the reach below Parapet Wall Segment 72.

Therefore, while some fines transport and subsequent clogging of the filters near to the upstream toe of the embankment would have theoretically been possible, clogging of the filters in this area would have not had a substantial impact on the phreatic surface at the downstream toe. Additionally, the gradients shown in *Figure 8-16* and field observations suggest that clogging of the filters under the downstream slope of the Dam did not occur.

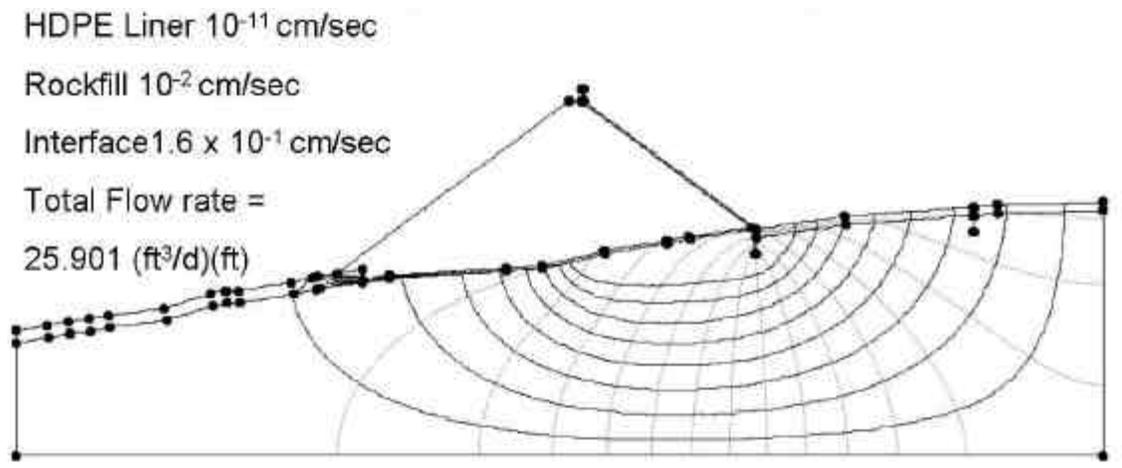
**FIGURE 8-18**

After calibrating the model shown on *Figure 8-15* and adding the HDPE Liner on the upstream face of the Dike, we performed a series of seepage analysis runs on the “Best Estimate” Model developed on *Figure 8-15* and modified to include the HDPE/LDPE Liner as shown in *Figure 8-17*. The resulting flow net shown on *Figure 8-18* indicates that the Liner significantly changed

the flow regime, dropping the phreatic surface to the level of the interface. This change increases the factor of safety for wedge failures along the interface significantly.

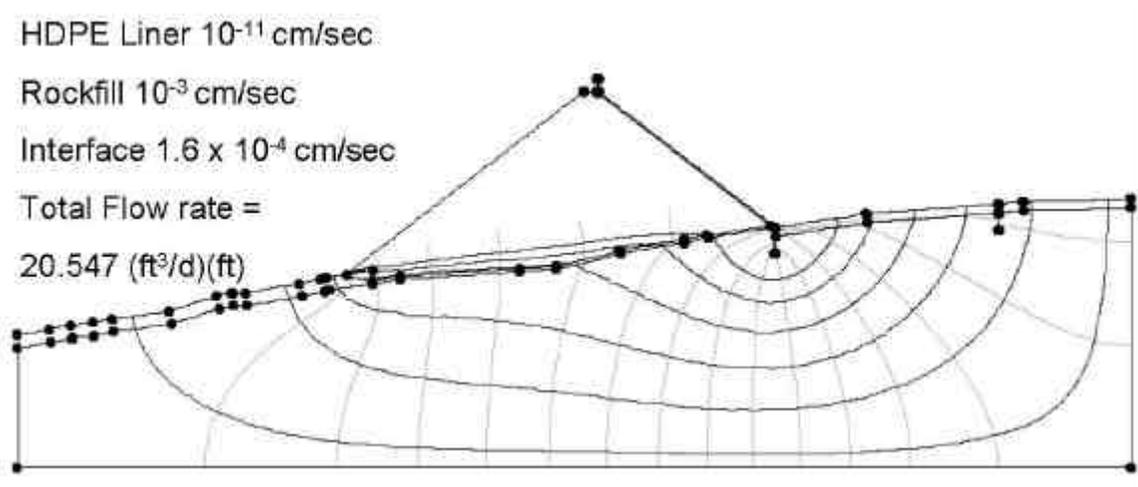
**FIGURE 8-19**

The results of these parametric runs presented in *Table 8-1* indicate that the permeability of the soil at the Dike/foundation interface and the Filters has a significant effect on the pore flow net and the pore pressure on the interface. To illustrate this point, we show below on *Figure 8-19* the flow net for Case 6 where the permeability of these two zones is postulated to be in the range of  $1 \times 10^{-4}$  cm/sec. The results also indicate that with the HDPE Liner in place, the permeability of the rock fill comprising the Dike is less important for the range of parameters that we considered.

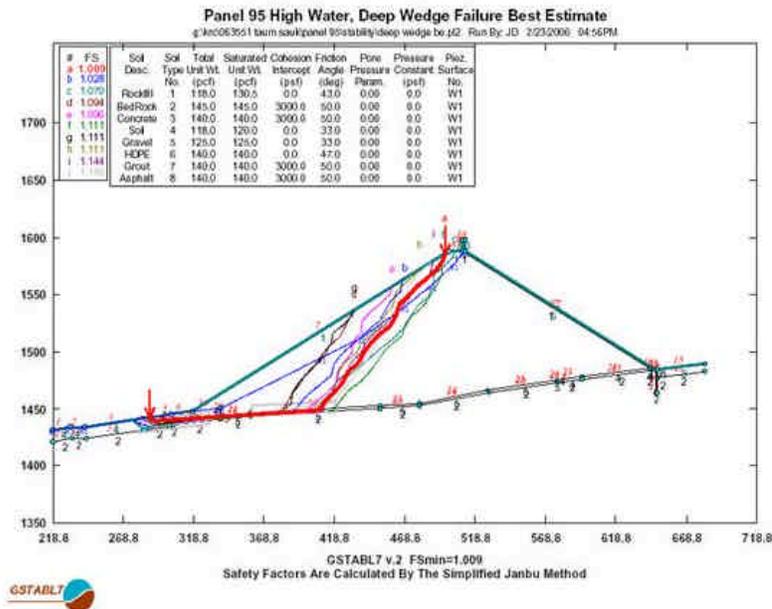
**FIGURE 8-22**

It is noted that significant pore pressure probably existed at the Dike/foundation interface before the HDPE liner was installed. The results presented in *Table 8-3* indicate that the Rockfill Dike

prior to installation of the geosynthetic liner in the Breach Area was marginally stable where the material properties were in the range of selected Lower Bounds.

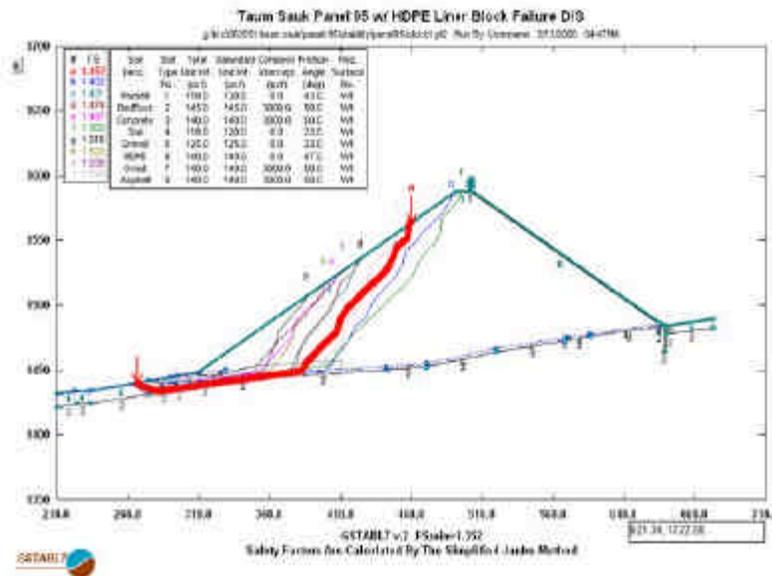
**FIGURE 8-26**

The results presented in *Table 8-4* indicate that the Rockfill Dike after installation of the geosynthetic liner in the Breach Area resulted in a slightly higher factor of safety. However, the results indicated that the section would still not meet FERC criteria for stability under static conditions for maximum storage pool (i.e., FS=1.5) (FERC, 1991). Although dynamic analyses have not been run, past experience suggests a high probability of failure under significant earthquake loading. The addition of a pseudo-static earthquake coefficient would result in a lower factor of safety approaching one. A pseudo static factor less than about 1.3 results in some amount of permanent deformation which increases exponentially with successively lower factors of safety.

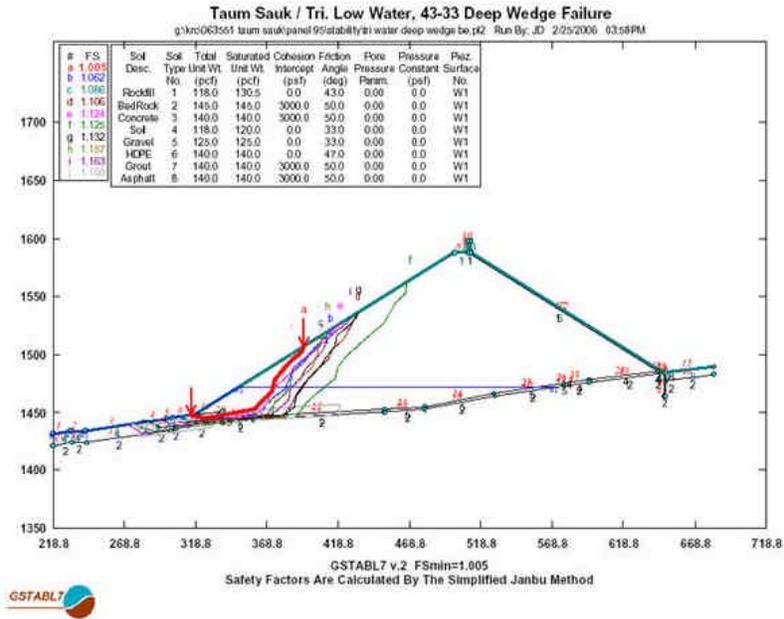
**FIGURE 8-30**

The first line of Table 8-5 indicates that RIZZO estimates that it would take about 18 minutes for the phreatic surface to increase to 34 feet above the bedrock. With the phreatic surface at this level, an intermediate to deep wedge type failure would have a factor of safety of one. Based on the analyses presented, it is RIZZO's opinion that the failure began at the toe (with either a wedge or circular failure). **Table 8-5** indicates that the toe failure condition reached a factor of safety of one when the phreatic surface was in the range of 12 feet to 17 feet above the bedrock. This occurred in the range of 10 to 13 minutes after the Upper Reservoir level reached El. 1597. The results also indicate that while failure began at the toe, probably exacerbated by run off down the slope, it rapidly progressed up slope within minutes.

The increase in phreatic surface within the Dike on the day of the Event is directly attributed to the overtopping flow. RIZZO is unable to measure or calculate with precision the level and shape of the phreatic surface just prior to the overtopping. The analyses summarized in **Table 8-5** assumed that the initial (pre-overtopping) phreatic surface was about five feet above bedrock. In terms of the Barriers presented in **Section 5.0**, this assumed initial phreatic surface might have been elevated by an ineffective Grout Curtain, Asphalt Pavement, or the Foundation Filters. Performance of the Foundation Filters was discussed and dismissed in **Section 8.3.1** as non-causal. If, on the other hand, the Grout Curtains and/or Asphaltic Pavement were ineffective and causing leakage through or seepage under, either could have impacted the level or the shape of the pore pressure distribution at the Dike/foundation interface. An increase in pore pressure would have diminished the (pre-overtopping) factor of safety against stability failure of the Rockfill Dike and possibly result in a faster time to failure as compared to the times presented in **Table 8-5**. However, it is RIZZO's opinion that neither the Grout Curtains nor the Asphalt Pavement played a substantial role in the Event and that, at best, an ineffective Grout Curtain or an ineffective Asphalt Pavement may have been a secondary contributing cause.

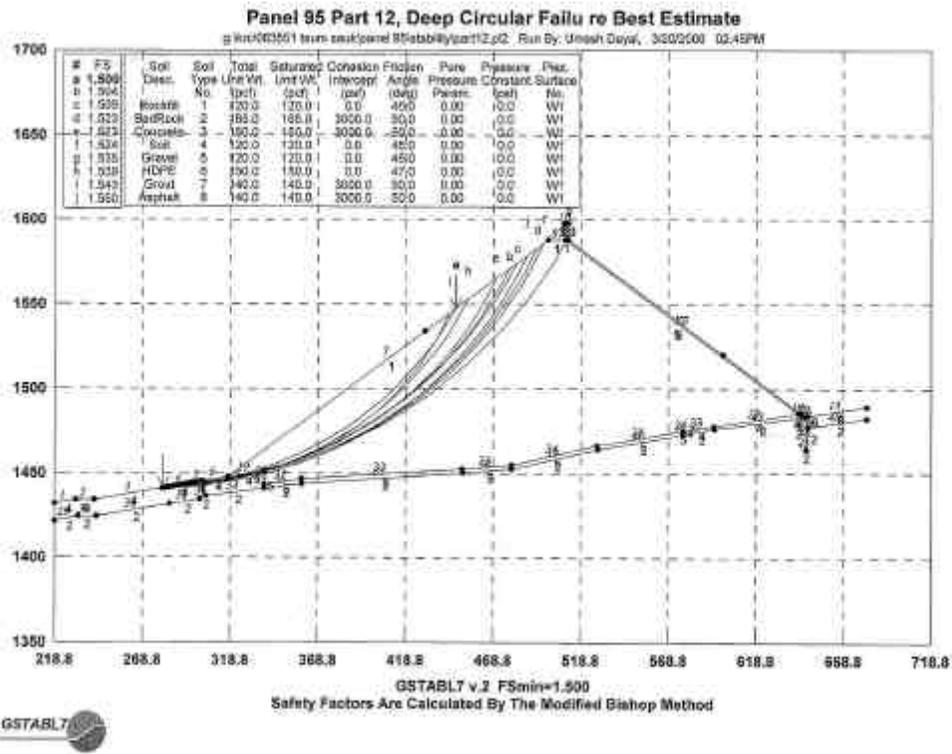
**FIGURE 8-34**

**Independent Check:** As a check, RIZZO has independently performed the slope stability analyses using the same geometry and strength properties as used in the original stability calculations—not the properties that RIZZO interprets to be appropriate. The results are presented on *Figure 8-34*. These results show a factor of safety of 1.5 as reported in the original calculations prepared by the original designer.
