NORTH AMERICAN ELECTRIC
RELIABILITY CORPORATION

Iberian Peninsula Blackout

Contextual Comparison with North American BPS Reliability Safeguards

Mark Lauby, SVP, Chief Engineer
FERC Open Meeting
June 26, 2025

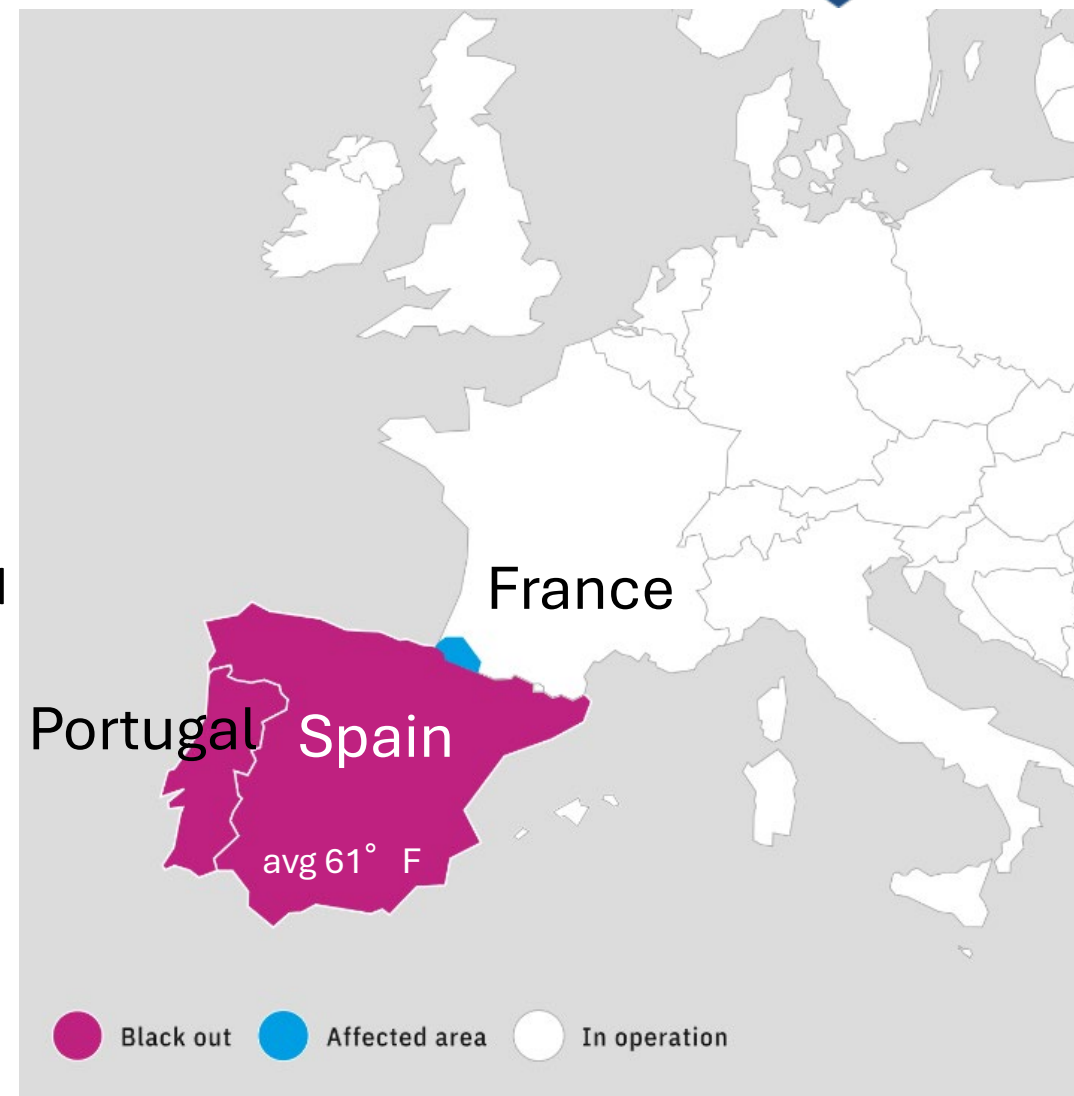
- Affected: Portugal & Spain
 - Small part of south France
- April 28, 2025
- 12:33 CET – Black Out
- 12:35 CET – Black-Start began
- 13:04 CET – Morocco-Spain interconnector reenergized
- 13:35 CET – Eastern France-Spain interconnector re-energized
- 18:36 CET – Tie-line between Portugal and Spain re-energized
- 21:35 CET – 400kV tie-line Portugal and Spain re-energized
- April 29
- 00:22 CET – Portugal transmission system restored
- 04:00 CET – Spain transmission system restored

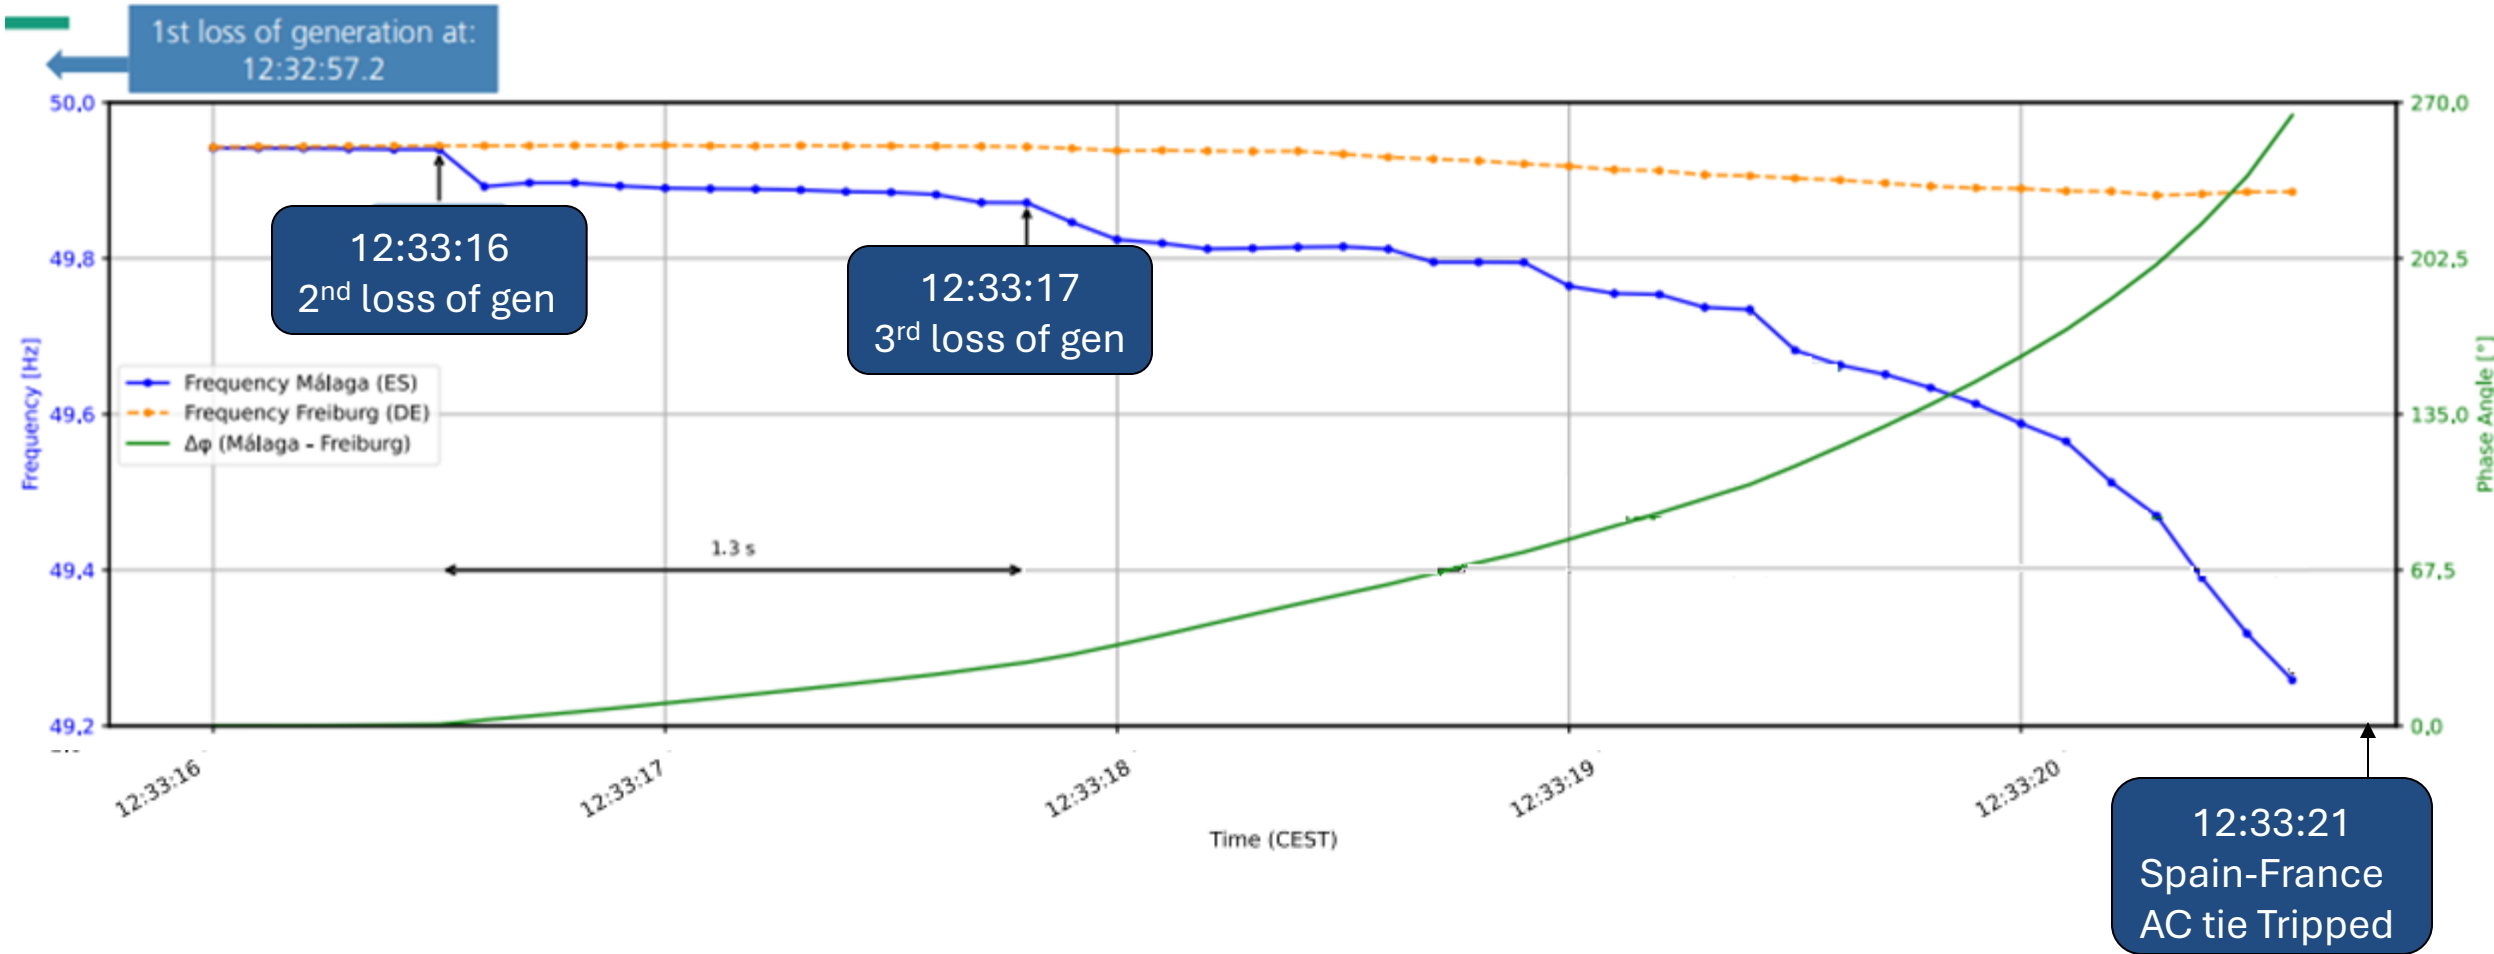
- 12:03 – 12:07 Local oscillation between Spanish and Portuguese systems (0.6 Hz)
- 12:16 – 12:22 Inter-area oscillation (0.2 Hz), followed by rising voltage due to DER tripping

Generation loss in Spain (355 MW, unknown type)
- Collector substation tripped due to overvoltage
- Some generators responsible for voltage regulation failed to perform

Generation loss in Spain (727 MW, 1 PV, 1 unknown type)

Generation loss in Spain (834 MW, 4 wind farms, 4 PV)
Sharp voltage increase, triggering a cascade of additional generation losses

Import from France reached 4,609 MW through AC ties. Iberian Peninsular system began to lose synchronism with the European system. Automatic load shedding began.

AC lines between France and Spain were disconnected by loss of synchronism protection

Spanish and Portuguese systems collapsed. HVDC lines stopped.

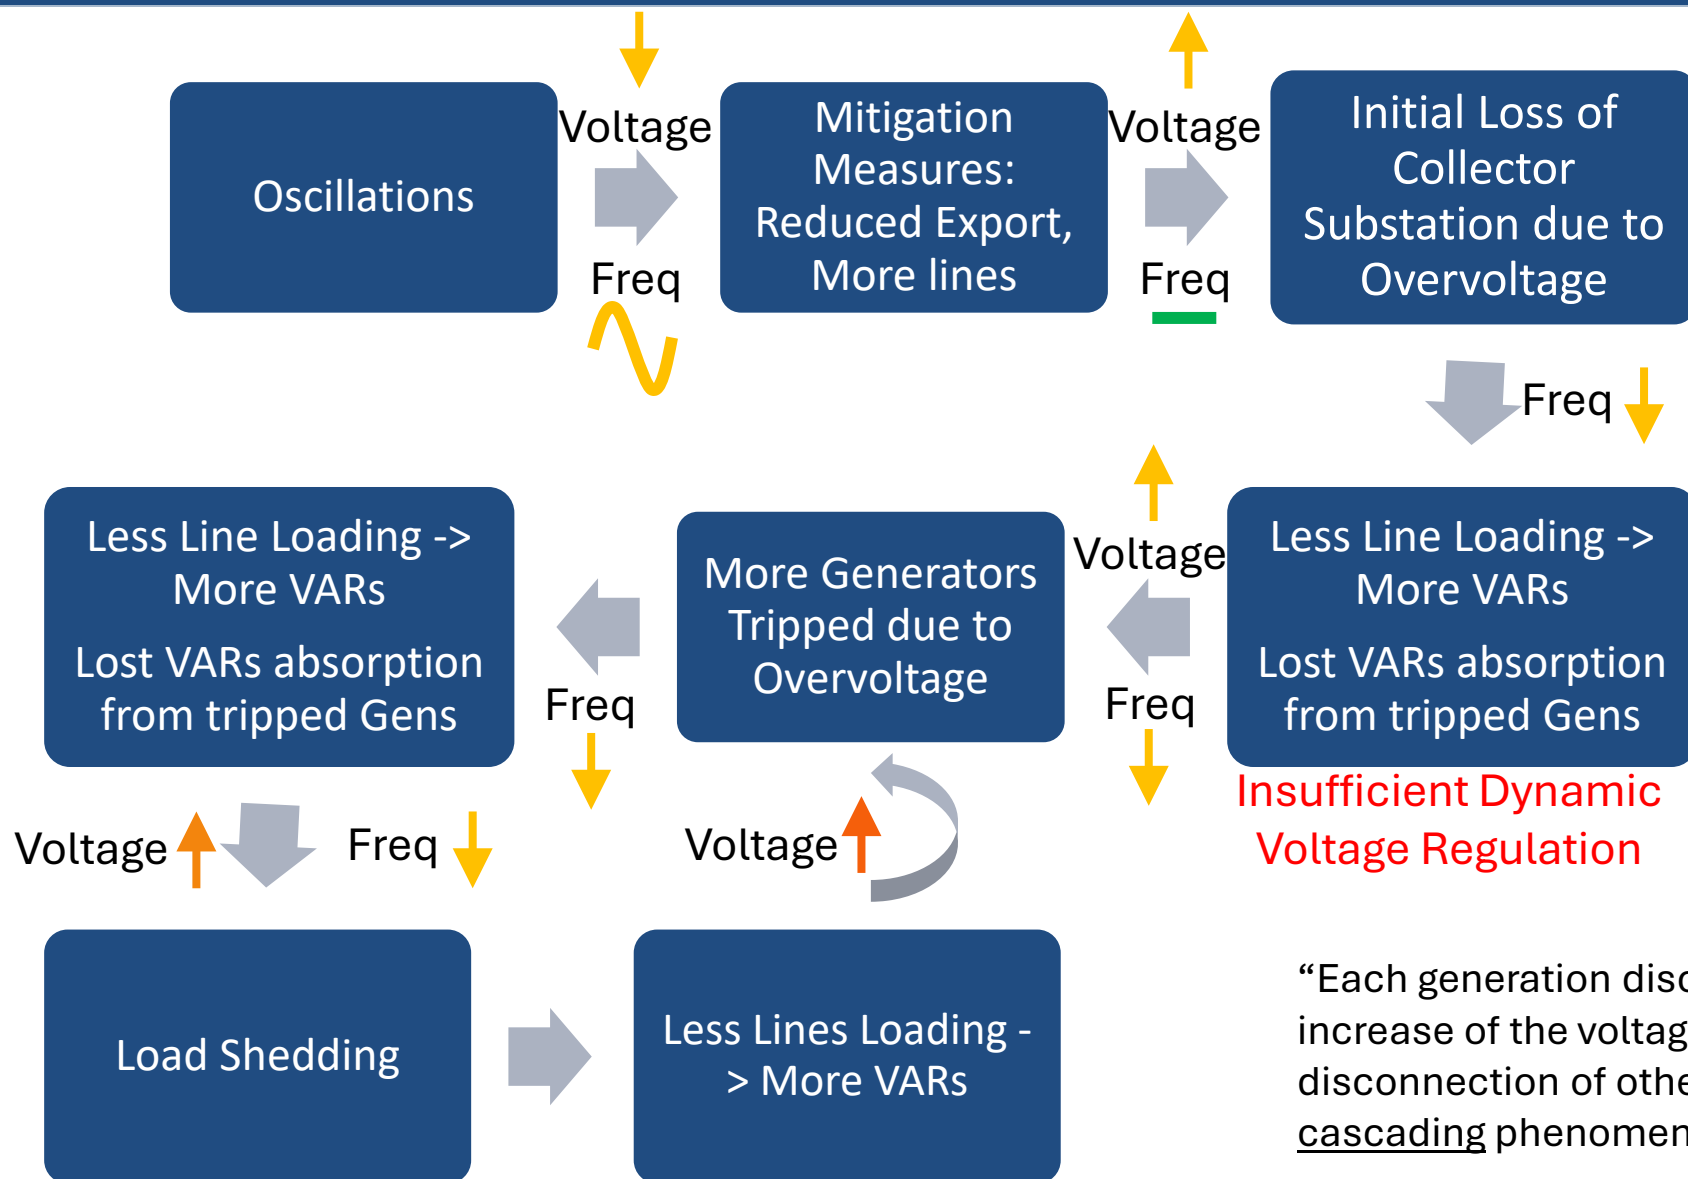
“Each generation disconnection causes a slight increase of the voltage, which in turn causes the disconnection of other generators, producing a cascading phenomenon.” - REE

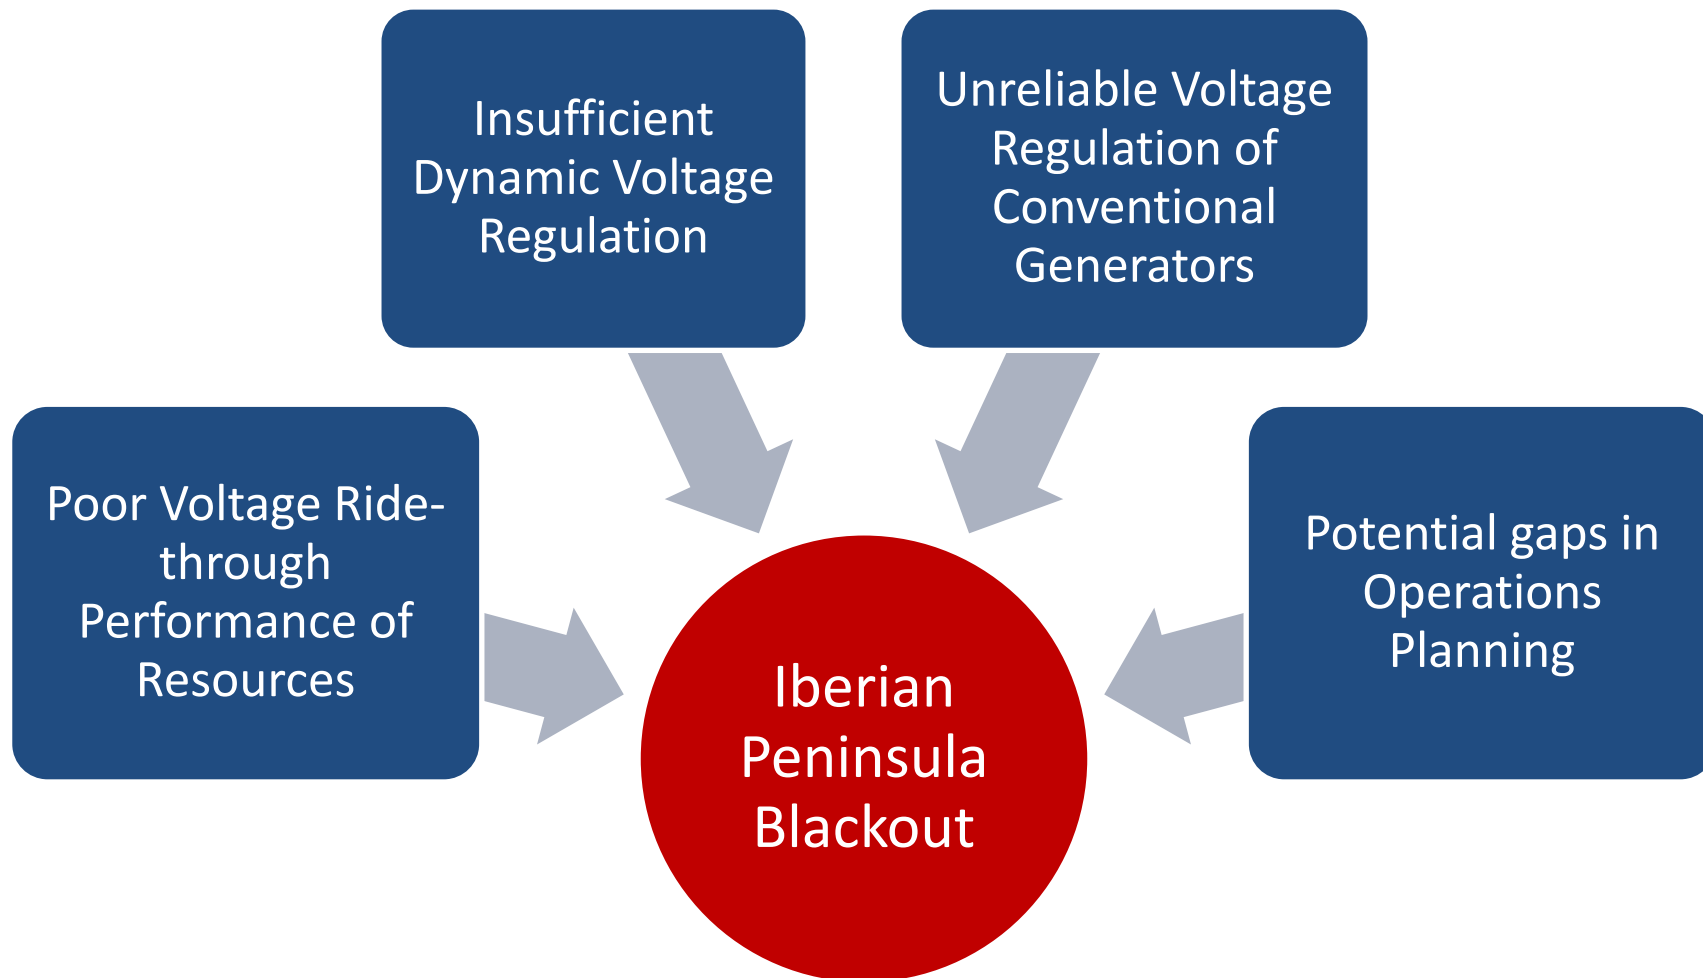
Lesson Learned for North America: If resource tripping is caused by overvoltage and results in underfrequency condition, UFLS will result in higher voltage in the absence of sufficient voltage regulation.
