**Observations on Existing Right-of-Way (ROW) Transmission Vegetation Management Program Practices by Electric Utilities and NYS PSC Regulation**

**Submission by Mark Gilliland – GEF LORAX Working Group, chairperson**

FERC Technical Conference on Vegetation Management, Oct. 26, 2010

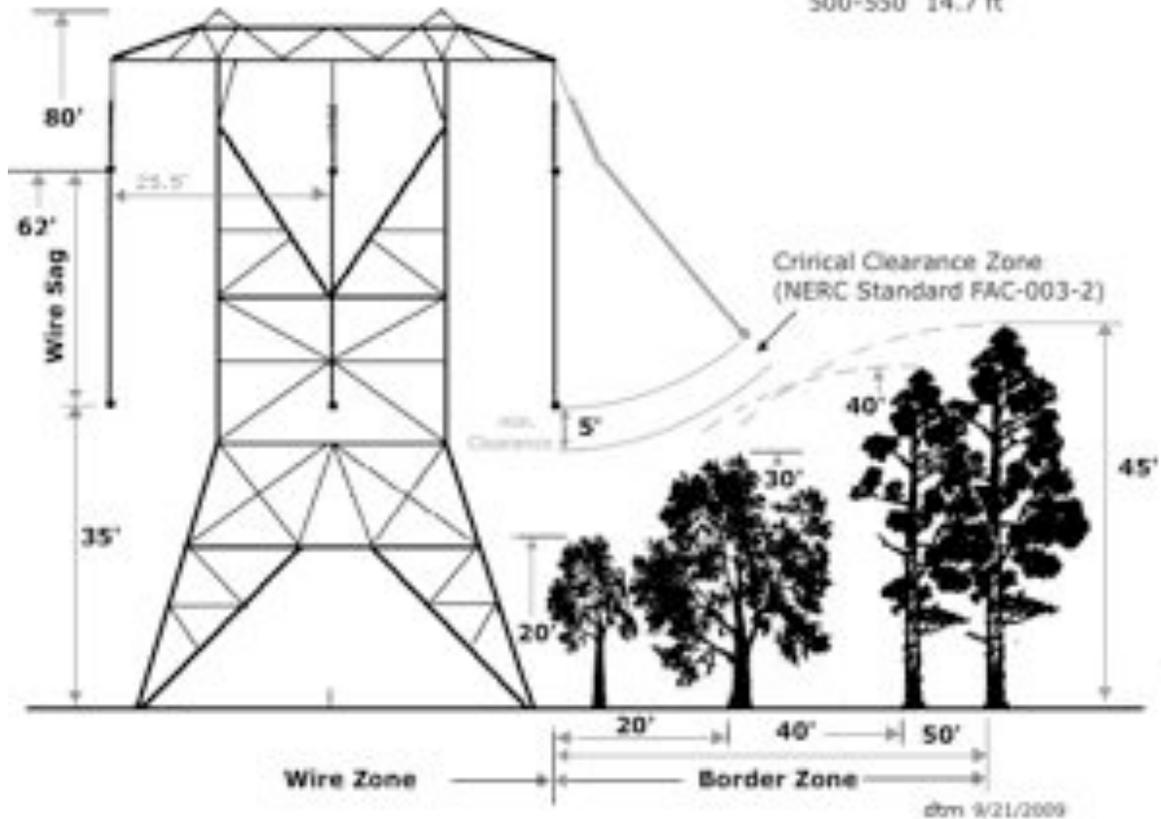
**Tree heights conforming to distance requirement to avoid arcing for 242 kV lines.**

(IEEE) Standard 516-2003  
 (Guide for Maintenance Methods on Energized Power Lines)

Voltage	Clearance
230-242	5 ft
345-362	9.4 ft
500-550	14.7 ft

R17: Remove the “Priority Zone” loophole in state guidelines through stricter definition of the term. See diagram (below) for example of a tiered management approach which meets Federal regulations.

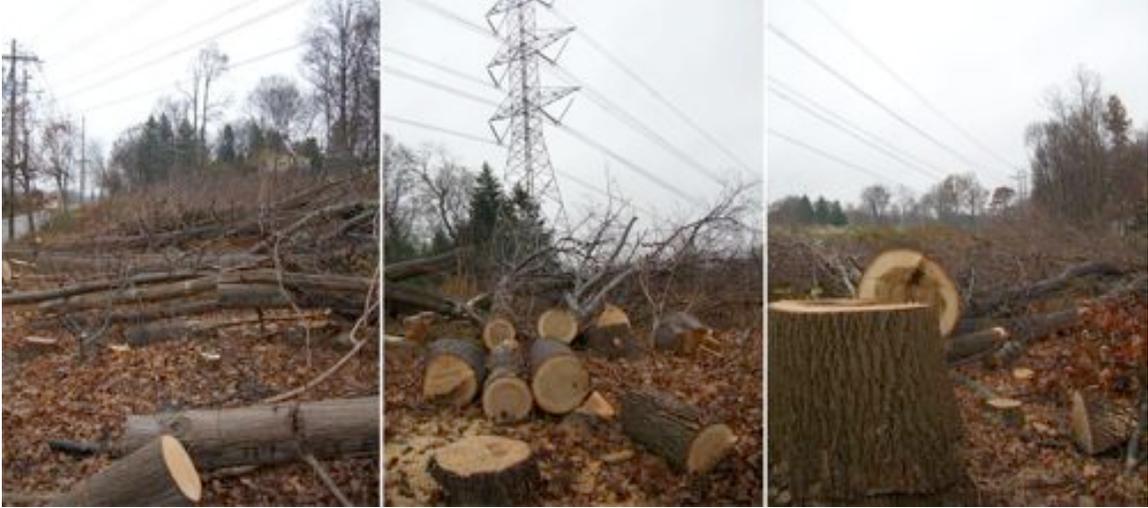
General view of deforestation along ROW.

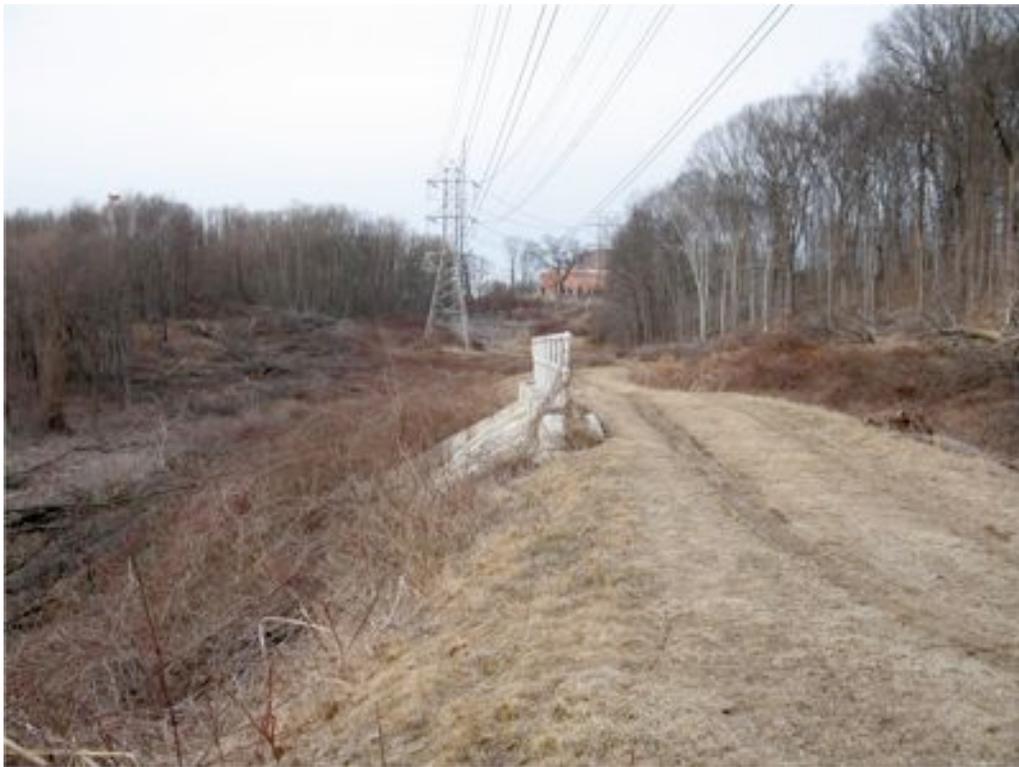
Utility access road and asymmetrical clear cutting, leaving a much narrower margin on the right side of the ROW. Also shows excessively wide “priority zone” buffer on the left side of ROW. Vegetation management has not taken into account the varying terrain elevations vis-à-vis wire zone and overhead wires.

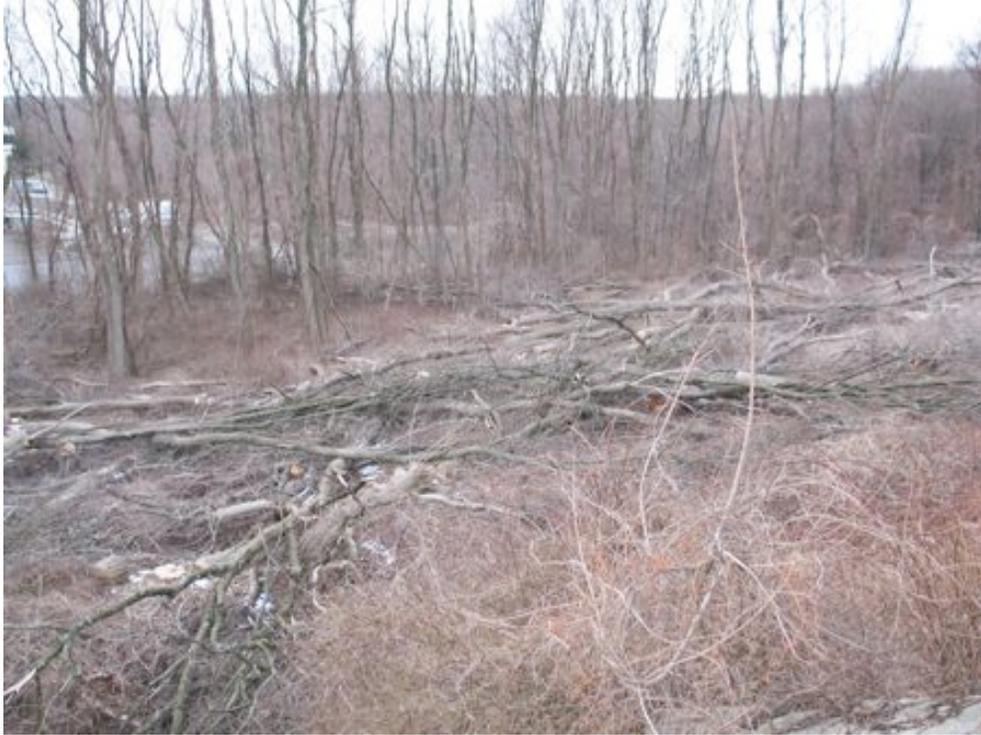
Windrowing of clear cut debris along ROW edge.

R14: Require proper & timely removal and disposal of all debris generated by VM activities within three weeks of occurrence, including but not limited to the remnants of any tree cut or cleared from wetlands, water courses, easements or other right-of-ways. Wood chips must be spread to a depth not-to-exceed 3 inches if left in situ.

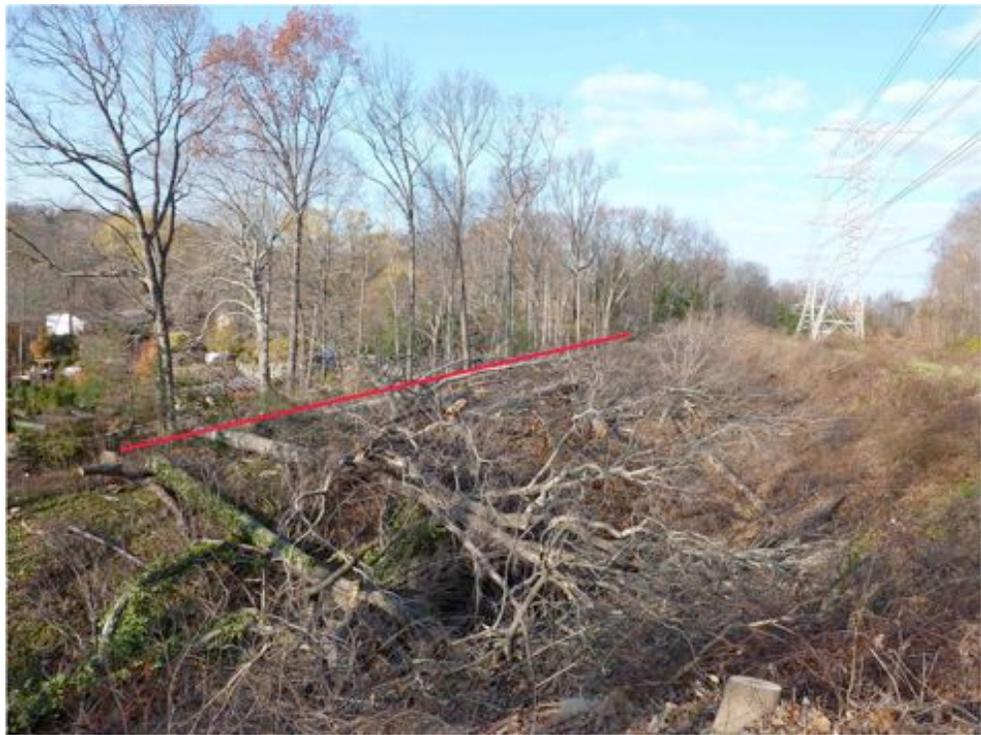
Remaining single line of private trees along ROW edge. Abutting property owner later reported that several of these trees fell due to “blow down” effects during the winter storms of March 2010, resulting in extensive damage to improvements on his property.

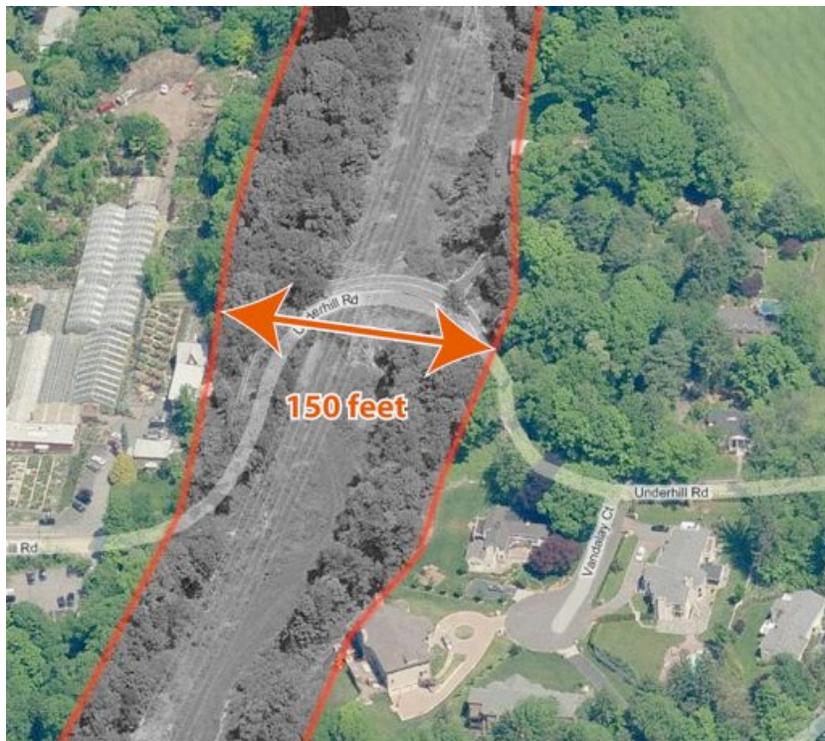
Diagram 2 – Estimated width of expanded ROW (post 2009) based upon onsite visual inspection.  
(Greenhouses can be seen on the left of these images.)

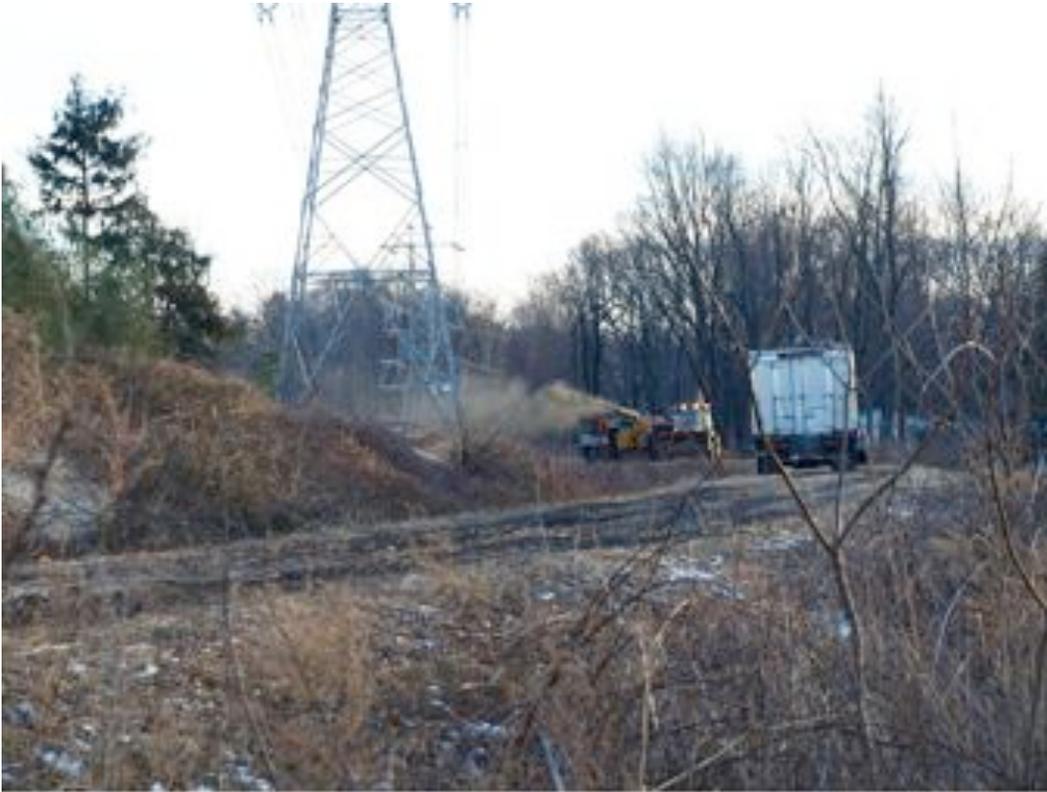
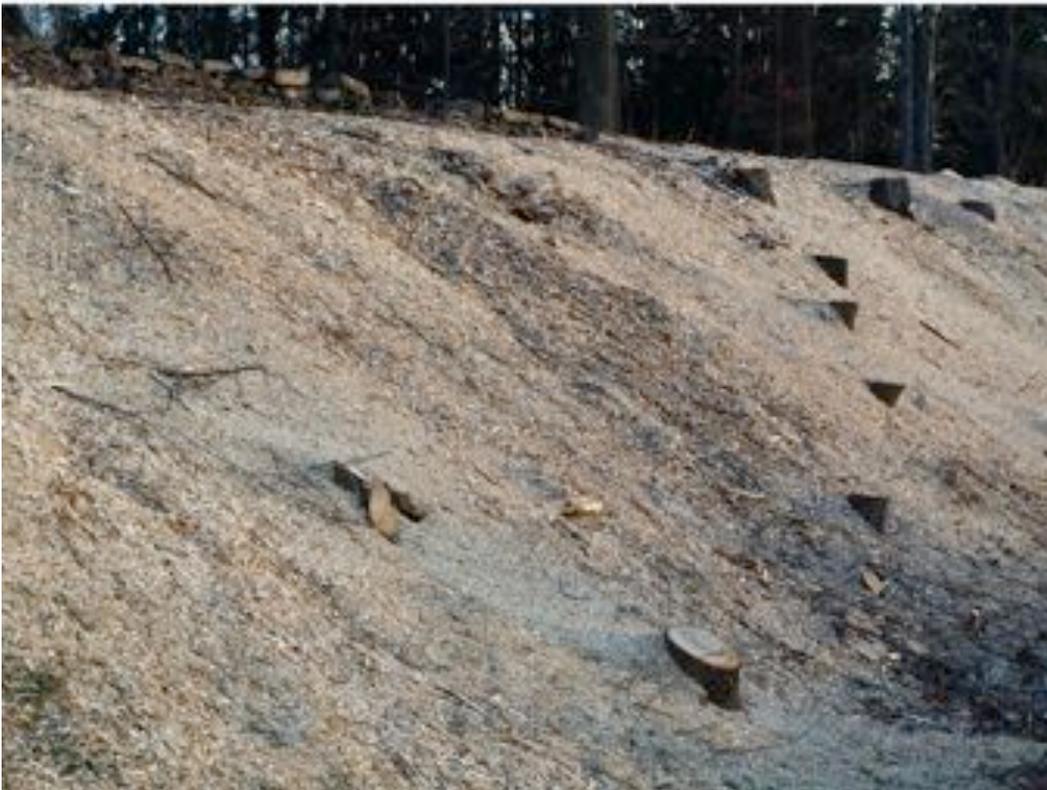
Post clear-cut chipping of debris in Sprain Road area. Note that the wood chip piles shown in the lower image were measured to be 24" deep in some areas of the ROW.

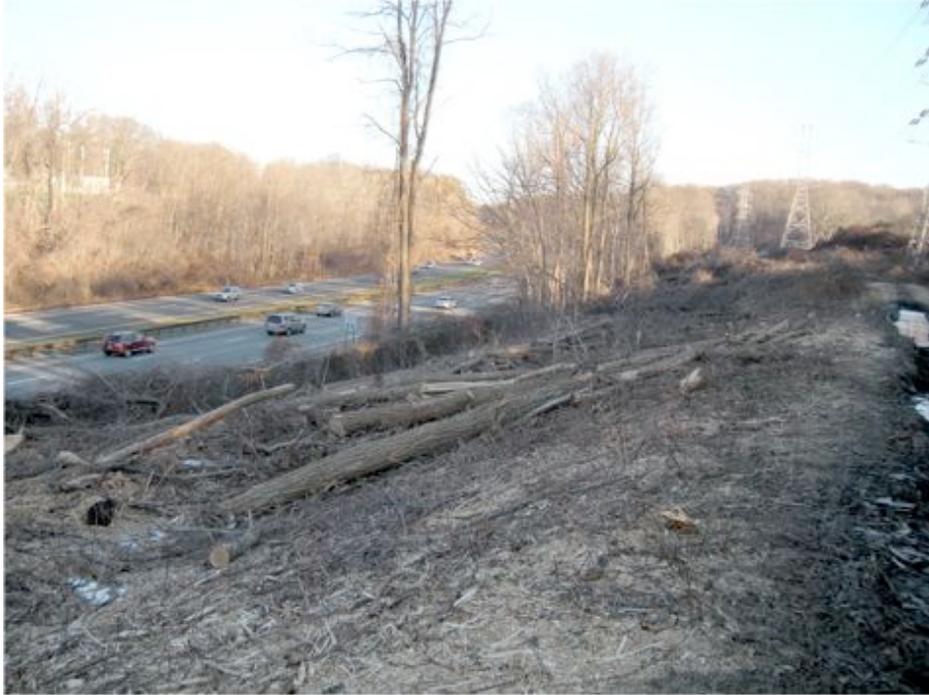
Area of ROW showing removal of wide woodland buffers, resulting in local residents' exposure to unfiltered highway noise, pollution and headlights.

R20: Retain and maintain vegetation providing headlight, wind & noise abatement, as well as any vegetation functioning as riparian buffers or specialized environmental function.

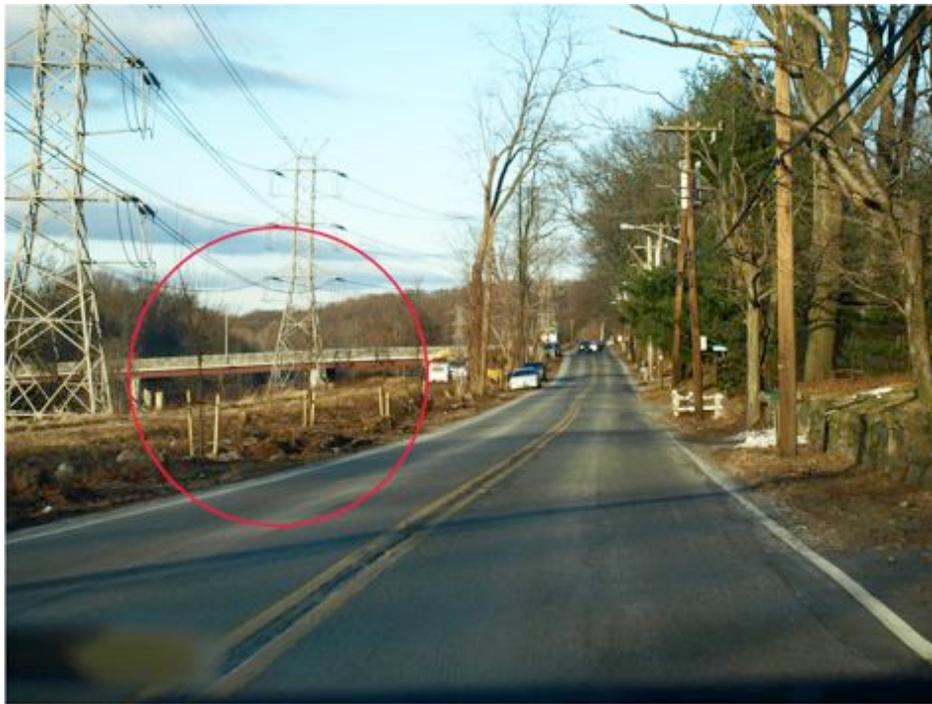
Showing 3 newly planted trees intended to act as mitigation for the removed wooded buffers. Removal in this area occurred illegally on municipal easement without prior approval or notification.

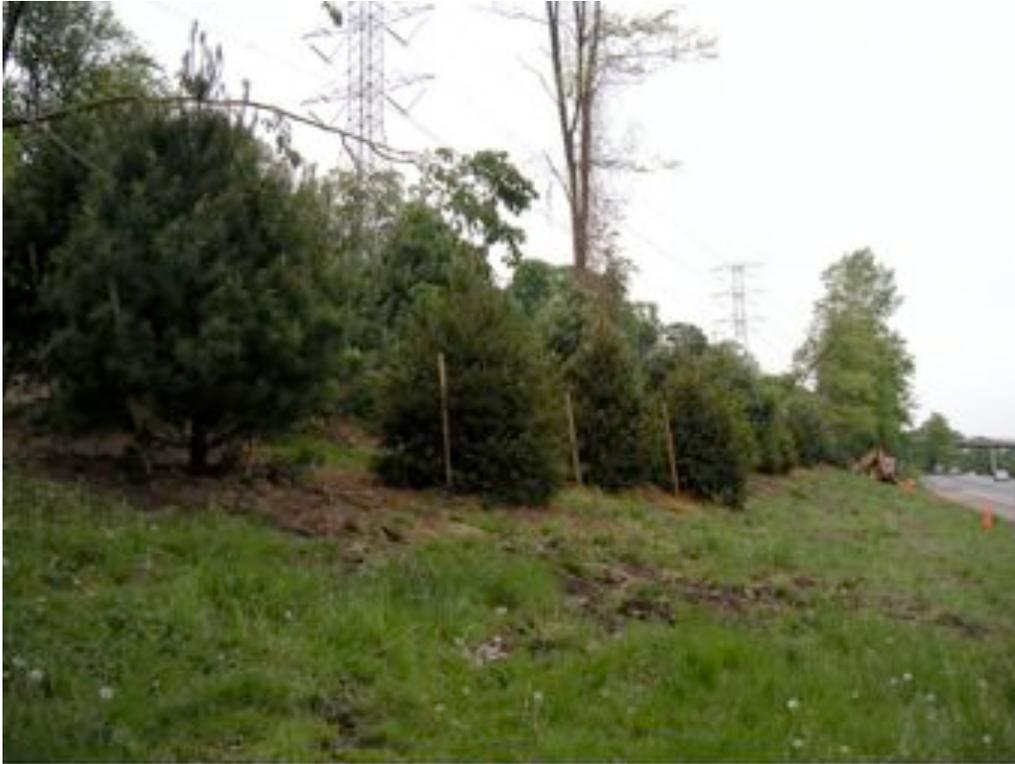
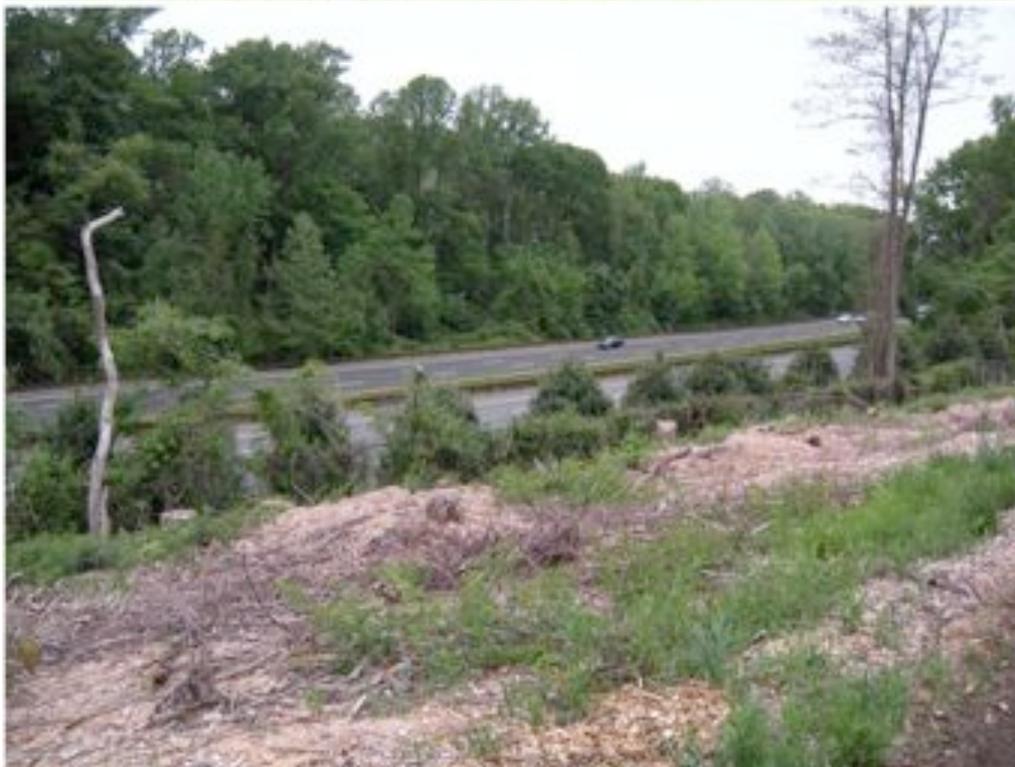
Replanting in the next to highway. Note that these trees have been planted on DOT easements. Note also that due to the small size of these evergreens, the intended mitigation for noise, headlight glare and exhaust pollution (etc.) from the highway on nearby residents will take years to become effective.

R30: Require TVMP plans to include mandatory replanting and restoration plans (on ROW or adjacent properties), whereby any significant tree removed as undesirable is replaced with a more desirable, preferably native, and right-of-way compatible species (and not by seedlings but rather more mature trees.) The goal is ecosystem / habitat recovery.

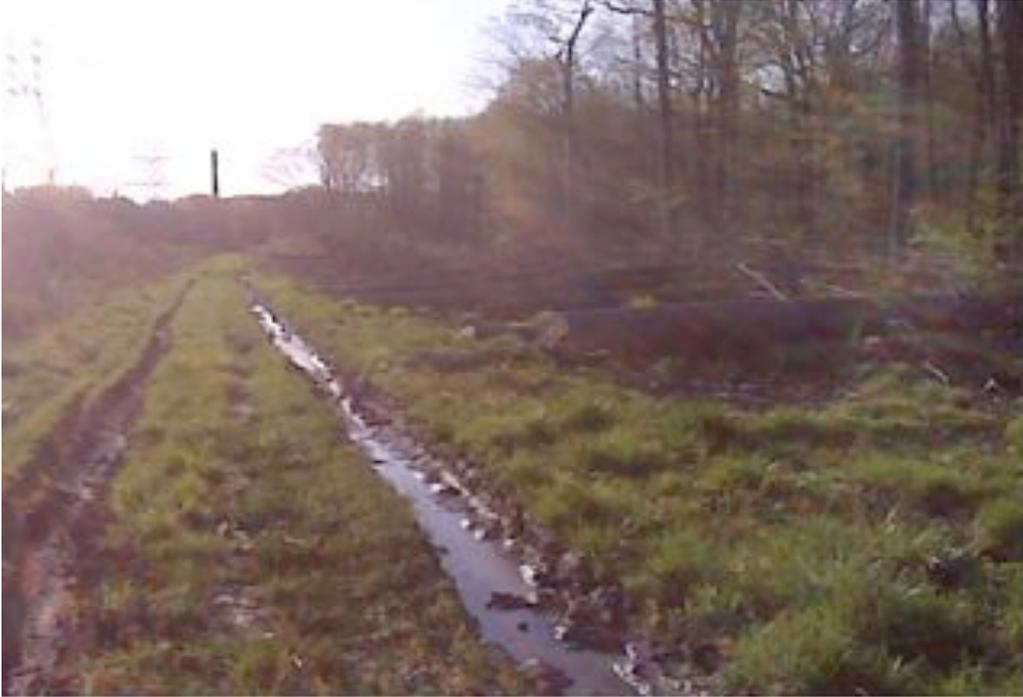
ROW showing access road, piles of clear cut trees along the ROW edge and overly wide "priority zone" buffer clearing in regards to the transmission lines located on left.

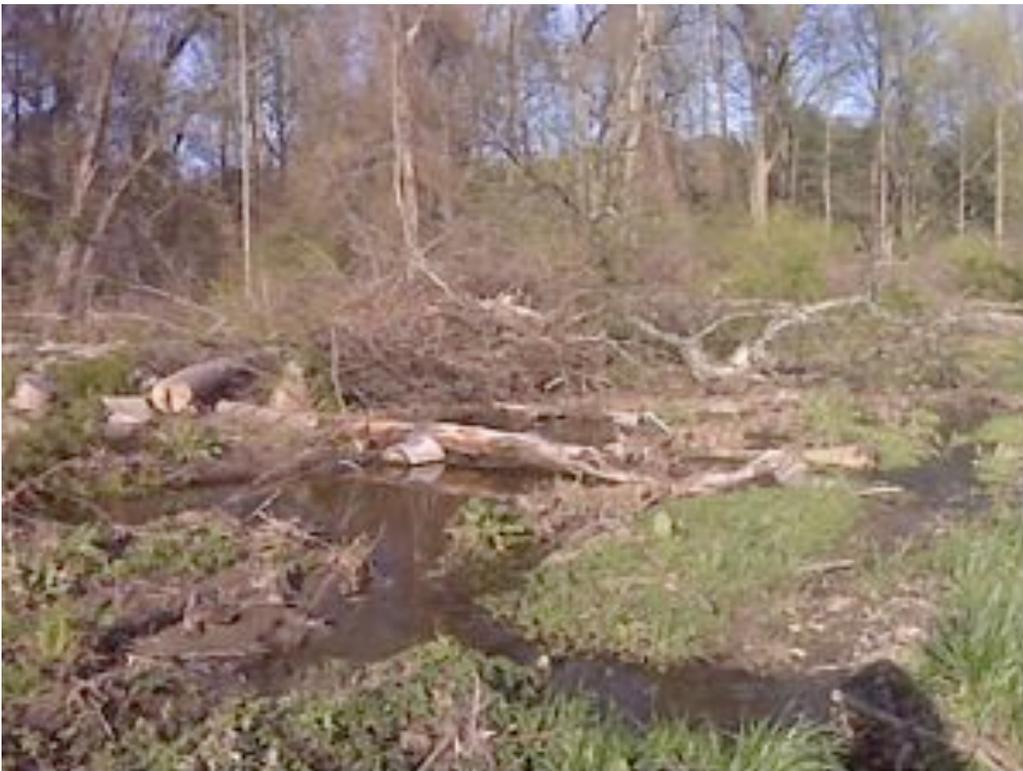
Area (near Park) showing vegetation debris left in water course in violation of state stormwater requirements.

R7: Adhere to state permit requirements for the protection of water courses and wetlands, as well as for stormwater, erosion and sediment control during and post VM activities.

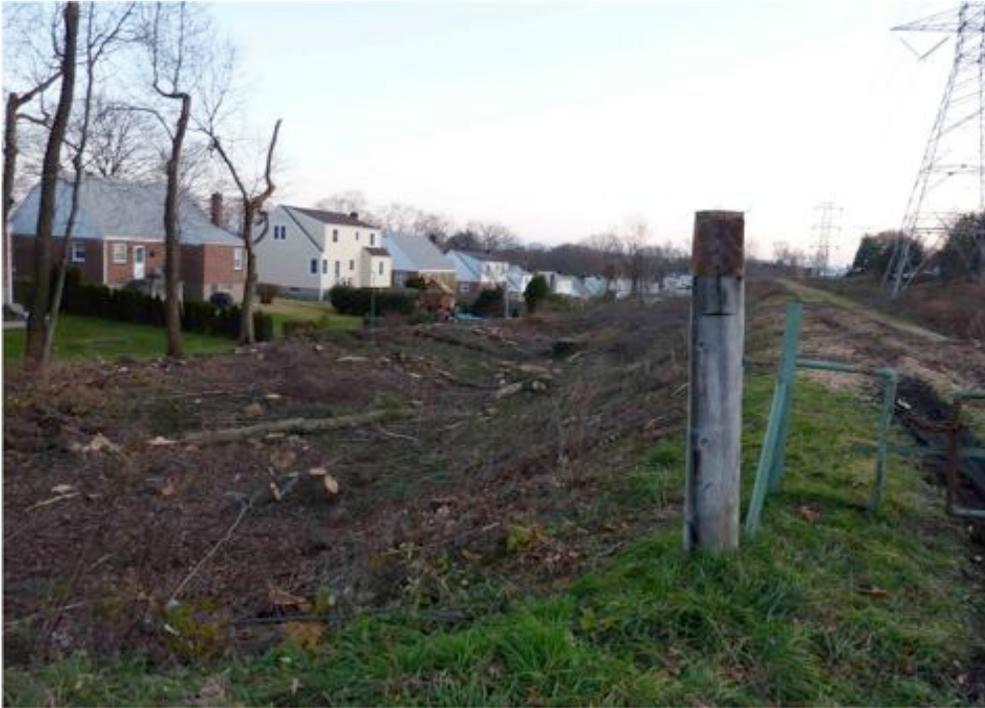
Showing negative property value impacts due to excessive clear cutting of visual buffer along the ROW.  
(See diagram below for camera angle.)

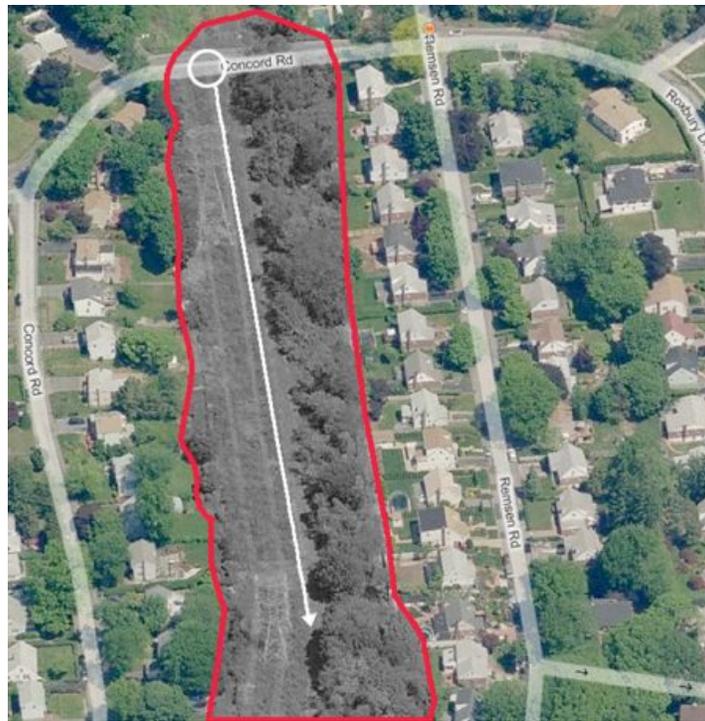
Above aerial perspective (camera POV shown by white arrow). This is a small part of the overall clear cutting which occurred in this heavily residential area of transmission lines.

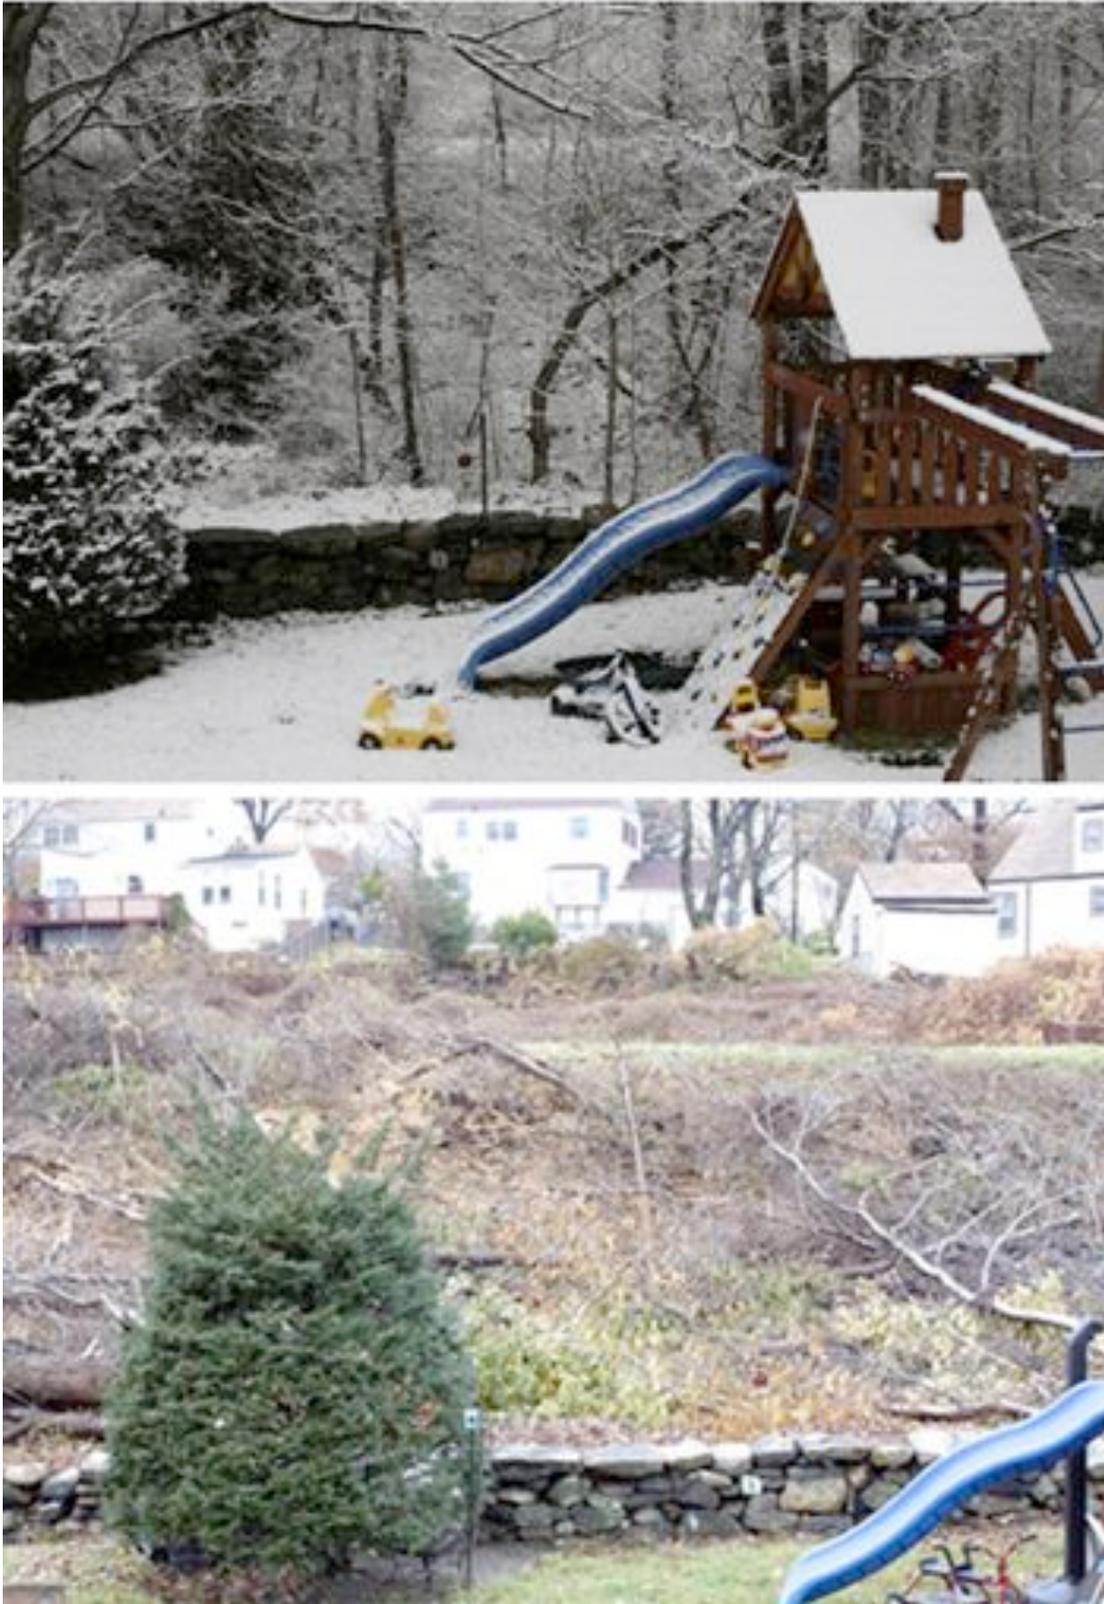
Showing a before (above) and after (below) view of impacts of green buffer removal.

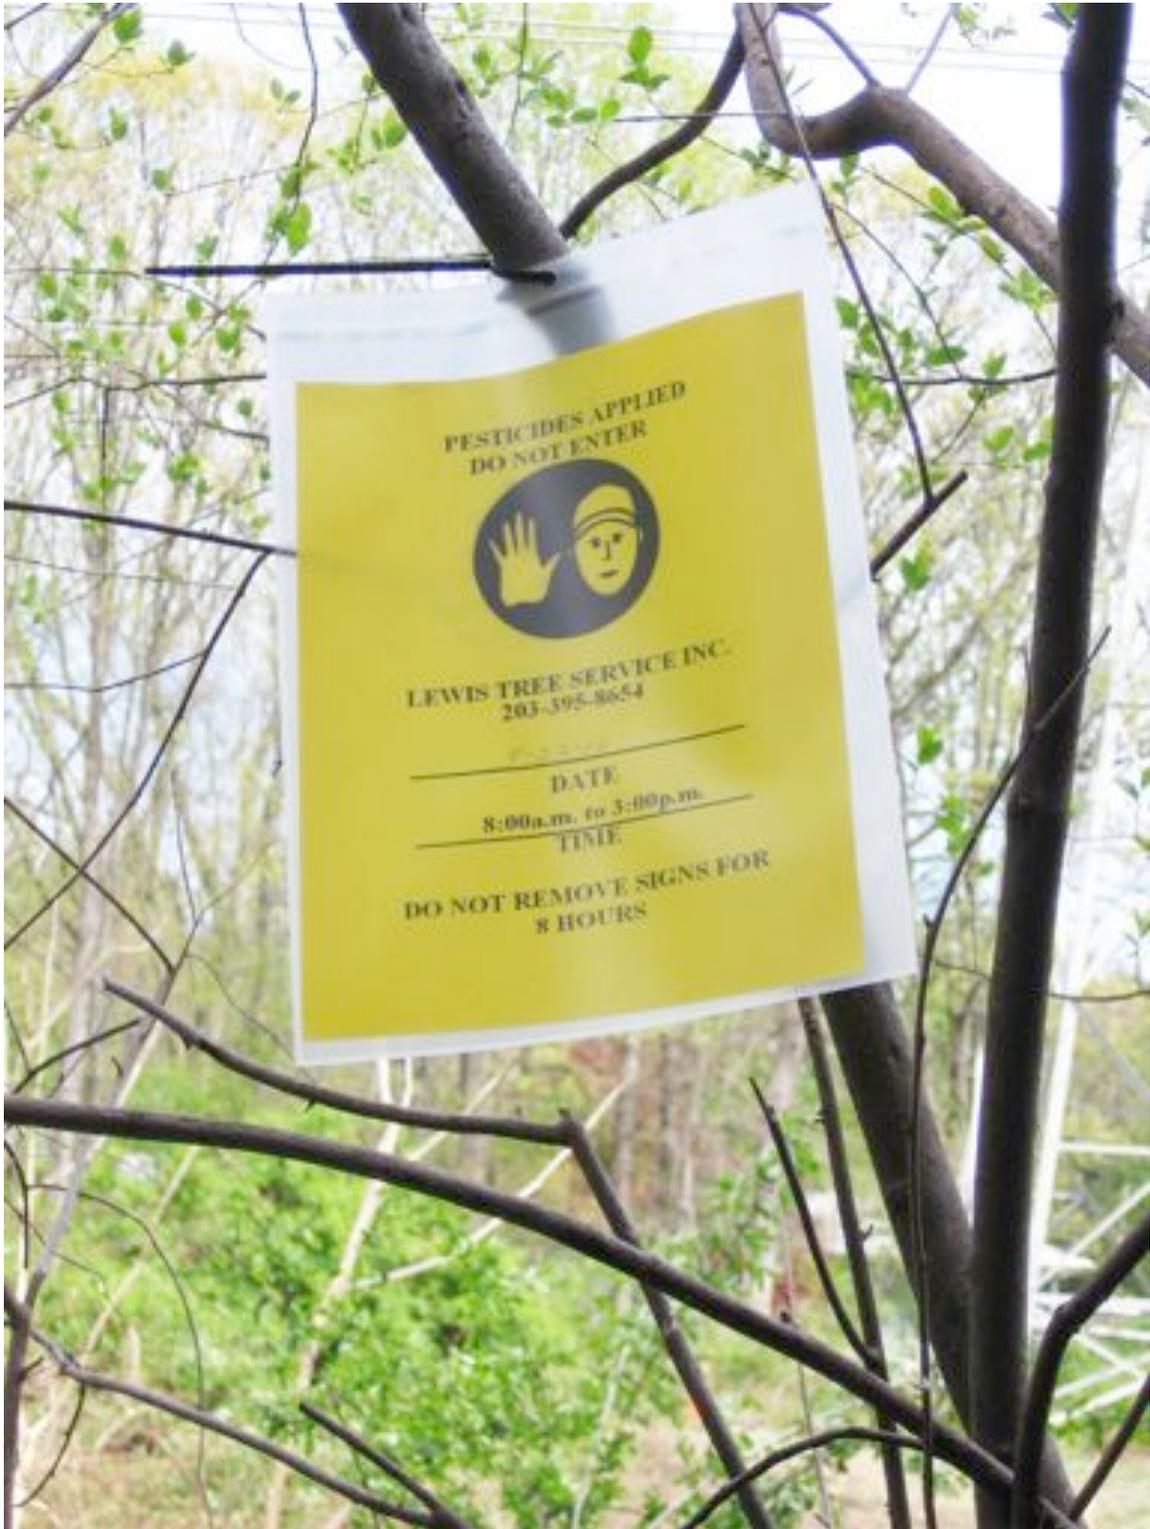
Showing non-compliant pesticide notification posted along the ROW.

R12: Provide better (clearer) notification of herbicide application through placement of more signs along ROW, left in place for a longer period of time.

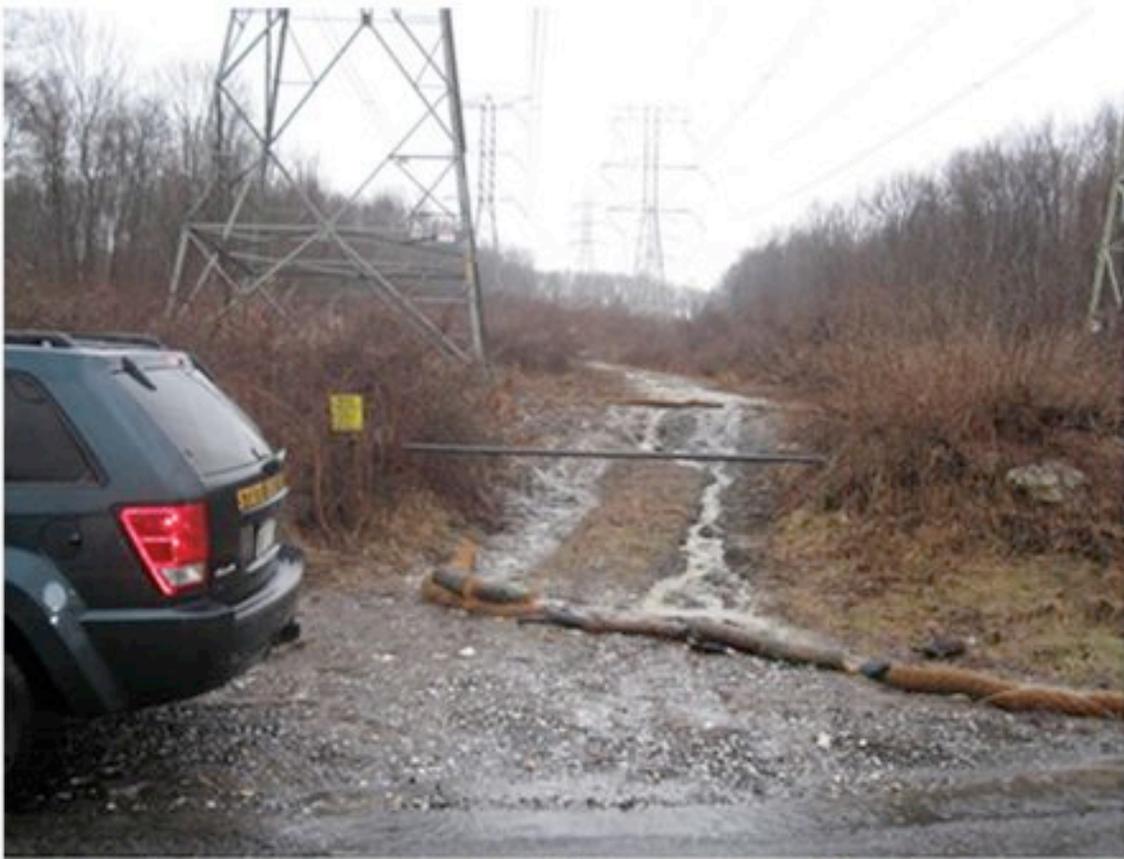
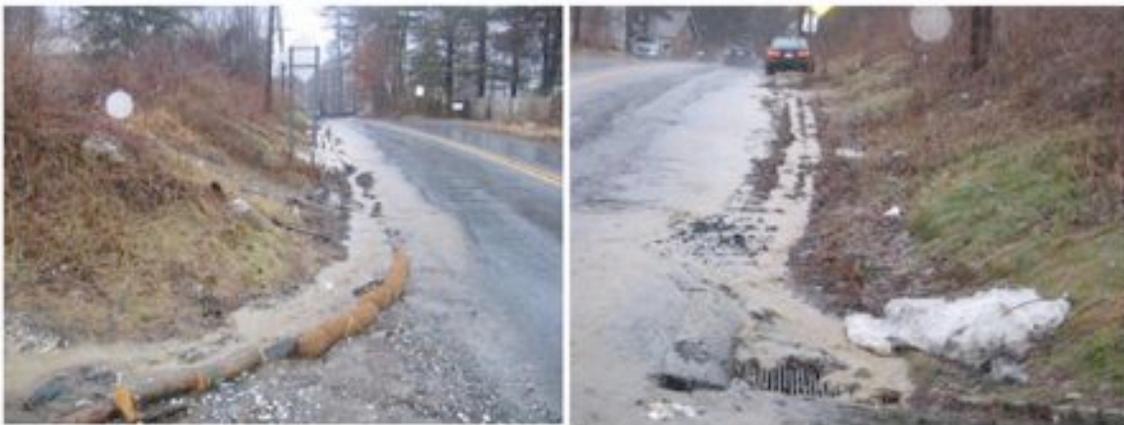
Showing excessive erosion and runoff, documenting the lack of required state permit erosion and sediment controls that must be in place during construction or disturbance activity.

R13: Require control of erosion and run-off that complies with state permit requirements and guidelines. Violations that have been reported to date include:

R40: Require on-going monitoring of sites post-VM so as to provide early detection of stormwater and erosion issues – or to detect failure of installed mitigation.

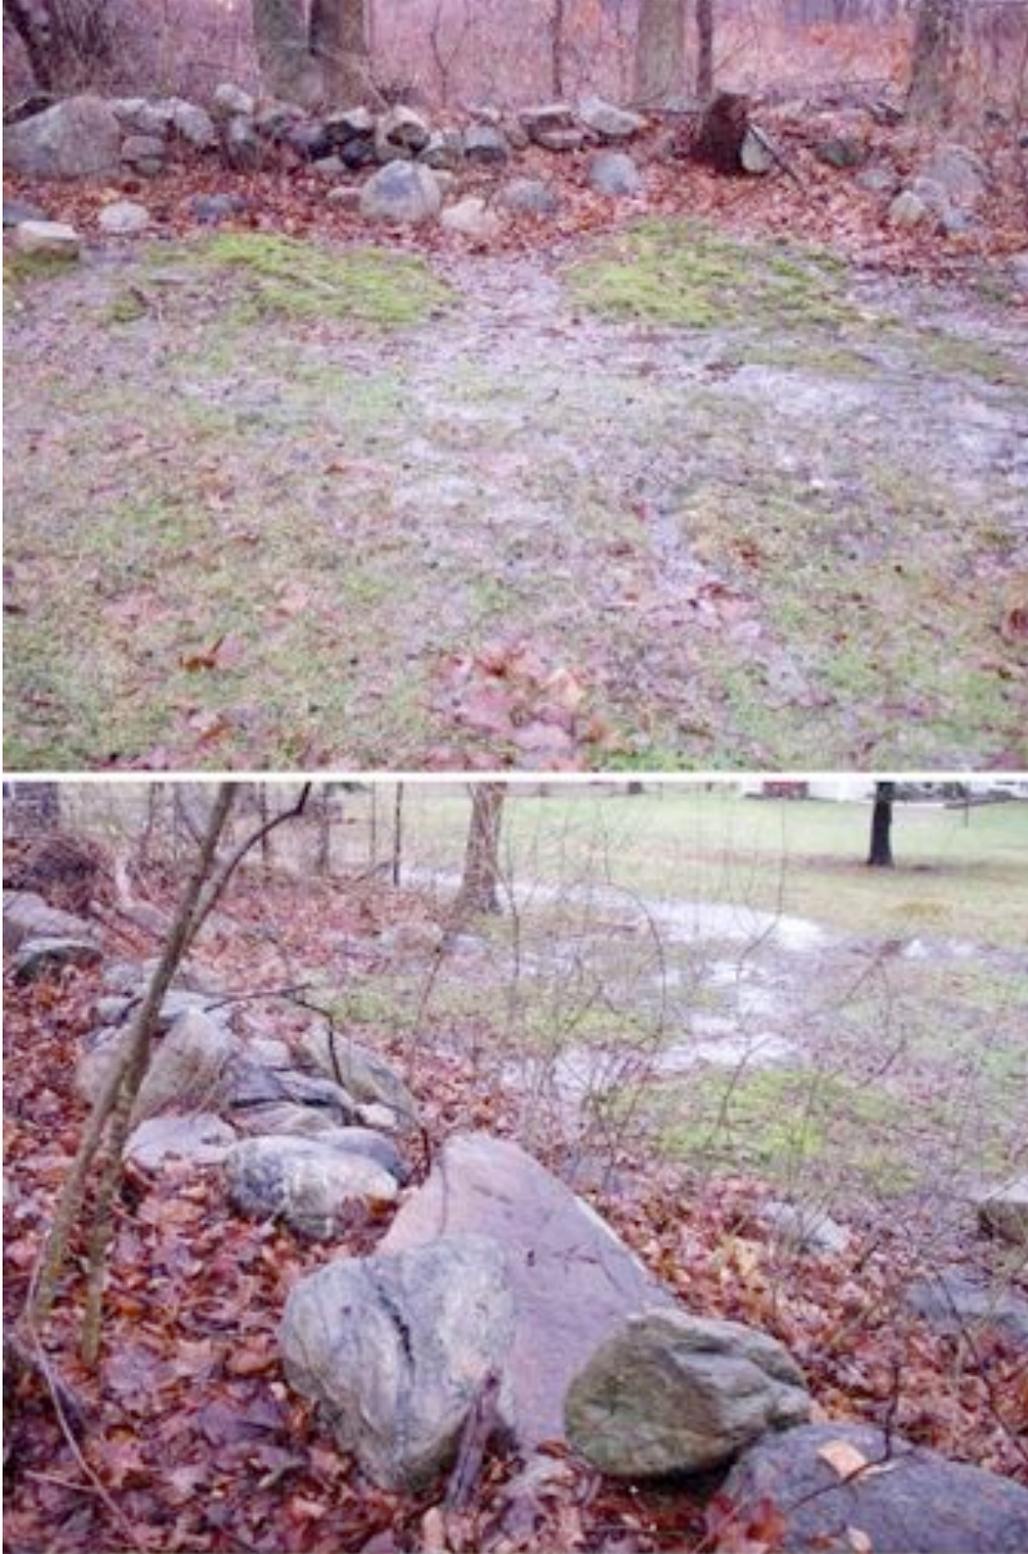
Showing increased runoff and flooding from the ROW (left of wall – lower frame) onto private property (right of wall – lower frame). The increase in stormwater runoff is directly traceable to clear cutting of the ROW. No mitigation for these excess stormwater impacts has been provided by the utility.
