Denali Alternative – Visual Impact Assessment

APPENDIX E: DENALI ALTERNATIVE - VISUAL IMPACT ASSESSMENT

E.1 AFFECTED ENVIRONMENT, IMPACTS, AND MITIGATION MEASURES AT KEY OBSERVATION POINTS IN THE DENALI NATIONAL PARK AND PRESERVE

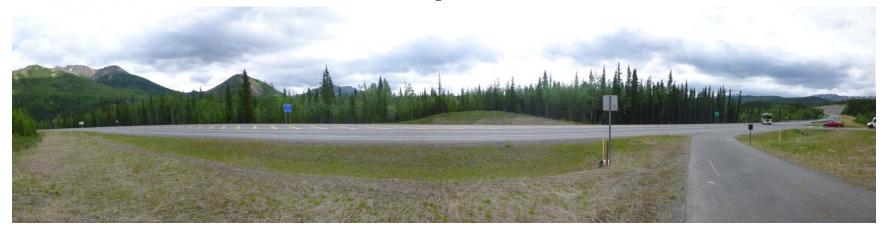
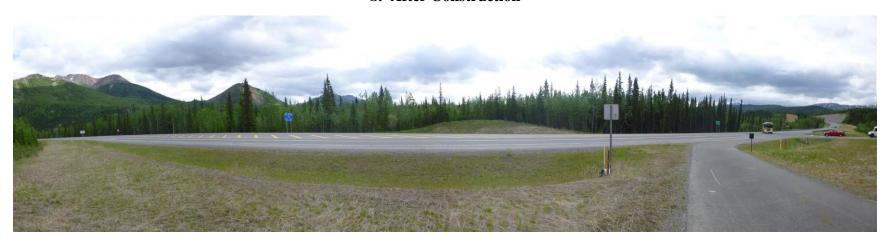
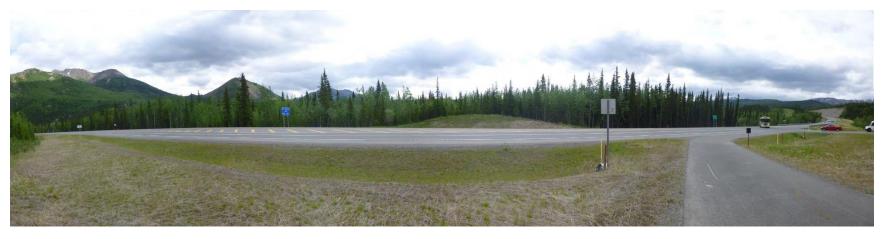
Figure E.1.2-1. Intersection of George Parks Highway and the DNPP Park Road Simulations; View of the Denali Alternative to the East a. Existing Conditions

b. After Construction

c. After Reclamation

Potential impact of Denali Alternative immediately after construction: There is potential for low visual contrast from the proposed Denali Alternative (see figures E.1.2-1b and E.1.2-2b in appendix E-1c). The right-of-way is only slightly visible after construction in the right furthest extent of the view to the southeast. Viewers do not spend a lot of time at this location and there are no prominent features in the view.

Potential impact of Denali Alternative after restoration: Mitigation measures would reduce the already low visual contrast (see figure E.1.2-1c in appendix E-1c).

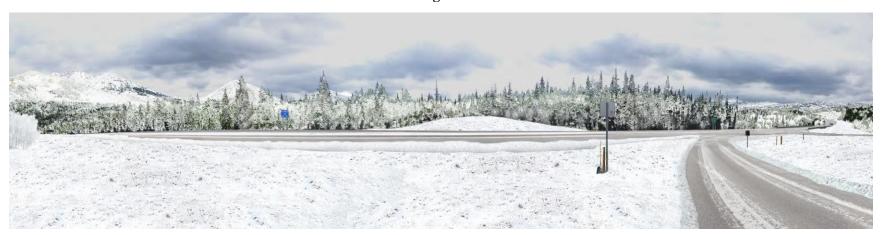
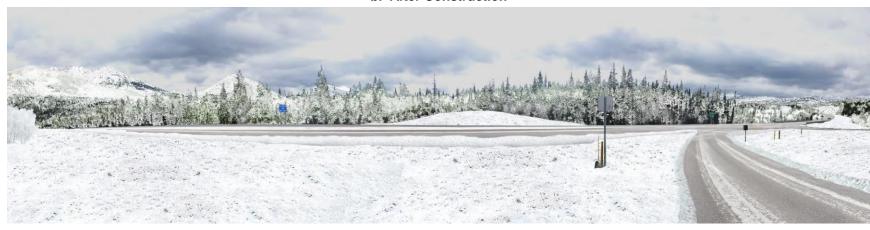
Figure E.1.2-2 Intersection of George Parks Highway and the DNPP Park Road Winter Simulations; View of the Denali Alternative to the East

a. Existing Conditions

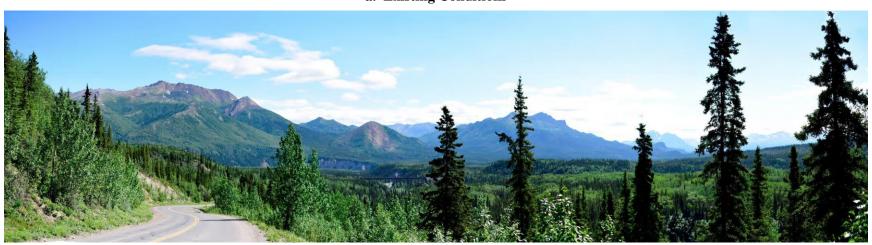
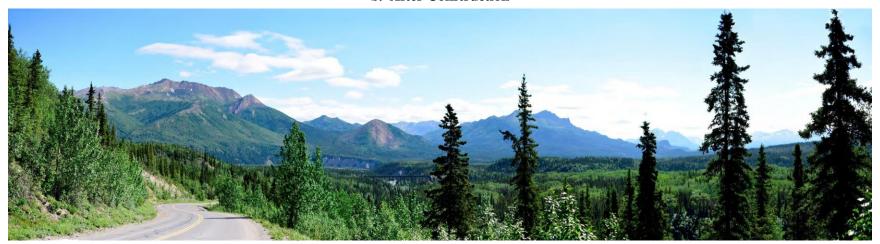
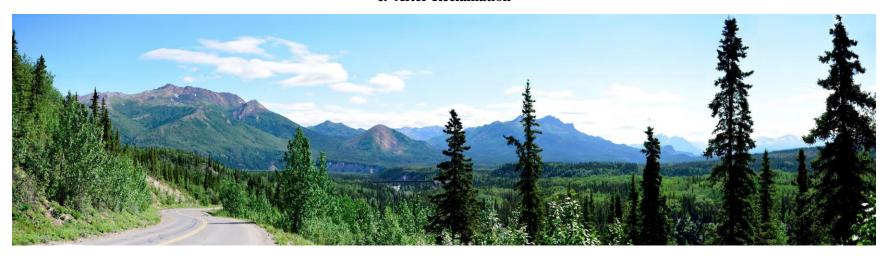
Figure E.1.3-1 Government Hill Simulations; View of the Denali Alternative to the East and Southeast a. Existing Conditions

b. After Construction

c. After Reclamation

Potential impact of the Denali Alternative immediately after construction: There is potential for low visual contrast from the proposed Denali Alternative (see figures E.1.3-1b and E.1.3-2b in appendix E-1c). The right-of-way is only slightly visible after construction in the center of the view. The prominent features remain the focal point and the right-of-way visual contrast is negligible.

Potential impact of the Denali Alternative after restoration: Mitigation measures would reduce the already low visual contrast (see figure E.1.3-1c in appendix E-1c).

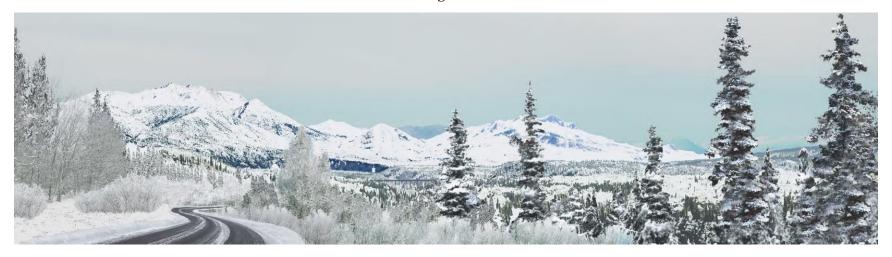
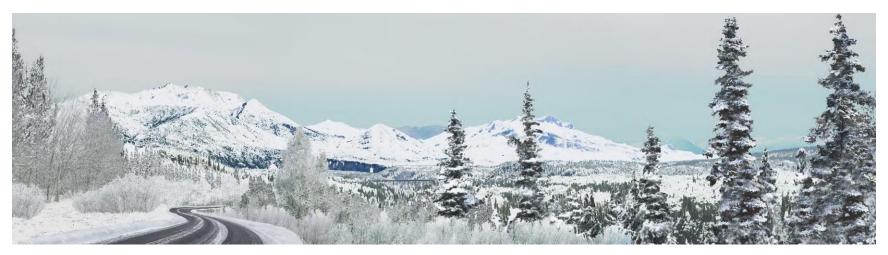
Figure E.1.3-2 Government Hill Winter Simulations; View of the Denali Alternative to the East and Southeast a. Existing Conditions

b. After Construction

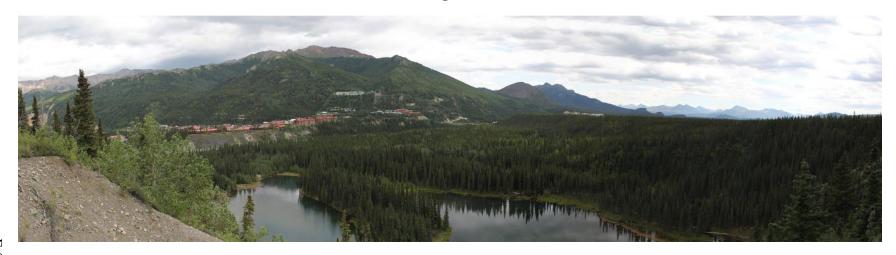
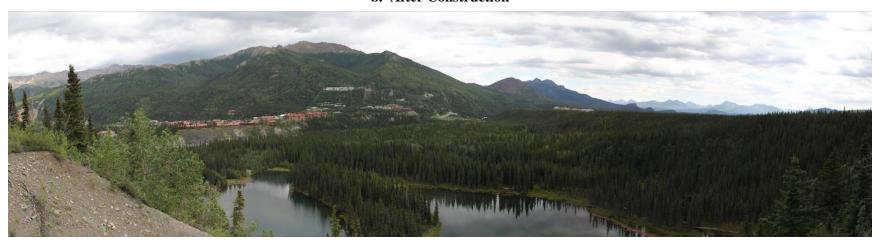
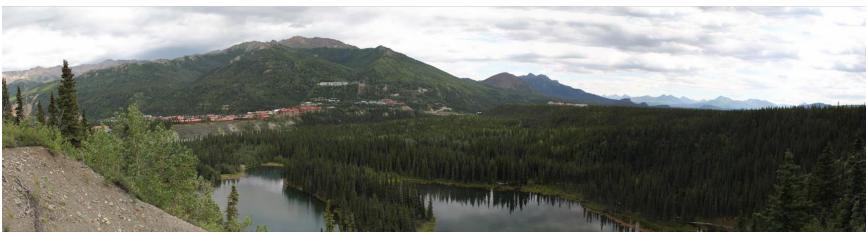
b. After Construction

c. After Reclamation

Potential impact of Denali Alternative immediately after construction: There is potential for low visual contrast from the proposed Denali Alternative (see figure E.1.4-1b and 1.4-2b in appendix E-1c). The right-of-way is only slightly visible after construction in the center of the view. Viewers do not spend a lot of time at this location.

Potential impact of Denali Alternative after restoration: Mitigation measures would reduce the already low visual contrast (see figure E.1.4-1c in appendix E-1c).

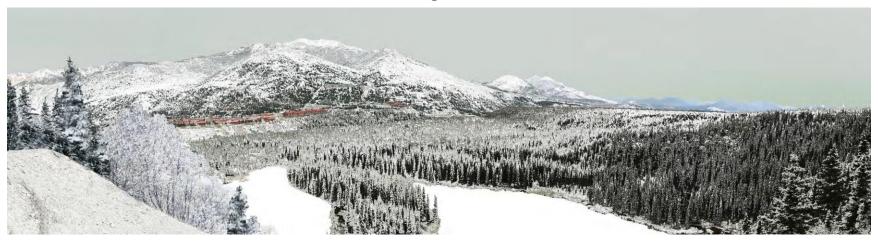
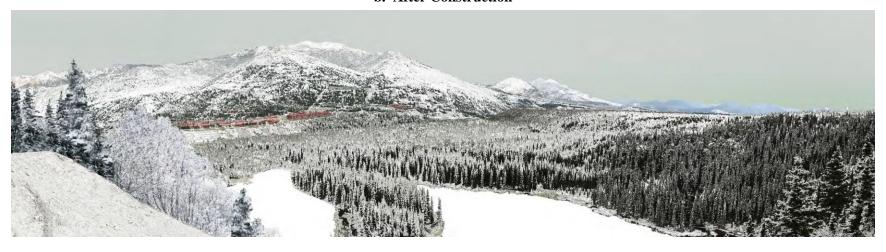
Figure E.1.4-2 Railroad Above Horseshoe Lake Winter Simulations; View of the Denali Alternative to the East a. Existing Conditions

b. After Construction

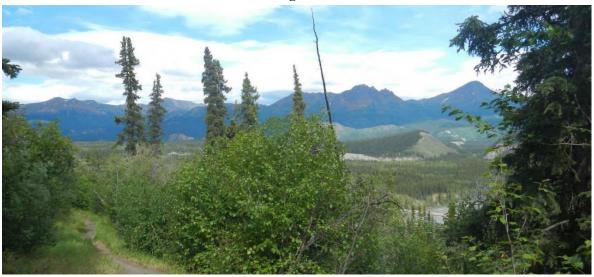
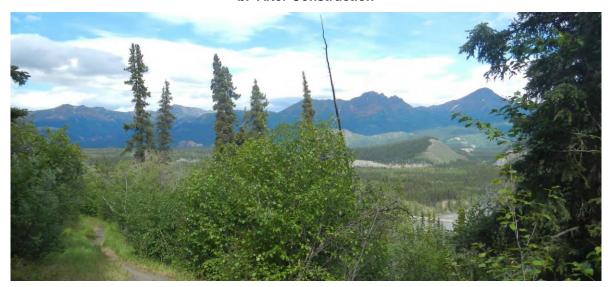
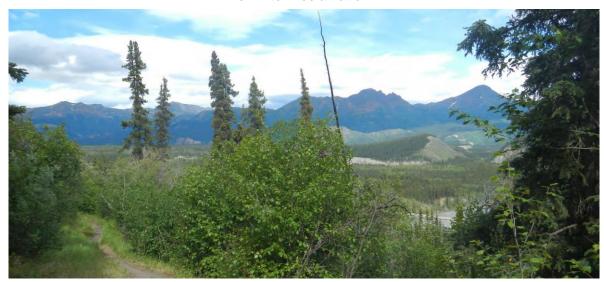
$Figure\ E.1.6-1\ Triple\ Lakes\ Trail\ Simulations;\ View\ of\ the\ Denali\ Alternative\ to\ the\ Northeast$

a. Existing Conditions

c. After Reclamation

Potential impact of the Denali Alternative immediately after construction: There is no potential for visual contrast from the proposed Denali Alternative (see figure E.1.6-1b and E.1.6-2b in appendix E-1c). The right-of-way is not visible from this location.

Potential impact of the Denali Alternative after restoration: There is no potential for visual contrast from the proposed Denali Alternative (see figure E.1.6-1c in appendix E-1c). The right-of-way is not visible from this location.

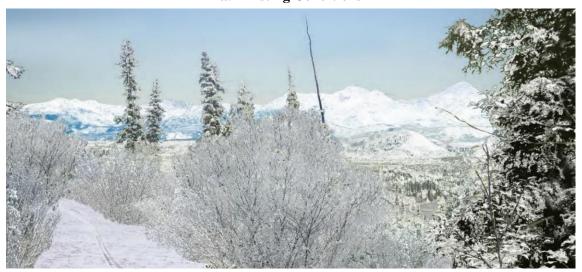
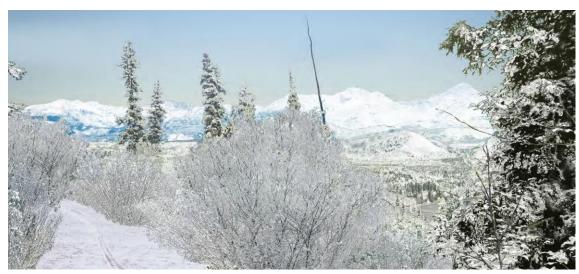
Figure E.1.6-2 Triple Lakes Trail Winter Simulations; View of the Denali Alternative to the Northeast a. Existing Conditions

b. After Construction

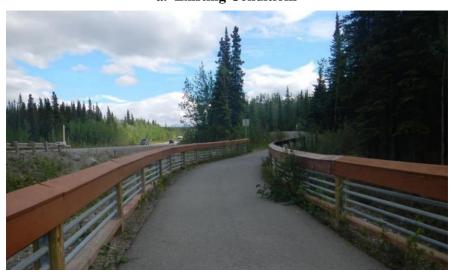
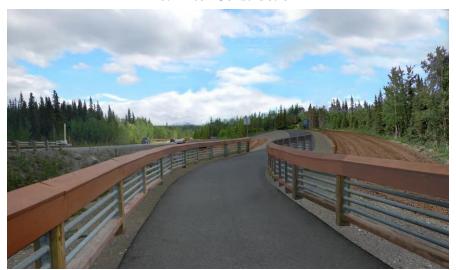
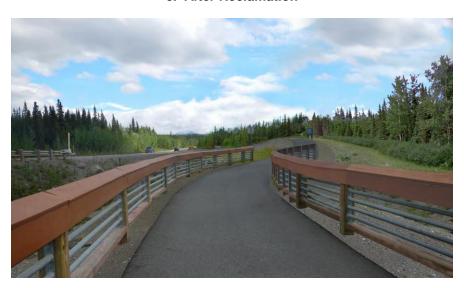
Figure E.1.7-1 Nenana River Pedestrian Bridge Simulations; View of the Denali Alternative to the South

a. Existing Conditions

b. After Construction

c. After Reclamation

Potential impact of the Denali Alternative immediately after construction: There is potential for high visual contrast from the proposed Denali Alternative (see figure E.1.7-1b and E.1.7-2b in appendix E-1c). The removal of trees and vegetation to construct the right-of-way and relocate/redesign the multi-use trail would affect the view at this location.

Potential impact of the Denali Alternative after restoration: Mitigation measures would reduce the visual contrast and would restore the multi-use trail (see figure E.1.7-1c in appendix E-1c).

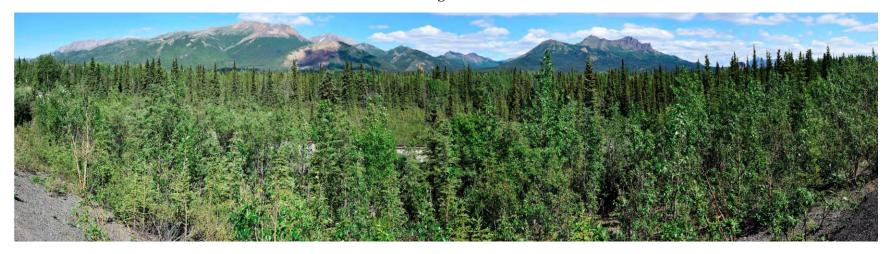
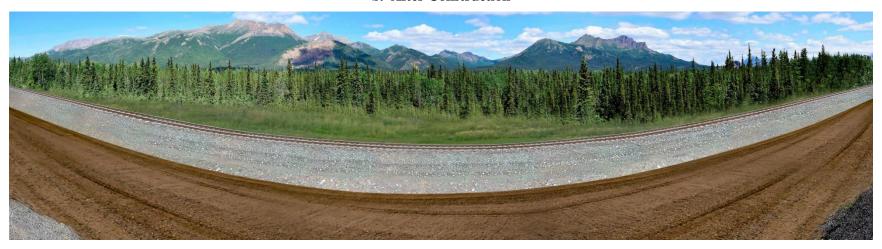
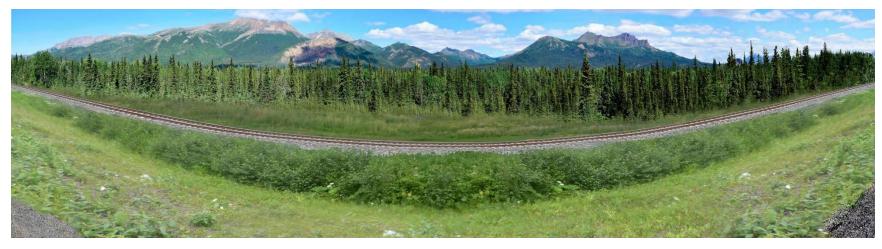
a. Existing Conditions

b. After Construction

Potential impact of the Denali Alternative immediately after construction: There is potential for moderate visual contrast from the proposed Denali Alternative (see figure E.1.8-1b and E.1.8-2b in appendix E-1c). The removal of trees and vegetation to construct the right-of-way near the Alaska Railroad and near the George Parks Highway would affect the view at this location. Viewers do not spend a lot of time at this location and there are no prominent features, other than in the background, in the view.

Potential impact of the Denali Alternative after restoration: Mitigation measures would reduce the visual contrast (see figure E.1.8-1c in appendix E-1c); however, the cleared right-of-way would still be visible.
