Taum Sauk Upper Dam Breach FERC No. P-2277

Technical Reasons for the Breach
of December 14, 2005

FERC Independent Panel of Consultants (IPOC)

May 24, 2006

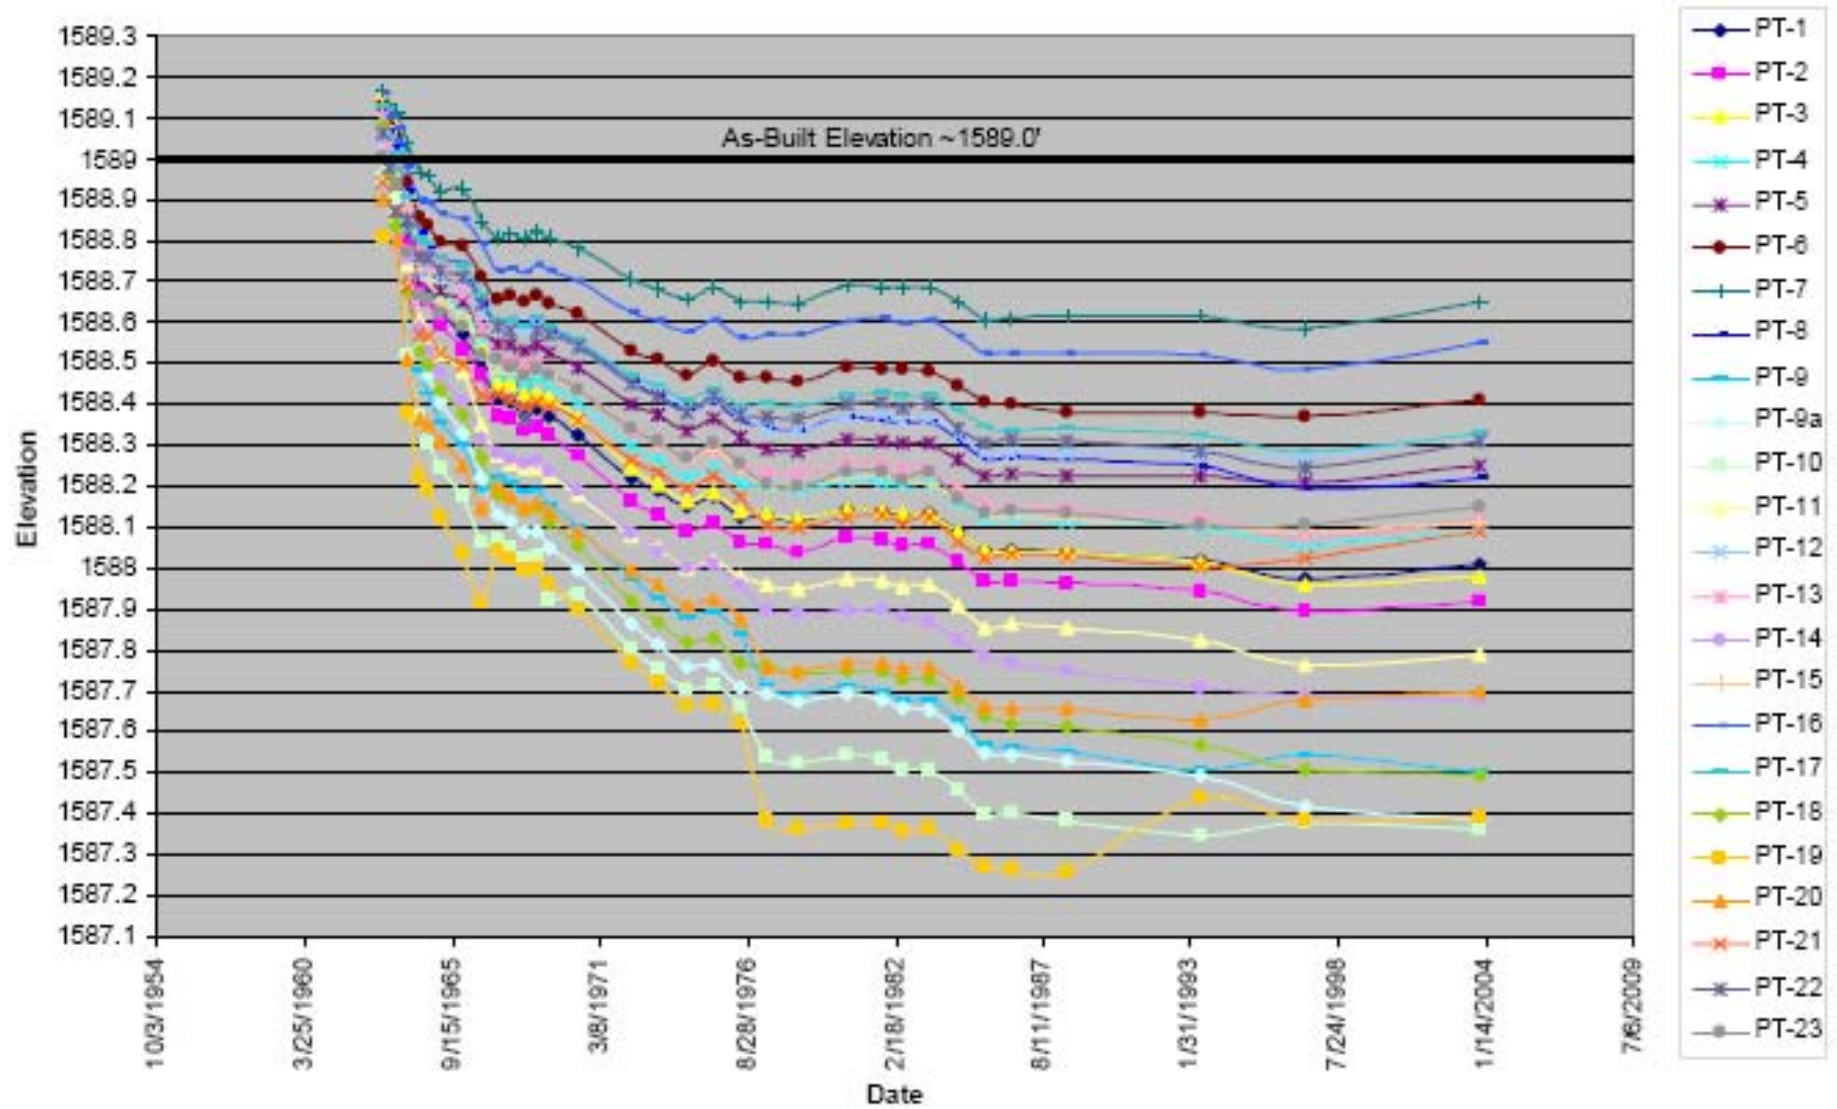
If it is noted that the original survey pins 18 and 19 (Figure 3-4) correspond to Panels 90 and 95 within the breach area and it is shown on Figure 3-3 that the 2004 elevation of Pin 18 and Pin 19 are 1587.5 and 1587.4, respectively. Then

Total Settlement History
Upper Reservoir Pin Elevations

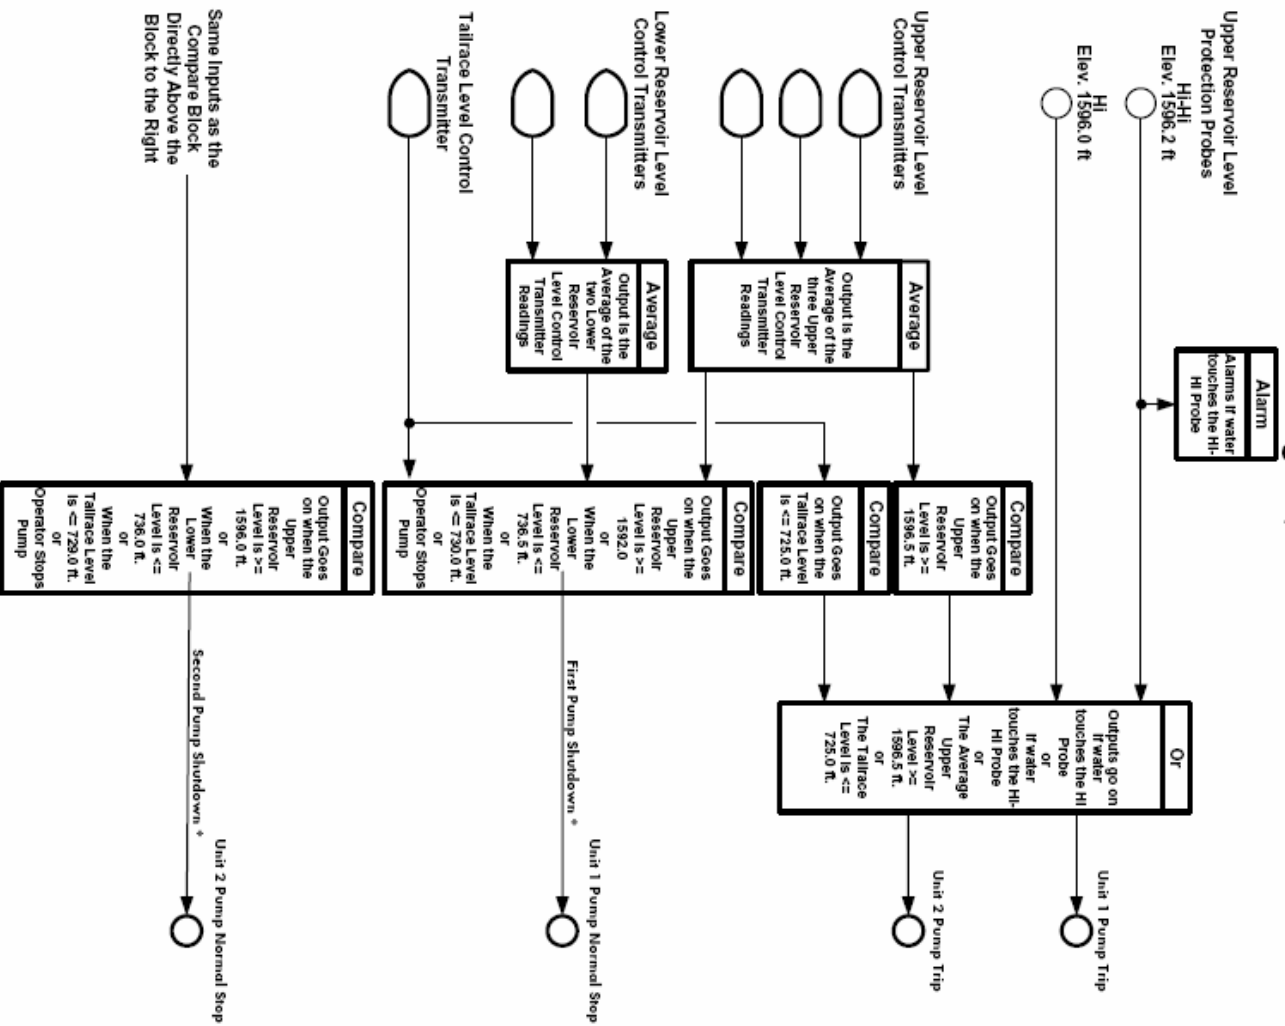
Figure 5-1

As shown in Figure 5-1, operation of either the Hi relay or the Hi-Hi relay provides a signal to the plant to stop the pumps and activate an alarm. AmerenUE reported that the Hi and Hi-Hi probes were tested at commissioning in the fall of 2004 as follows:

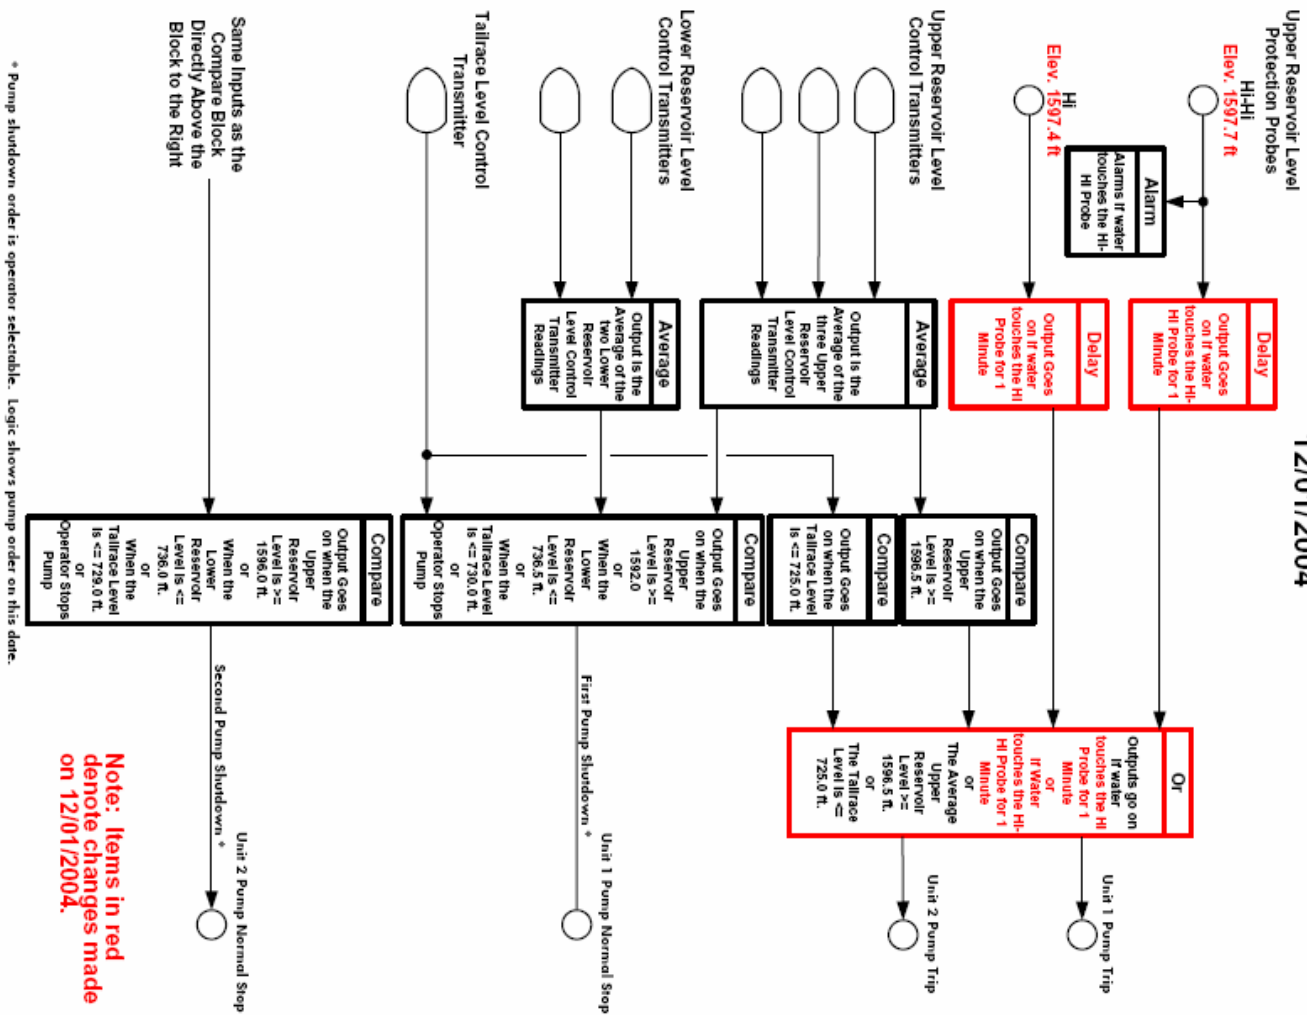
Figure 5-2

In December 2004, the PLC logic was changed so that both relays had to be energized for sixty seconds to provide a signal to stop the pumps and activate an alarm. In addition, both the Hi and Hi-Hi probes were reportedly raised to Elevations 1596.7 and 1596.9 respectively as shown on Figure 5-2. These changes were documented in comments within the PLC code and as revision 15 to drawing 8303-P-26648.

Note: Items in red denote changes made on 12/01/2004.

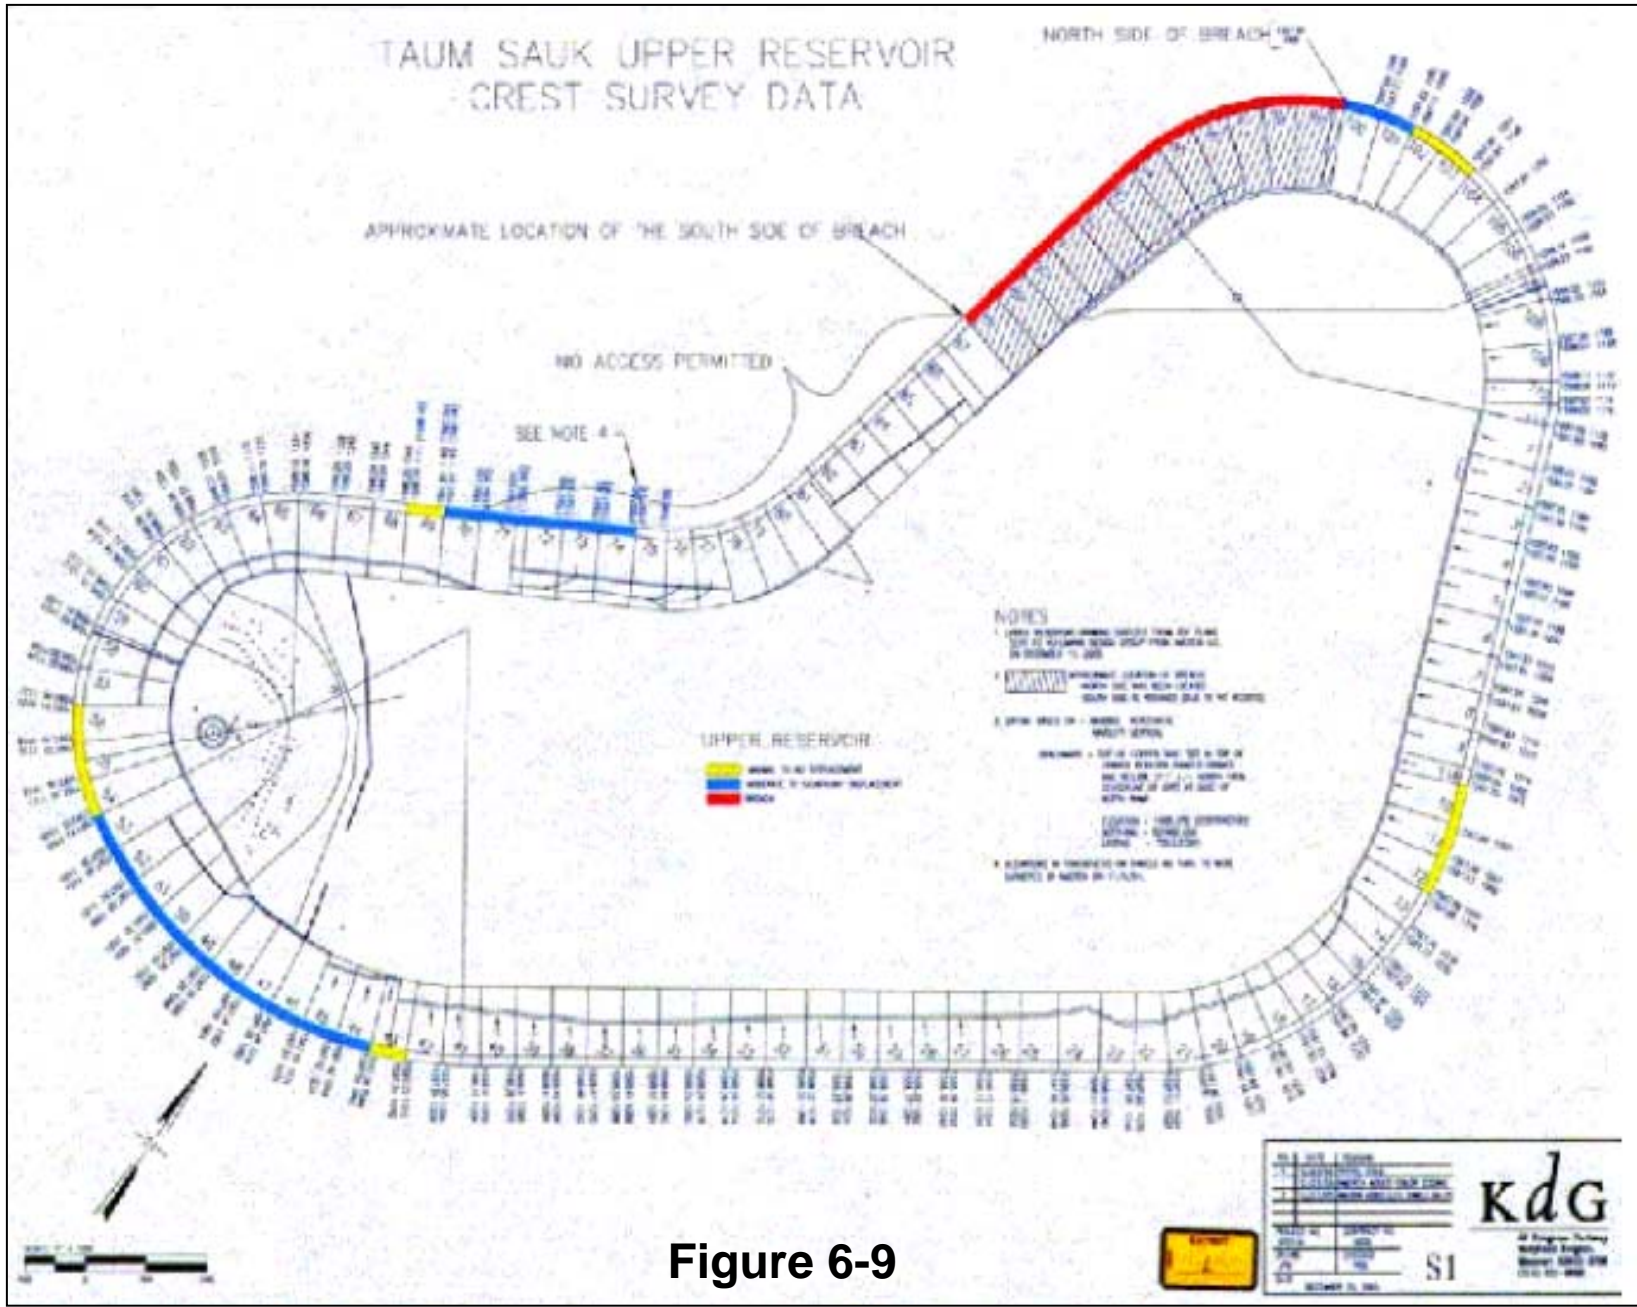
Figure 6-9

A post breach survey by KdG is shown in Figure 3-5 and in Figure 6-9. These figures show the breach area including Panels 88 through 99. The survey indicates that there are 4 areas where there is evidence of overflow. These areas include:

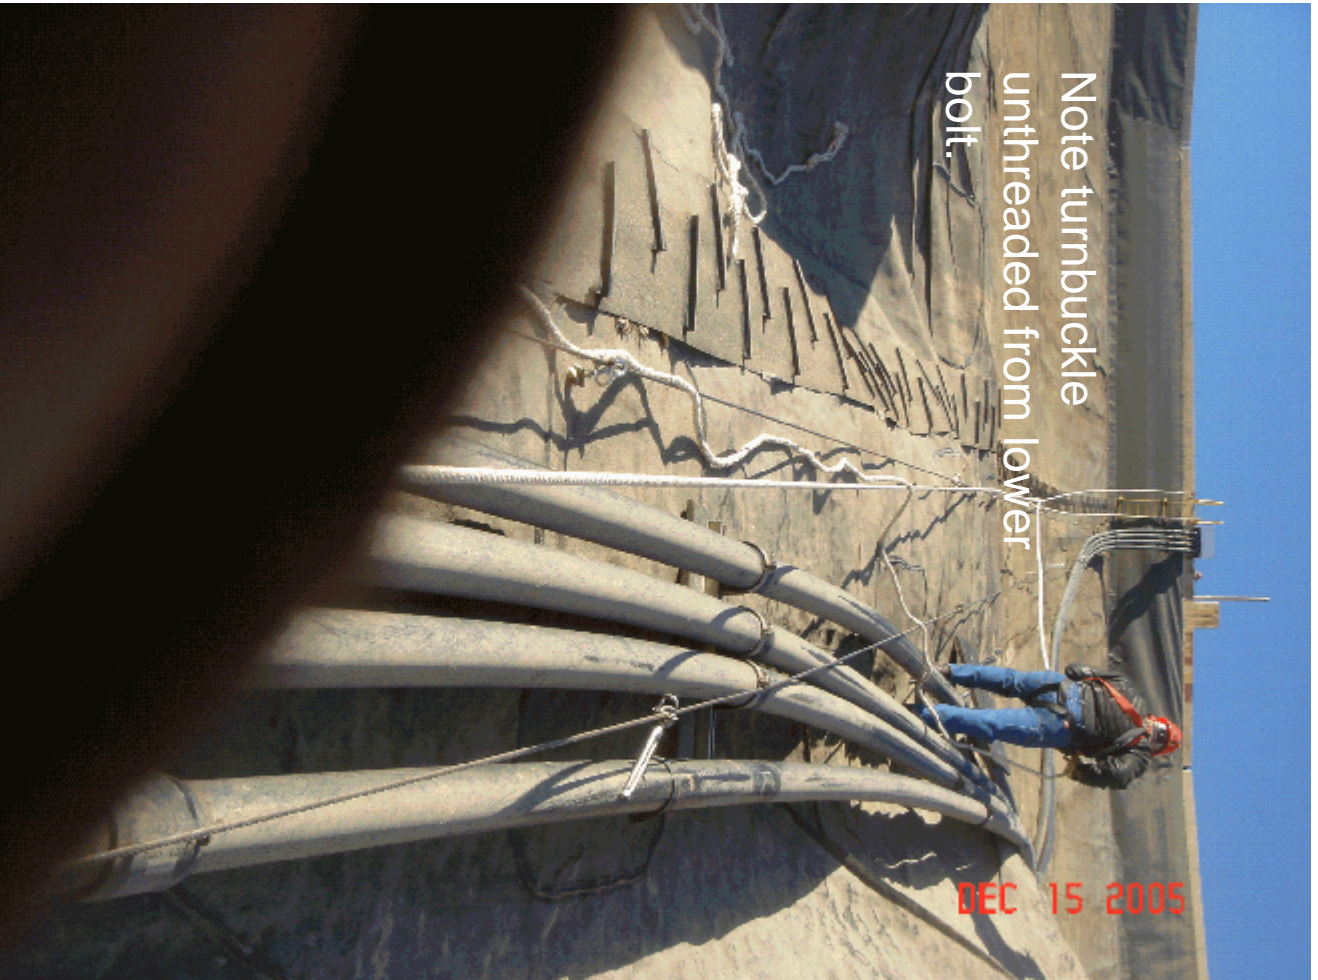
Figure 7-3

A visual examination of the pressure transducer protective pipes, Figures 7-3 through 7-5, shows that the protective pipes had moved from their straight alignment in the lower elevation of the reservoir. Since the transducer cables remained fixed at their instrument box on the parapet wall (Figure 7-6), any movement of the protective pipes from their initial straight alignment would produce an upward movement of the pressure transducer and a corresponding negative error in the water level reading. That is, the reported water level would be less than the actual level.

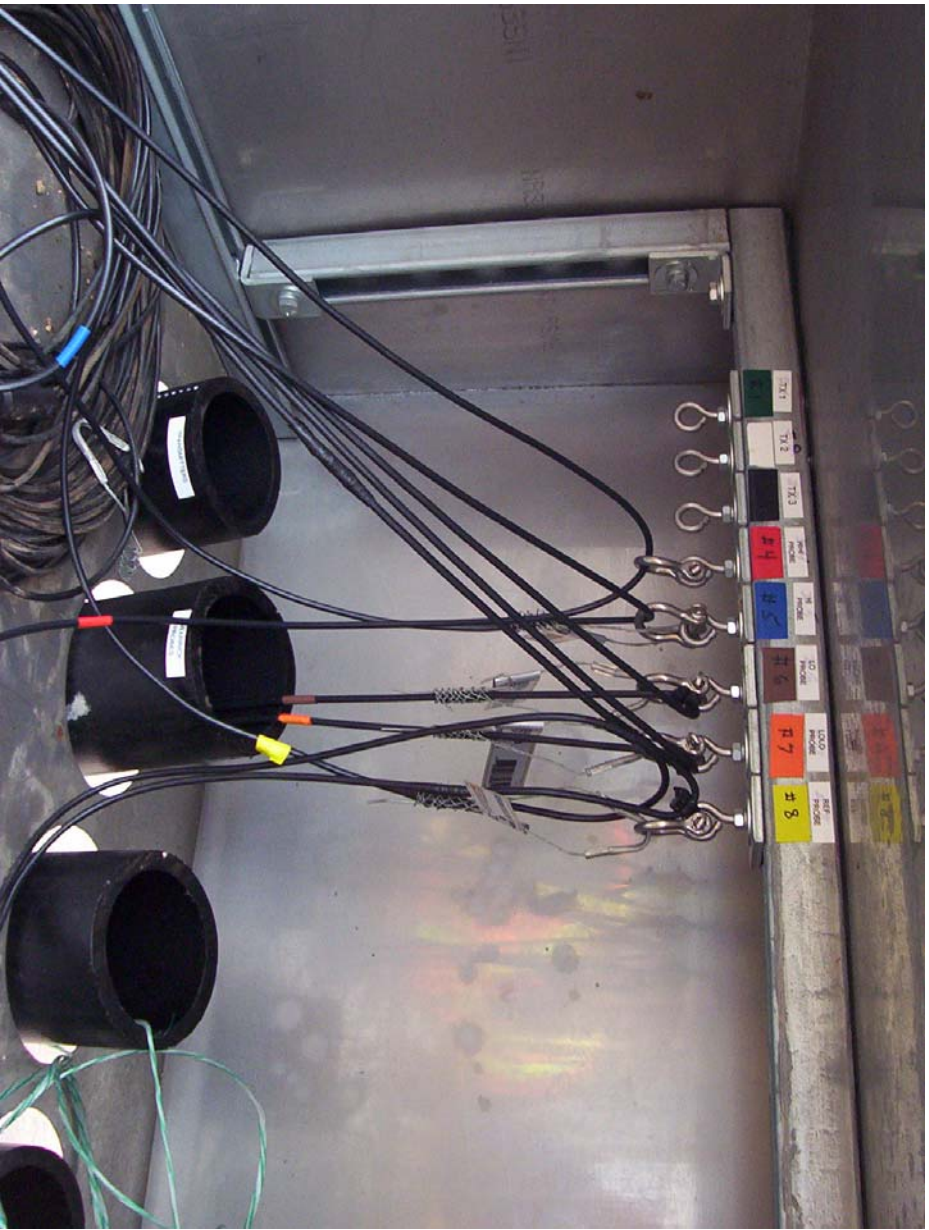
Figure 7-6

**Upper ends of protective pipes
with instrument cables in enclosure on parapet.
Pressure transducers use left pipe
and conductivity probes use the second pipe from left.**

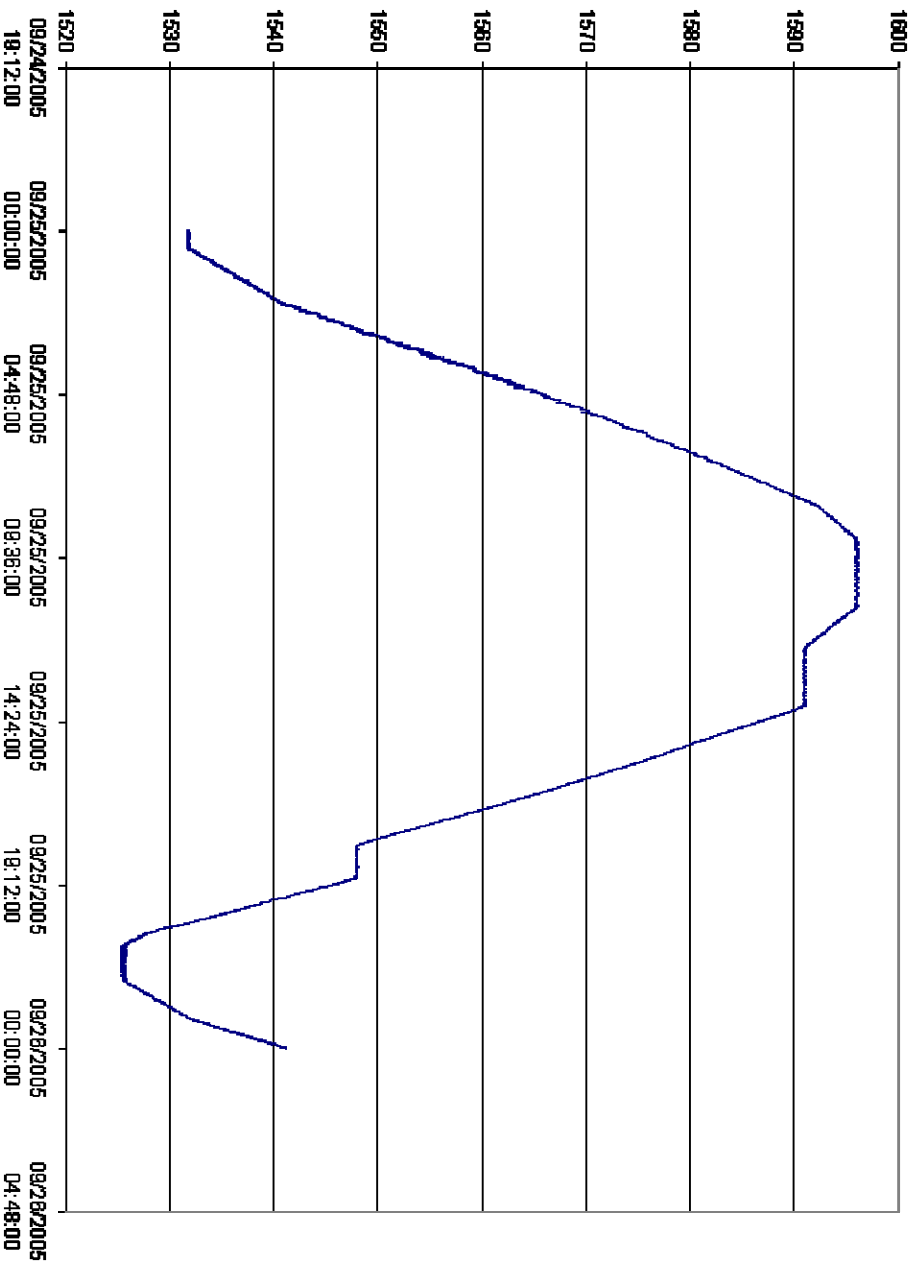
Figure 7-9

Figures 7-9 through 7-11 show upper reservoir water level readings taken during and prior to the Hurricane Rita event.

Hurricane Rita Event

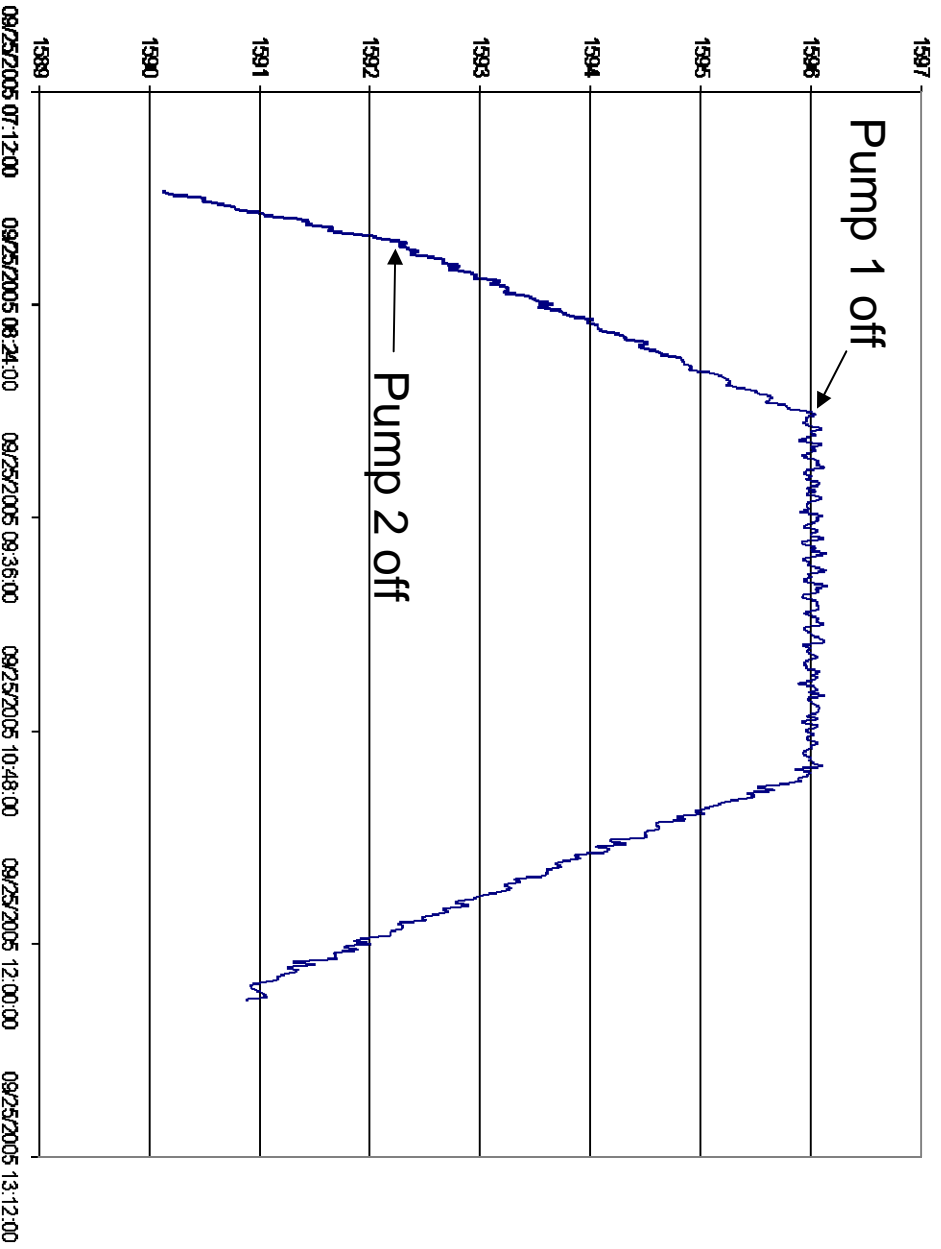
Figure 7-10

Hurricane Rita Event

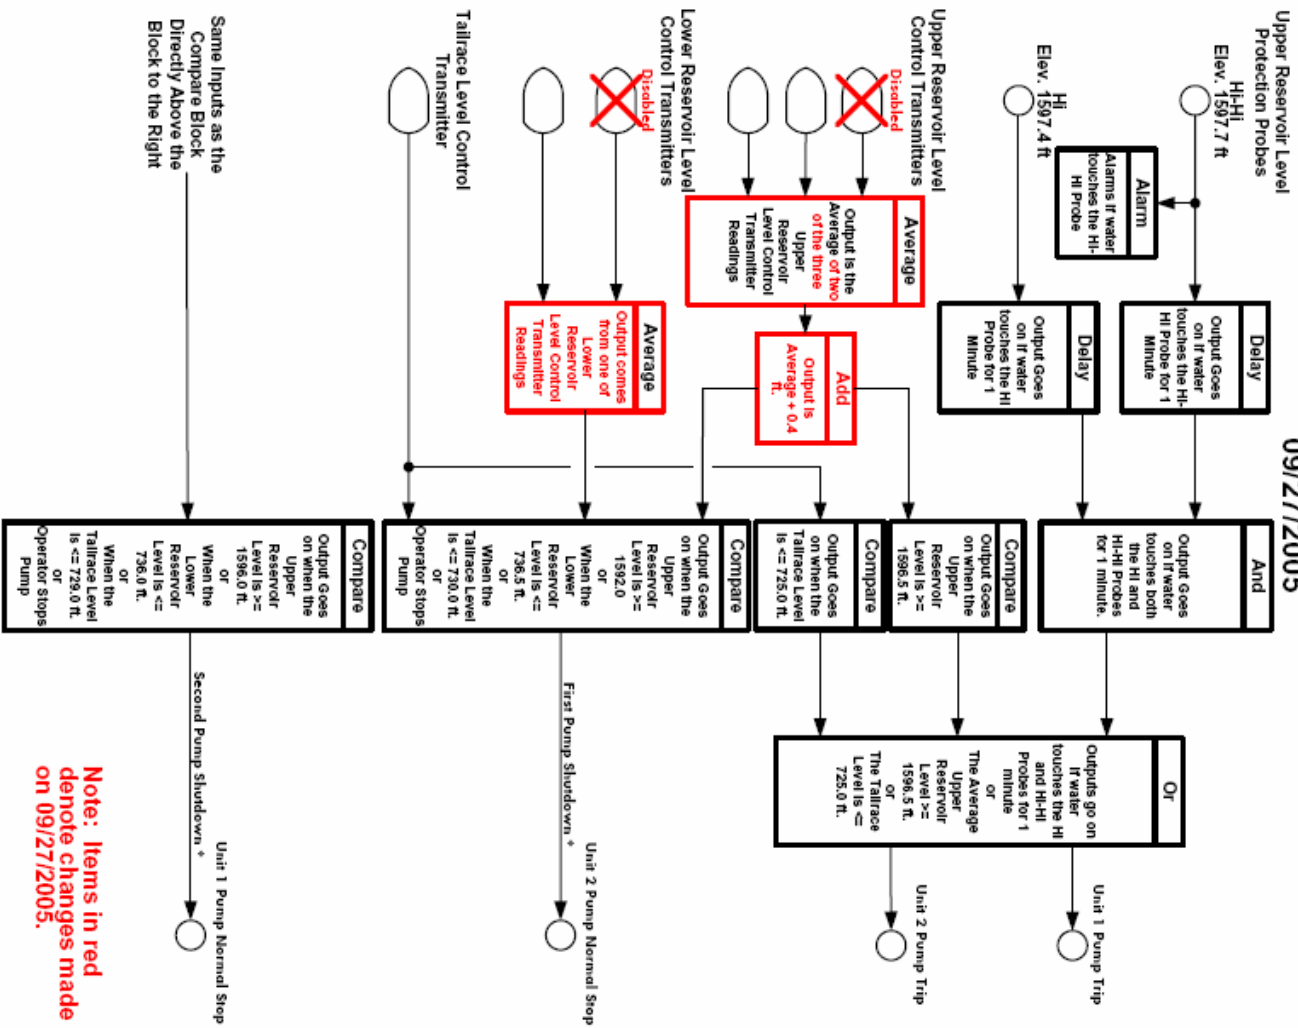
Figure 7-12 (09/27/2005) shows the disabling of one upper reservoir pressure transducer and one lower reservoir pressure transducer and the addition of the 0.4 feet offset in the upper reservoir level indication.

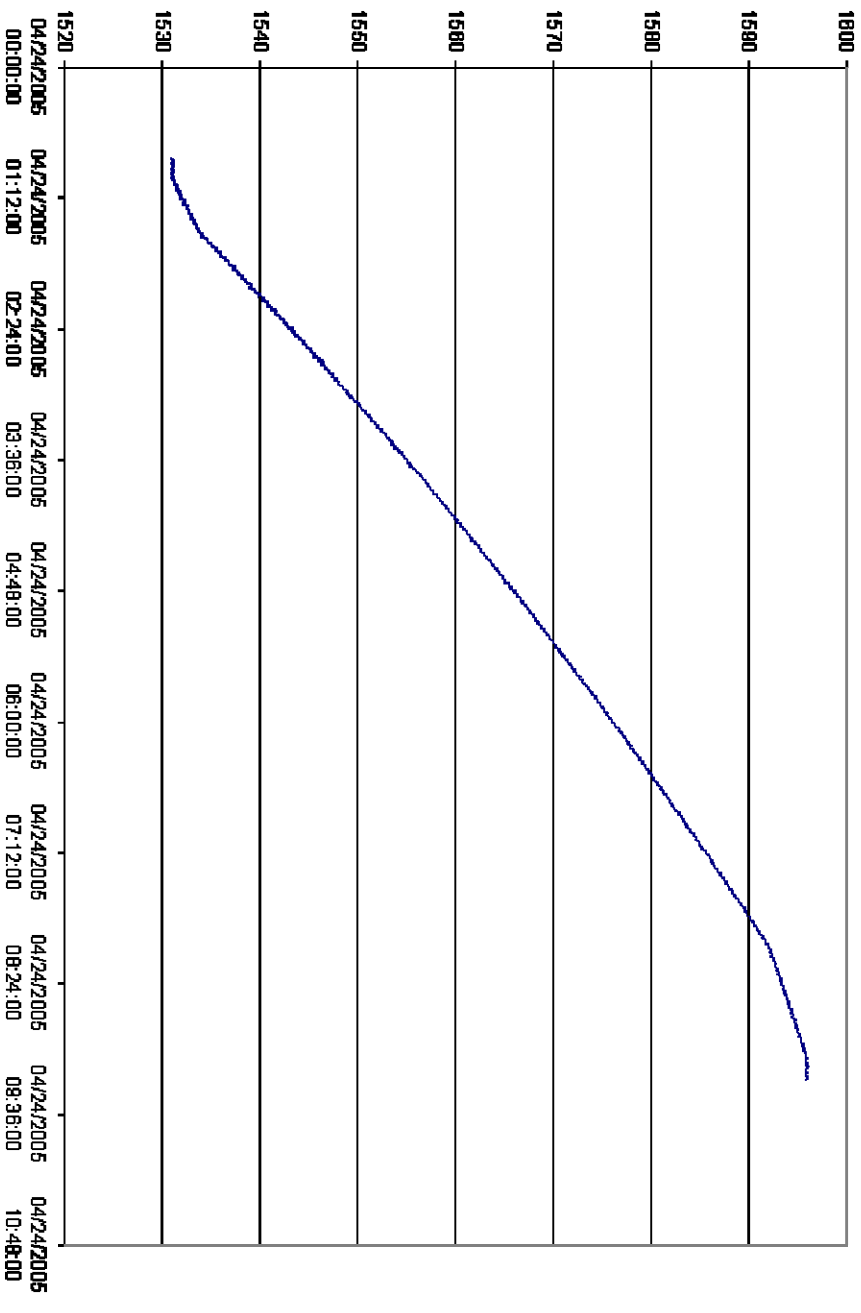
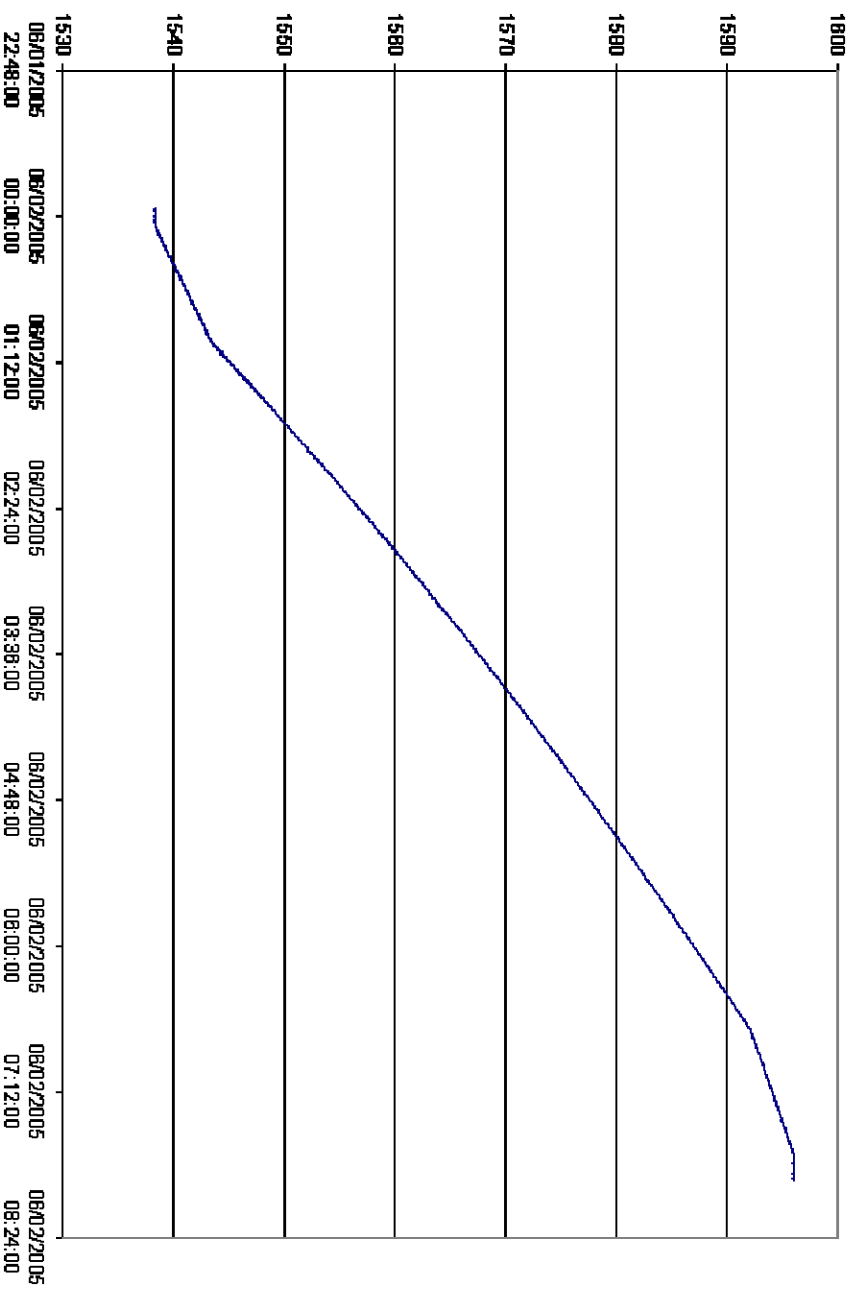
A review of two pump operations during 2005 shows that the upper reservoir water level indications are reasonably stable until early August. Figures 7-15 through 7-22 are examples of these levels from the pressure transducers. Beginning in early August, the water level plots begin to show the erratic behavior that increased until December 14, 2005.
