Transmission Facility Outages During the Northeast Snowstorm of October 29–30, 2011

Causes and Recommendations

Federal Energy Regulatory Commission *and* the North American Electric Reliability Corporation

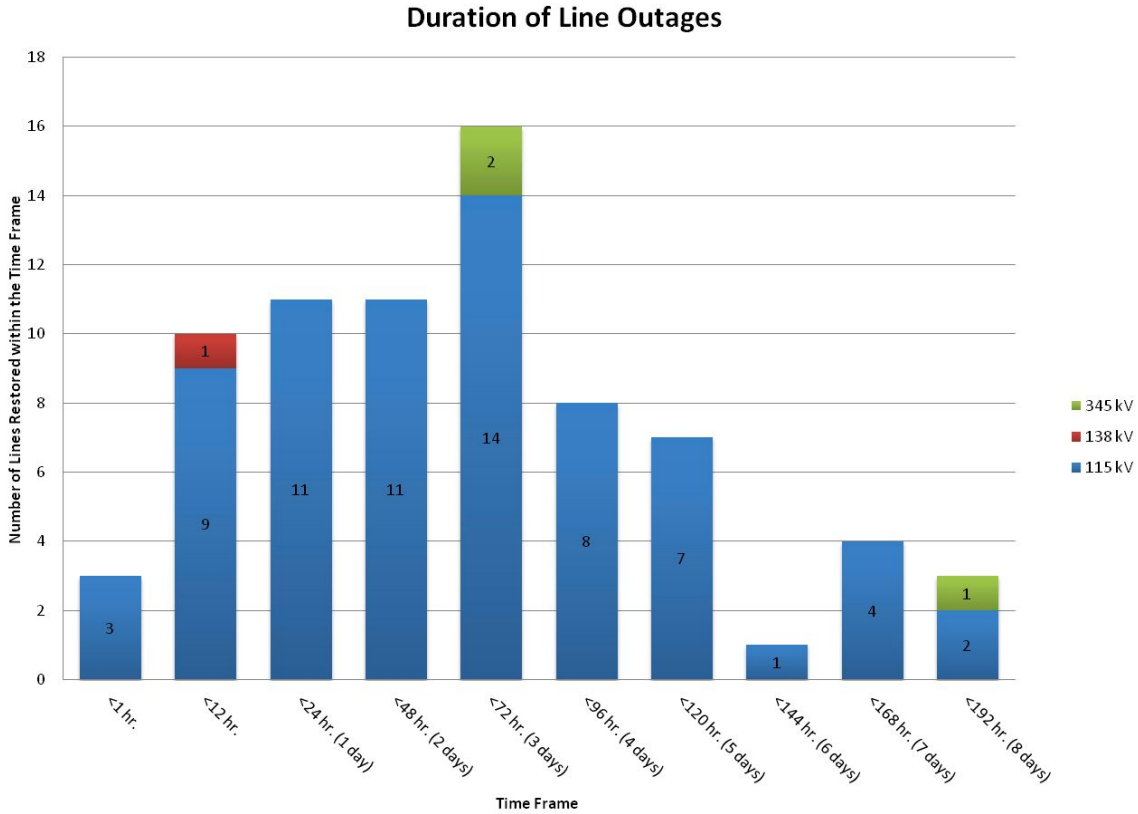
Figure 10: Duration of Transmission Line Outages

Utilities faced several physical obstacles in restoring the seven transmission lines that were out of service for six to eight days. Each of these lines or its supporting structures had significant structural damage that required rebuilding. For example, on five of these seven lines, falling trees snapped insulators, cross-arms, and various support structures. In addition, the site of the damage to the 345 kV line that was out of service for nearly eight days was particularly difficult to access. Again, no retail customers were without service due to these seven line outages.

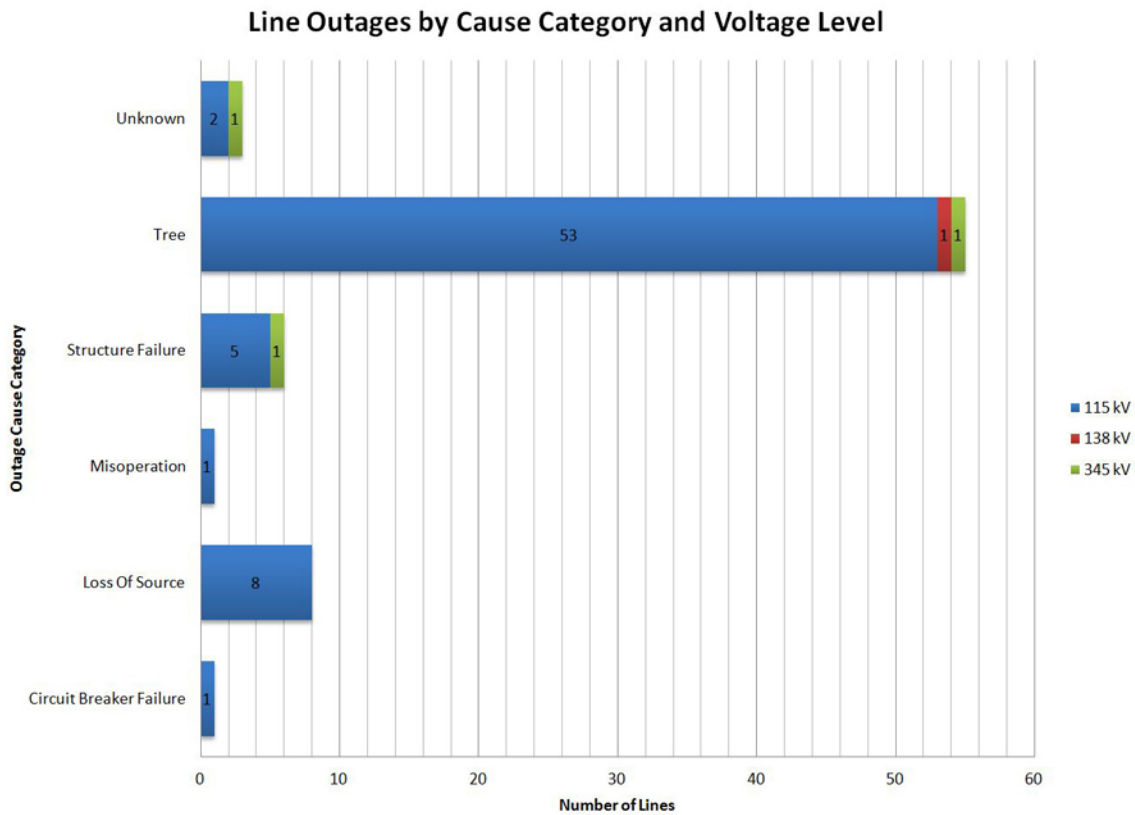
Figure 11: Line Outages by Cause Category and Voltage Level

As could be expected from a major snowstorm, the vast majority of transmission line outages during the October event were caused by tree contact or the accumulation of ice and heavy, wet snow on transmission conductors.⁶⁰ Other causes included losses of source⁶¹ and relay misoperation.
