**SIEMENS' REPORT
MARCH 24, 2006
AmerenUE**

AmerenUE Taum Sauk Incident Instrumentation and Controls Root Cause Investigation Report

March 24, 2006

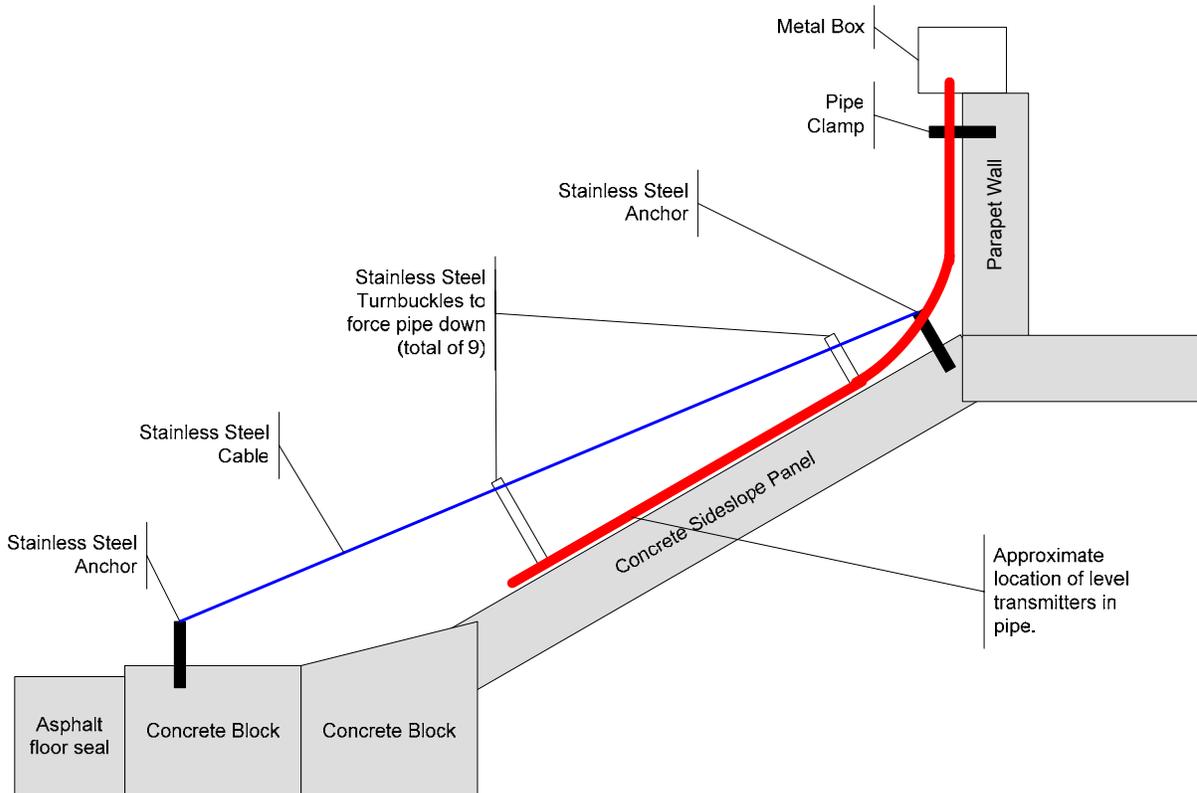
Figure 13: Instrumentation Pipe Installation Sketch

Two HDPE pipes are utilized to hold in place and protect all of these instruments. Four pipes are installed (two are spares) into the upper reservoir and held against the liner per IMG121866 - Sketch SB1306-3 "Gage Pipe Supports As Constructed". Also see the sidewall riser pipe cross-section detail on IMG013196 - Side Slope Relining Details III drawing 8304-X-155099 r5 for specifications of where holes were drilled into pipes. Also see the 15-Nov-04 photo of the pipe installation.

According to installation drawings and pictures presented by Ameren, the transmitters were installed into a pipe with the holes per the installation drawings. If clogged, these pipes could impact the ability of the transmitters to accurately measure the reservoir level. Ameren engineers reported that they found no significant clogging throughout the length of the as-found level transmitter pipe. They reported that they checked for clogging with a borescope and by cutting a few large holes into the pipe (see photo marked 15-Dec-05). Ameren engineers also reported that the as-found 0.5" water passage holes drilled in the pipes showed no significant signs of clogging. Based on these reports, Siemens does not believe that this pipe served as a stilling well.

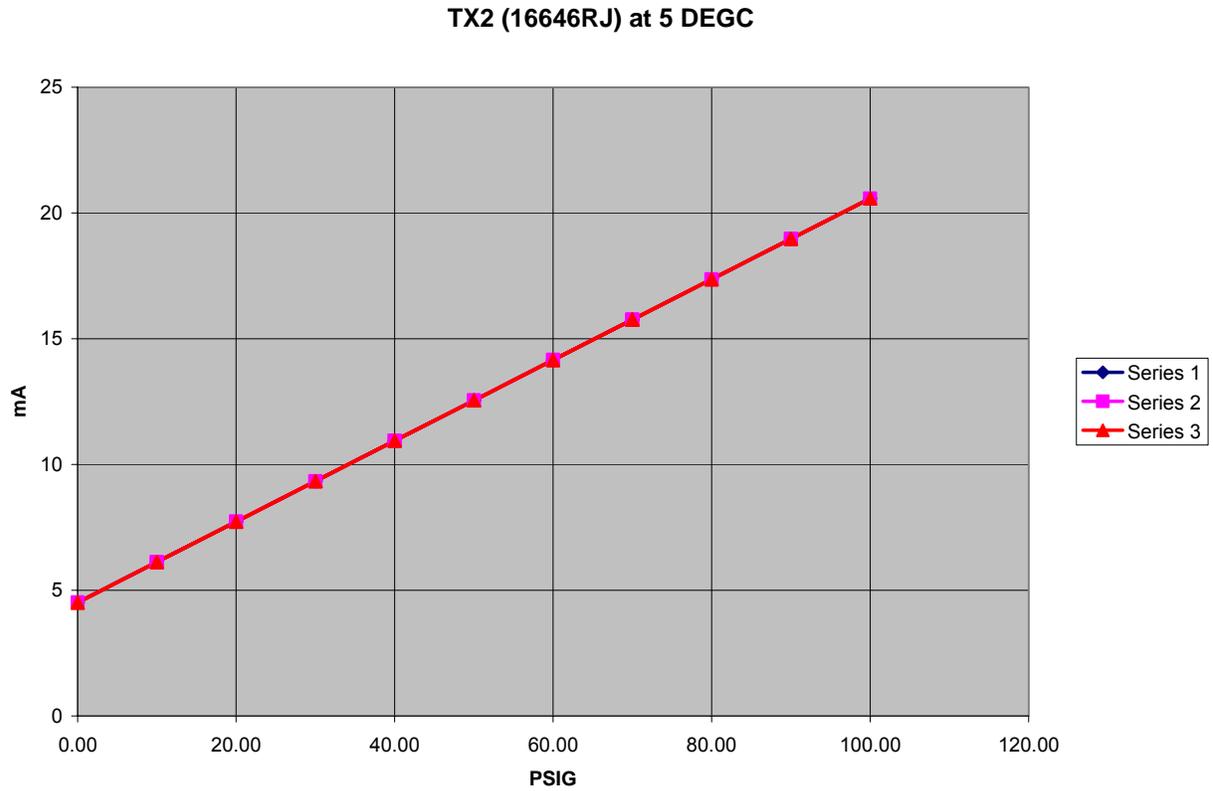
Figure 15: TX2 (16646RJ) Repeatability Test

In order to validate the repeatability of the transmitters, the mA output of the transmitters was measured three times at pressures between 0 and 100 psi. The measurements were made at a temperature of 5 degrees Celsius, the water temperature at the event.

As the following two charts demonstrate that the transmitter outputs were very repeatable:

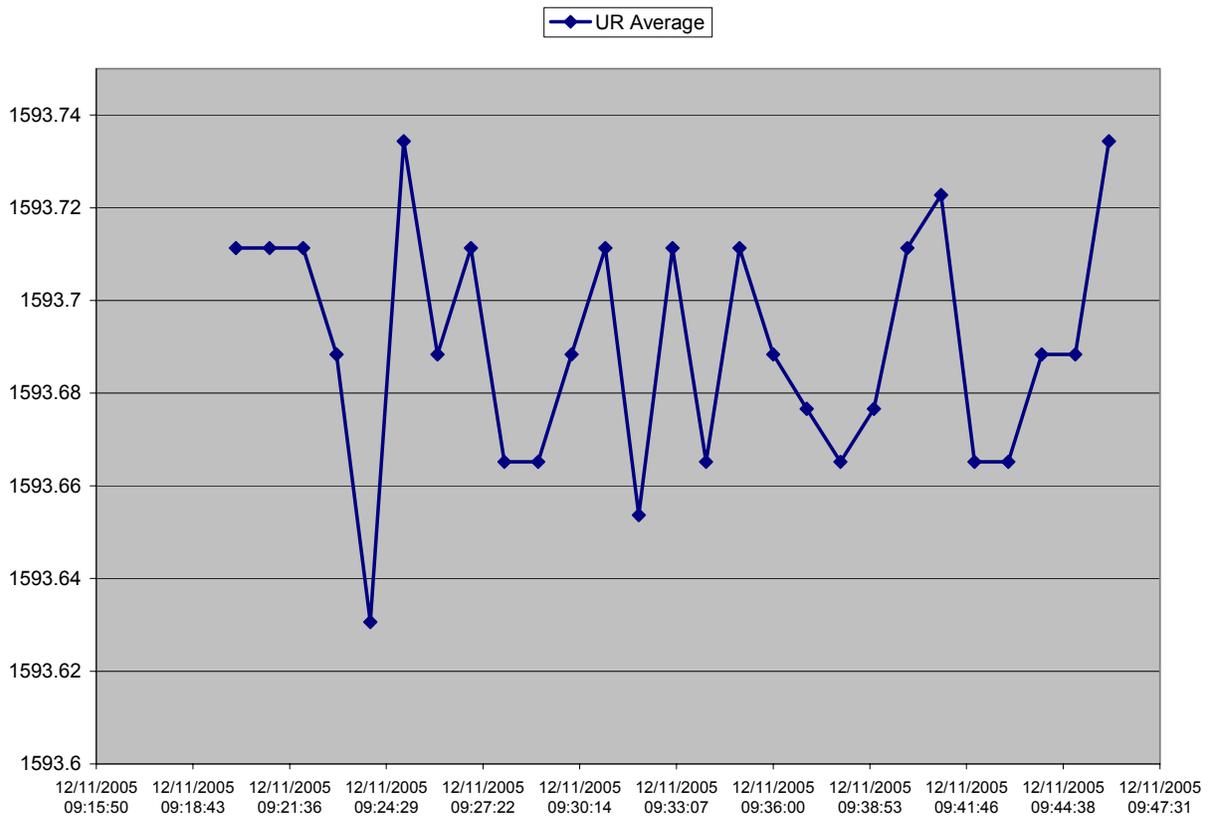
Figure 22: Average UR Transmitter Reading on 11-Dec-05 between 09:20 and 09:46

The following chart shows the average transmitter reading (calculated in the PLC as the average of TX2 and TX3) on 11-Dec-05 between 09:20 and 09:46. The maximum variation is 0.1 feet. The last pump stopped at 07:50am on this morning. The data sample started 90 minutes after the last stop. It should be expected that there was no movement of the reservoir level.

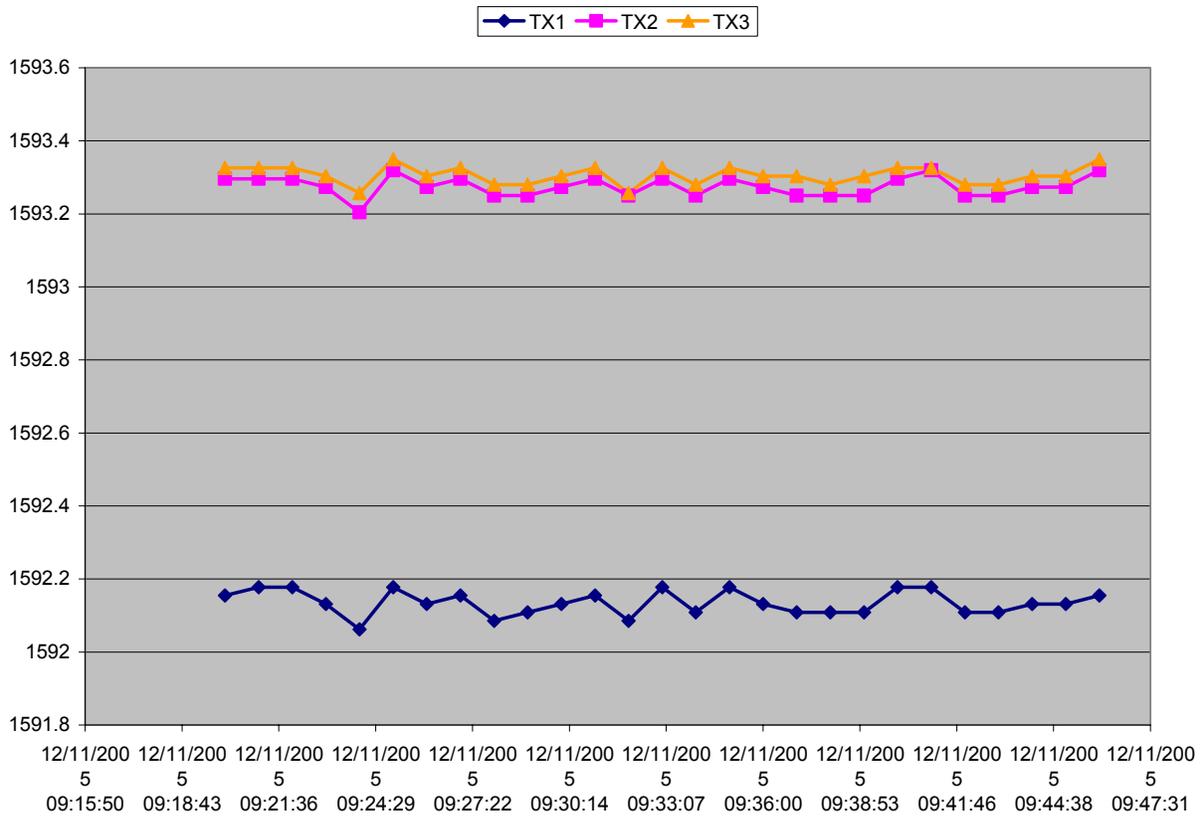
Figure 23: Individual UR Transmitter Reading on 11-Dec-05 between 09:20 and 09:46

The following chart shows the individual transmitter readings for the same time period (note that TX1 was not used for the calculation of the average value):

This data indicates that all three transmitter readings are moving in parallel. This becomes more evident if the one minute value changes are plotted (here for TX2 and TX3 which were actually used for level control):

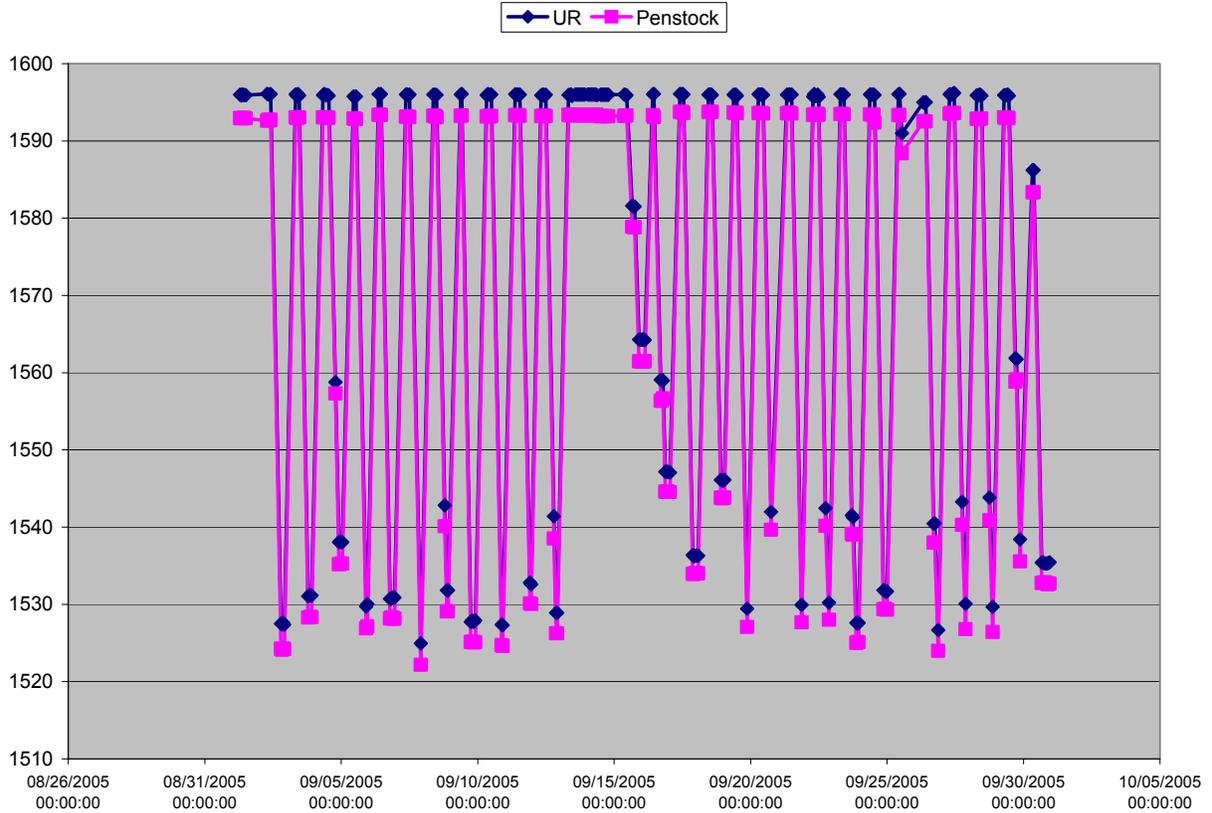
Figure 25: Comparison between UR Average and PS Level Transmitter Readings

The following chart shows the UR level compared to the Penstock head during calm plant conditions (no generation or pumping) for the month of September 2005. The chart indicates that the head measured by the Penstock transmitter is closely correlated to upper reservoir level:

The head measured by the penstock transmitter is not suitable for use as a level measurement while the Unit is operating as the measured pressure includes water flow and penstock loss affects that make an upper reservoir level correlation difficult.

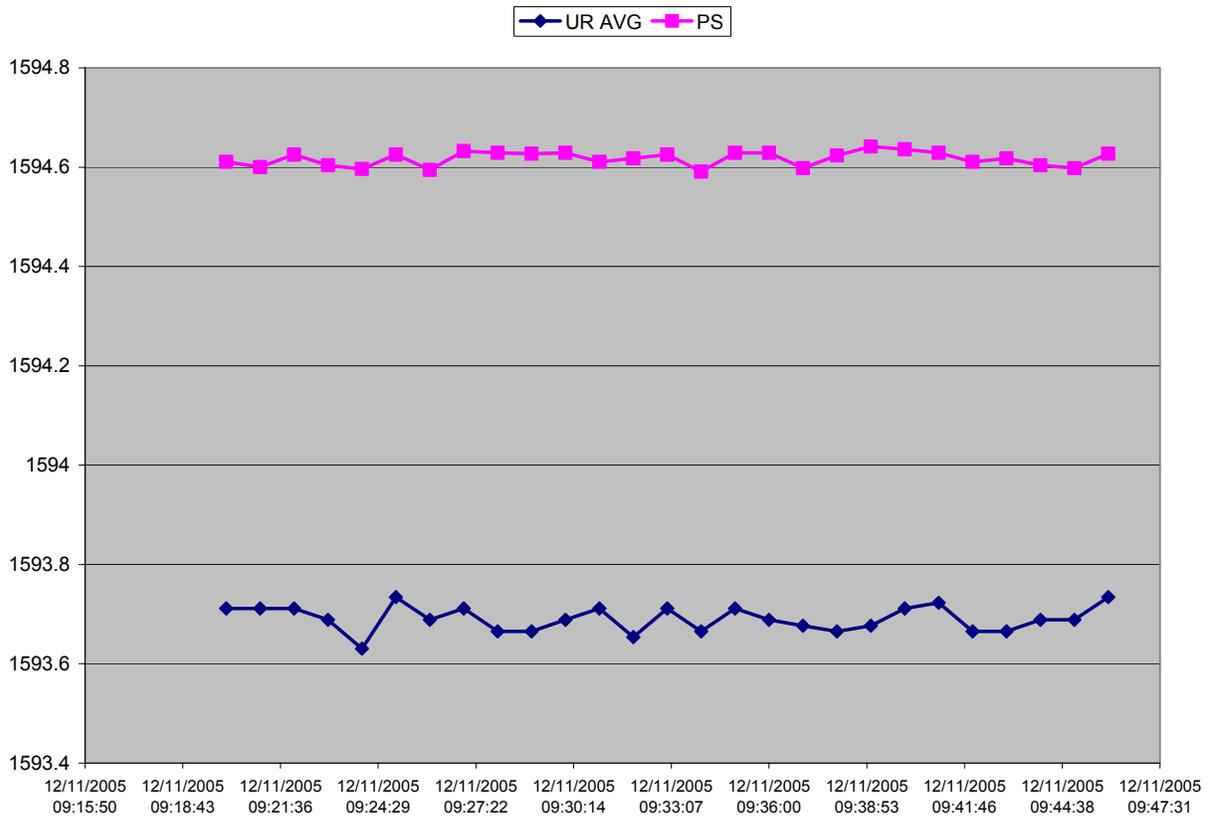
Figure 26: UR Average Transmitter Readings vs. PS Transmitter Readings

This chart indicates again that the levels measured by the UR average transmitters and the levels measured by the PS transmitters correlate and that the PS level transmitter shows less signal noise. Siemens concludes that the installation of the penstock transmitter filters out most wave action affects on level measurement.

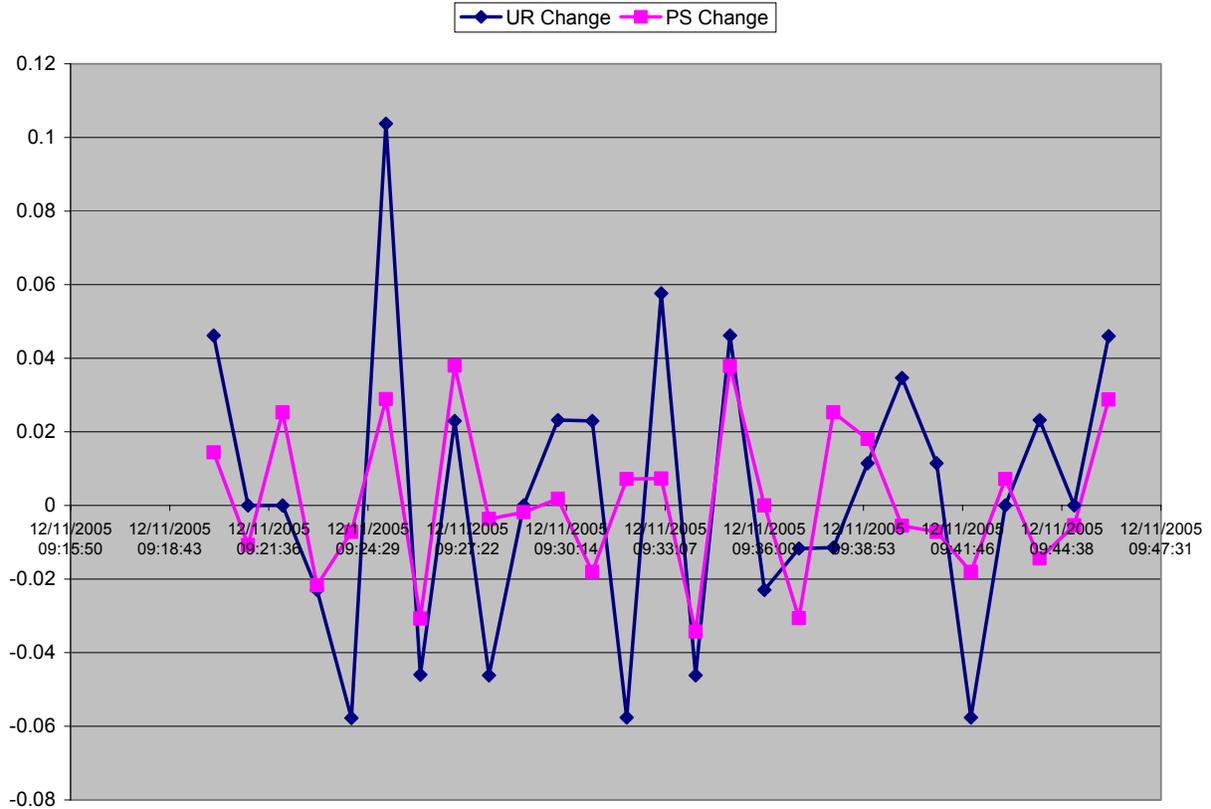
Figure 27: UR vs. PS Transmitter Reading Changes

Again, this chart indicates that the PS level transmitter shows less signal noise than the UR level transmitter average. The standard deviation for the UR series is 0.00399, the standard deviation of the PS series is 0.00204.

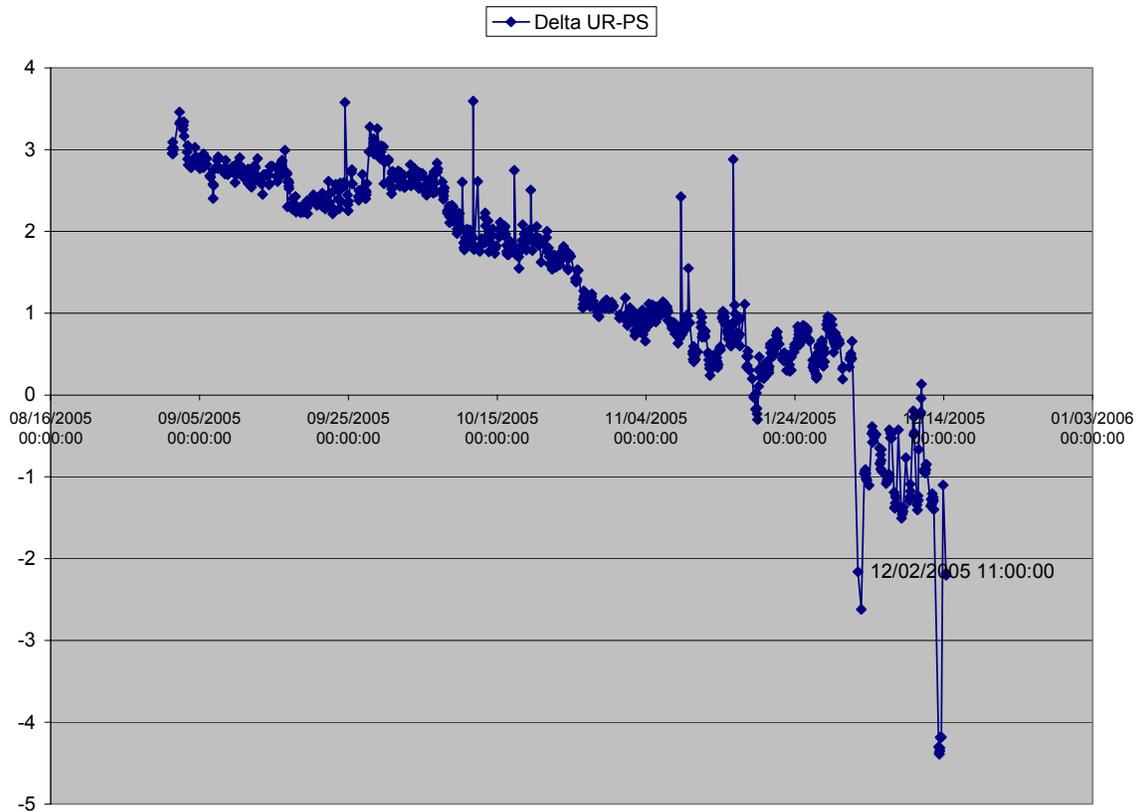
Figure 28: Difference between UR Transmitter Average and PS Transmitter

The gradual decrease of the difference may be explained with a gradual movement of the upper reservoir level transmitter locations. The step changes at the beginning and in the middle of December are discussed below.

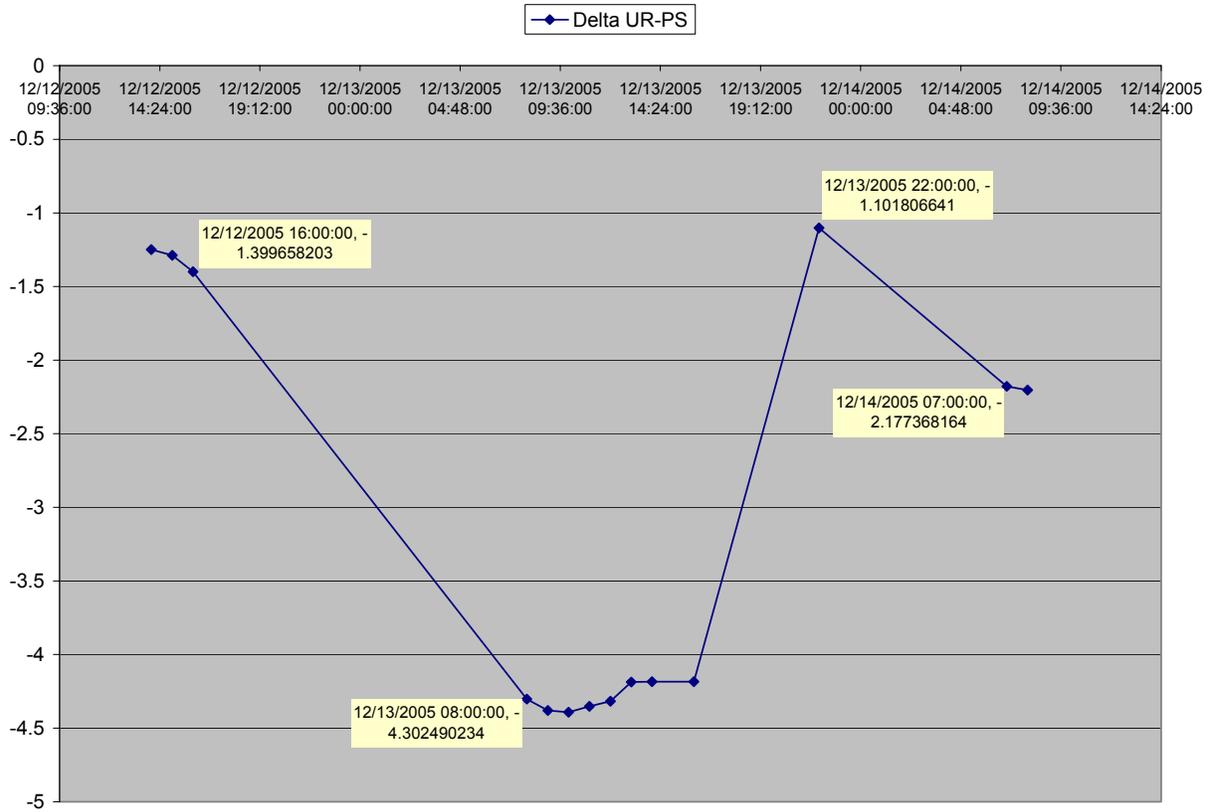
Figure 32: Difference between UR Transmitter Average and PS Transmitter between 12-Dec-05 and 13-Dec-05

A similar sudden change of the transmitter readings can be observed between 12-Dec-05 and 13-Dec-05. This change is also likely to be caused by a shift of the instrument elevation.

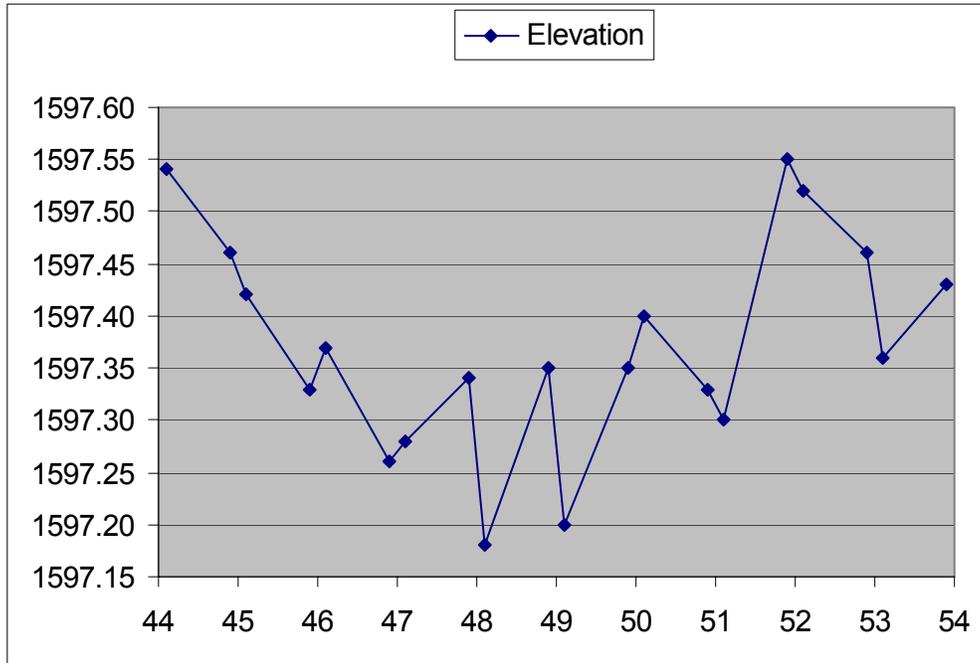
Figure 33: Surveyed Wall Elevations between Panel 44 and 53

The average elevation in this area is 1597.37 feet.

Based on this information, it can be assumed that the upper reservoir level measurement which was used to control the automatic stop of the last pump was reading at least 3.65 feet (1597.37 – 1593.72) too low.

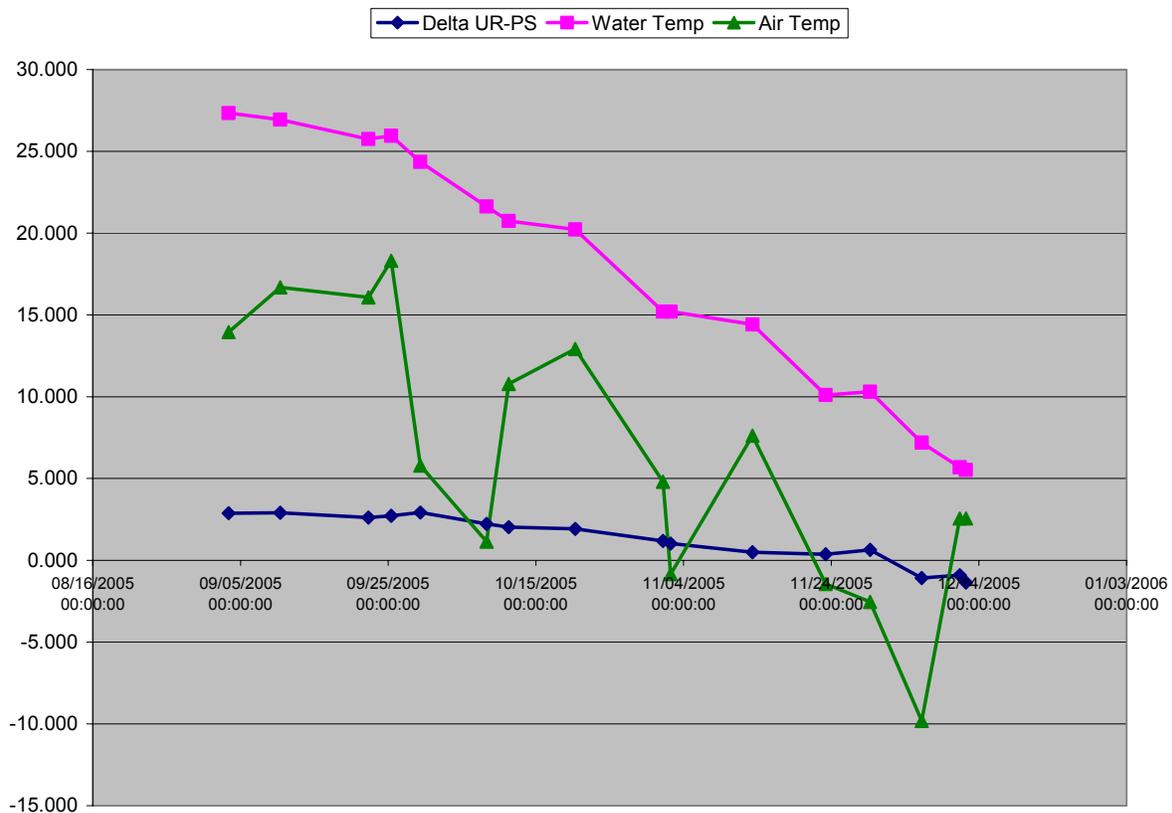
Figure 30: Transmitter Difference and Temperatures

As discussed in chapter 5.2.3, the average upper reservoir level reading was off by at least 3.65 feet low. The estimated minimum instrument lift was at least 2.54 feet. The difference of 1.11 feet (3.65 – 2.54) is most likely attributable to additional lift. As indicated in chapter 4.6.2.3 temperature affects are unlikely.

The following chart shows the difference between the UR and PS transmitter readings in calm conditions (after an auto pump stop), the ambient air temperature and the water temperature between 3-Sep-05 and 12-Dec-05:

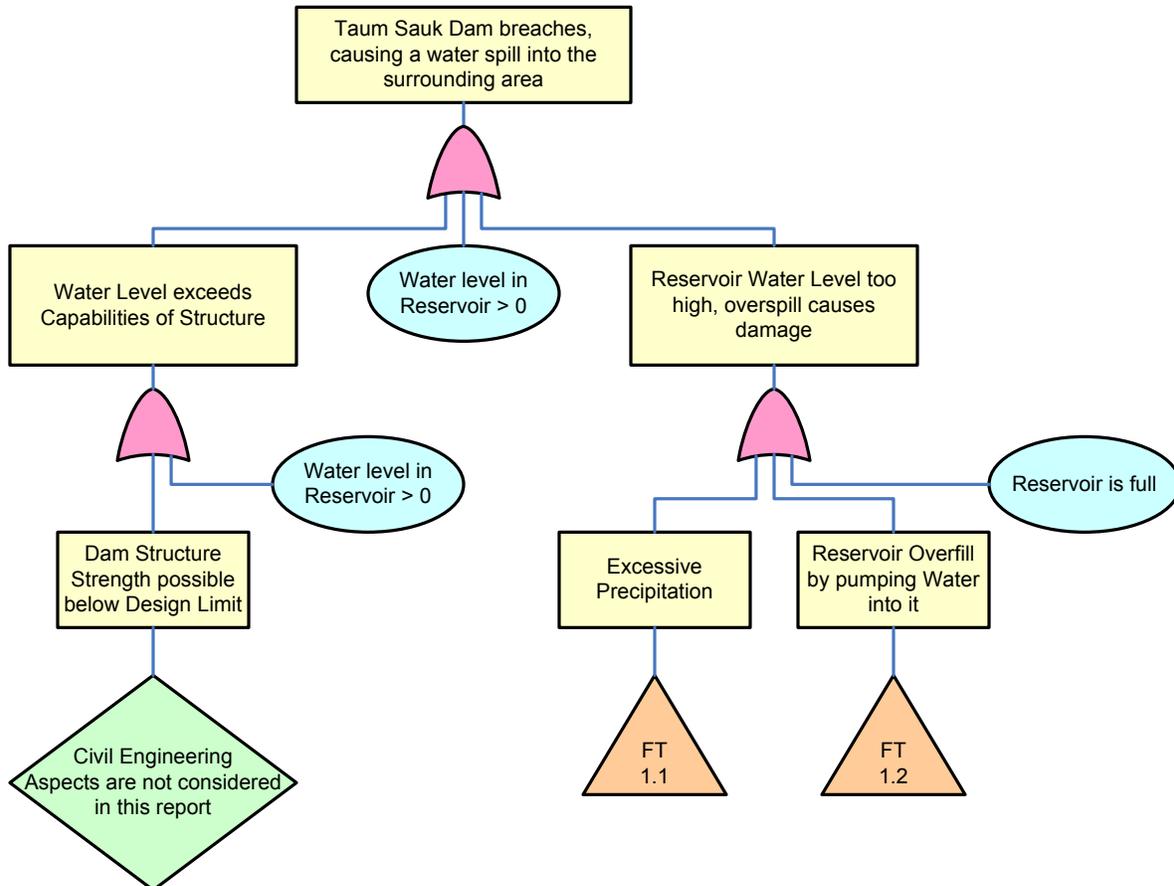
Figure 31: Fault Tree 1: Possible Causes for Dam Breach

The dam breach could have been caused either by a normal water level and a weakened dam structure or by water overspill which subsequently caused damage to the dam structure. The overspill could have been caused by precipitation or by pumping water into the reservoir. Since the dam structure analysis is covered by a separate report, this possibility is not explored further.

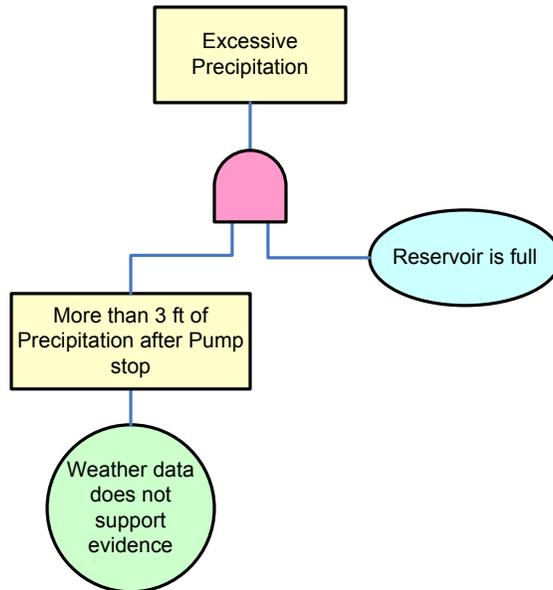
Figure 32: Fault Tree 1.1: Excessive Precipitation

Excessive precipitation may cause an overflow if it amounts to 3 feet after the auto-stop of the last pump which occurs at 1594⁷ feet (the lowest wall elevation is 1597 feet). However, the weather data reviewed by Siemens does not support this possible cause.

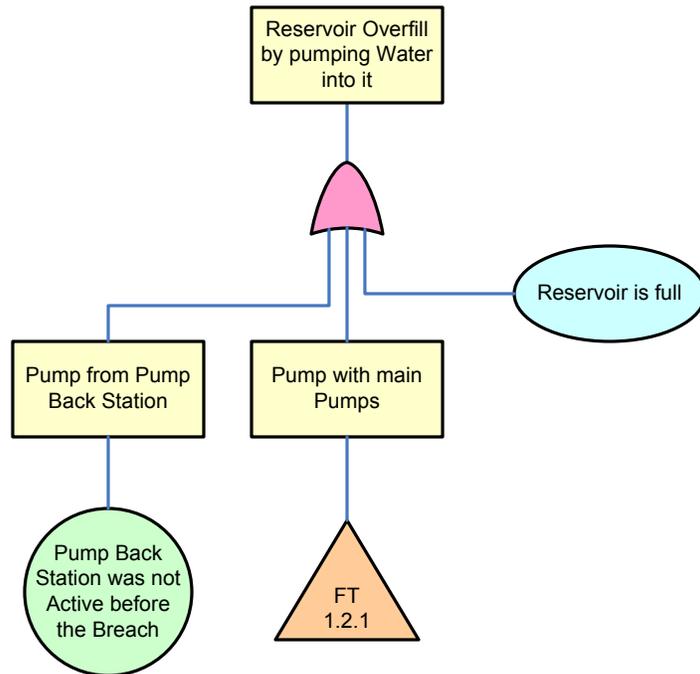
Figure 33: Fault Tree 1.2: Reservoir Overfill by Pumping Water

The reservoir can be filled by two independent pumping systems: The main pumps and a small pump-back pump. The main pumps are used to pump the water from the lower reservoir into the upper reservoir.

Since the upper reservoir was reported by Ameren to be leaking water at a small rate, the leakage water was collected in a small pond close to the UR. If the water level in that pond rises to a predefined level, it is to trigger a limit switch which causes the pump-back pump to start. The small size of the pump and the fact that it does not appear to have been running during the incident suggests that it did not contribute to the overfilling.

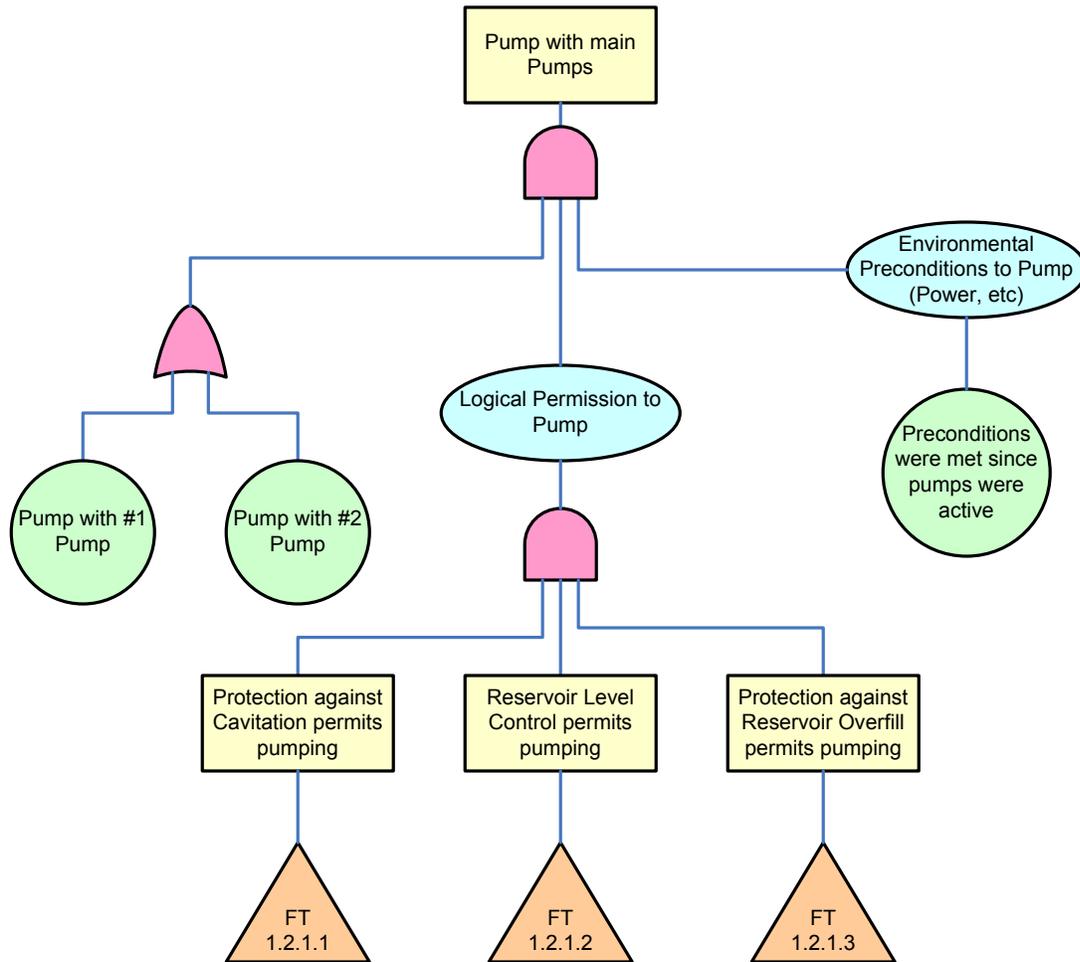
Figure 34: Fault Tree 1.2.1: Pump with Main Pumps

Certain environmental preconditions and permissions need to be met to enable the pumps to continue to operate. Start permissions for the pumps are not considered further since the data reviewed by Siemens suggests that the pumps were running throughout the incident.

To enhance readability, the permissions for the two pumps are analyzed in parallel. It has been discussed in this report that the pump trip logic for pump 2 may have been disabled due a programming issue. However, Siemens believes that this programming issue did not contribute adversely to the incident since pump 2 was to be stopped automatically by level control.

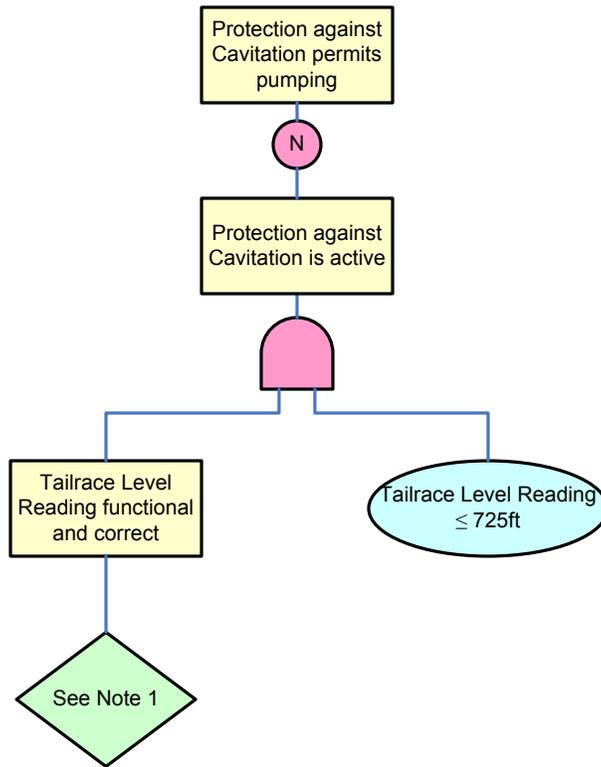
Figure 35: Fault Tree 1.2.1.1: Protection against Cavitation

Since Siemens believes that a wrong tail race reading would not be the root cause for an overspill, it is not considered any further.

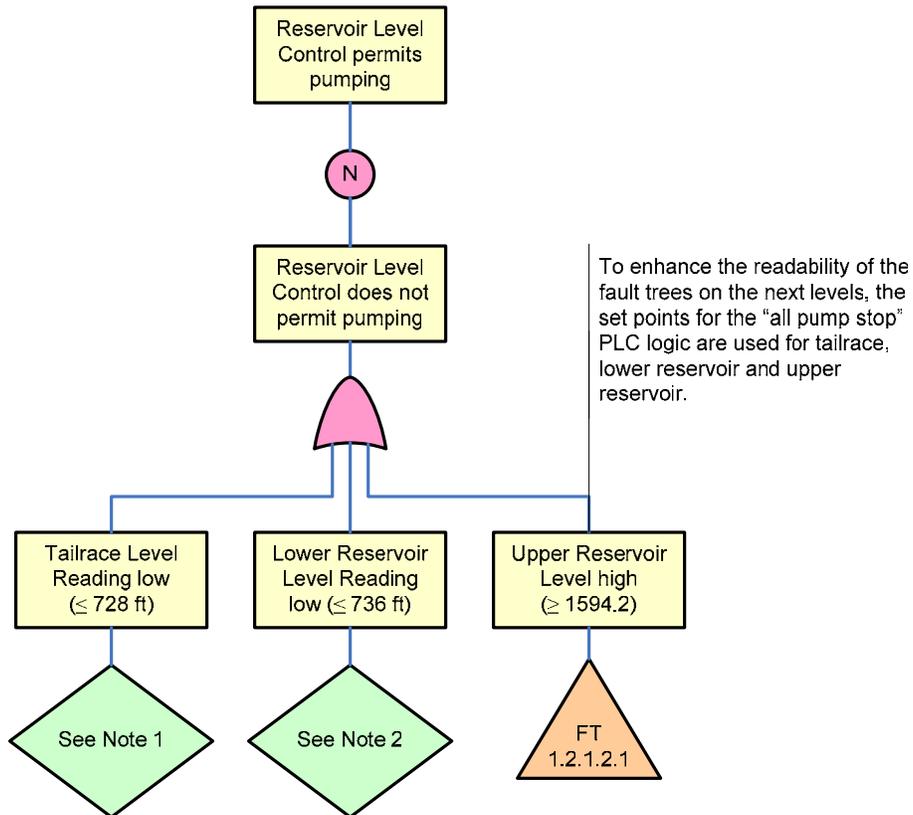
Figure 36: Fault Tree 1.2.1.2: Level Control

Since Siemens believes that a wrong tail race or lower reservoir level reading would not be the root cause for an overflow, it is not considered any further.

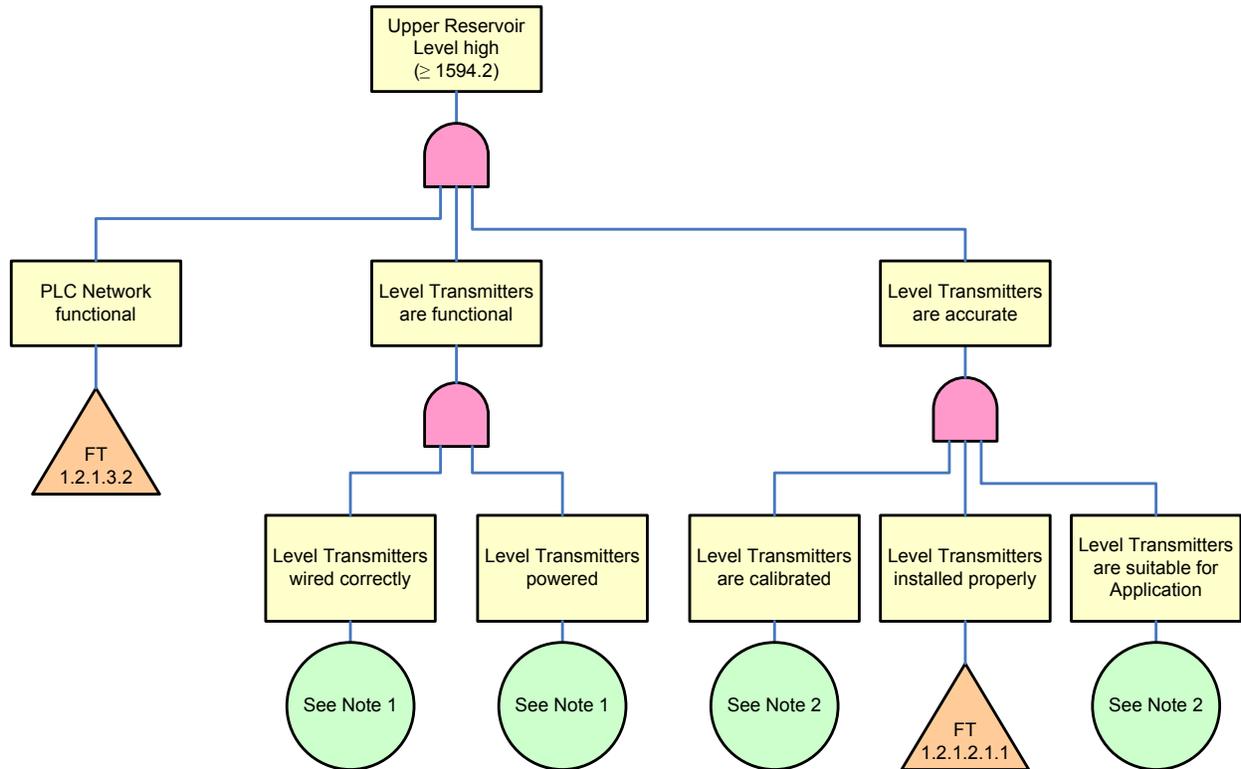
Figure 37: Fault Tree 1.2.1.2.1: Upper Reservoir Level Control

| 2 | Testing of the transmitters at the manufacturer’s facility demonstrated that the transmitters were sufficiently calibrated and suitable for this application (see chapter 4.6.2.3). The temperature sensitivity of TX2 did not contribute adversely to the event. |

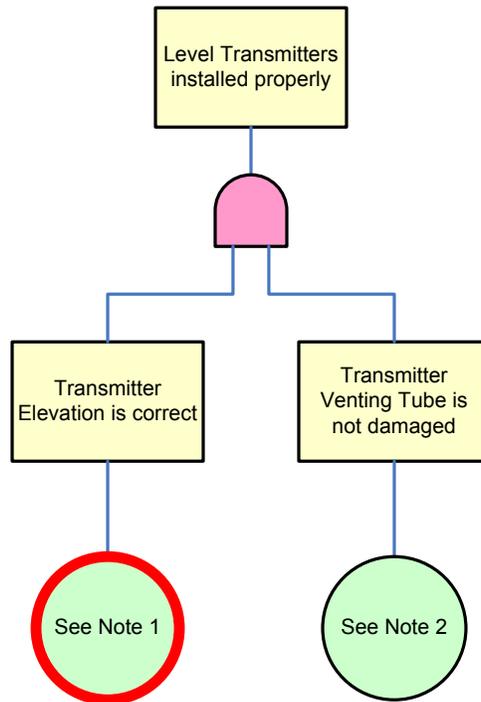
Figure 38: Fault Tree 1.2.1.2.1.1: Level Transmitter Installation

| 2 | The barometric air pressure was compared with level transmitter measurements. At stable plant conditions changes of the barometric pressure did not affect the level measurement of the upper reservoir. Therefore, Siemens assumes that the venting tube was not damaged. |

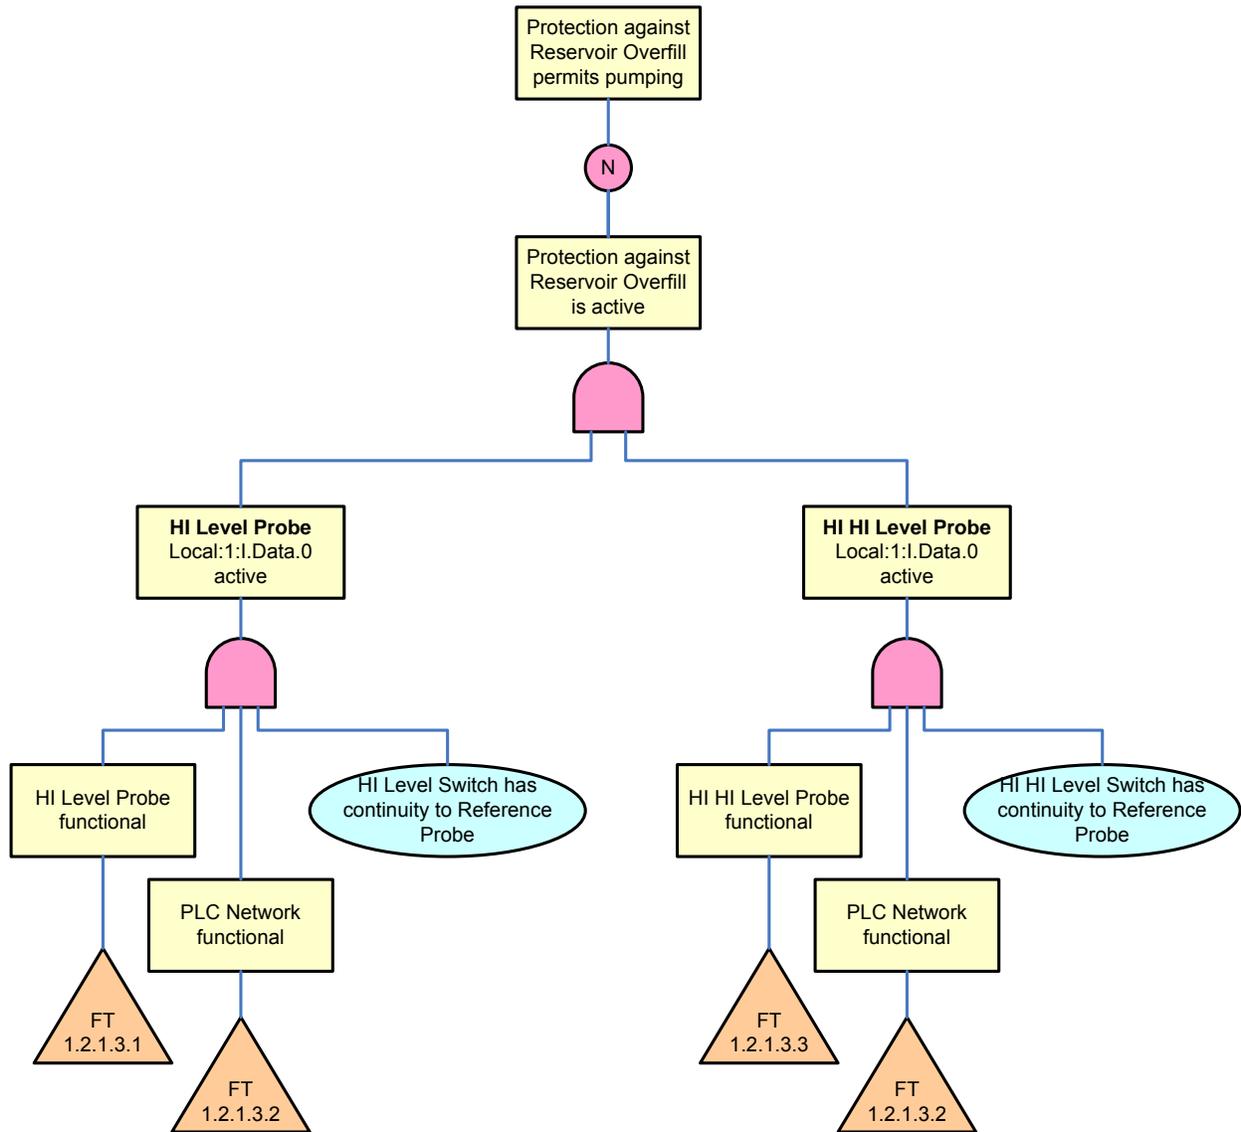
Figure 39: Fault Tree 1.2.1.3: Level Protection

In the as-found logic, the protection against overfill requires the HI and the HI-HI probe to become active. The probes can only become active if they are functional. In addition, the probe signals are processed properly only if the PLCs and the network are operational.

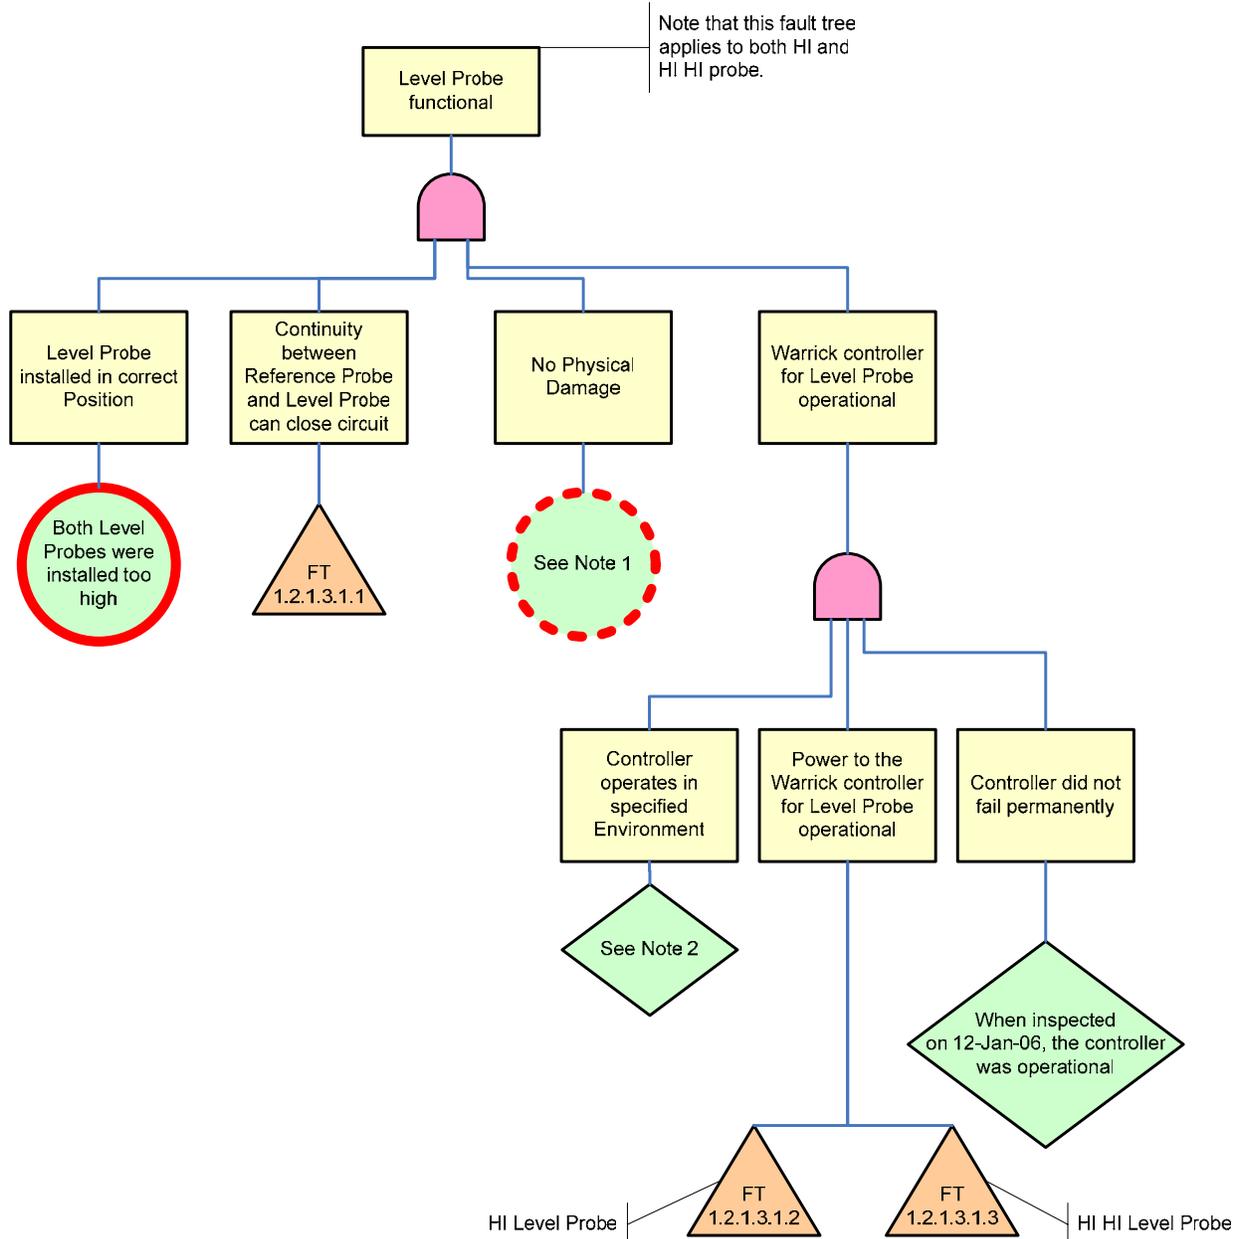
Figure 40: Fault Tree 1.2.1.3.1-3 Level Probe functional

This fault tree applies to both the HI and the HI-HI level probes since they are of the same design. It is known that the level probes were installed too high which effectively disabled them.

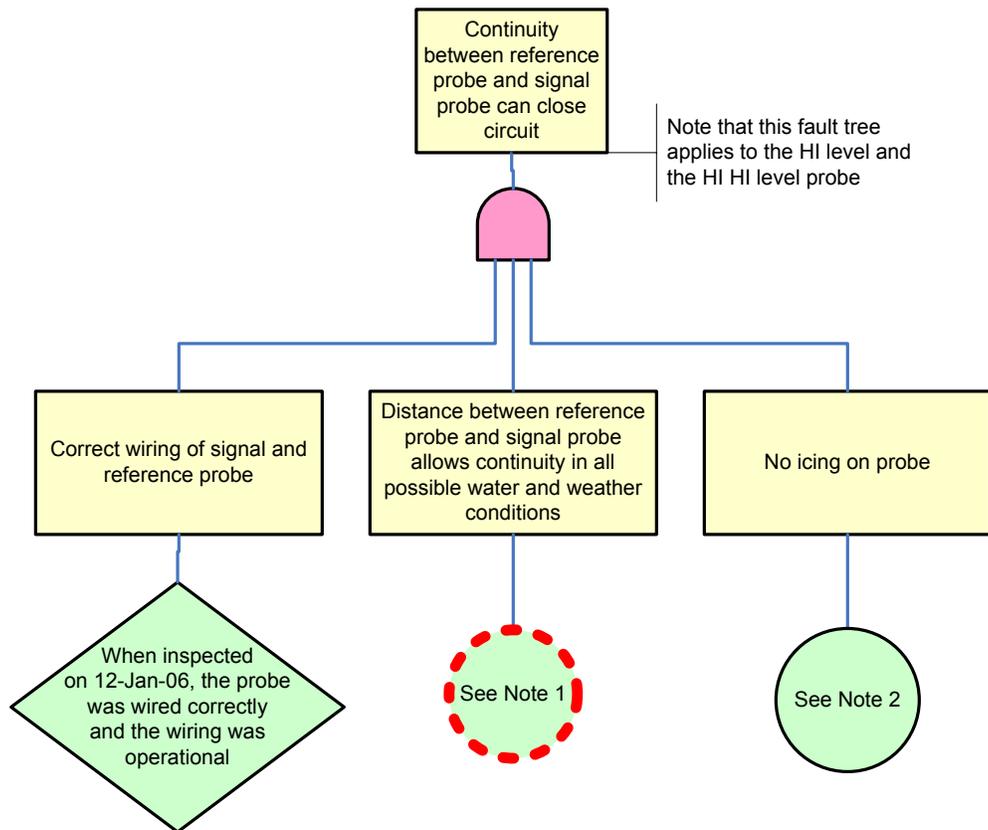
Figure 41: Fault Tree 1.2.1.3.1.1: Continuity between the Signal Probe and the Reference Probe

Note that this fault tree applies to the HI level and the HI HI level probe

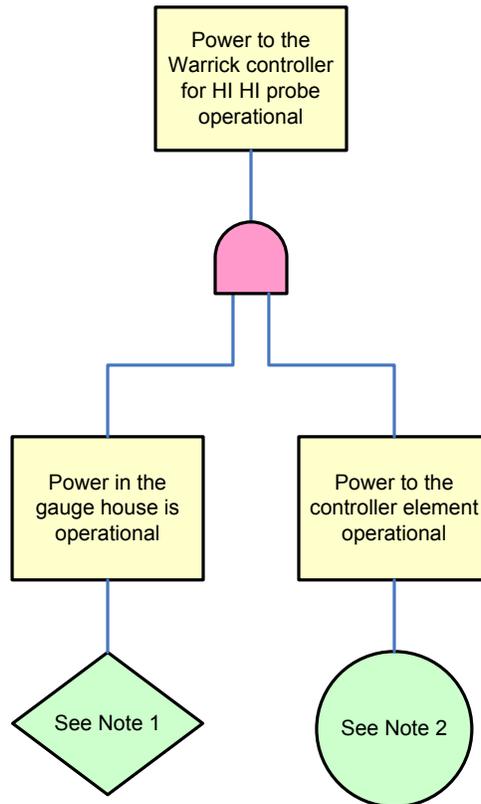
Figure 43: Fault Tree 1.2.1.3.1.3: Power to HI-HI Level Probe operational

| 2 | A failure of power should cause a LO-LO alarm since both contacts are supplied by the same power source. That LO-LO alarm was not observed. |

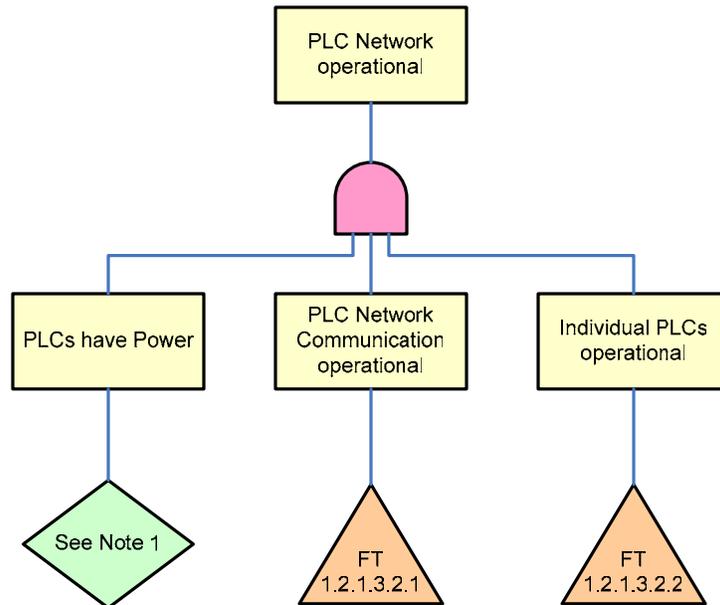
Figure 44: Fault Tree: 1.2.1.3.2 PLC Network Functional

The availability of power, network communication and the operational status of the individual PLCs are preconditions for the PLC network operation.
