**SIEMENS' REPORT
MARCH 24, 2006
AmerenUE**

AmerenUE Taum Sauk Incident Instrumentation and Controls Root Cause Investigation Report

March 24, 2006

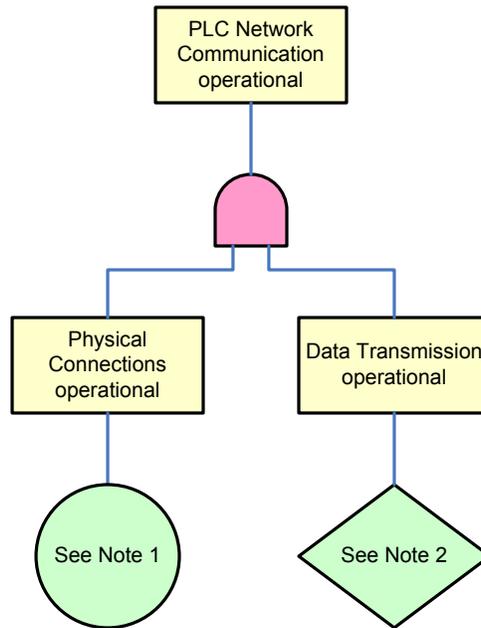
Figure 45: Fault Tree 1.2.1.3.2.1: PLC Network Communication

| 2 | According to Ameren, the last PLC program change before the incident was performed on 7-Dec-05. Since that date, several auto pump stops were performed by the system. This suggests that the PLCs were transmitting data between each other. Since there were no active physical network alarms reported on the data historian at the day of the incident, Siemens assumes that the PLCs were transmitting data throughout the incident. The communication with the Wonderware data process archive also appears to have been operational throughout the day of the incident. |

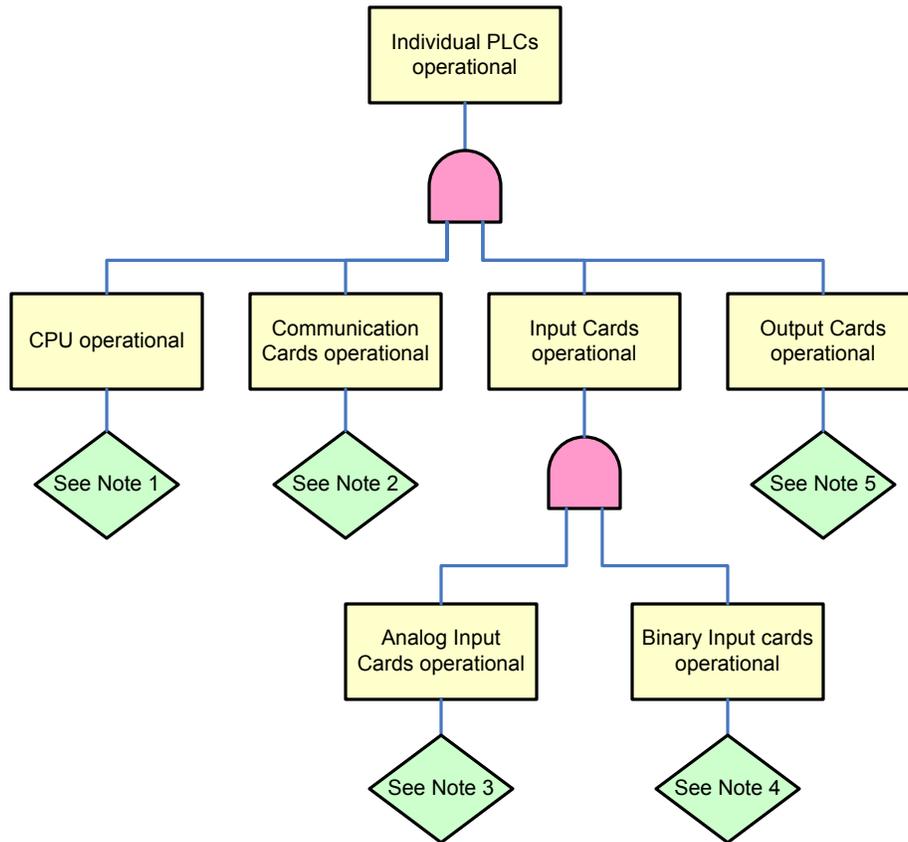
Figure 46: Fault tree 1.2.1.3.2.2: Individual PLC Status

| 3 | There is small likelihood that the analog input cards may have contributed to the level transmitter inaccuracy. However, according to the manufacturer’s documentation and the fact that the building was thermostatically heated, and calculations performed by Siemens based upon the information reviewed, analog input inaccuracy may cause a variation of 1”-3” of water level. |

Analyzing the output cards would not contribute to this root cause analysis since the PLC logic would not have attempted to activate the necessary outputs to stop the pumps. Testing performed after the event suggests that the cards were operational on 2-Feb-06.
