## 2.0 SUMMARY DESCRIPTION OF THE TAUM SAUK PLANT

The Taum Sauk Plant is located in Reynolds County, Missouri, on the East Fork of the Black River, approximately 90 miles southwest of St. Louis, Missouri. It is a reversible pumped storage project used to supplement the generation and transmission facilities of AmerenUE, and consists basically of a ridge top Upper Reservoir, a Shaft and Tunnel conduit, a 450-MW, two-unit pump-turbine, motor-generator plant, and a Lower Reservoir as illustrated on **Figure 2-1**.

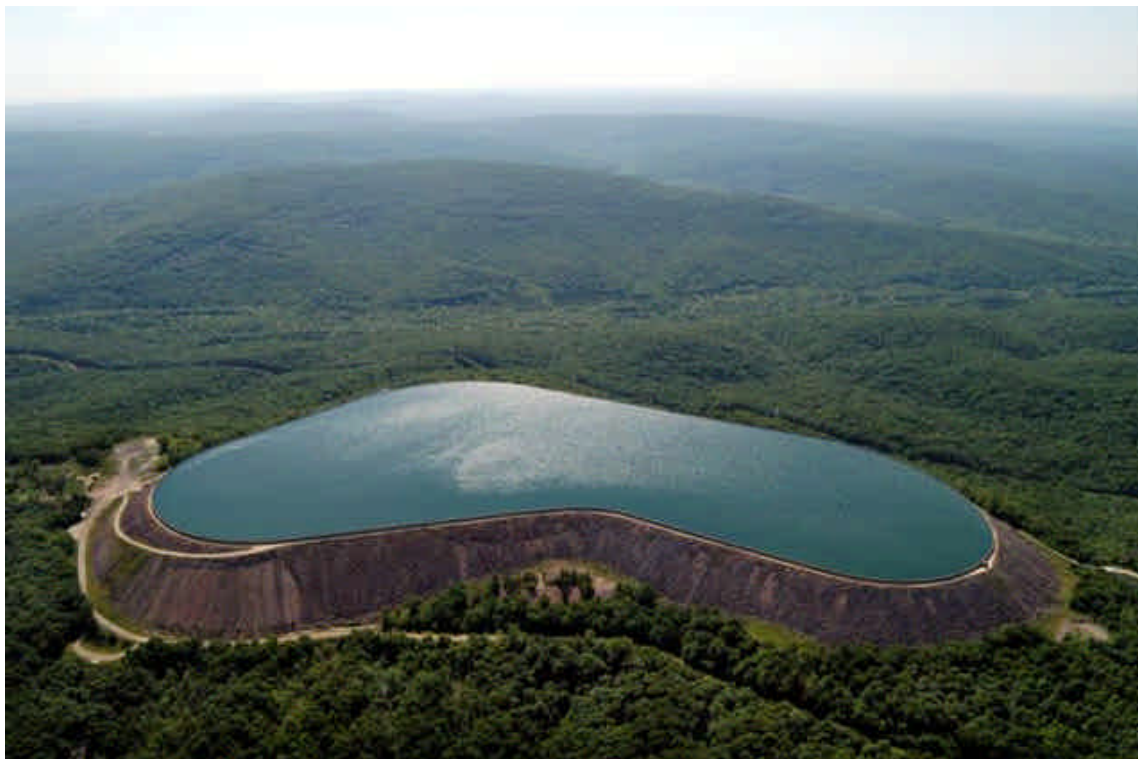
**FIGURE 2-2**

The Upper Reservoir Dike is 6,562-feet long and forms a kidney-shaped reservoir as illustrated on **Figure 2-2**. The Dike is a concrete-faced dumped rockfill dam (CFRD) with a maximum height in the range of 84 feet above the reservoir floor. The floor is generally at El. 1505 and the 12-foot wide crest of the Dike is at El. 1589. A 10-foot-high, 1-foot-thick reinforced concrete Parapet Wall on the crest of the Dike fill extends the maximum pool level to El. 1599. However, as the Dike has settled over time, the true top of the Parapet Wall is as much as two feet lower than the design level at El. 1599.

**VIEW OF UPPER RESERVOIR**

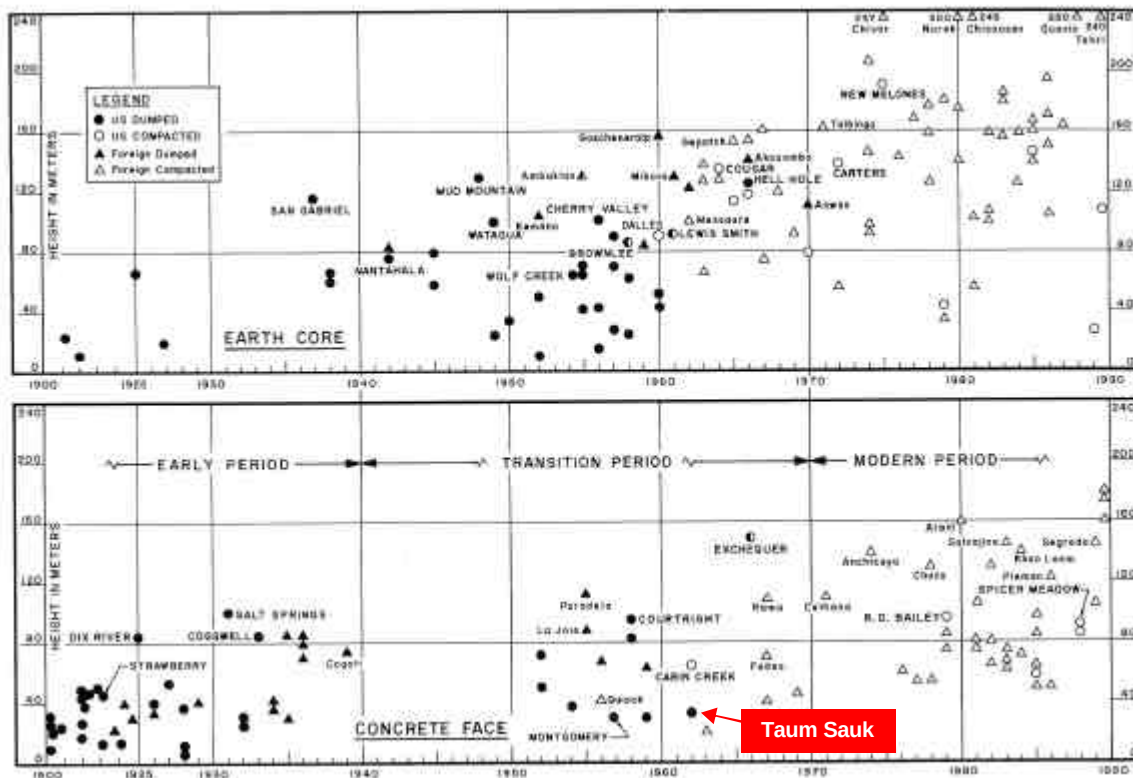
FIGURE 2-6

## TRENDS IN TYPE AND HEIGHT OF ROCKFILL DAMS

Poor behavior of dumped rockfill versus compacted rockfill was known at the time. It would appear, in hindsight, that the design was flawed and not consistent with the evolving state of the practice in the early 1960s. It is noted that the URRD was the last dumped rockfill dike built in the United States and possibly in the world (refer to **Figure 2-6** shown above).
