3.0 SUMMARY DESCRIPTION OF THE SITE GEOLOGY

3.3 GEOLOGIC MAPPING OF THE BREACH AREA

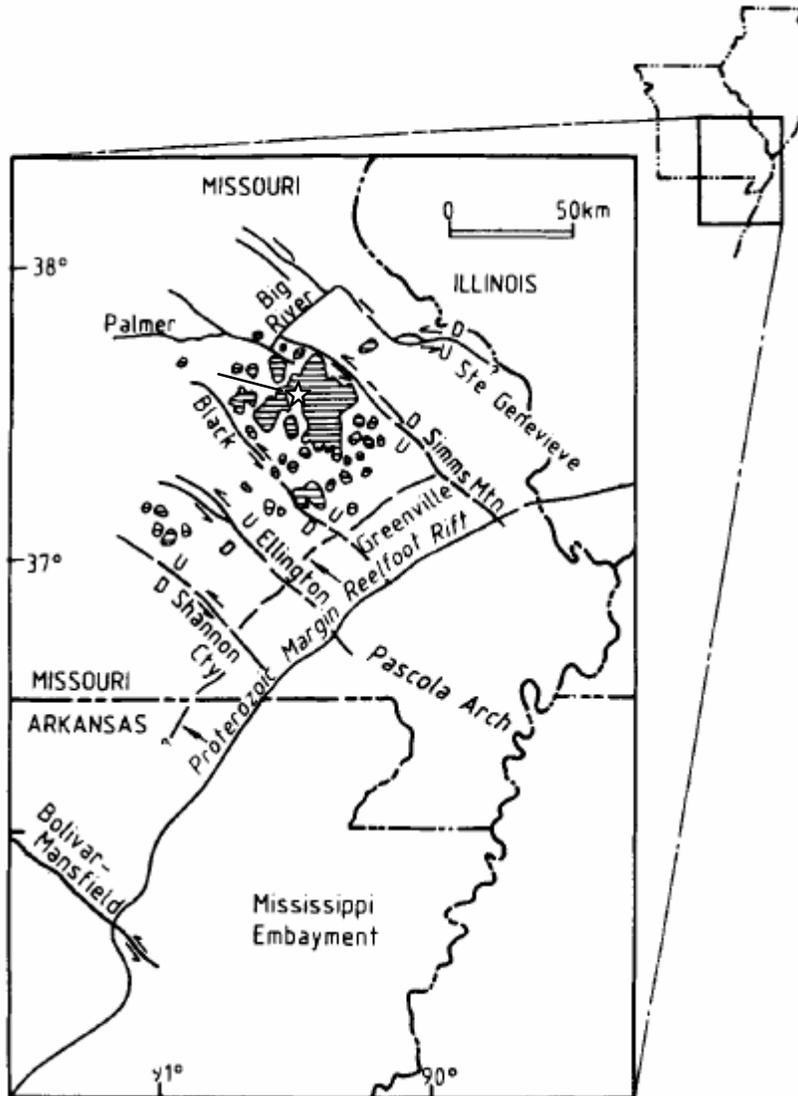
FIGURE 3-1

As shown on *Figure 3-1* there are a number of northwest trending faults associated with the Reelfoot Rift.

NORTHWEST TRENDING FAULTS ASSOCIATED WITH THE REELFOOT RIFT

The Black Fault is the closest of these named faults to the site.

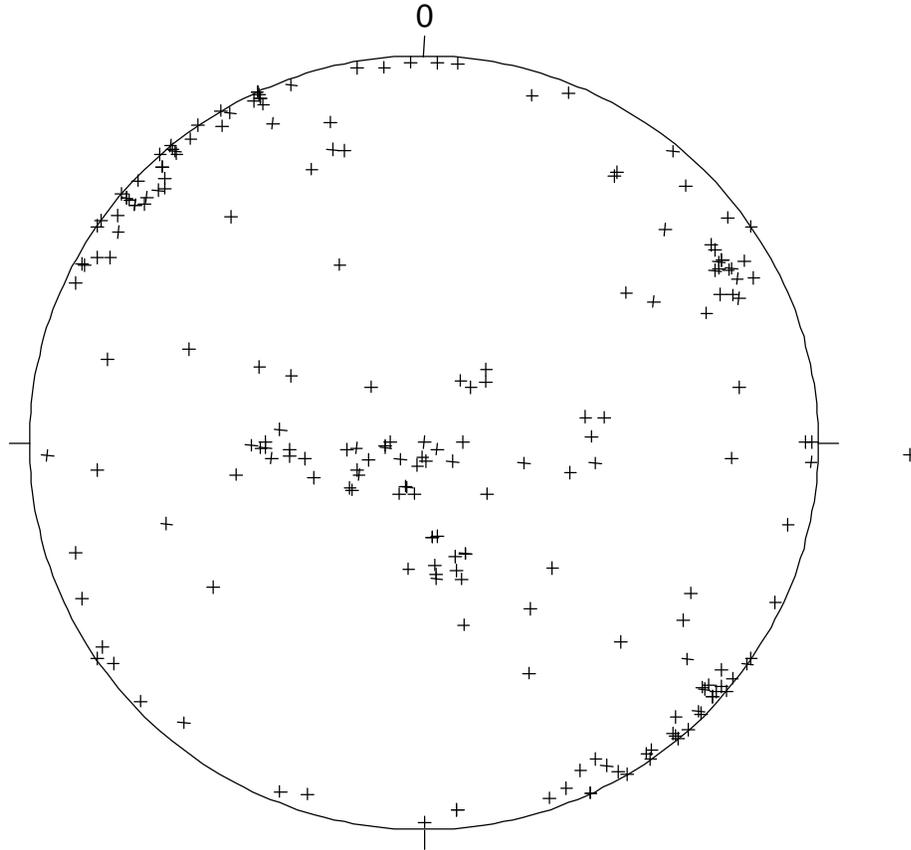
FIGURE 3-2

Table 3-1. The dominant fracture sets are FS-1, FS-2, FS-12, and FS-14. Stereonet analysis of these data lead to the conclusion that fracture sets FS-2, FS-12, and FS-14 are likely the same set that strikes N40-60E and dips 85-90 NW and SE. These fractures are very continuous (greater than 100 feet in length) and are the dominant structural feature in the rock mass. Most of the fracture sets are too steeply dipping to present planar failure potential given the geometry of the slope of Proffit Mountain. However, less dominant, shallow dipping sets such as FS-7 may present the potential for localized planar failure.

STEREONET OF FRACTURES: LOWER HEMISPHERE, POLE TO PLANE, N=193

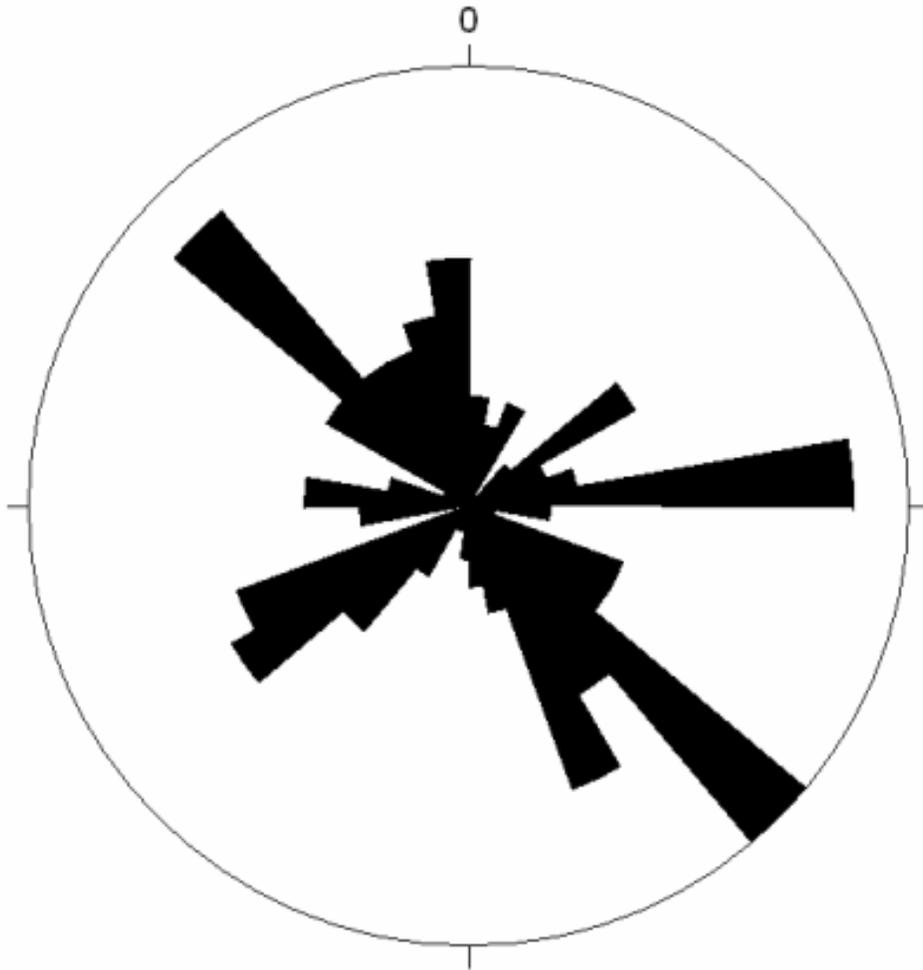
FIGURE 3-3

ROSE DIAGRAM OF FRACTURES, N=193

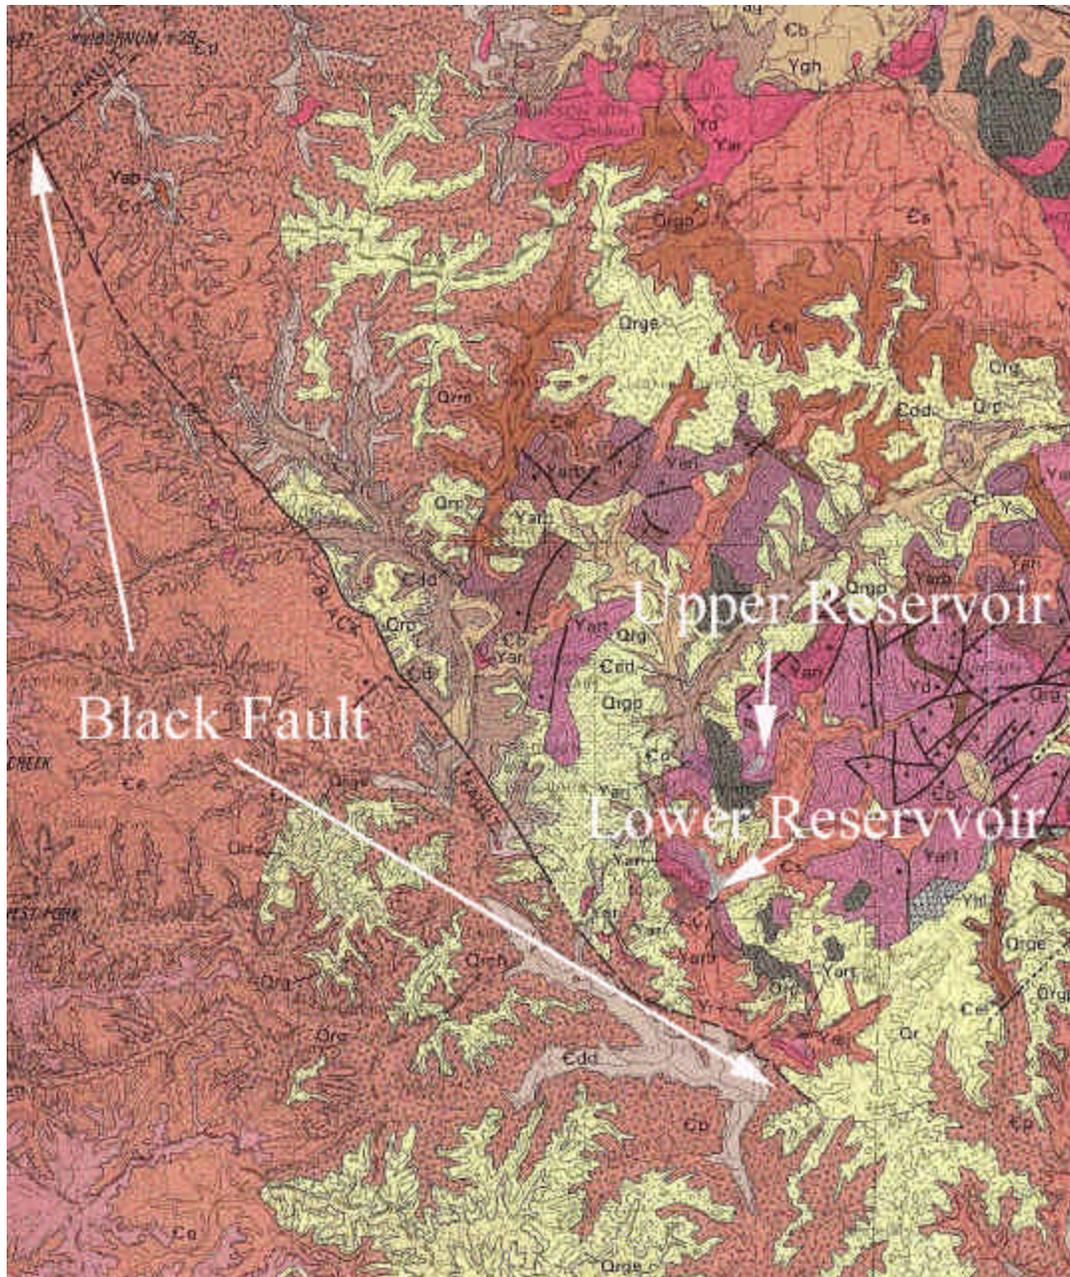
FIGURE 3-9
PORTION OF ROLLA 1° X 2° GEOLOGIC MAP

Two narrow faults, or significant shear zones, were reportedly exposed during the excavation for the Upper Reservoir. Mapping of the breach area revealed shear zones and fault features as discussed in *Section 3.3*. No faults are reported near the Lower Reservoir Dam. The nearest major fault zone is in the New Madrid Fault Zone, about 160 kilometers Southeast. Associated with the New Madrid Fault are a number of northwest trending faults. The closest of these faults is the Black Fault. As shown on *Figure 3-9*, the Black Fault is at least 25 miles long and at its closest point approximately 8 kilometers from the Upper Reservoir. This fault has both strike slip and normal offset. It is mapped as Cretaceous and possibly younger sediments in one location and is mapped as bounding the relatively young sediments in other area. The Quaternary-age sediments are colored yellow on *Figure 3-9*. The shears mapped within the Breach Area are oriented such that they may be Riedel Shears associated with the Black Fault.

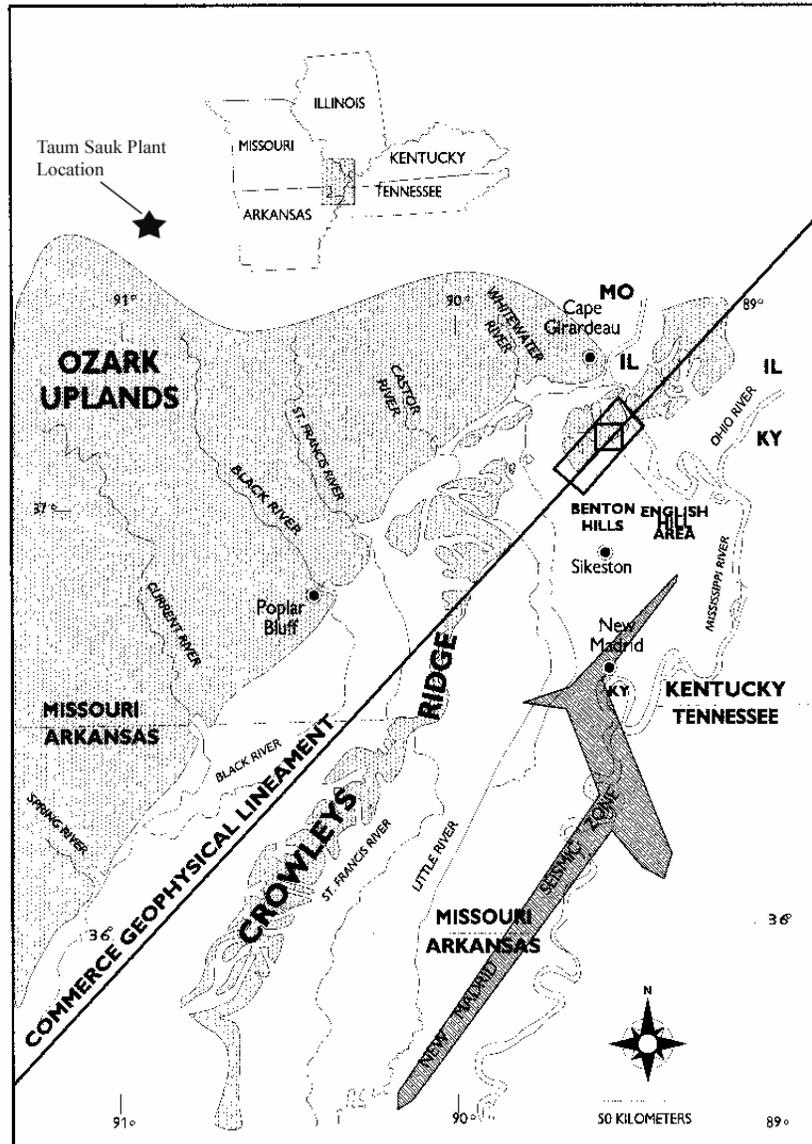
FIGURE 3-10

In addition to the New Madrid Seismic Zone, Langenheim and Hildenbrand (1997) identify the Commerce Geophysical Lineament and Commerce Fault, a zone in strike with and northwest of the New Madrid seismic zone as potential sources of seismicity. Anderson (1997) relates the Commerce Geophysical Lineament to Quaternary faulting. *Figure 3-10* shows the location of the Commerce Geophysical Lineament relative to the Taum Sauk Plant site and the New Madrid Seismic Zone.

**COMMERCE GEOPHYSICAL LINEAMENT AND NEW MADRID SEISMIC ZONE
(FROM ANDERSON, 1998)**

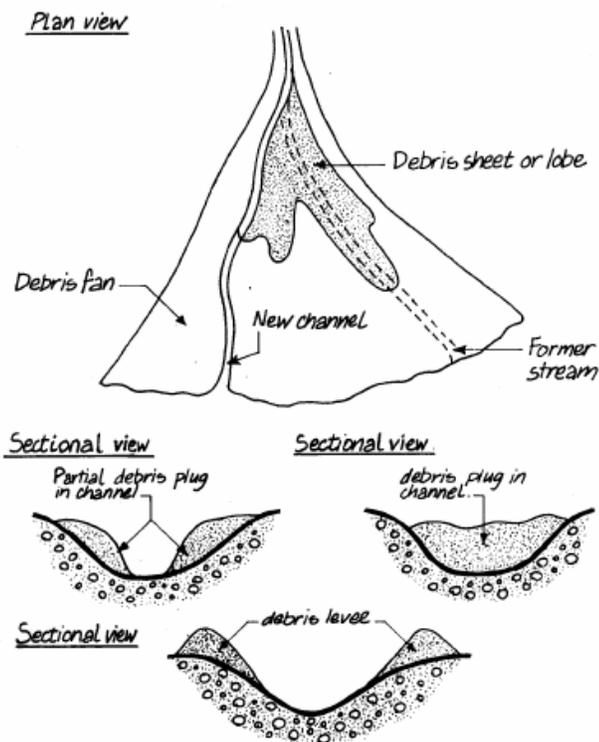
FIGURE 3-13

When referring to the deposition process, it should be noted that all of the original deposits along the Breach Channel were scoured, removed and displaced by sediments derived from the Breach Area as well as the reworked original deposits. When the coarse-grained debris from a “channellized” debris flow stops, it can take many forms, depending on the character of the debris and the debris fan, and on the presence of natural or artificial impediments. These forms, as shown in *Figure 3-13*, include sheets or lobes of debris on the debris fan, plugs of debris deposited in the stream channel, and debris levees along the stream channel.

**FORMS OF CHANNELIZED DEBRIS FLOW DEPOSITION
(D.F. VANDINE, 1996)**

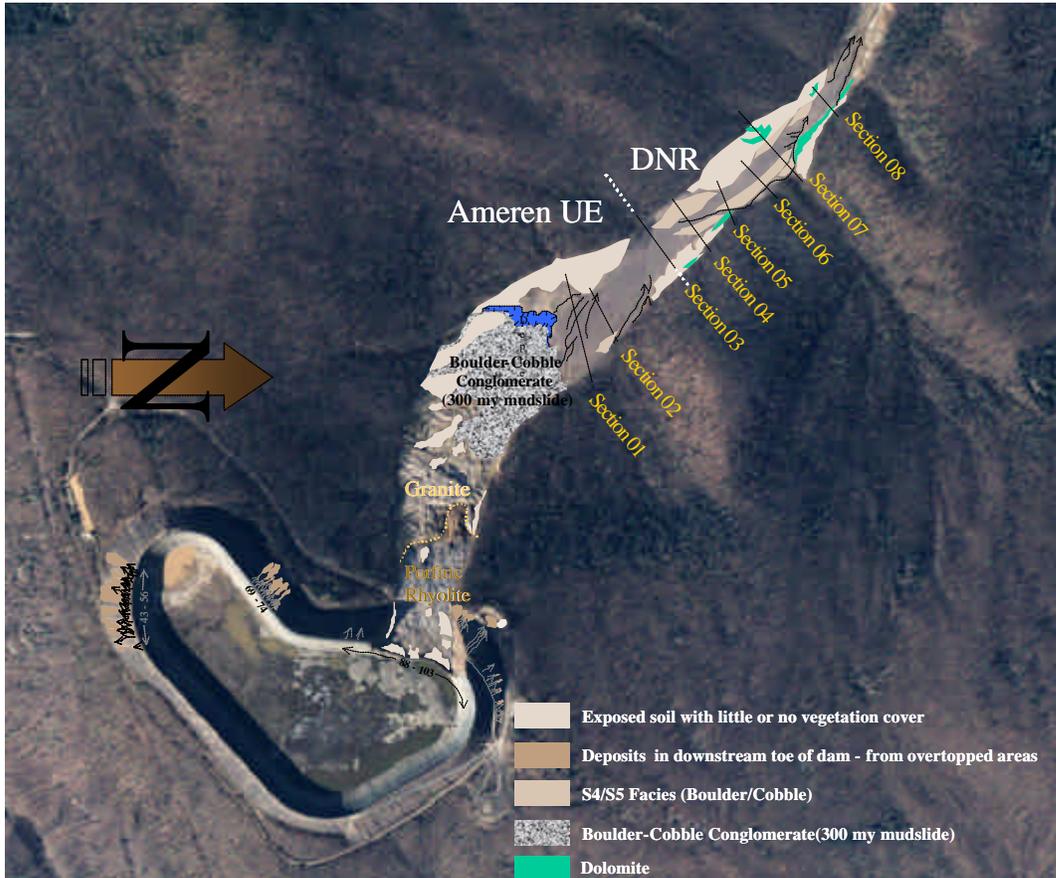
FIGURE 3-14

GENERALIZED DISTRIBUTION OF DEPOSITS DERIVED FROM BREACH AREA AND SUBSEQUENT DEBRIS TORRENT

Referring back to *Figure 3-14*, the deposits shown in Breach Area are those distinctive facies S4/S5, with larger particle sizes as shown on *Figure 3-18*. The facies at the other sections indicated on *Figure 3-14* are shown on *Figures 3-18 and 3-19*.

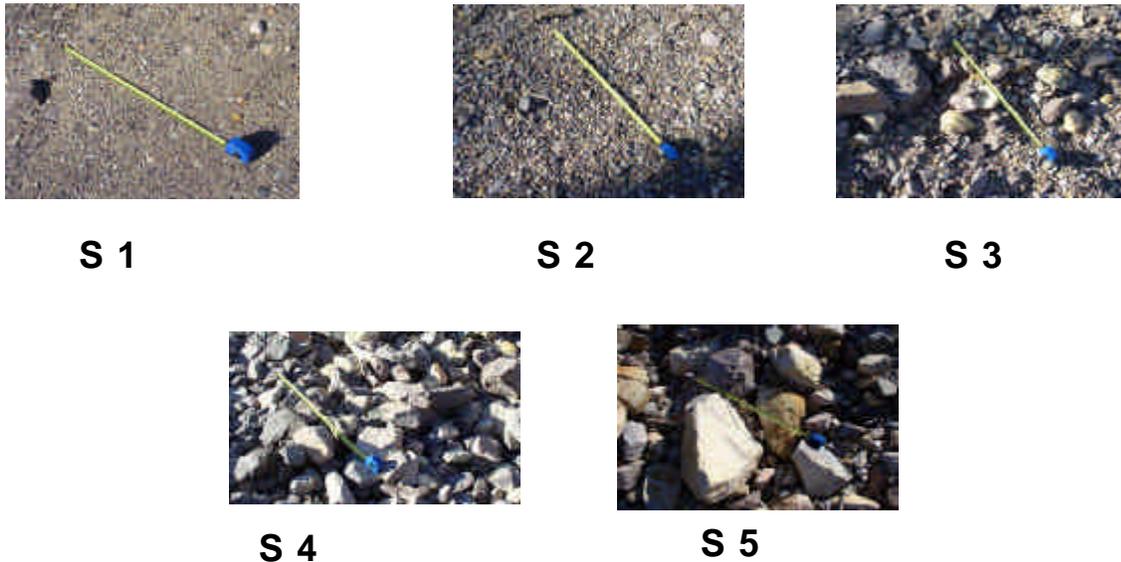
FIGURE 3-19

FACIES TYPES USED IN DESCRIBING SECTIONS NORMAL TO FLOW

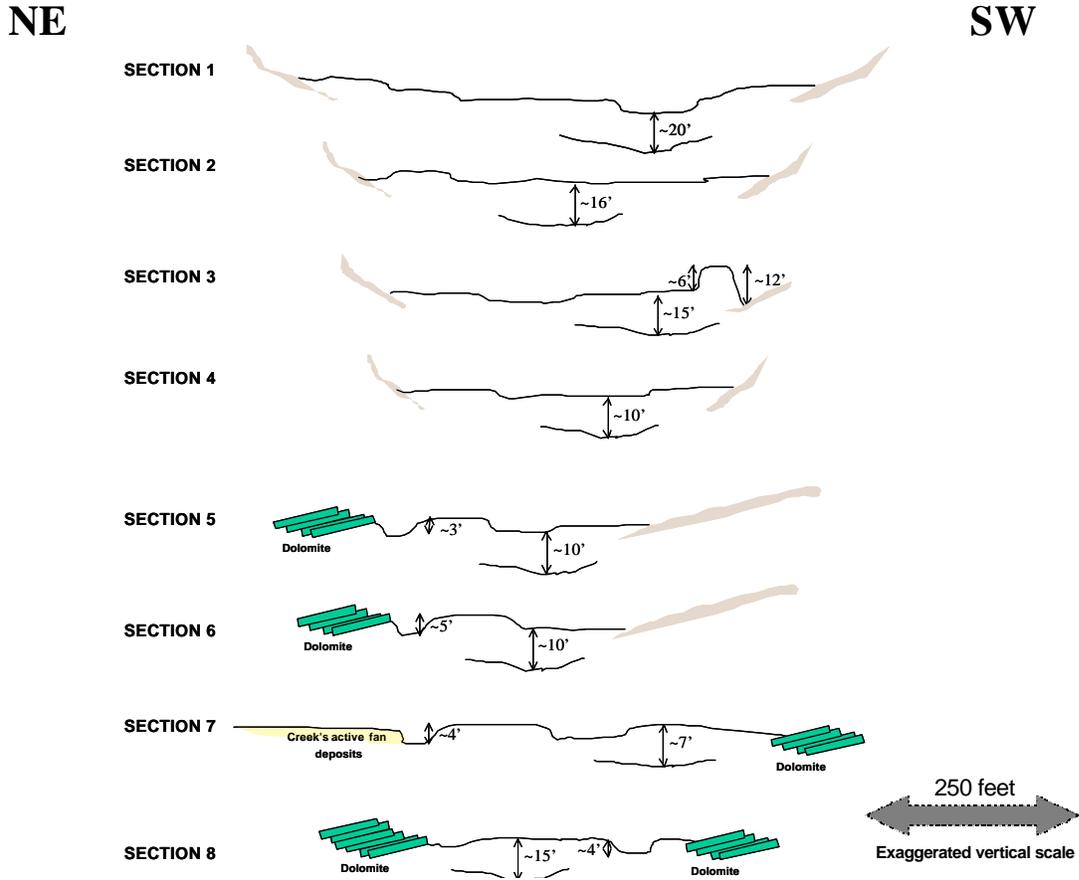
FIGURE 3-20

The Sections located on *Figure 3-18* are shown below on *Figure 3-20* and the fraction of the various facies at each section is indicated on *Figure 3-21*.

CROSS SECTIONS OF BREACHED CHANNEL
