NORTH AMERICAN ELECTRIC
RELIABILITY CORPORATION

Iberian Peninsula Blackout

Contextual Comparison with North American BPS Reliability Safeguards

Mark Lauby, SVP, Chief Engineer
FERC Open Meeting
June 26, 2025

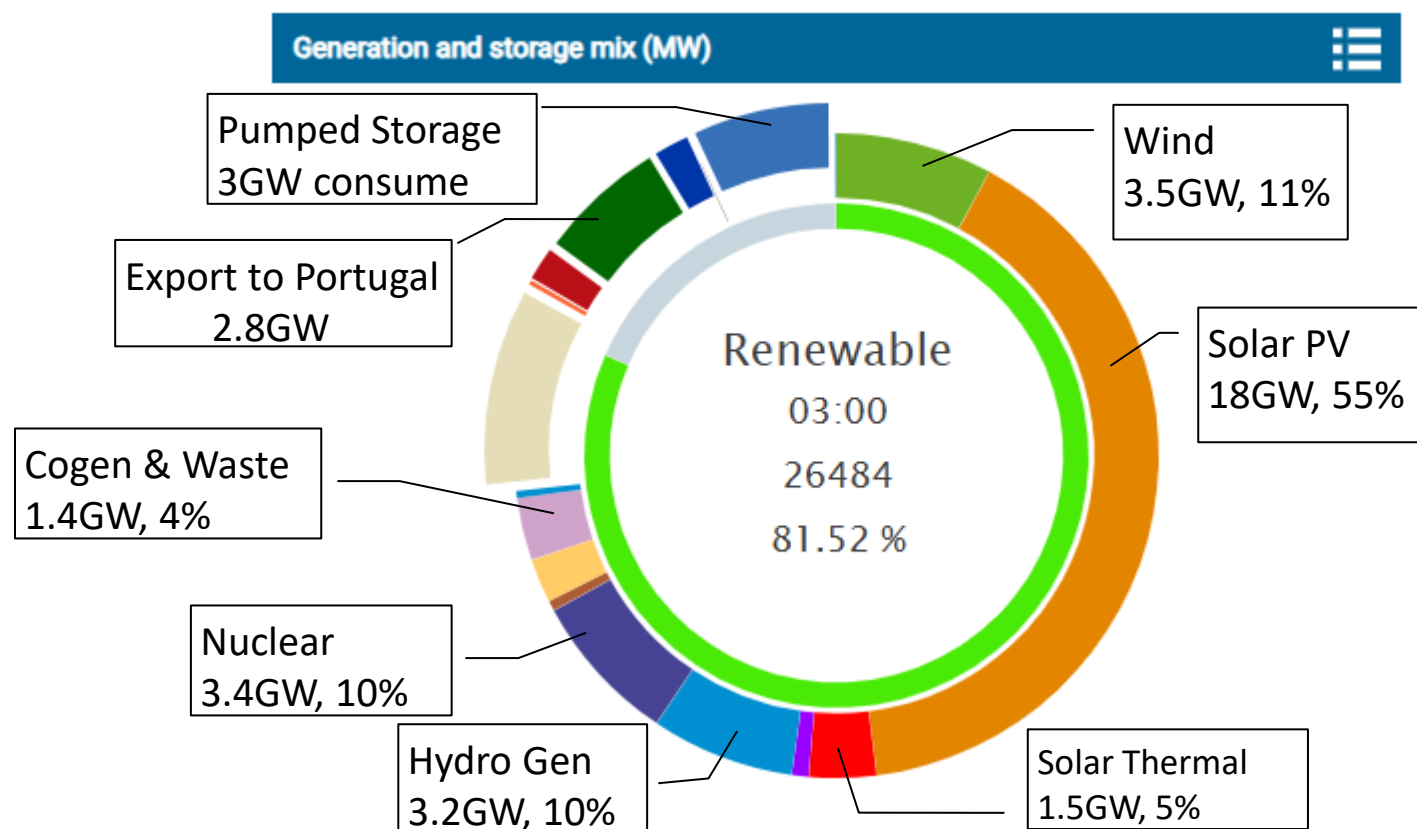
- **System Strength:** Weak grid conditions - higher voltage sensitivity to network changes
- **Total load pre-event:** 27 GW
- **Export pre-event:** 1 GW to France, 2.8GW to Portugal, 800MW to Morocco

- Affected: Portugal & Spain
 - Small part of south France
- April 28, 2025
- 12:33 CET – Black Out
- 12:35 CET – Black-Start began
- 13:04 CET – Morocco-Spain interconnector reenergized
- 13:35 CET – Eastern France-Spain interconnector re-energized
- 18:36 CET – Tie-line between Portugal and Spain re-energized
- 21:35 CET – 400kV tie-line Portugal and Spain re-energized
- April 29
- 00:22 CET – Portugal transmission system restored
- 04:00 CET – Spain transmission system restored

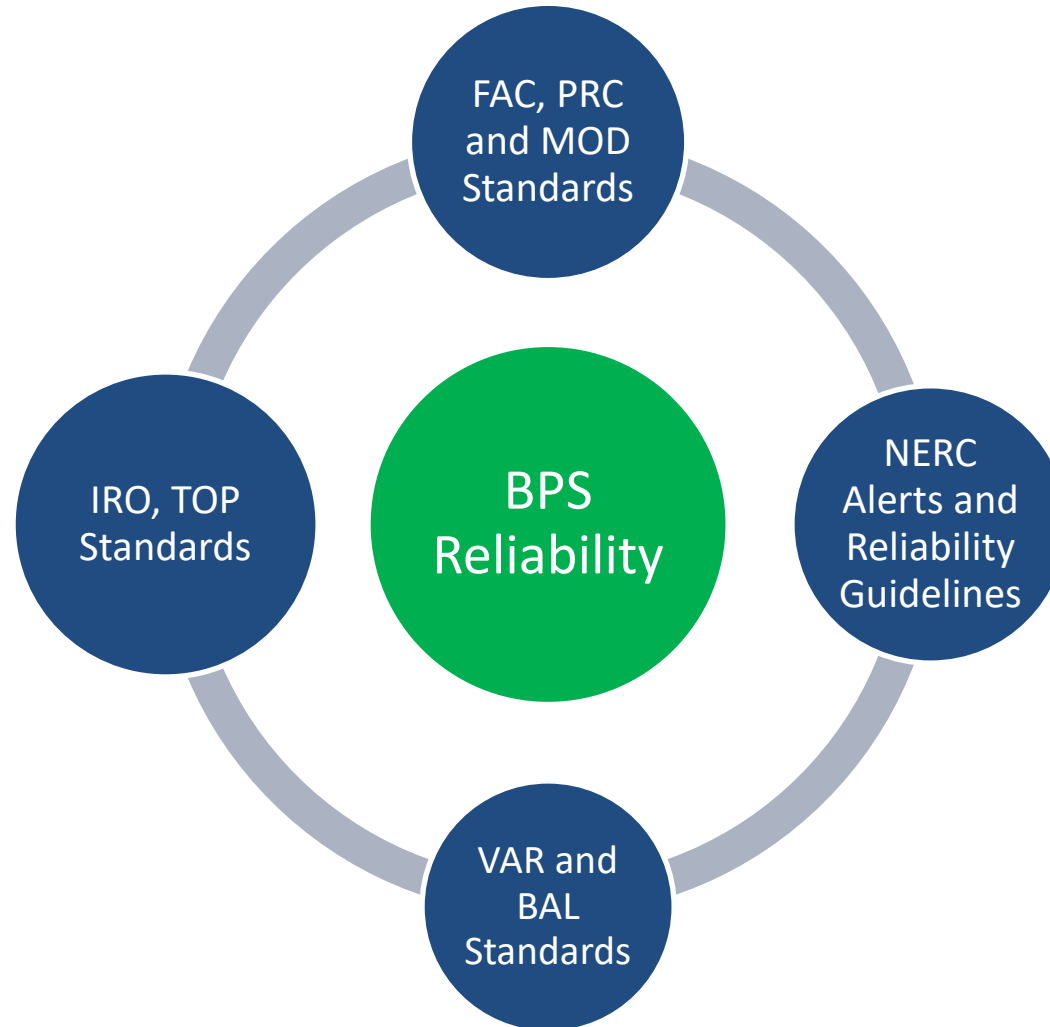
Lesson Learned for North America: If resource tripping is caused by overvoltage and results in underfrequency condition, UFLS will result in higher voltage in the absence of sufficient voltage regulation.

Mandate all generation units, including IBRs capable of voltage regulation perform such control

- We already do this!
- NERC VAR-002-4 and FERC Order No. 827
