FERC/DSOD Hydrologic Study of Sly Creek Dam and Ponderosa Dam

Western Regional Dam Safety Forum

January 16, 2008

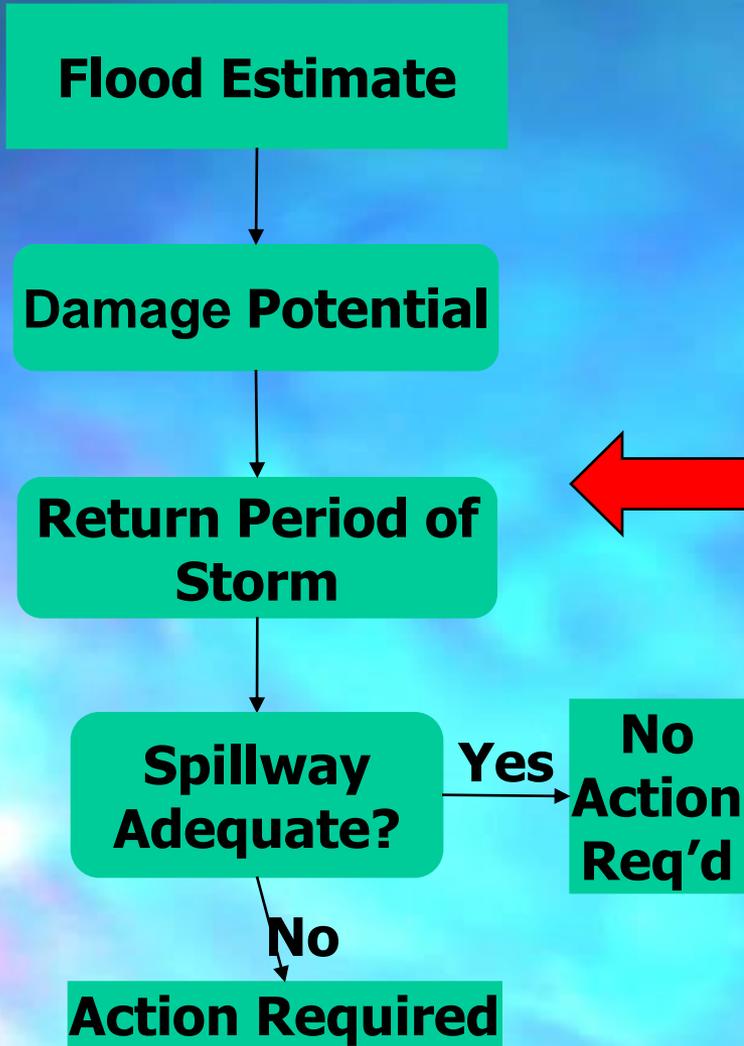
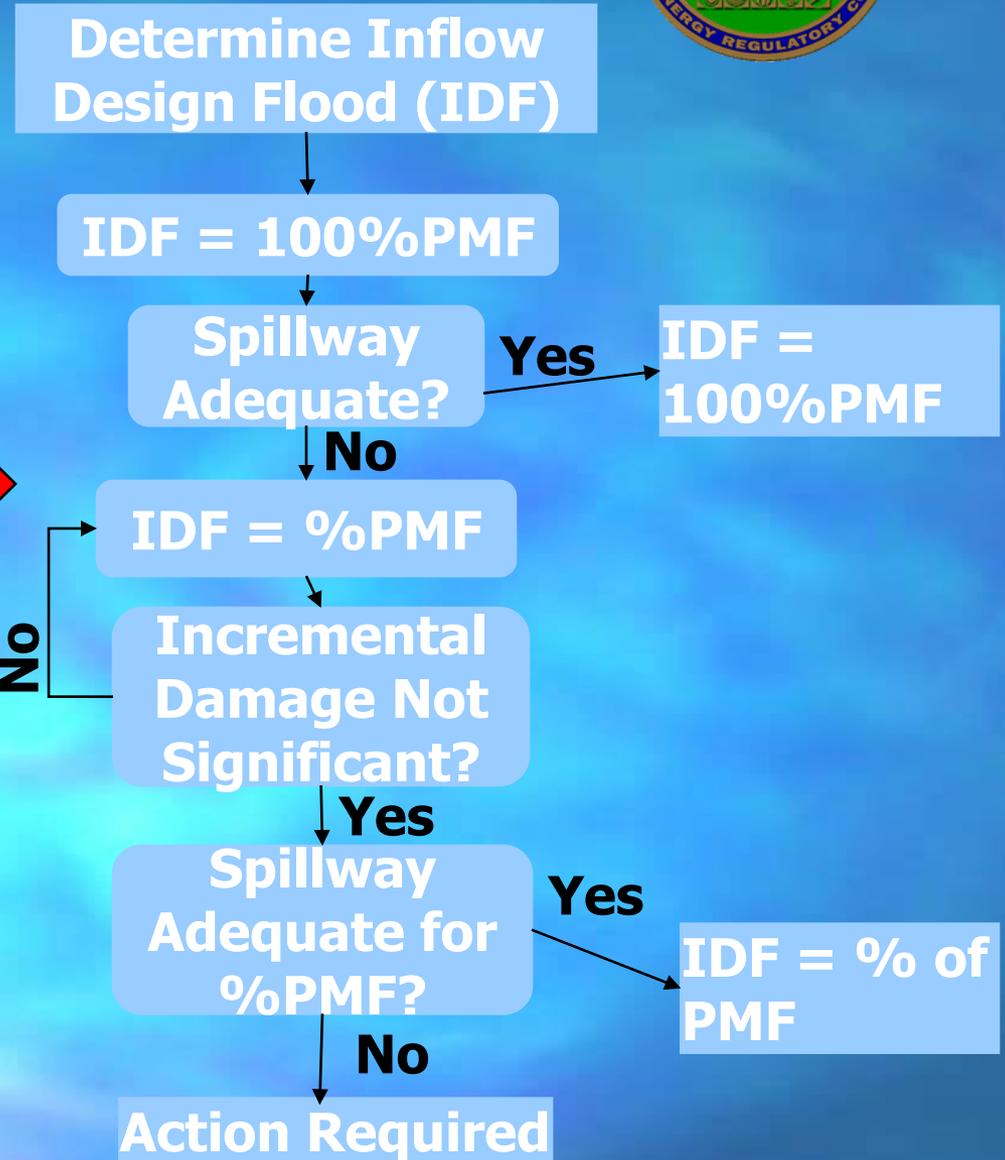
Spillway Adequacy Determination

(Sequential/Probabilistic)

(Iterative/Deterministic)

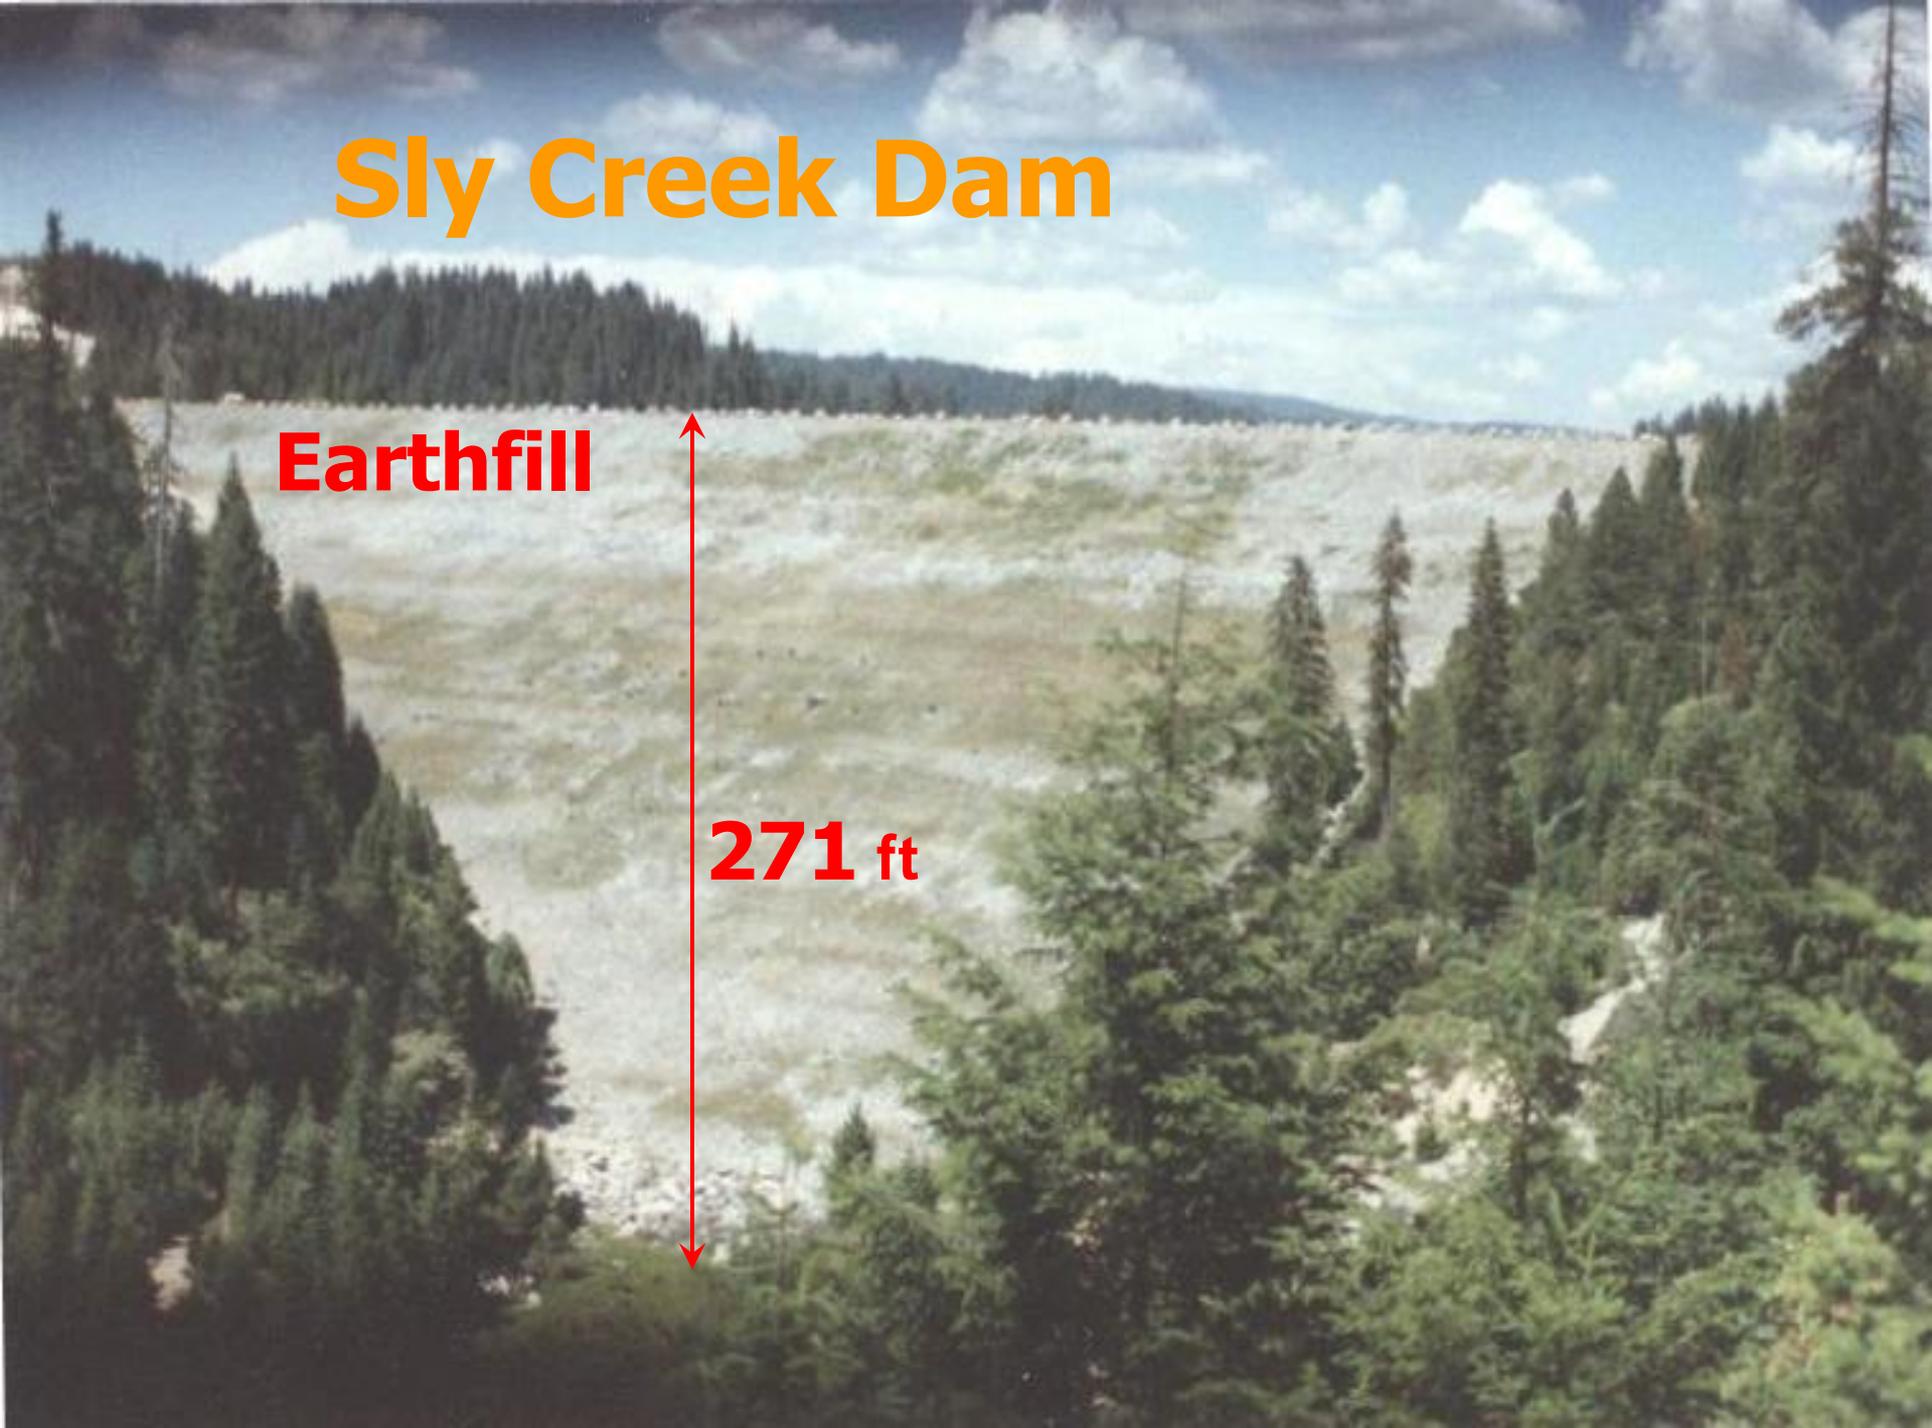
Earthfill

271 ft

Sly Creek Dam

Drainage Area = 24 sq mi

Storage Capacity = 65,050 ac-ft

Total Freeboard = 21 ft

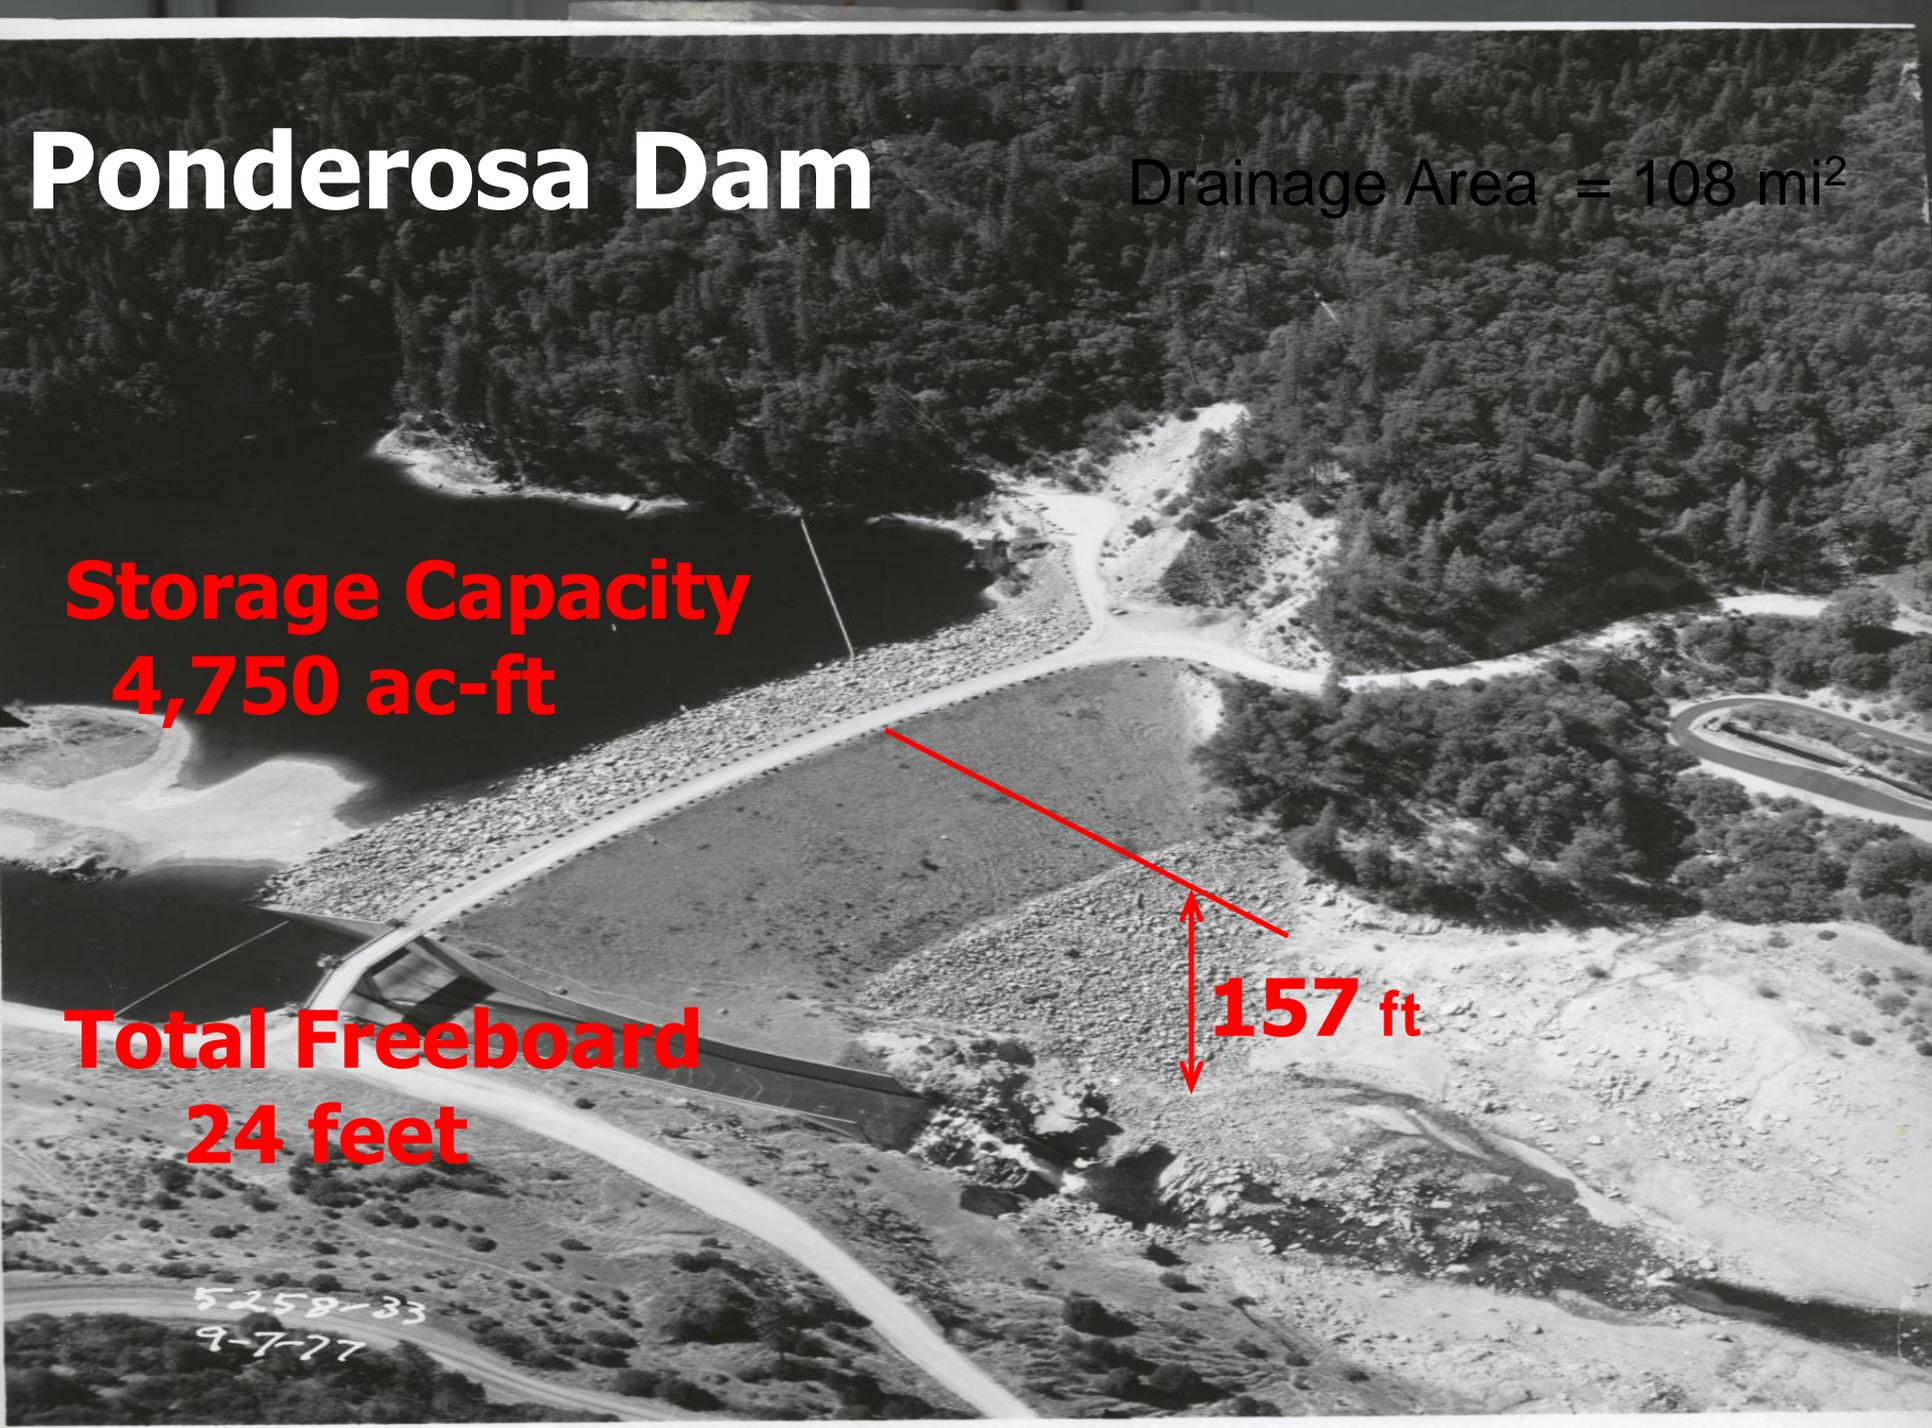
Ponderosa Dam

Drainage Area = 108 mi²

Storage Capacity
4,750 ac-ft

Total Freeboard
24 feet

157 ft

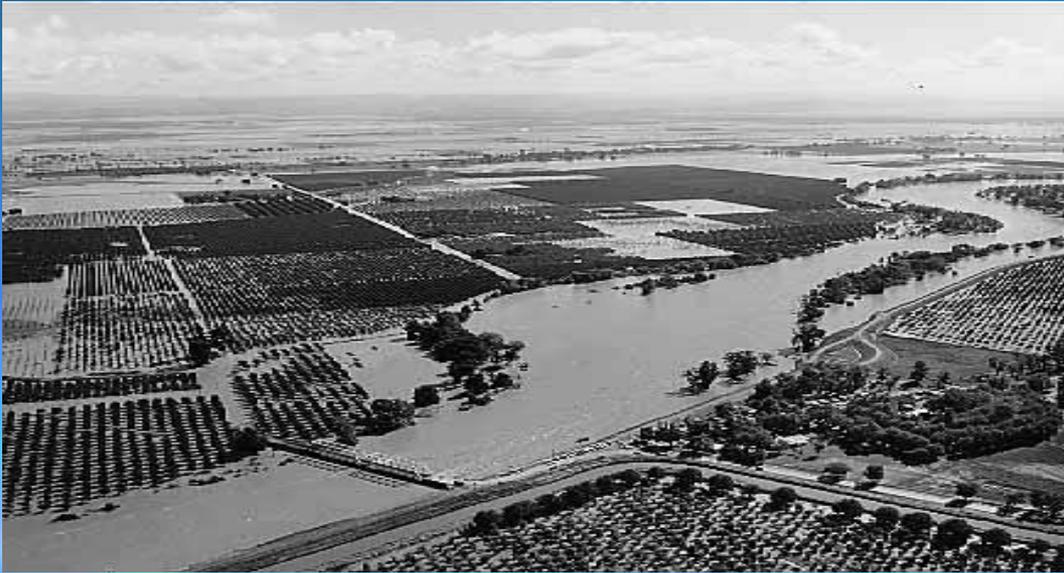
FERC Inflow Design Flood

- **The Inflow Design Flood is the flood flow above which the incremental increase in water surface elevation due to failure of a dam or other water impounding structure is no longer considered to present an unacceptable threat to downstream life and property.**
- **The upper limit of the IDF is the PMF**

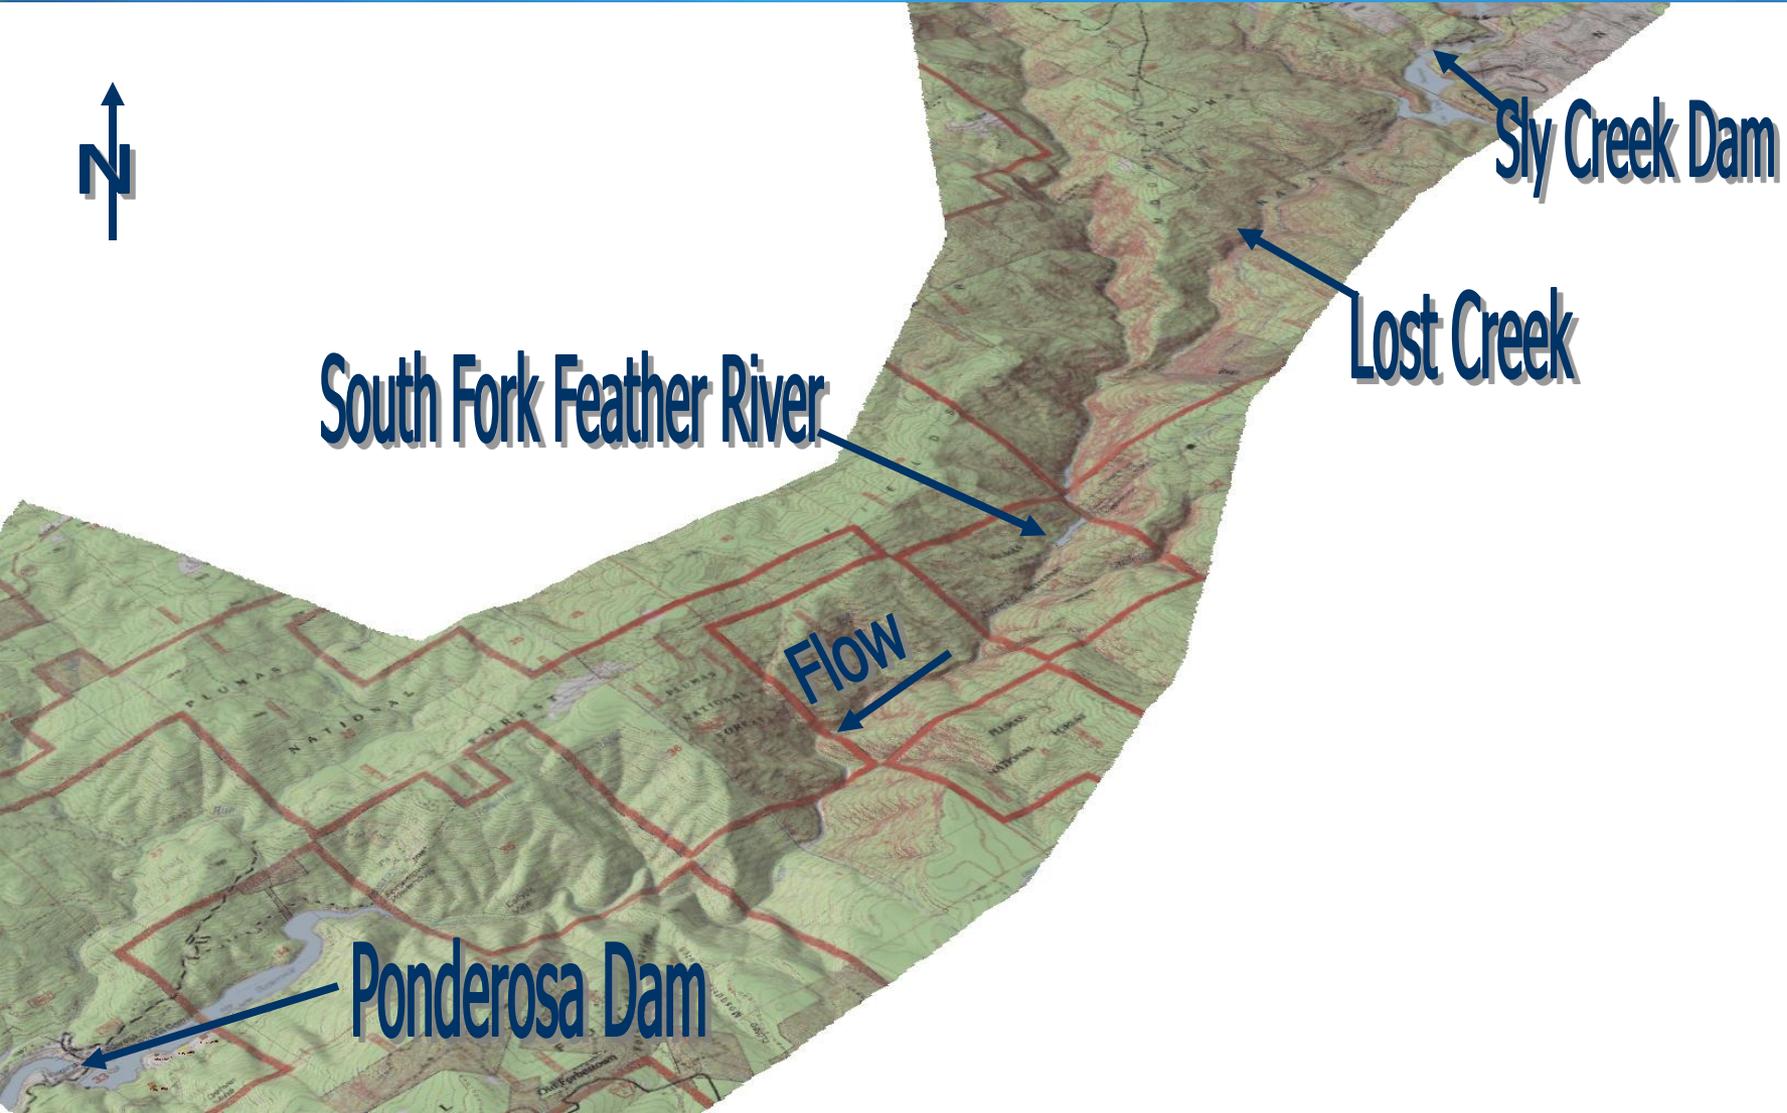
Sly Creek Dam

Lost Creek

South Fork Feather River

Flow

Ponderosa Dam

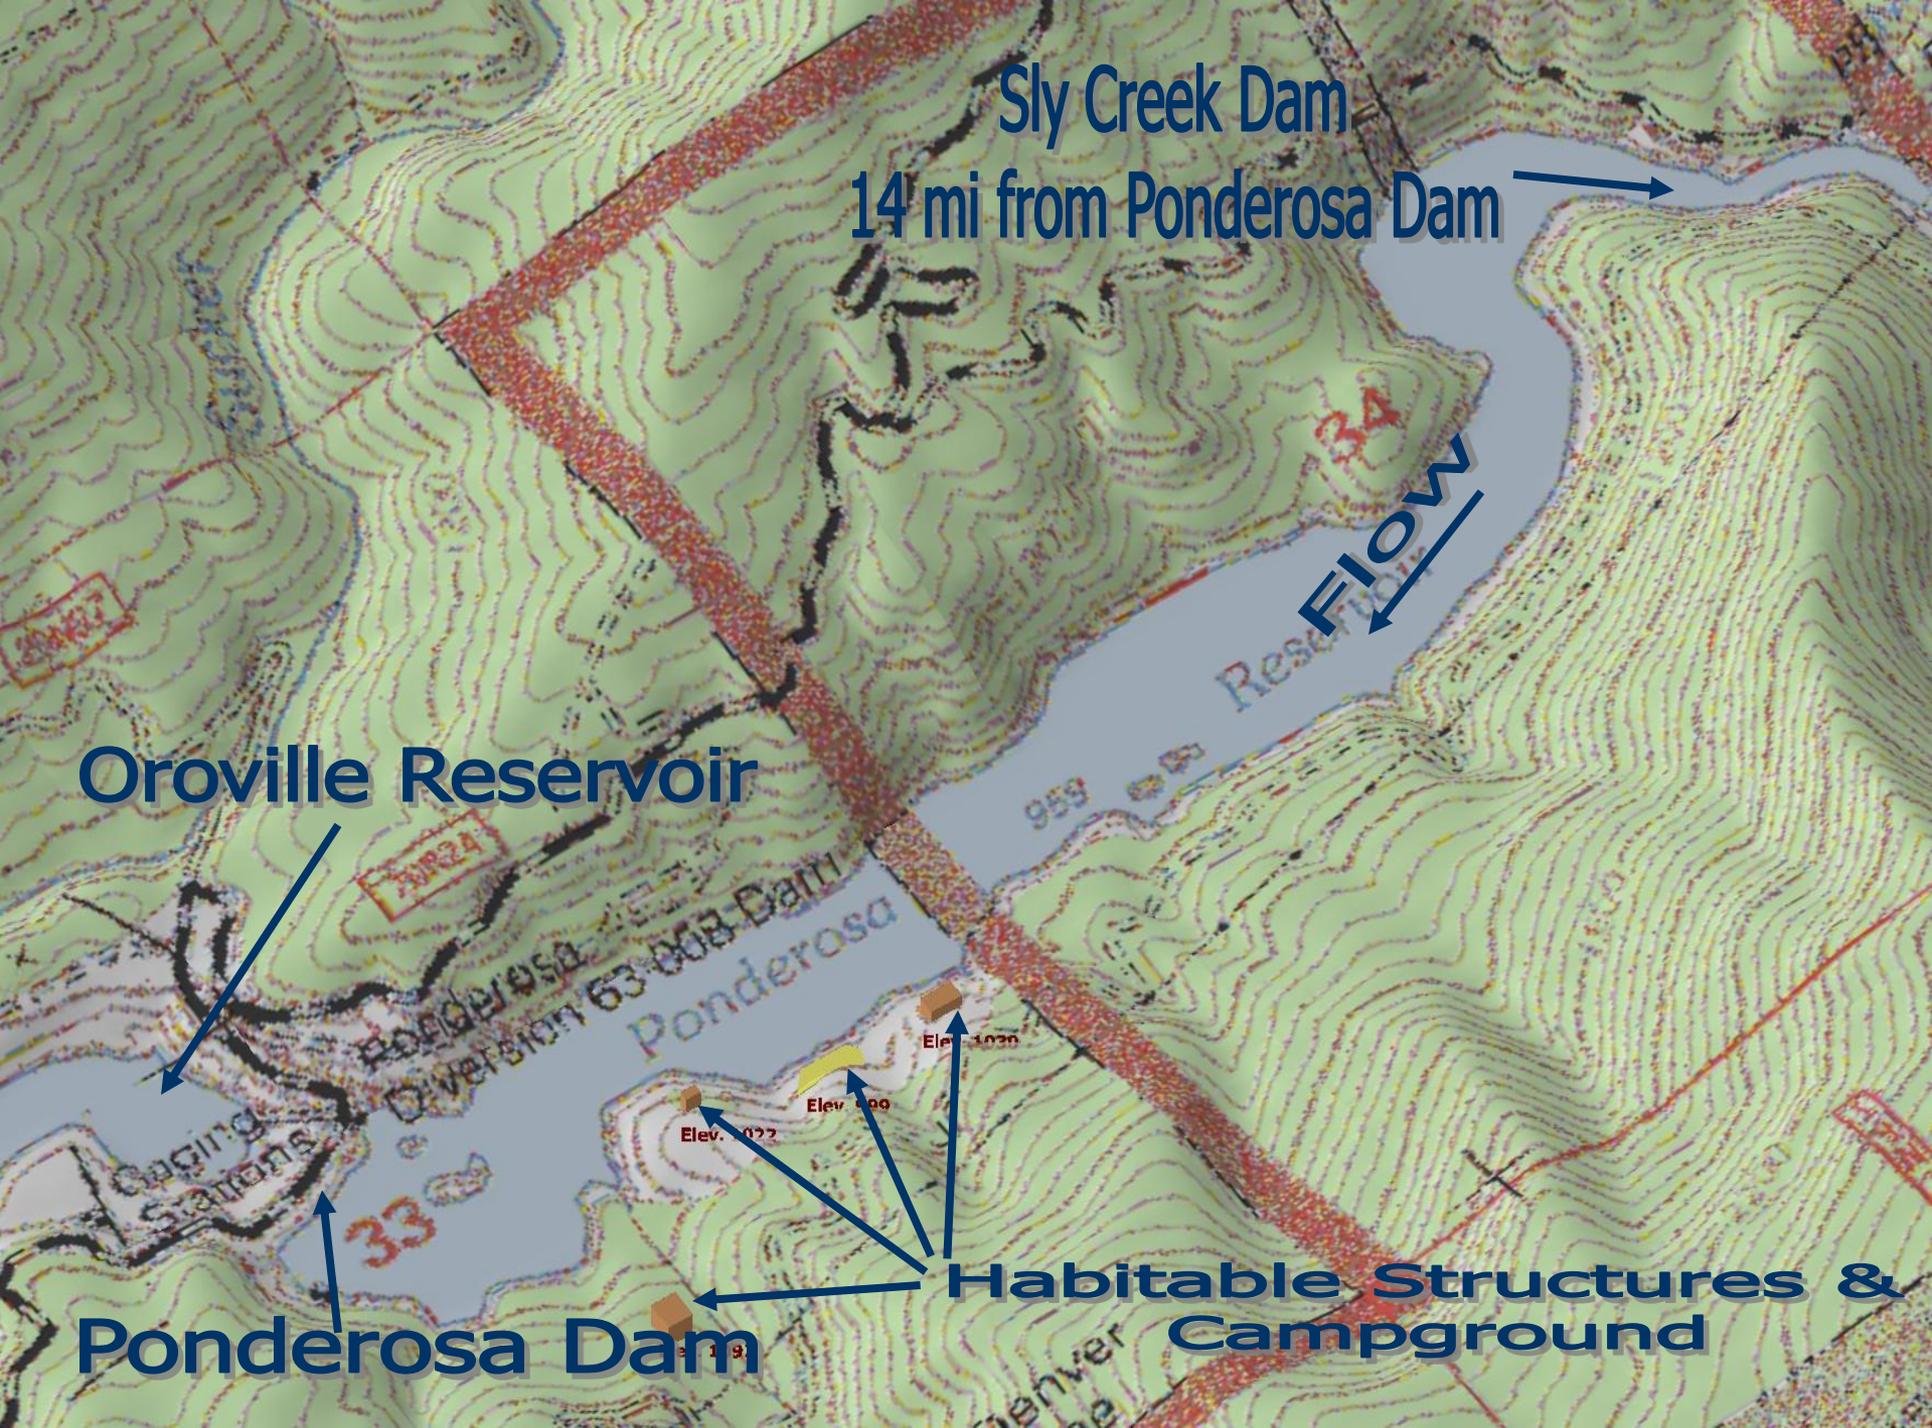
HEC-RAS & GeoRAS

Sly Creek Dam

14 mi from Ponderosa Dam

FLOW

Oroville Reservoir

Ponderosa Dam

Habitable Structures & Campground

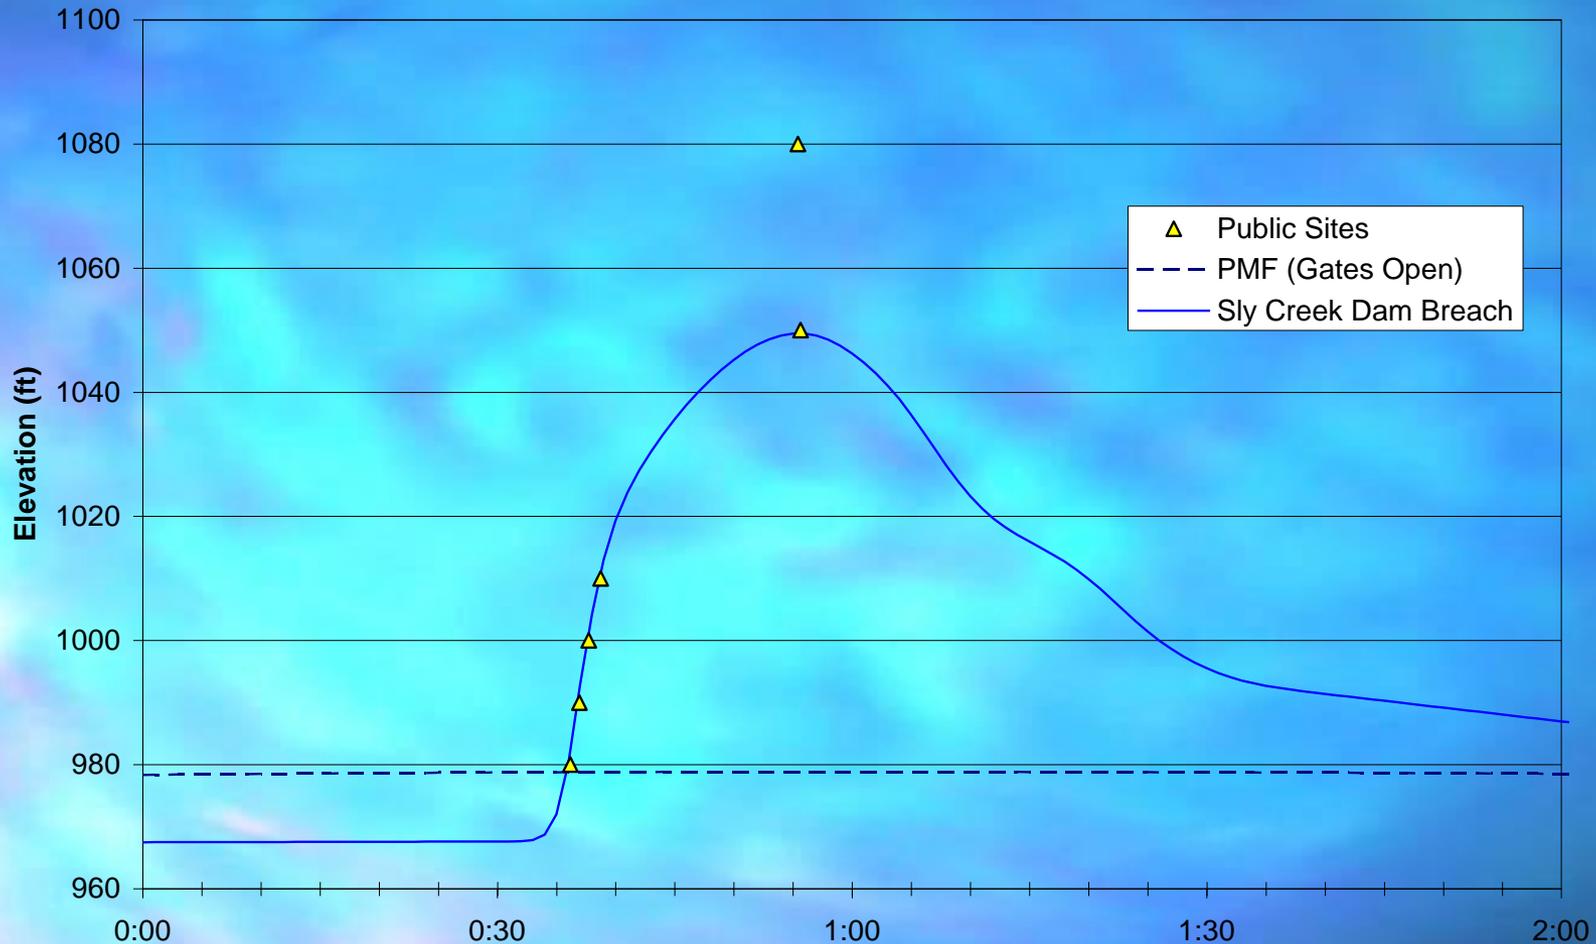
Flood Arrival Time at Ponderosa Reservoir

Graph of Sly Creek Dam IDF Results

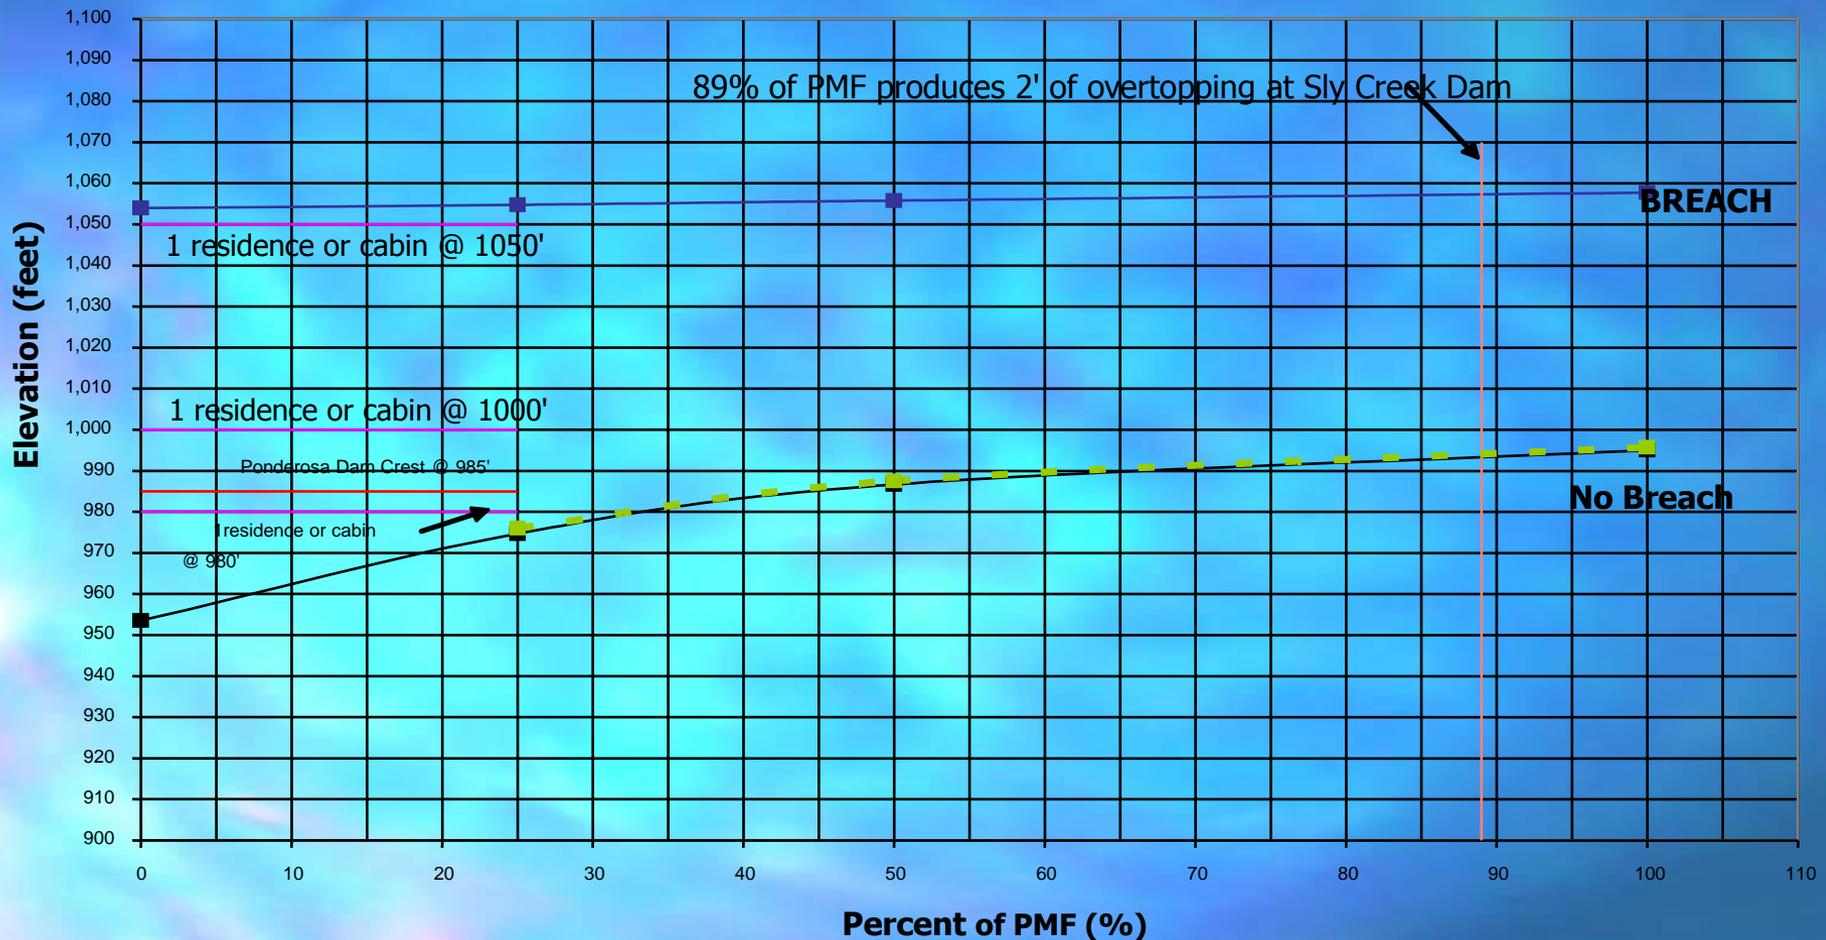
IDF Study Results

Sly Creek Dam

(Maximum Flood Stage at Ponderosa Reservoir)
