# What Can Owners Do to Prepare for RIDM?

RIDM Level 1 Workshop – Spring 2012

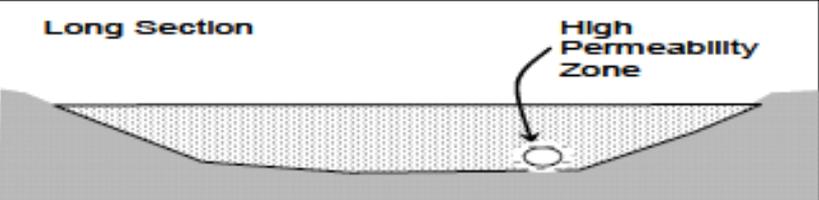
FM 18	Poorly compacted or high permeability zone around a conduit through the embankment

<p>Long Section</p> <p>High Permeability Zone</p>
FM 19A	Erosion into a (non-pressurized) conduit
