PLATE 2.1  
SITE TOPOGRAPHIC MAP  
TAUM SAUK PLANT  
UPPER RESERVOIR DIKE  
PREPARED FOR  
FOLEY & LARDNER LLP  
MILWAUKEE, WISCONSIN

PLATE 3.1  
BREACH AREA FOUNDATION  
GEOLOGIC MAP  
TAUM SAUK PLANT  
UPPER RESERVOIR DIKE  
PREPARED FOR  
FOLEY & LARDNER LLP  
MILWAUKEE, WISCONSIN

PLATE 3.2  
BREACH AREA FOUNDATION  
ENGINEERING PROPERTIES MAP  
TAUM SAUK PLANT  
UPPER RESERVOIR DIKE  
PREPARED FOR  
FOLEY & LARDNER LLP  
MILWAUKEE, WISCONSIN

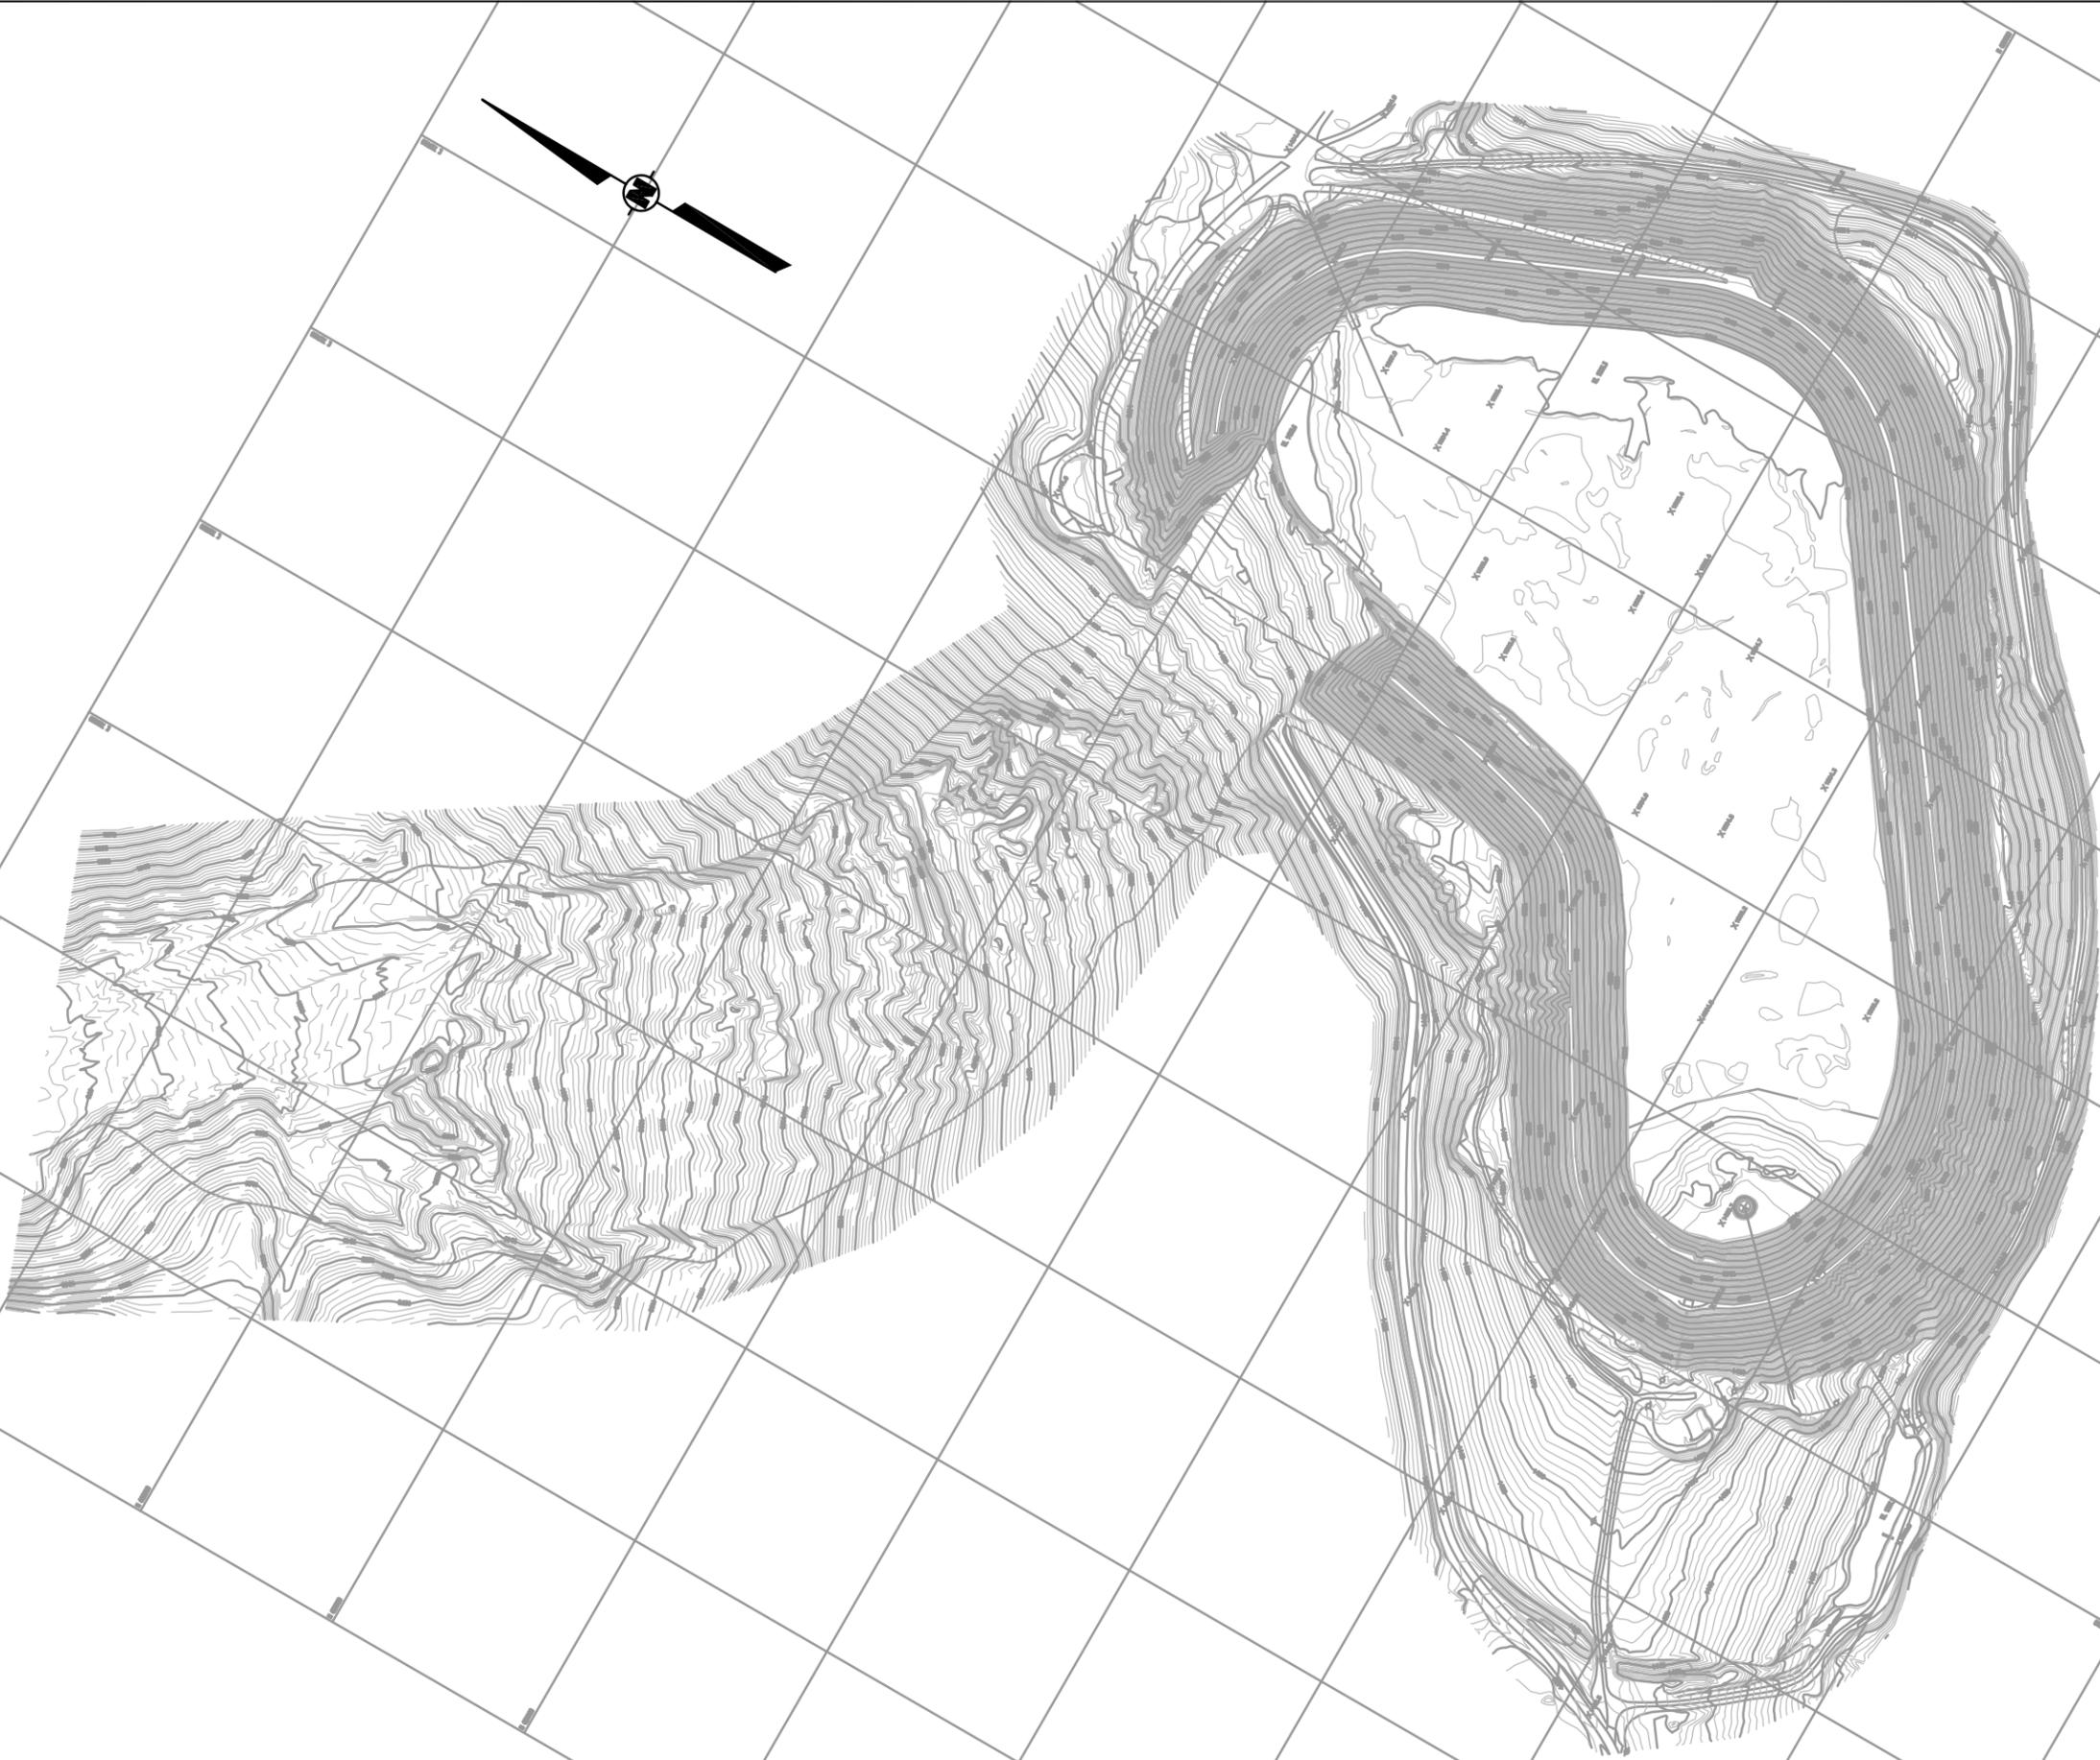
REFERENCE:  
TOPO TAKEN FROM SURDEX CORPORATION, JOB NO. 1501211/62  
DRAWING TAUM SAUK RESERVOIR SHEET 1 OF 1. DATE OF  
PHOTOGRAPHY 12/19/2005

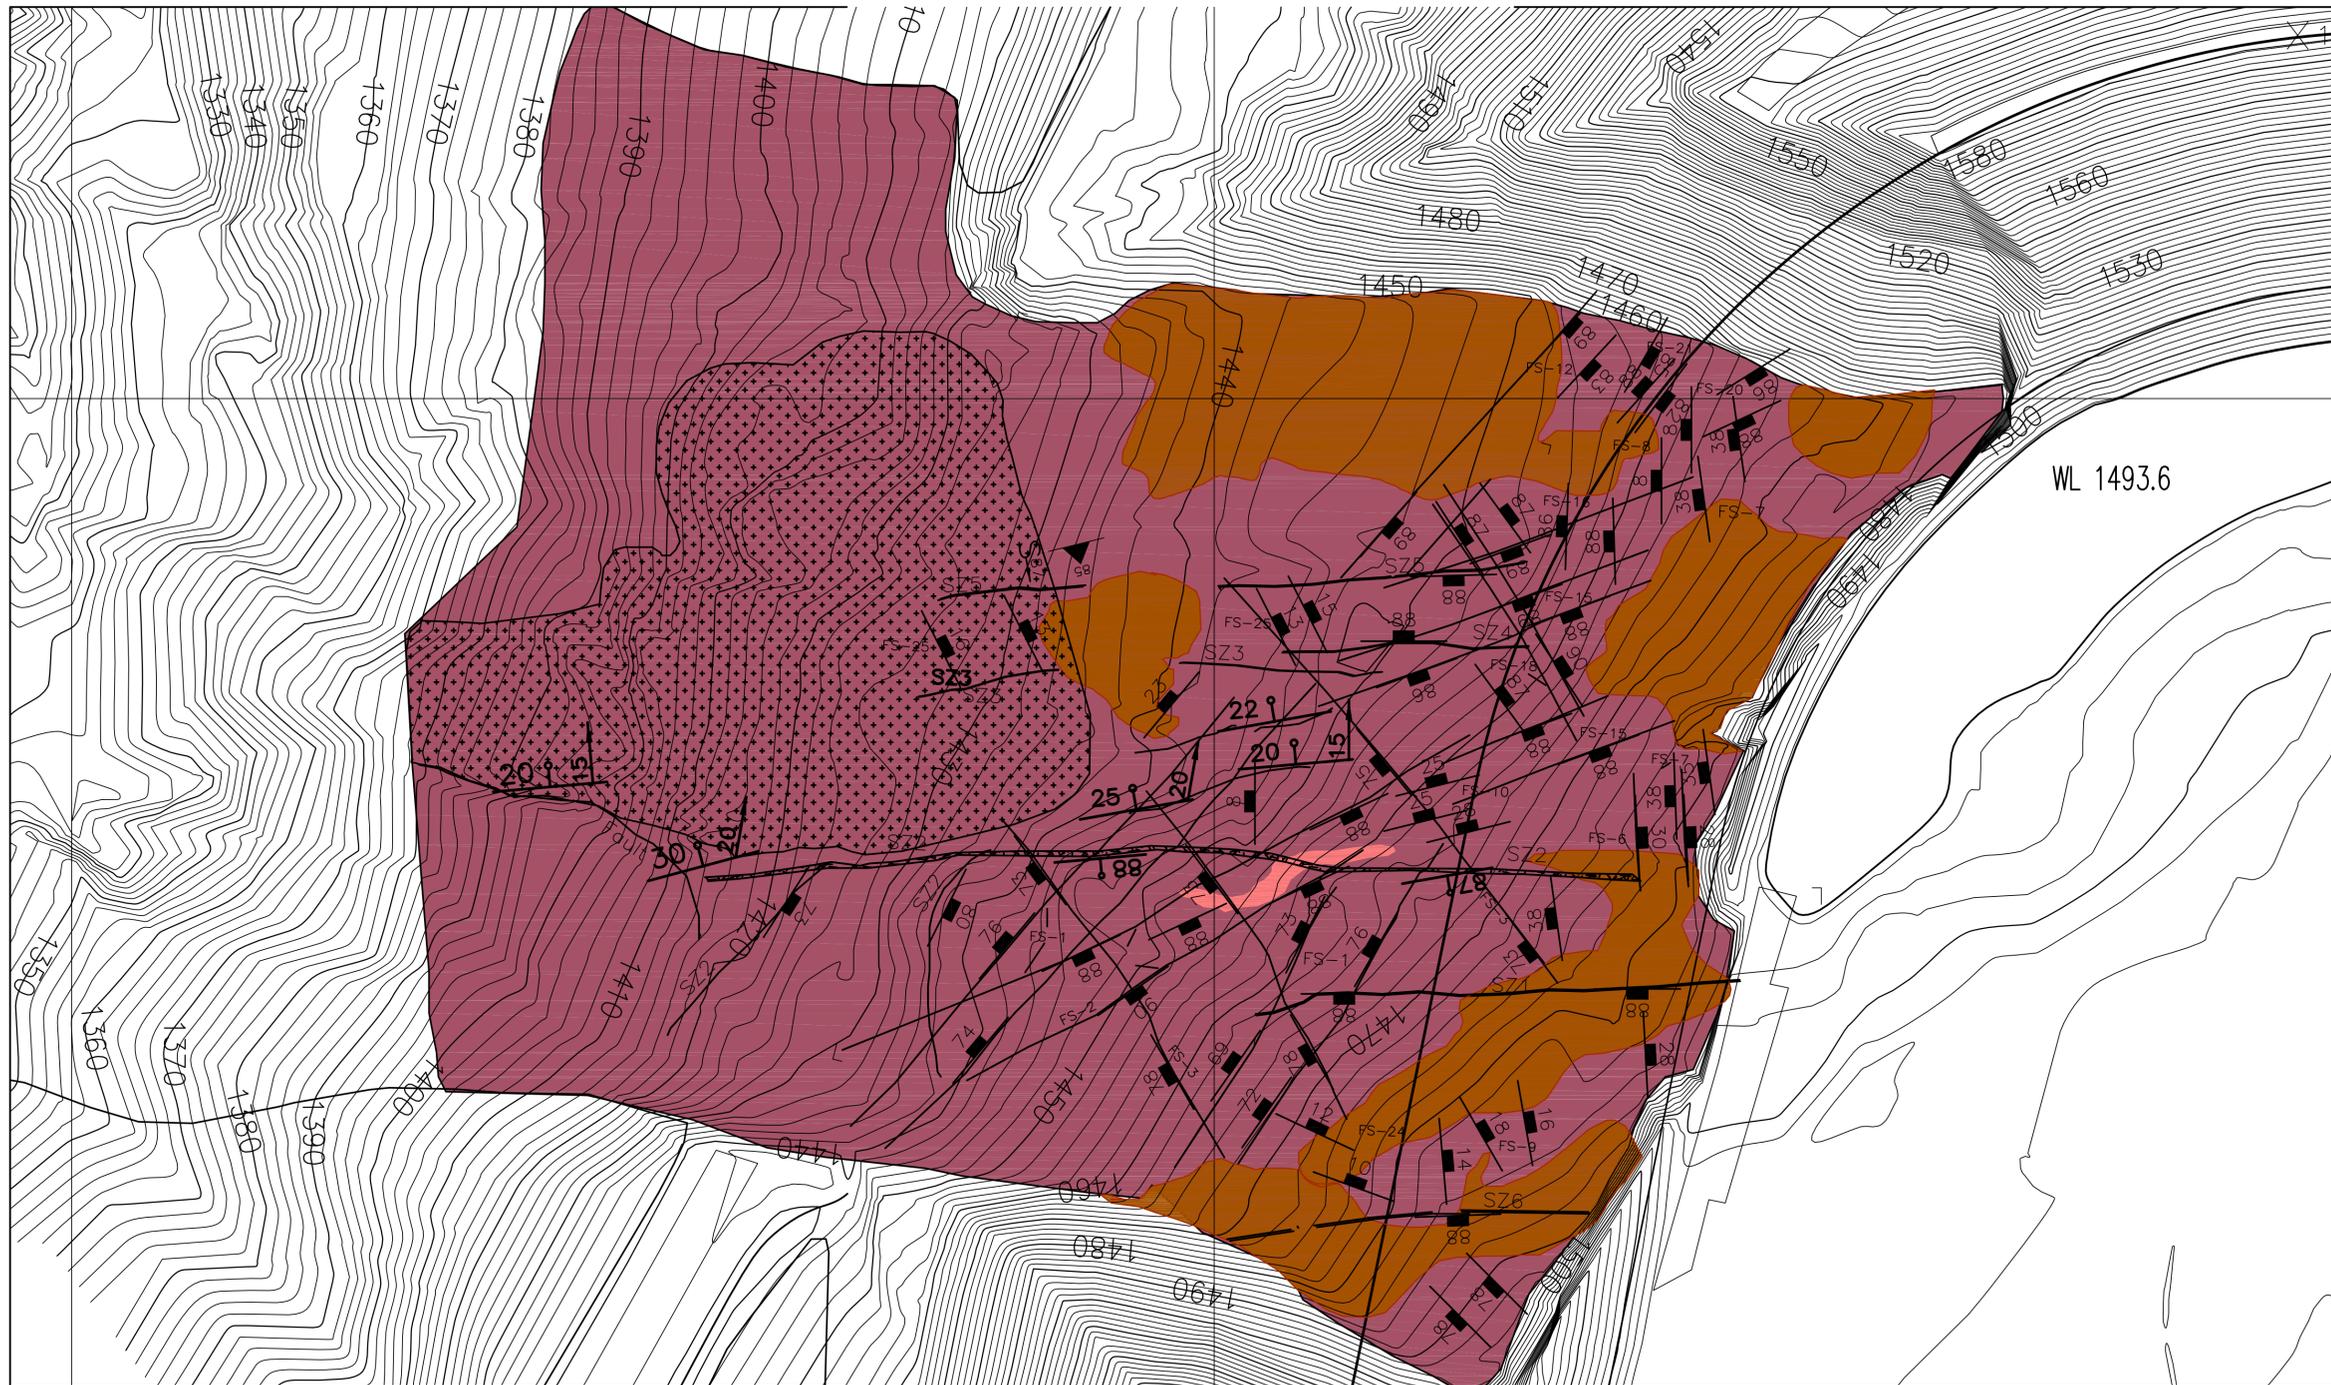
- RHY1-PORPHYRITIC RHYOLITE, very dark red to very dusky purple, aphanitic groundmass with 0.5-5mm feldspar phenocrysts, 0.5-2mm quartz phenocrysts, hard to very hard when fresh or slightly weathered, moderately to intensely fractured, 60% of mapped area is exposure of fresh to slightly weathered rock, 20% highly weathered rock, and 20% residual soil.
- RHY2- RHYOLITE, aphanitic, light red to moderate pink, fresh to slightly weathered, hard to very hard.
- SOIL - residual and/or detrital soil. Residual soil contains abundant roots and is silt with clay (plasticity not noted). Detritus includes 1-6 inch rocks pressed into silt with clay. Soil is 0.1 to 1.6 feet thick. Some zones grade into weathered rock, approximately 20% of foundation area is covered with soil.
- BR - Breccia/damage zone.
- BZ - "Baked" zone recrystallized by contact metamorphism.

- FEATURE TYPE (F=Fracture, SZ=shear zone, sense of offset not determined)
- ^ F-22 - GEOLOGIC FEATURE NUMBERS (NOTE: Descriptions included in tables)
- ∇ FEATURE NUMBER
- Dip and dip direction of banding.
  - Dip and dip direction of fracture.
  - Dip and dip direction of inclined fault.
  - Left lateral apparent offset.
  - Right lateral apparent offset.
  - Plunge and plunge direction of slickensides.

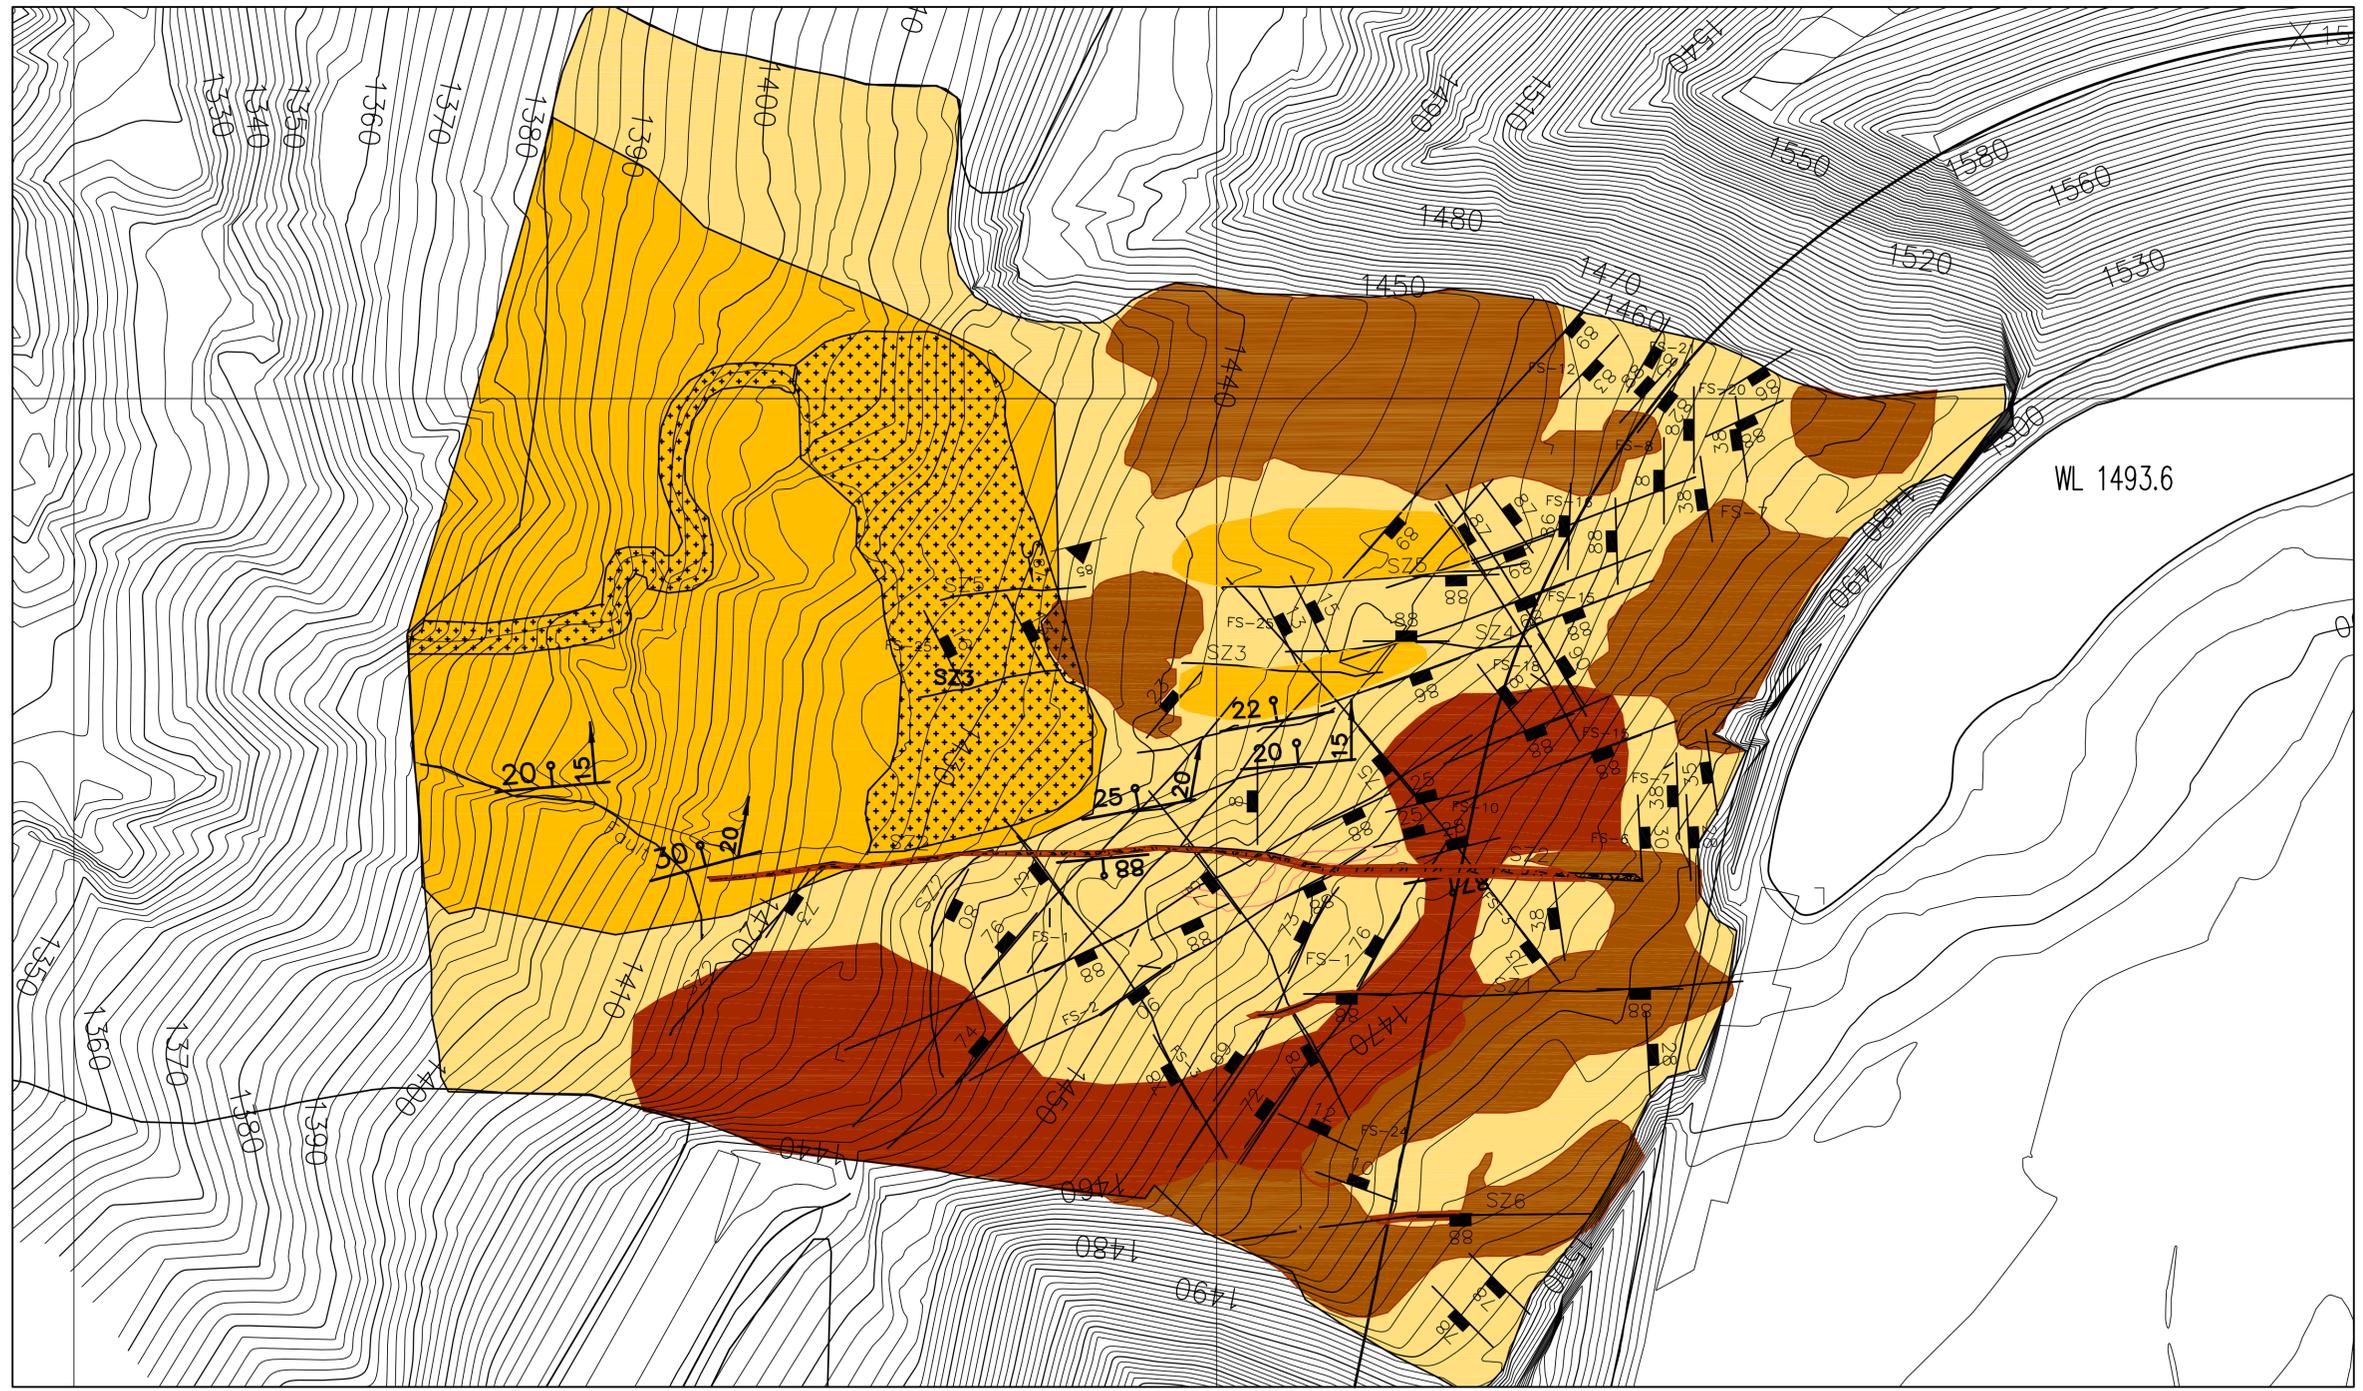
- GOOD ROCK, Rock Mass Rating RMR 80-61.
- FAIR ROCK, rock mass rating 60-41.
- POOR ROCK, rock mass rating 40-21.
- Soil; residual and/or detrital soil. Residual soil contains abundant roots and is silt with clay (plasticity not noted). Detritus includes 1-6 inch rocks pressed into silt with clay. Soil is 0.1 to 1.6 feet thick. Some zones grade into weathered rock, approximately 20% of foundation area is covered with soil.
- BR - Breccia/damage zone.
- BZ - "Baked" zone recrystallized by contact metamorphism.

- FEATURE TYPE (F=Fracture, SZ=shear zone, sense of offset not determined)
- ^ F-22 - GEOLOGIC FEATURE NUMBERS (NOTE: Descriptions included in tables)
- ∇ FEATURE NUMBER
- Dip and dip direction of banding.
  - Dip and dip direction of fracture.
  - Dip and dip direction of inclined fault.
  - Left lateral apparent offset.
  - Right lateral apparent offset.
  - Plunge and plunge direction of slickensides.

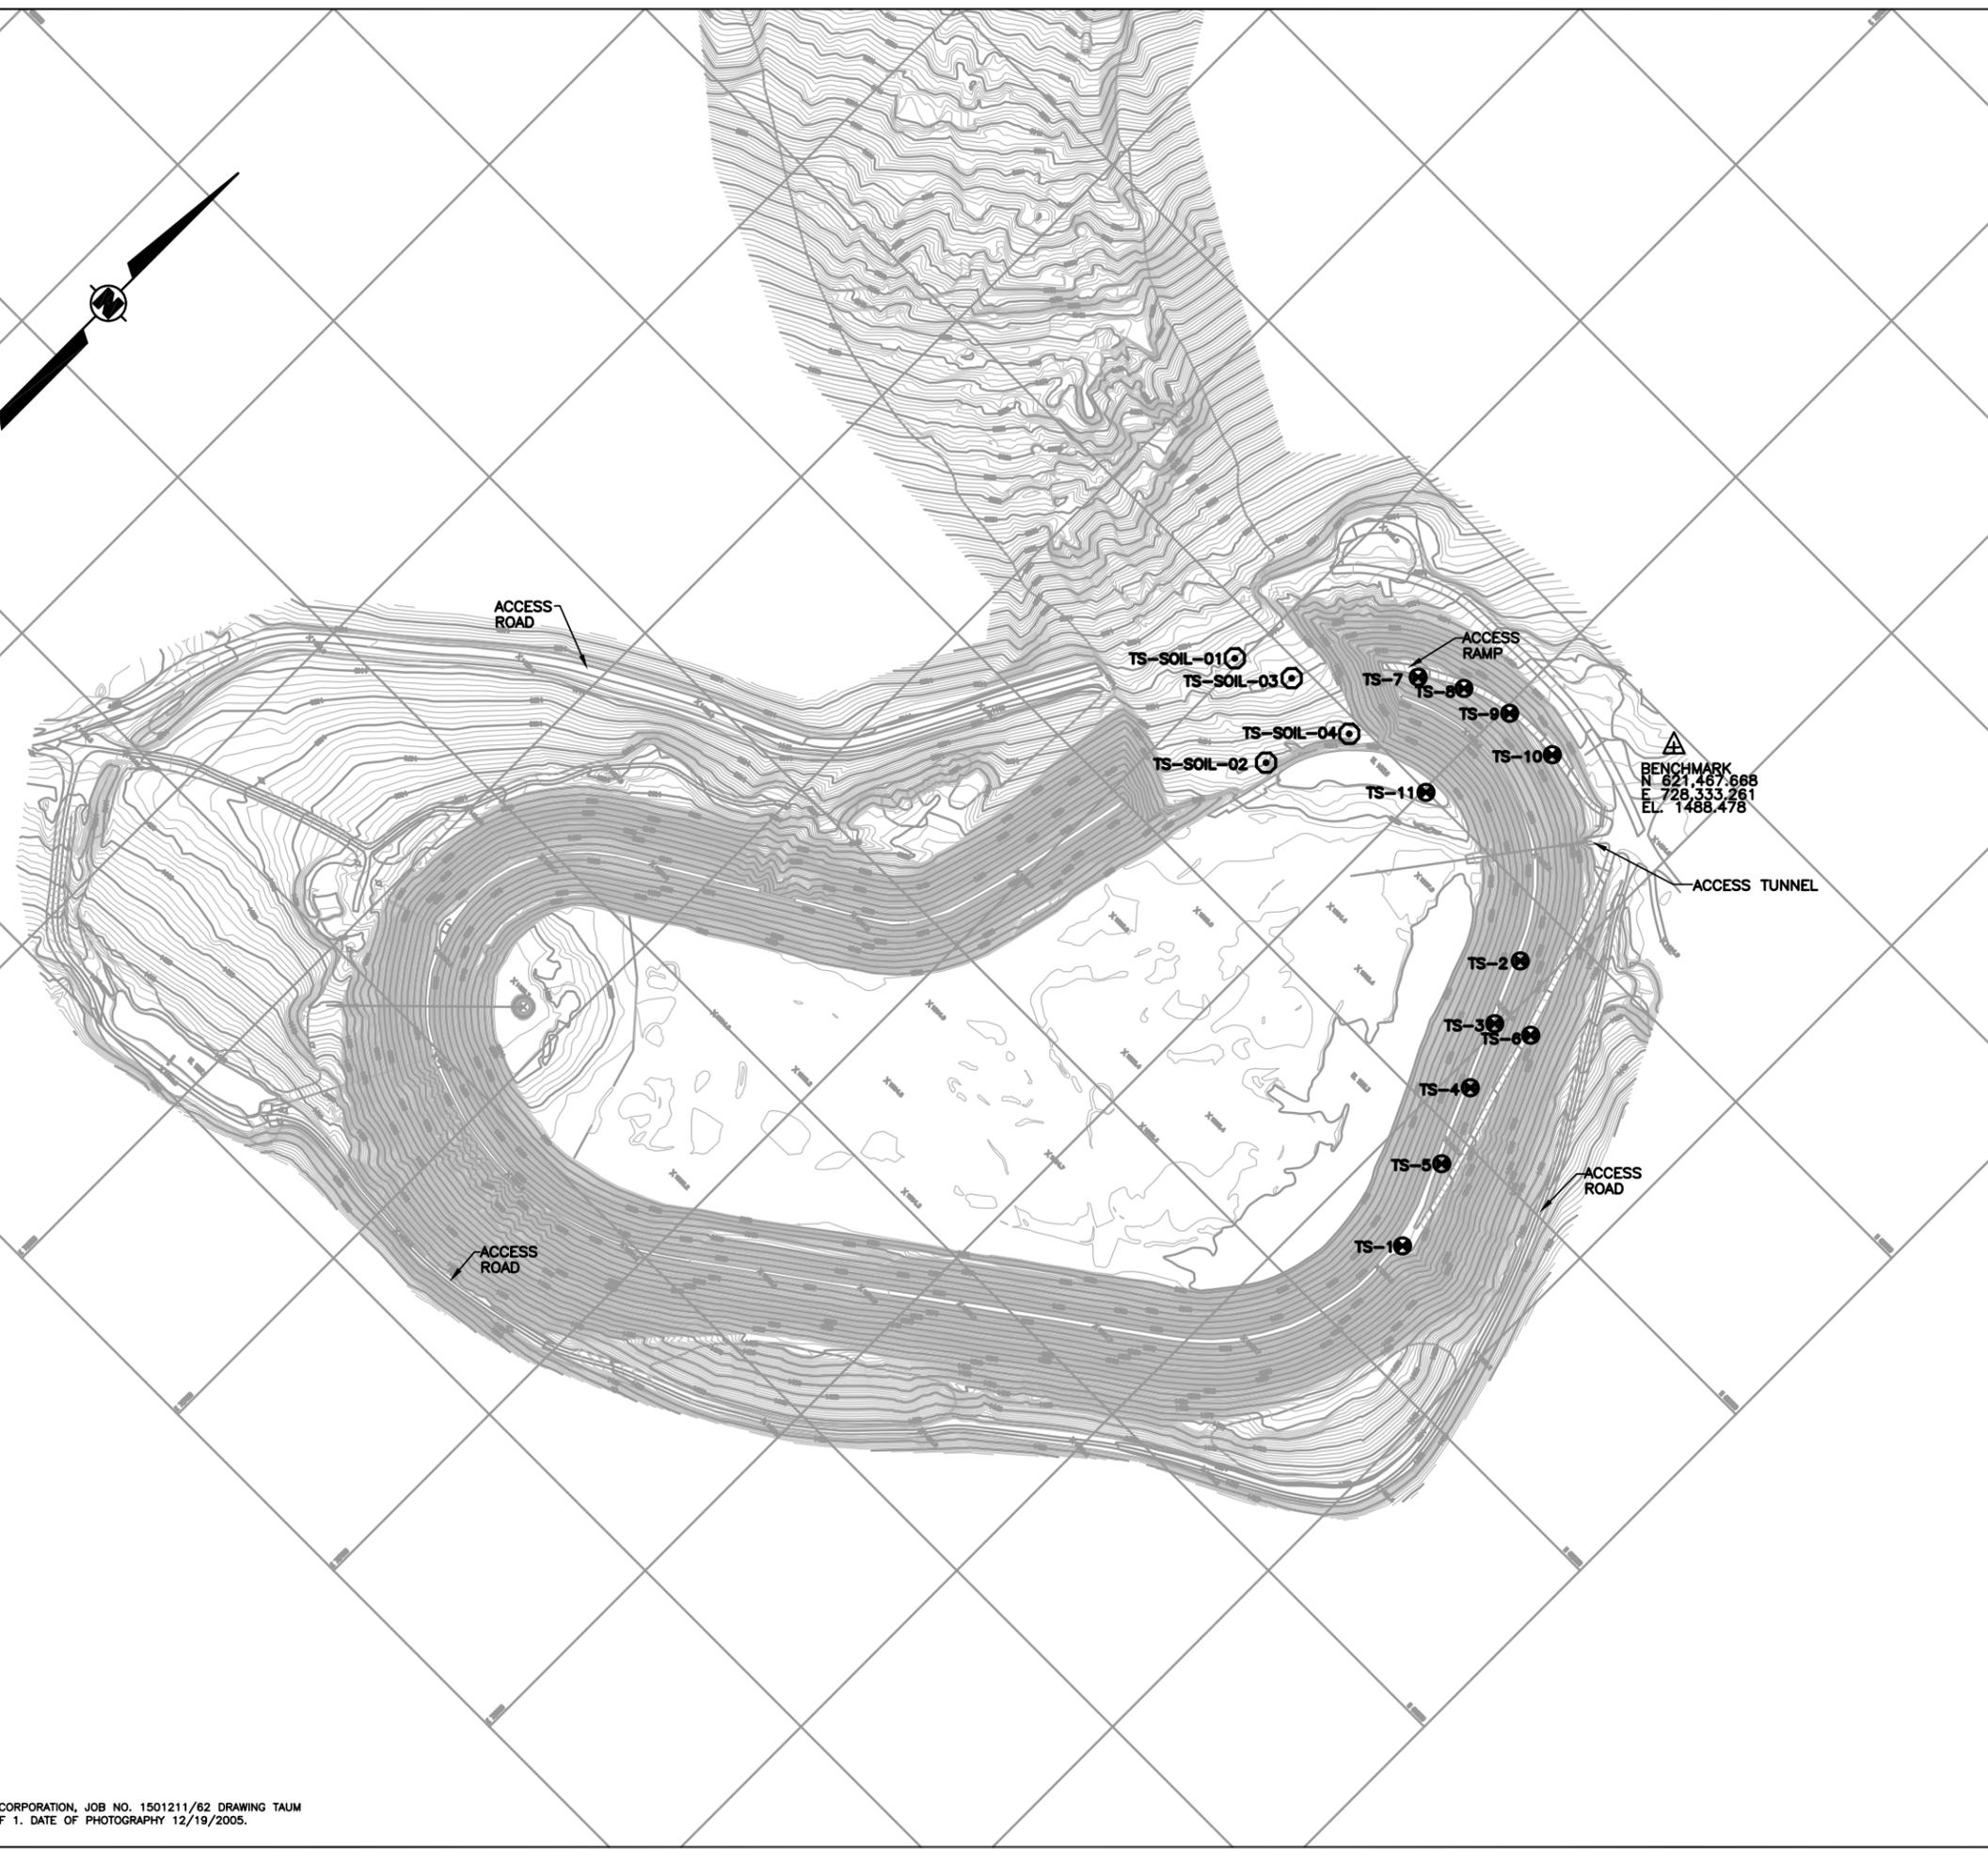
- TS-SOIL-01 PCRA SOIL SAMPLE LOCATION AND DESIGNATION
- TS-1 PCRA BORING LOCATION AND DESIGNATION
