Senior Leaders Dam Safety Seminar

FERC Dam Safety Program

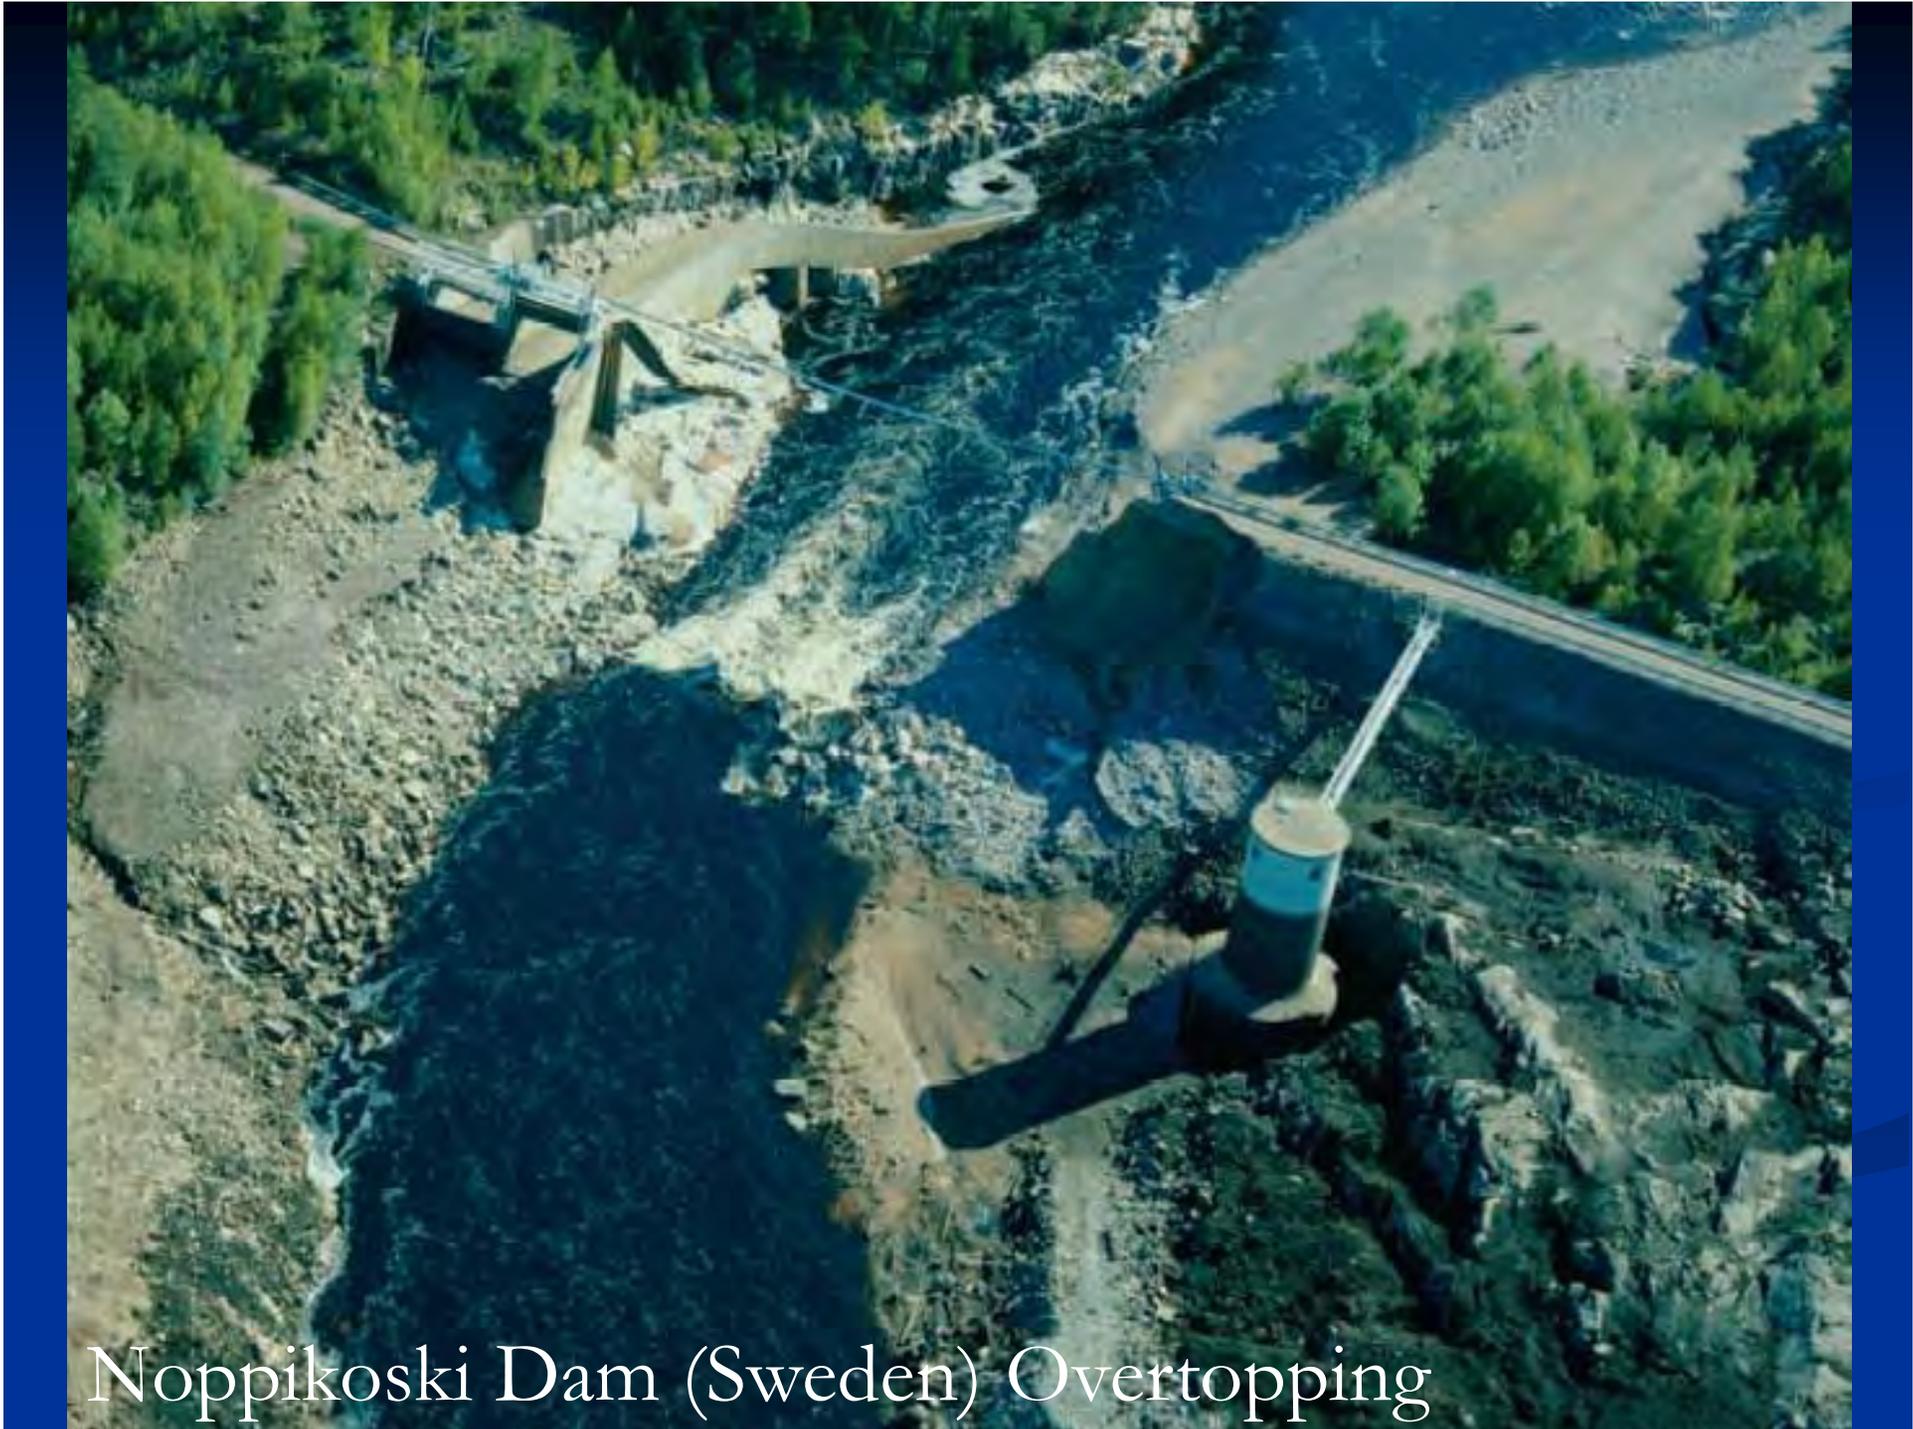
Noppikoski Dam (Sweden) Overtopping

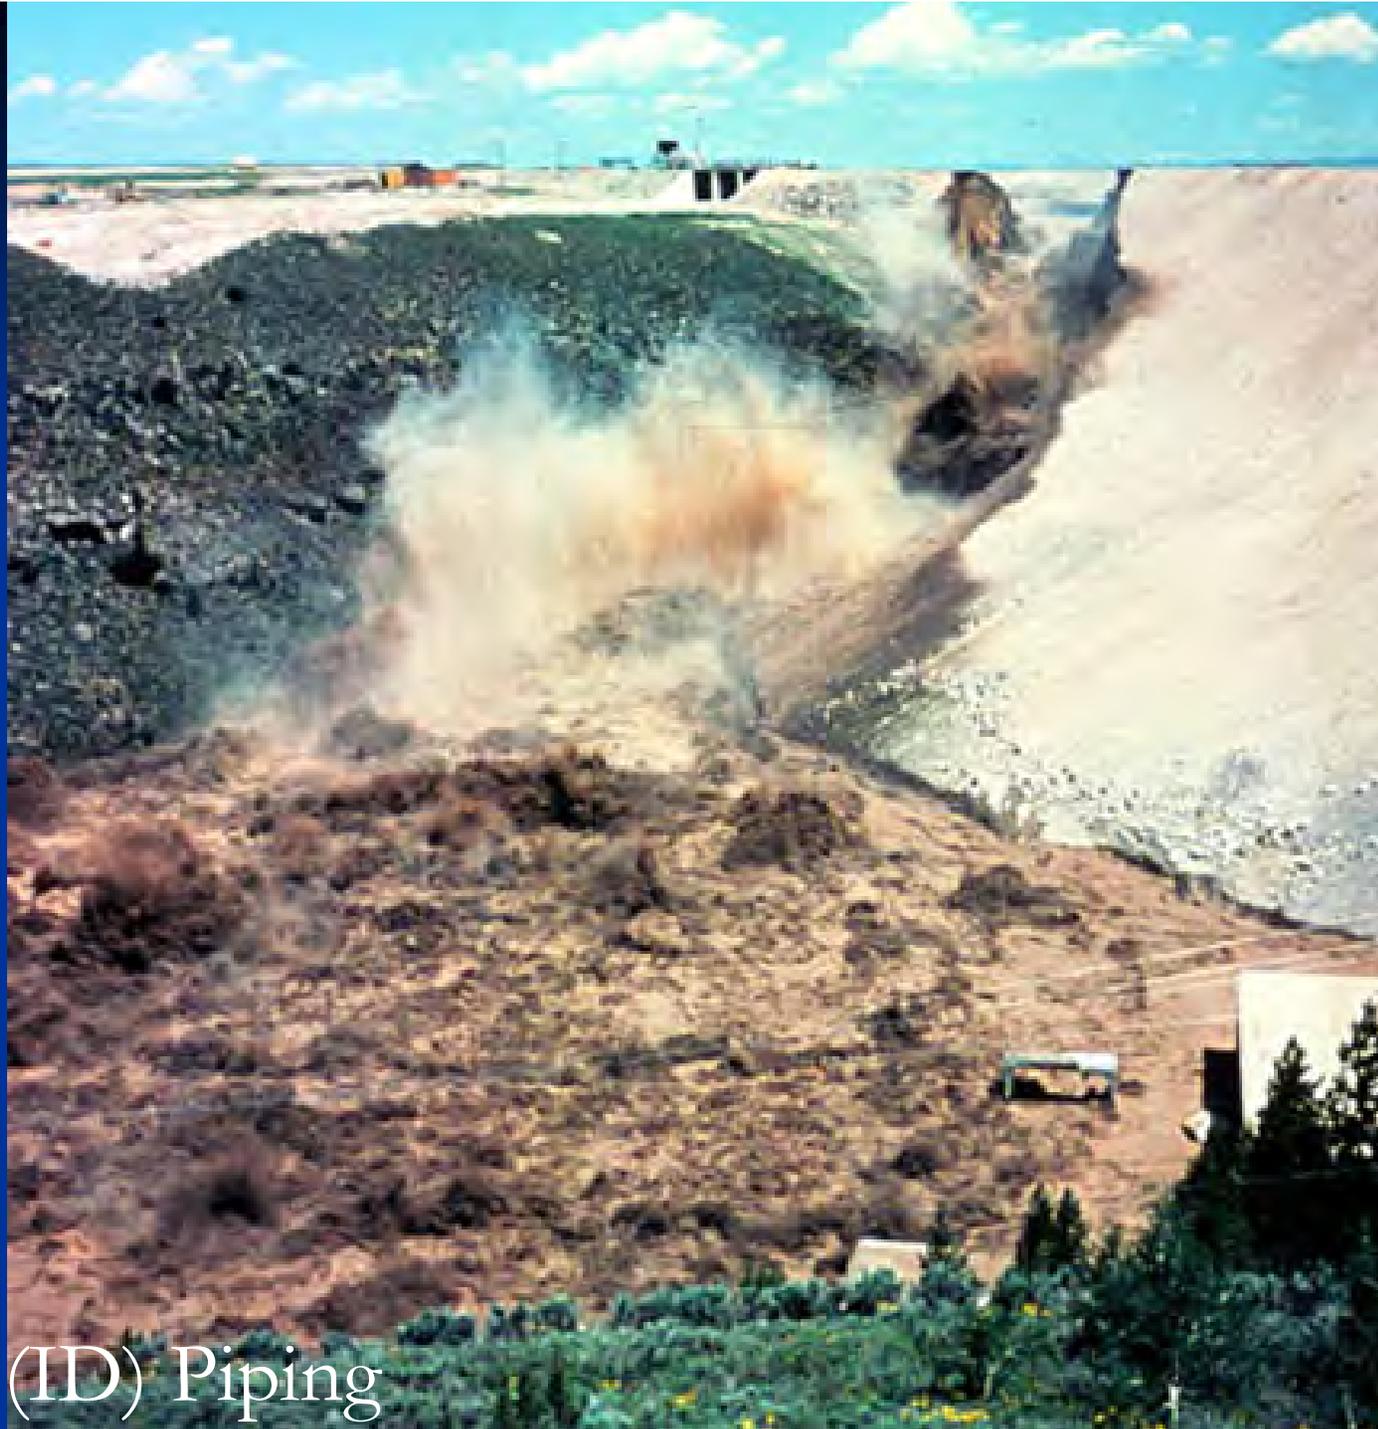
Teton (ID) Piping

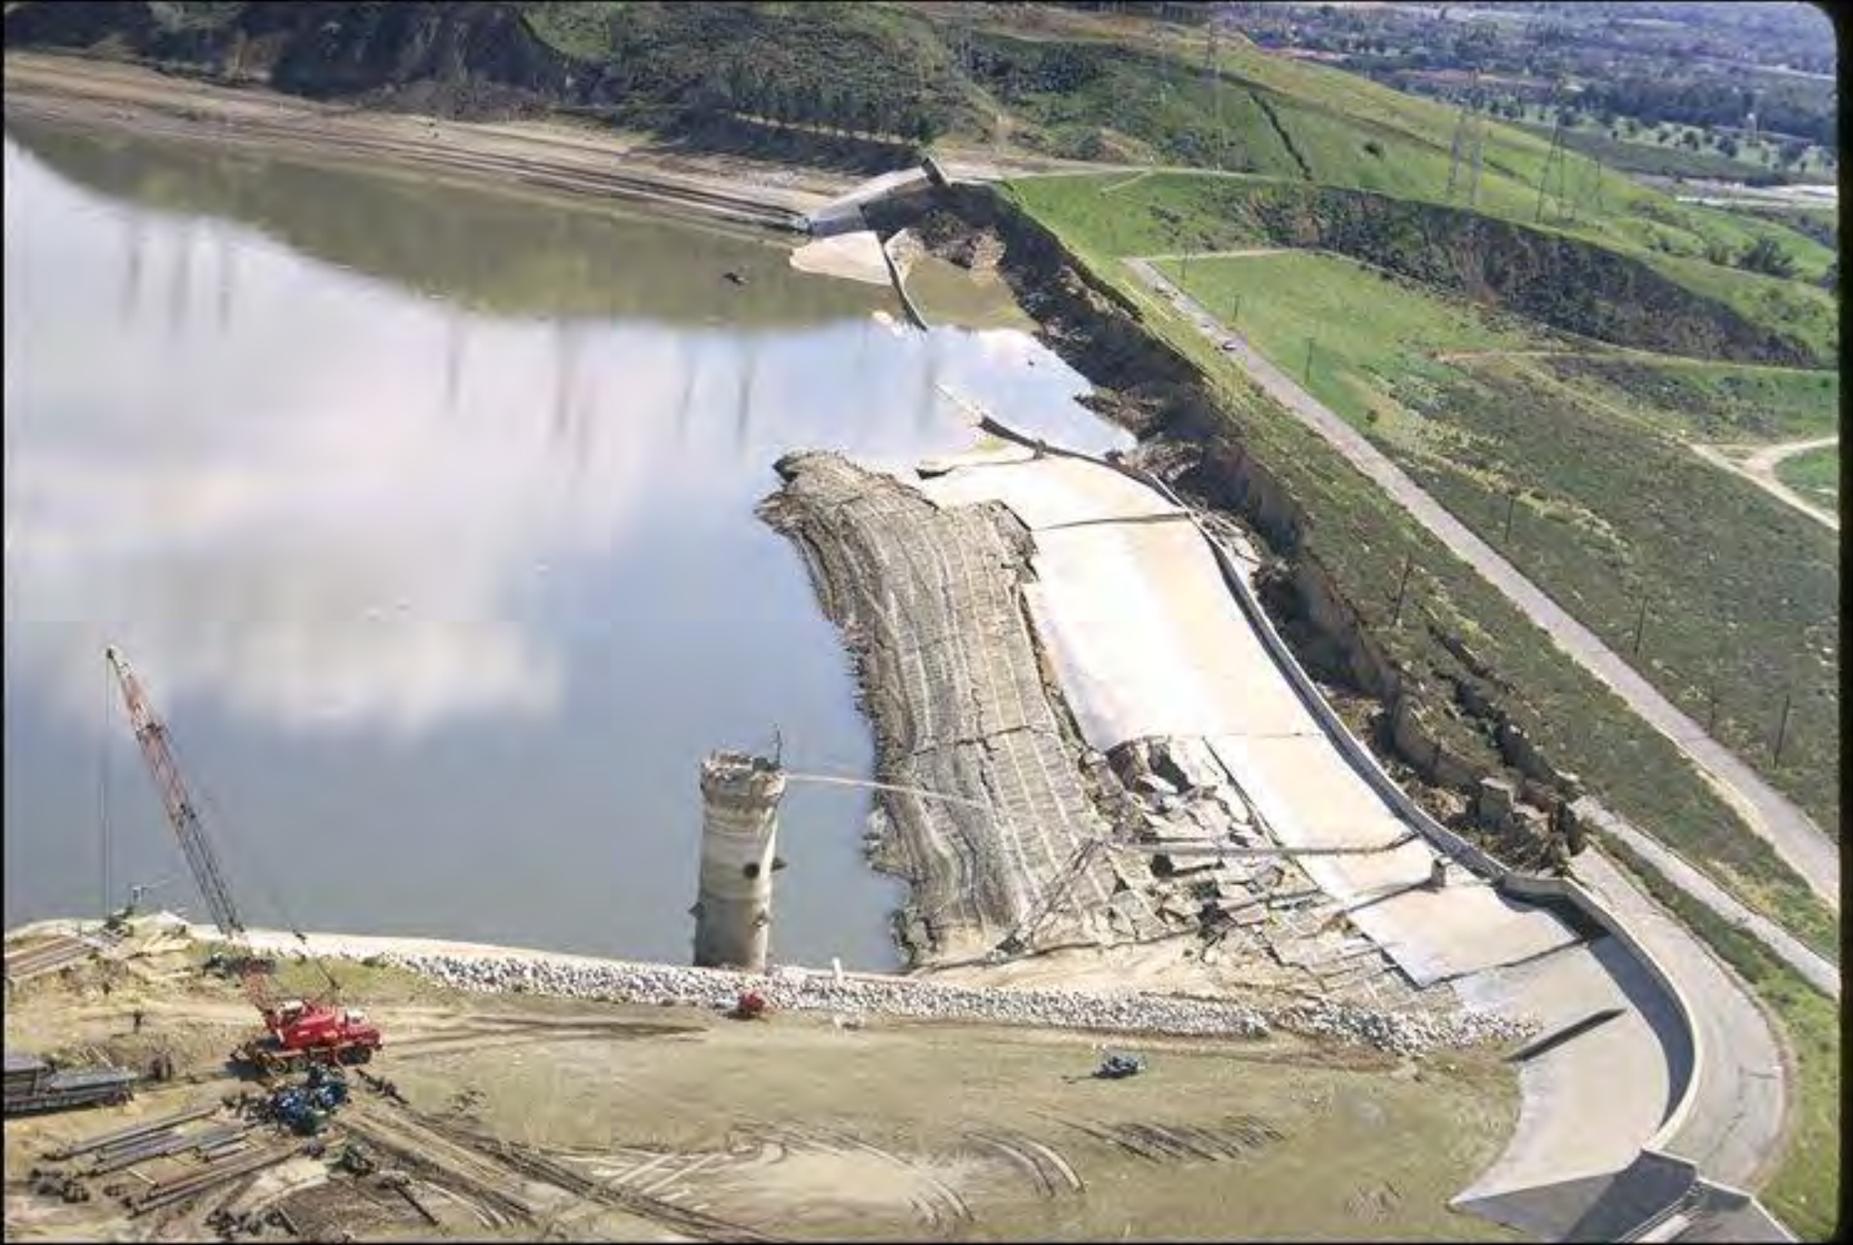
Lower San Fernando (CA) Liquefaction

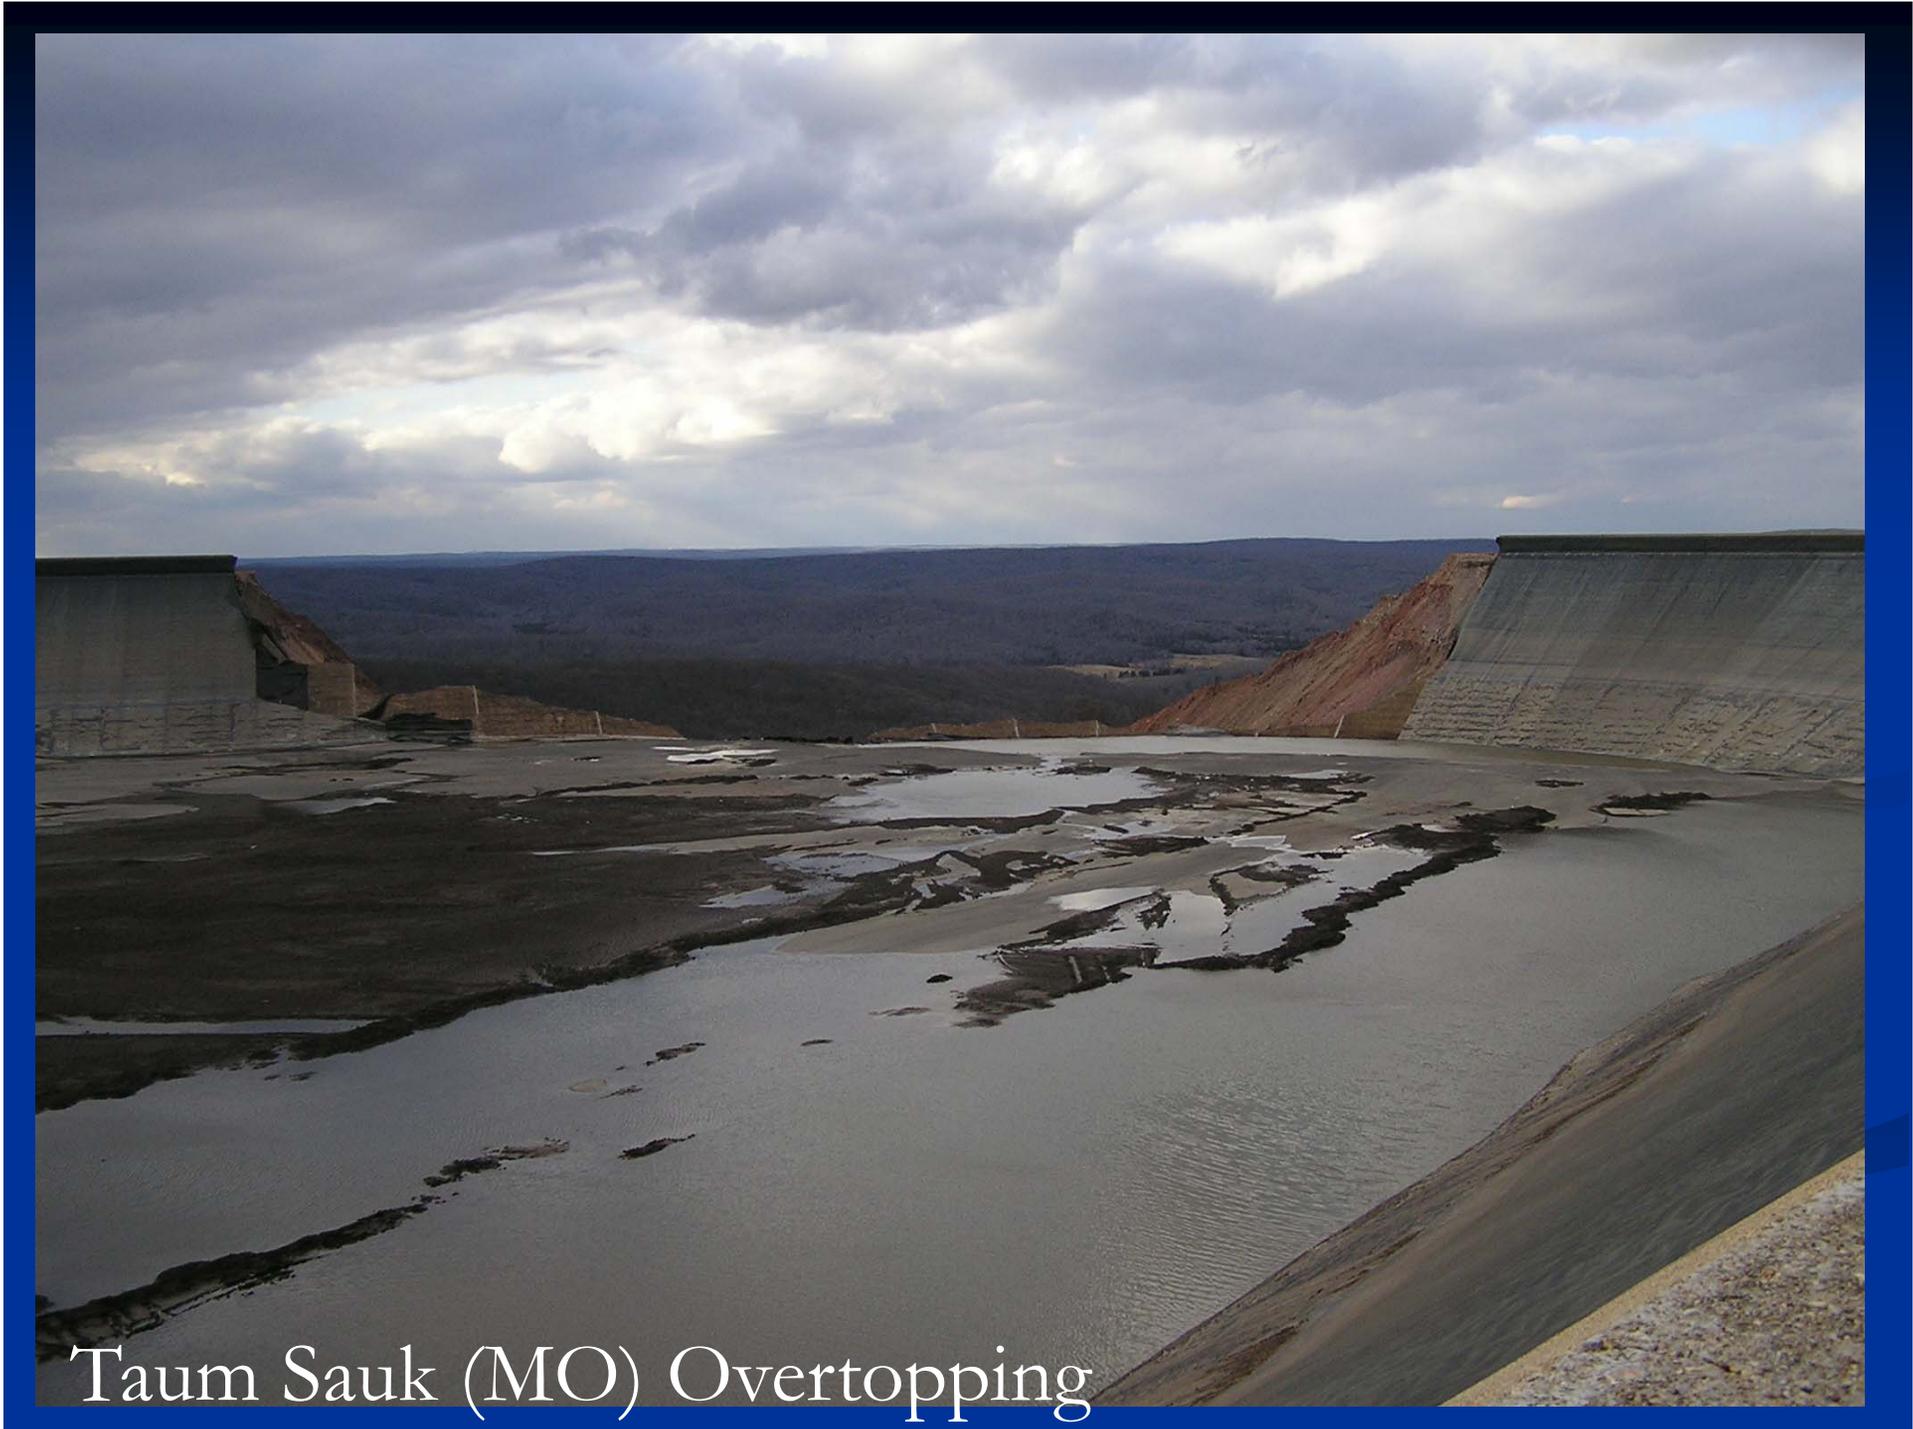
Taum Sauk (MO) Overtopping

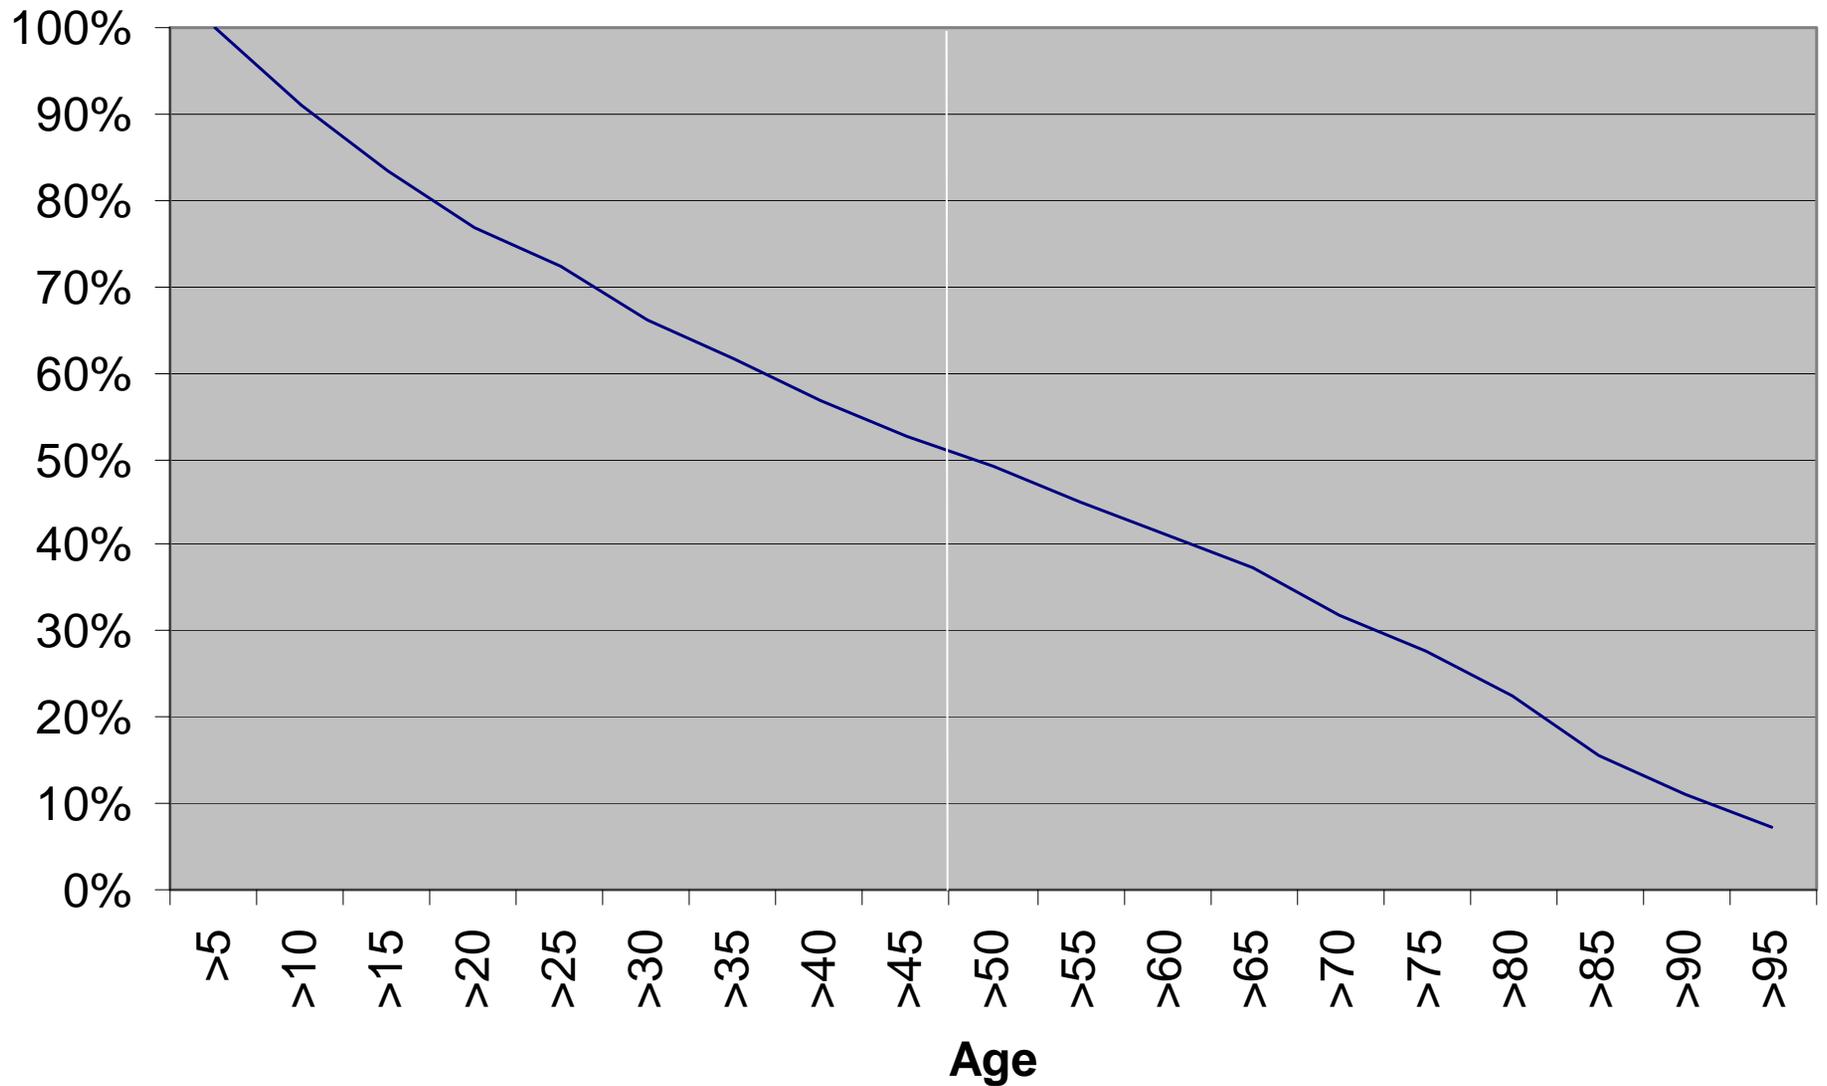
% of Incidents that Occur at an Age Greater Than All Dams that Survive their 1st Five Years

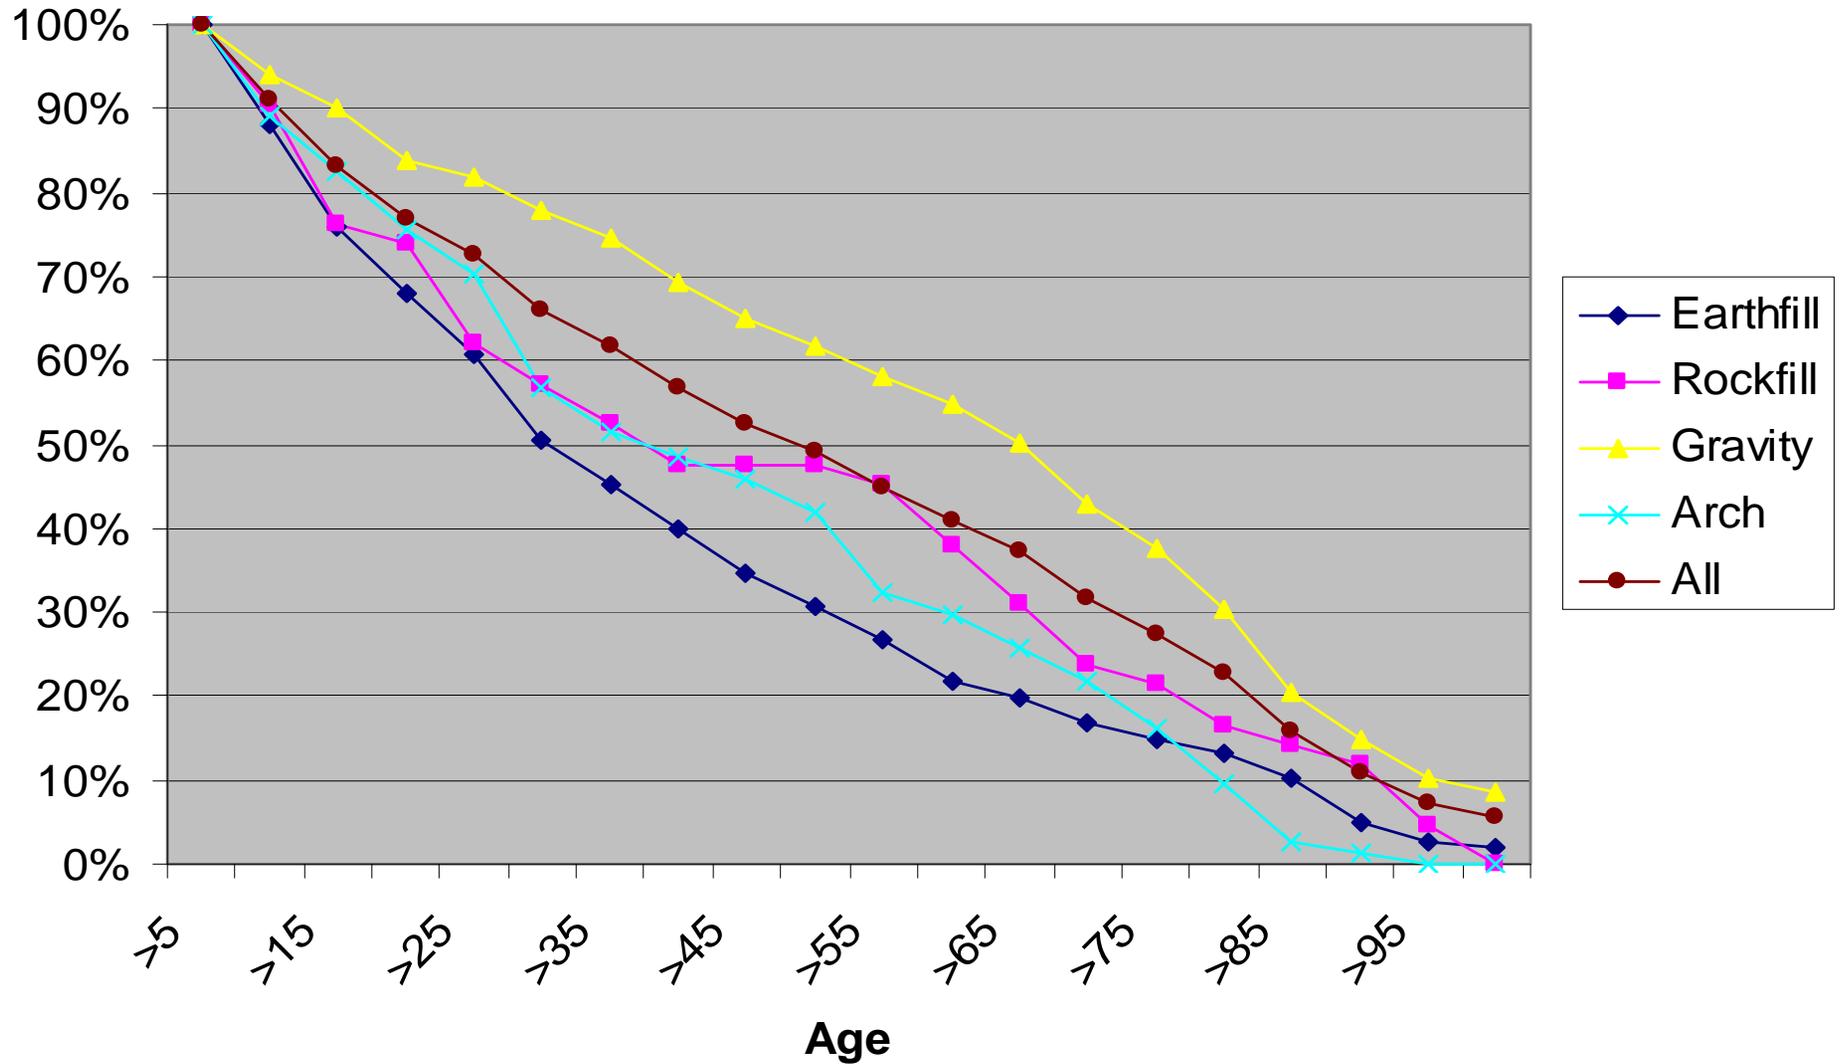
% of Incidents That Occur At An Age Greater Than By Type of Dam

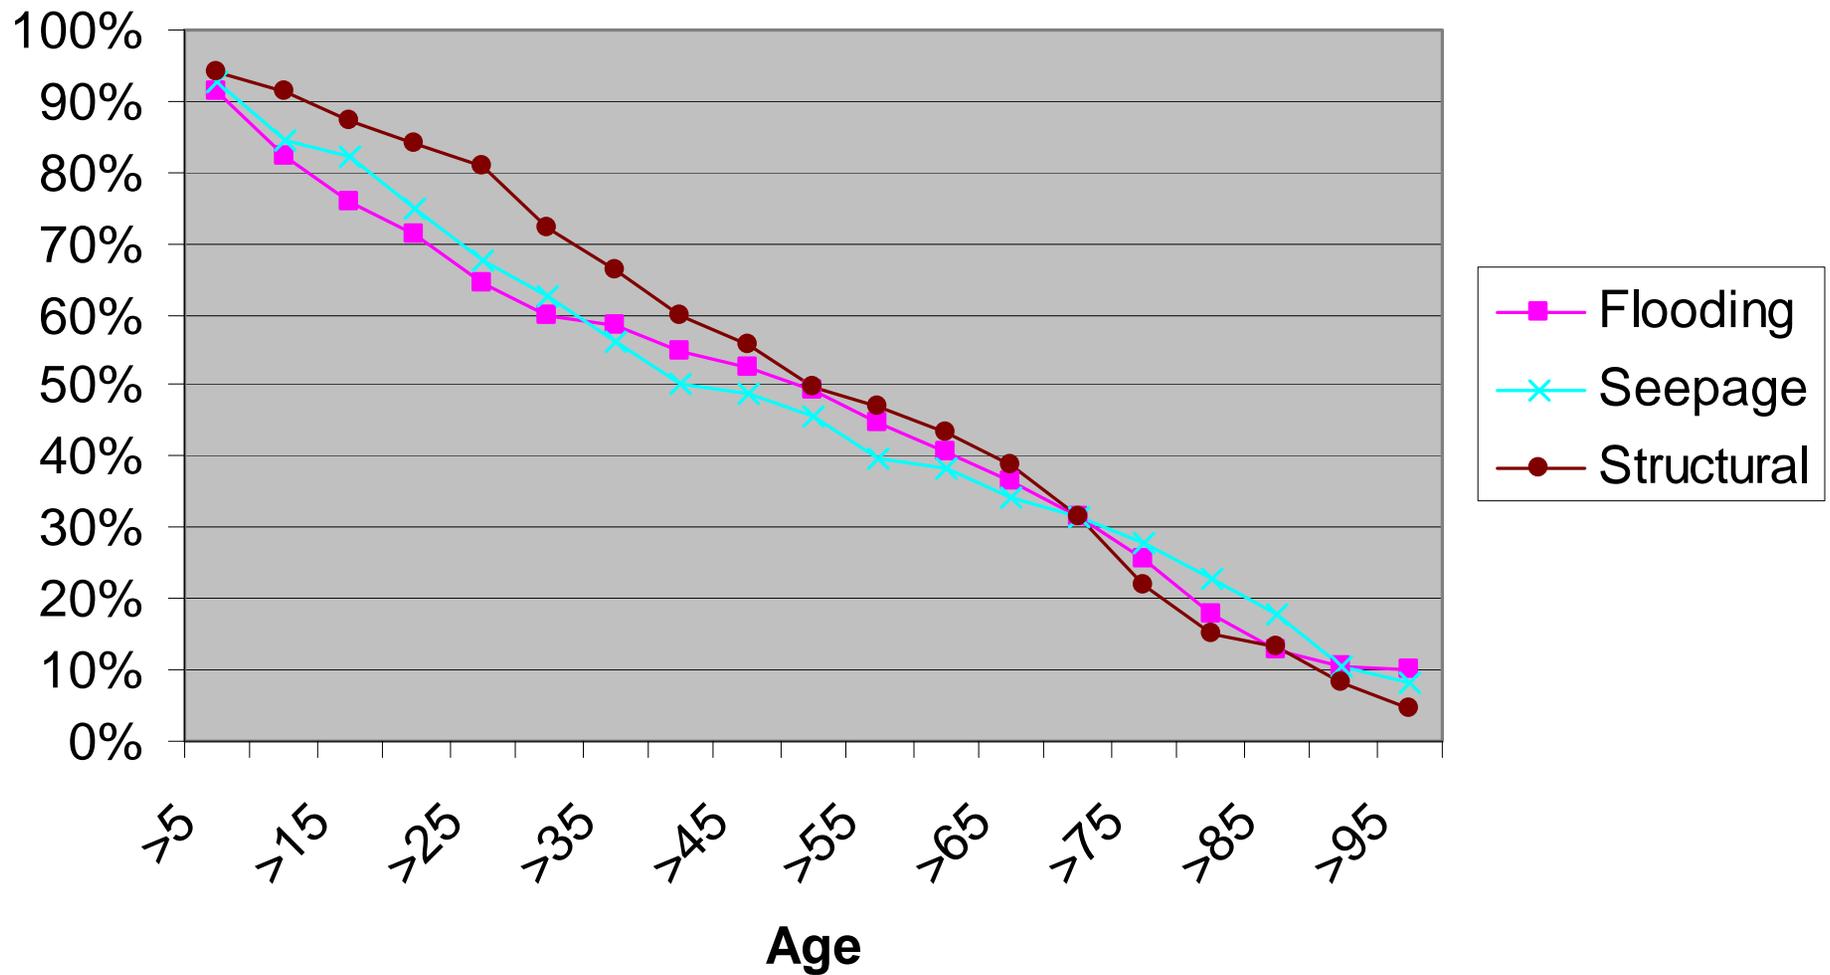
% of Incidents that Occur at an Age Greater Than by Failure Mode After 1st 5 Years of Operation

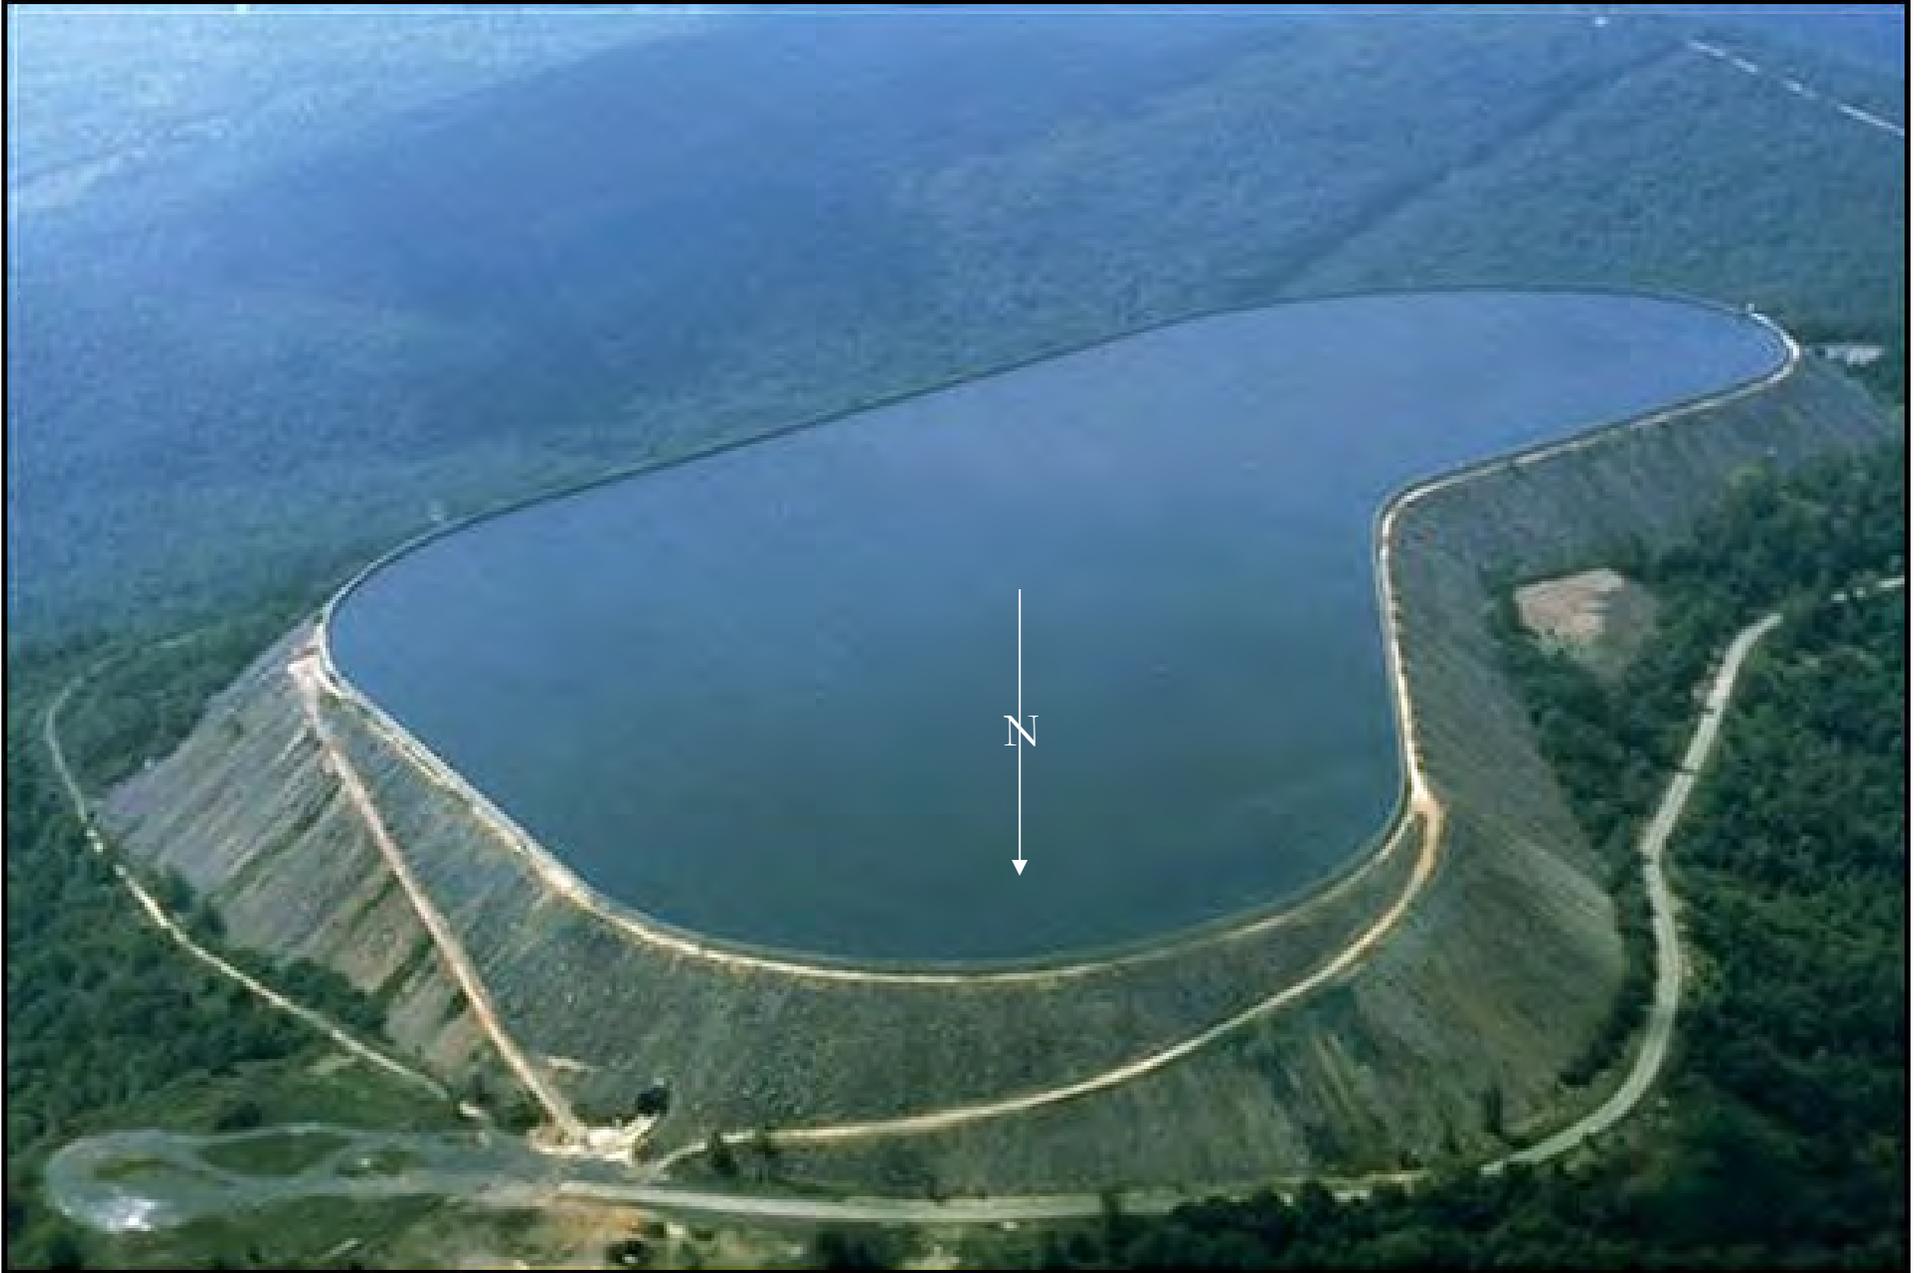
- Dam Type: Concrete-faced rockfill
- Dam Height: 84'
- Reservoir Capacity: 4350 ac-ft
- Spillway Capacity: N/A
- Pumping Capacity: 5258 cfs
- Flood of Record: N/A

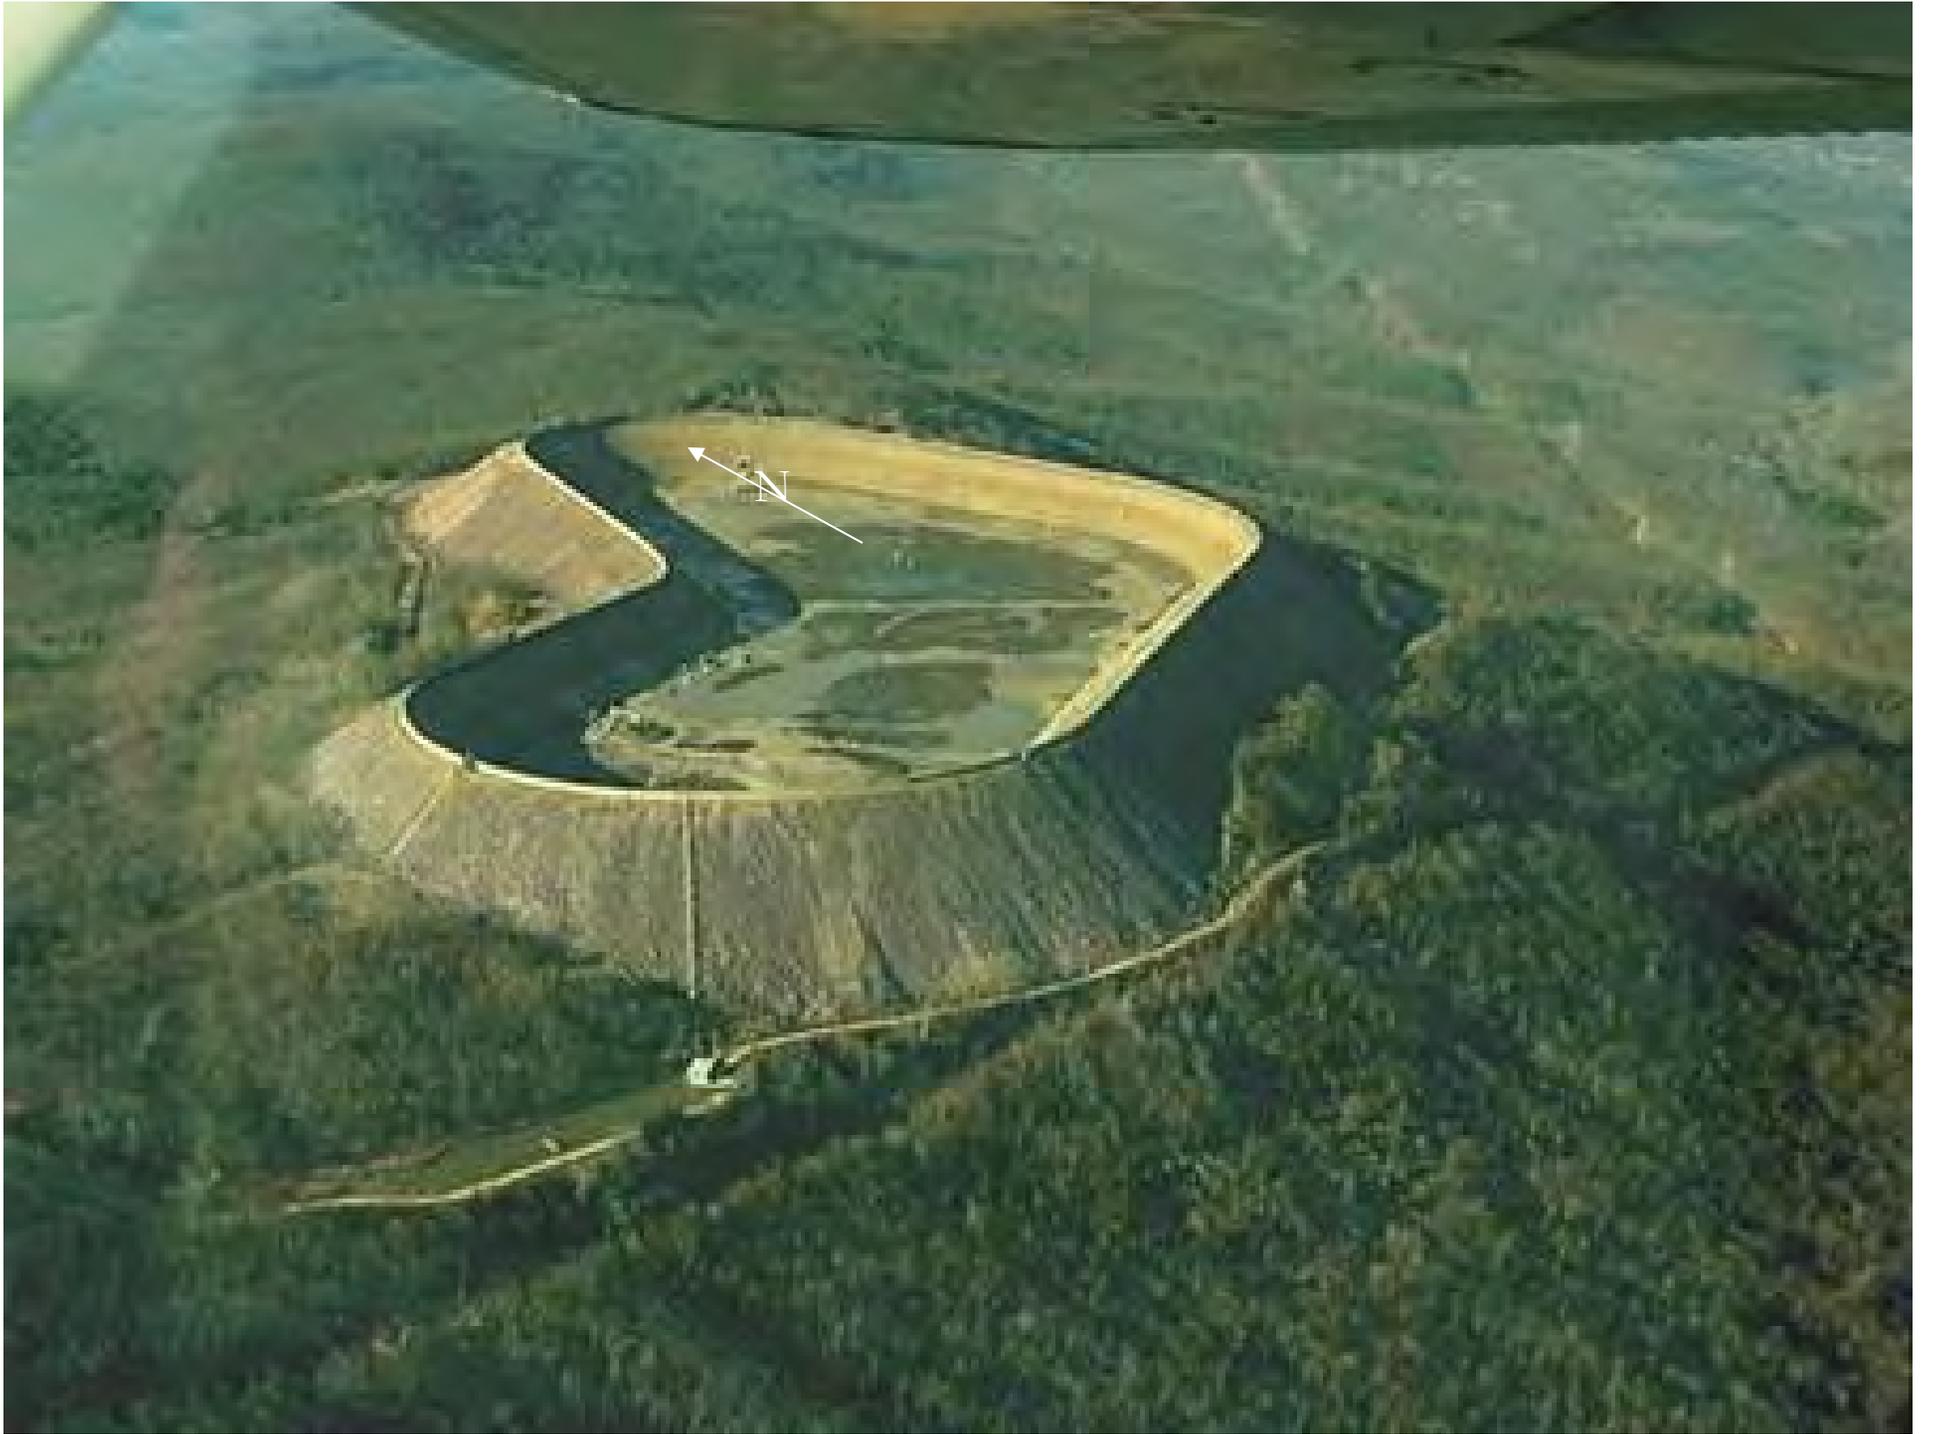
- The dike was topped with a 12' layer of rock placed in 4' lifts and compacted with a vibratory roller. The crest was 12' wide.
- The 10' high parapet wall was cast in place on top of this layer.
- The shotcrete face slab had a design thickness of 10 inches with No. 7 bars at 12 inches both ways.
- The face slab was placed in 60' wide panels.
- Expansion joints used 3/4-in asphaltic expansion joint material and U-shaped copper water stops.
- A reinforced concrete plinth was placed at the toe of the concrete face.

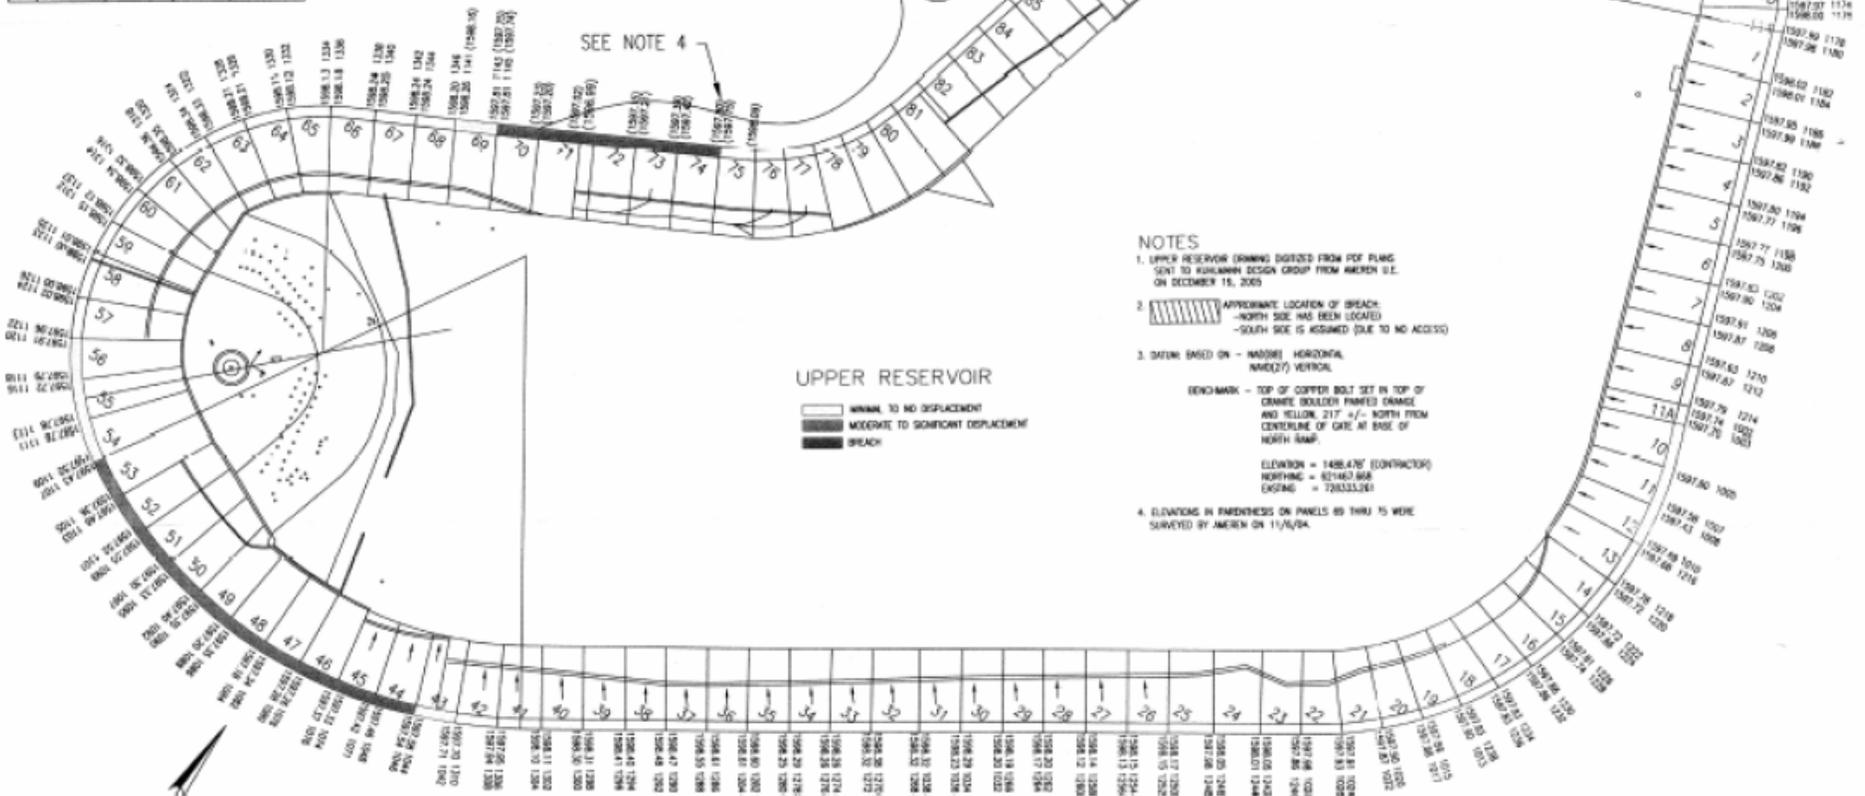
- Settlement of the rockfill varied between 1 and 2 feet with the lowest area at Panel 72, where the top of the parapet wall was 1596.99. (Original top of wall was El 1599)
- Several other panel areas ranged in elevations from El 1597 to 1598. (November 6, 2004 survey data)
