Senior Leaders Dam Safety Seminar

FERC Dam Safety Program

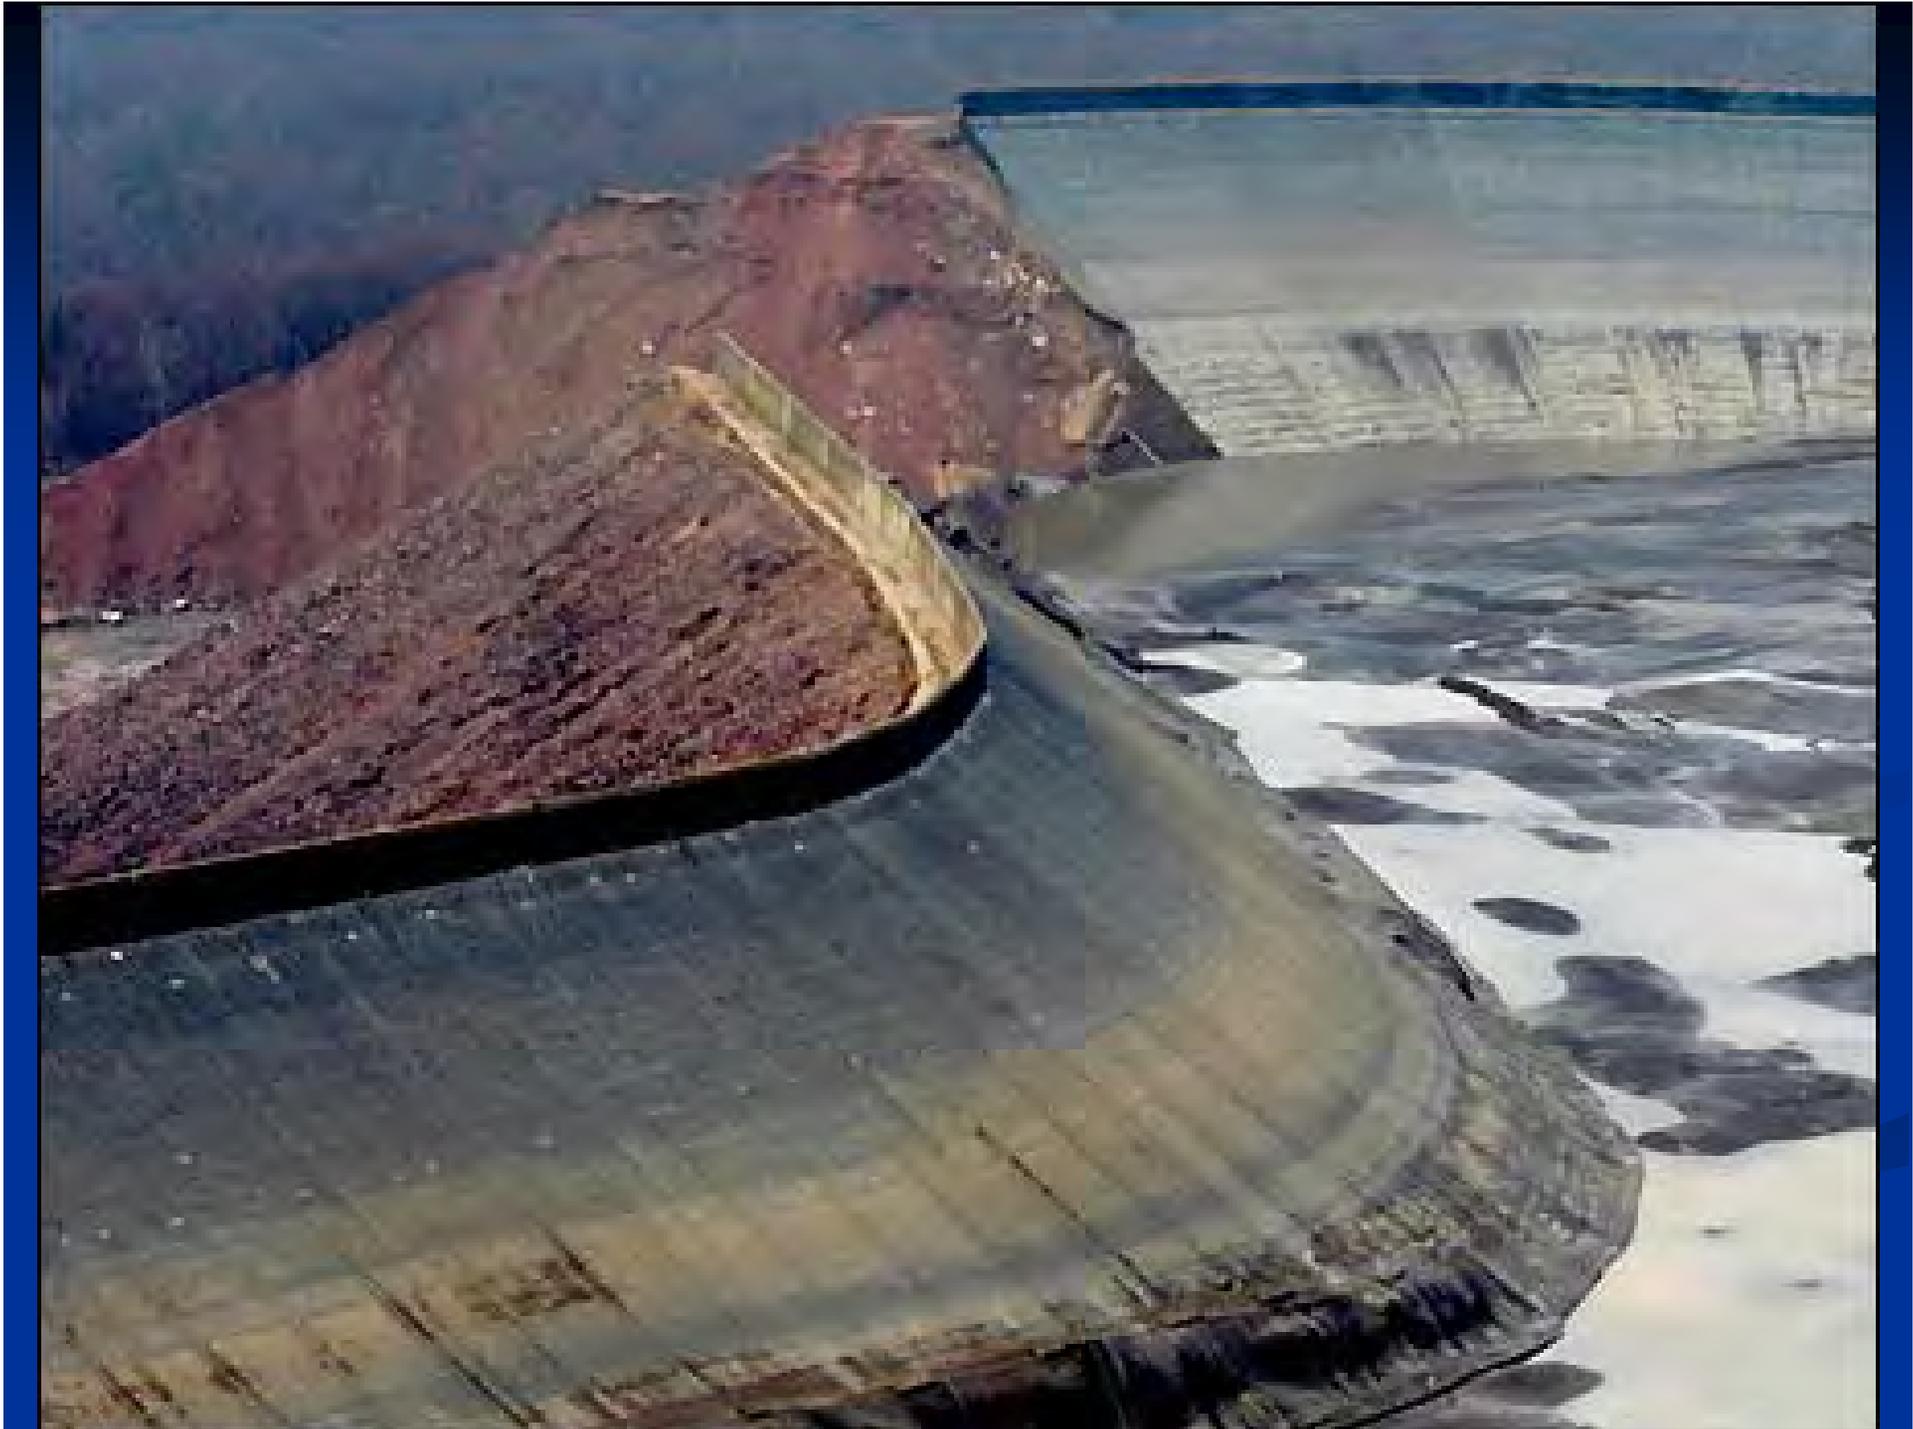
The Upper Reservoir of the Taum Sauk Pumped Storage Project was overtopped during the final minutes of the pumping cycle on the morning of Dec. 14, 2005. Data indicate that pumping stopped at 5:15 AM with the initial breach forming at about the same time. Once overtopping began, erosion started at the downstream toe of the 10' high parapet wall. Erosion progressed below the parapet wall, likely causing instability and resulting in the initial loss of one or two parapet wall sections.

Subsequent erosion and breach of the rockfill embankment formed a breach about 656' wide at the top of the rockfill dam and 496' at the base of the dam. The peak discharge from breach was about 273,000 cfs which occurred within 10 minutes of the initial breach. The complete evacuation of the reservoir occurred within 25 minutes.

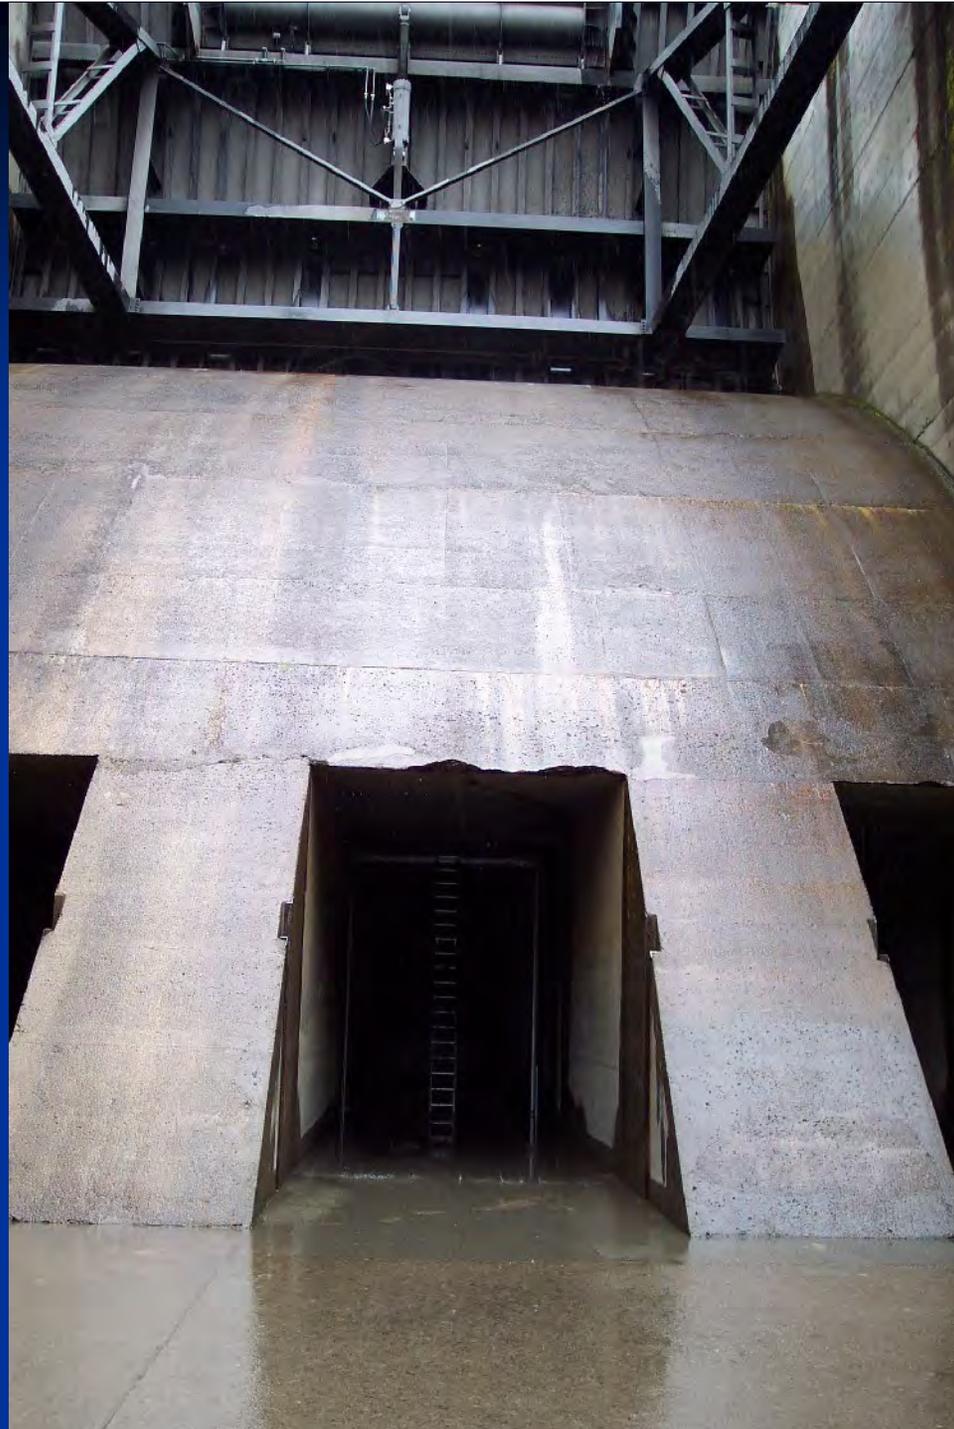
- During high flows the Cowlitz Falls project is required to flush sediment through low level outlets to prevent flooding upstream
- The design of the dam has the low level outlets beneath the radial gates
- The control system is designed to NOT allow the sluice gates to open while the spill gates are open due to excessive vibration in the sluice gates

- In 2003, the Cowlitz Falls project was undergoing a SCADA upgrade.
- An early storm had Cowlitz Falls spilling
- Without operator intervention, the sluice gate opened, bypassing both the intent of the SCADA system and a PLC designed to lockout the sluice when the spill gate was open

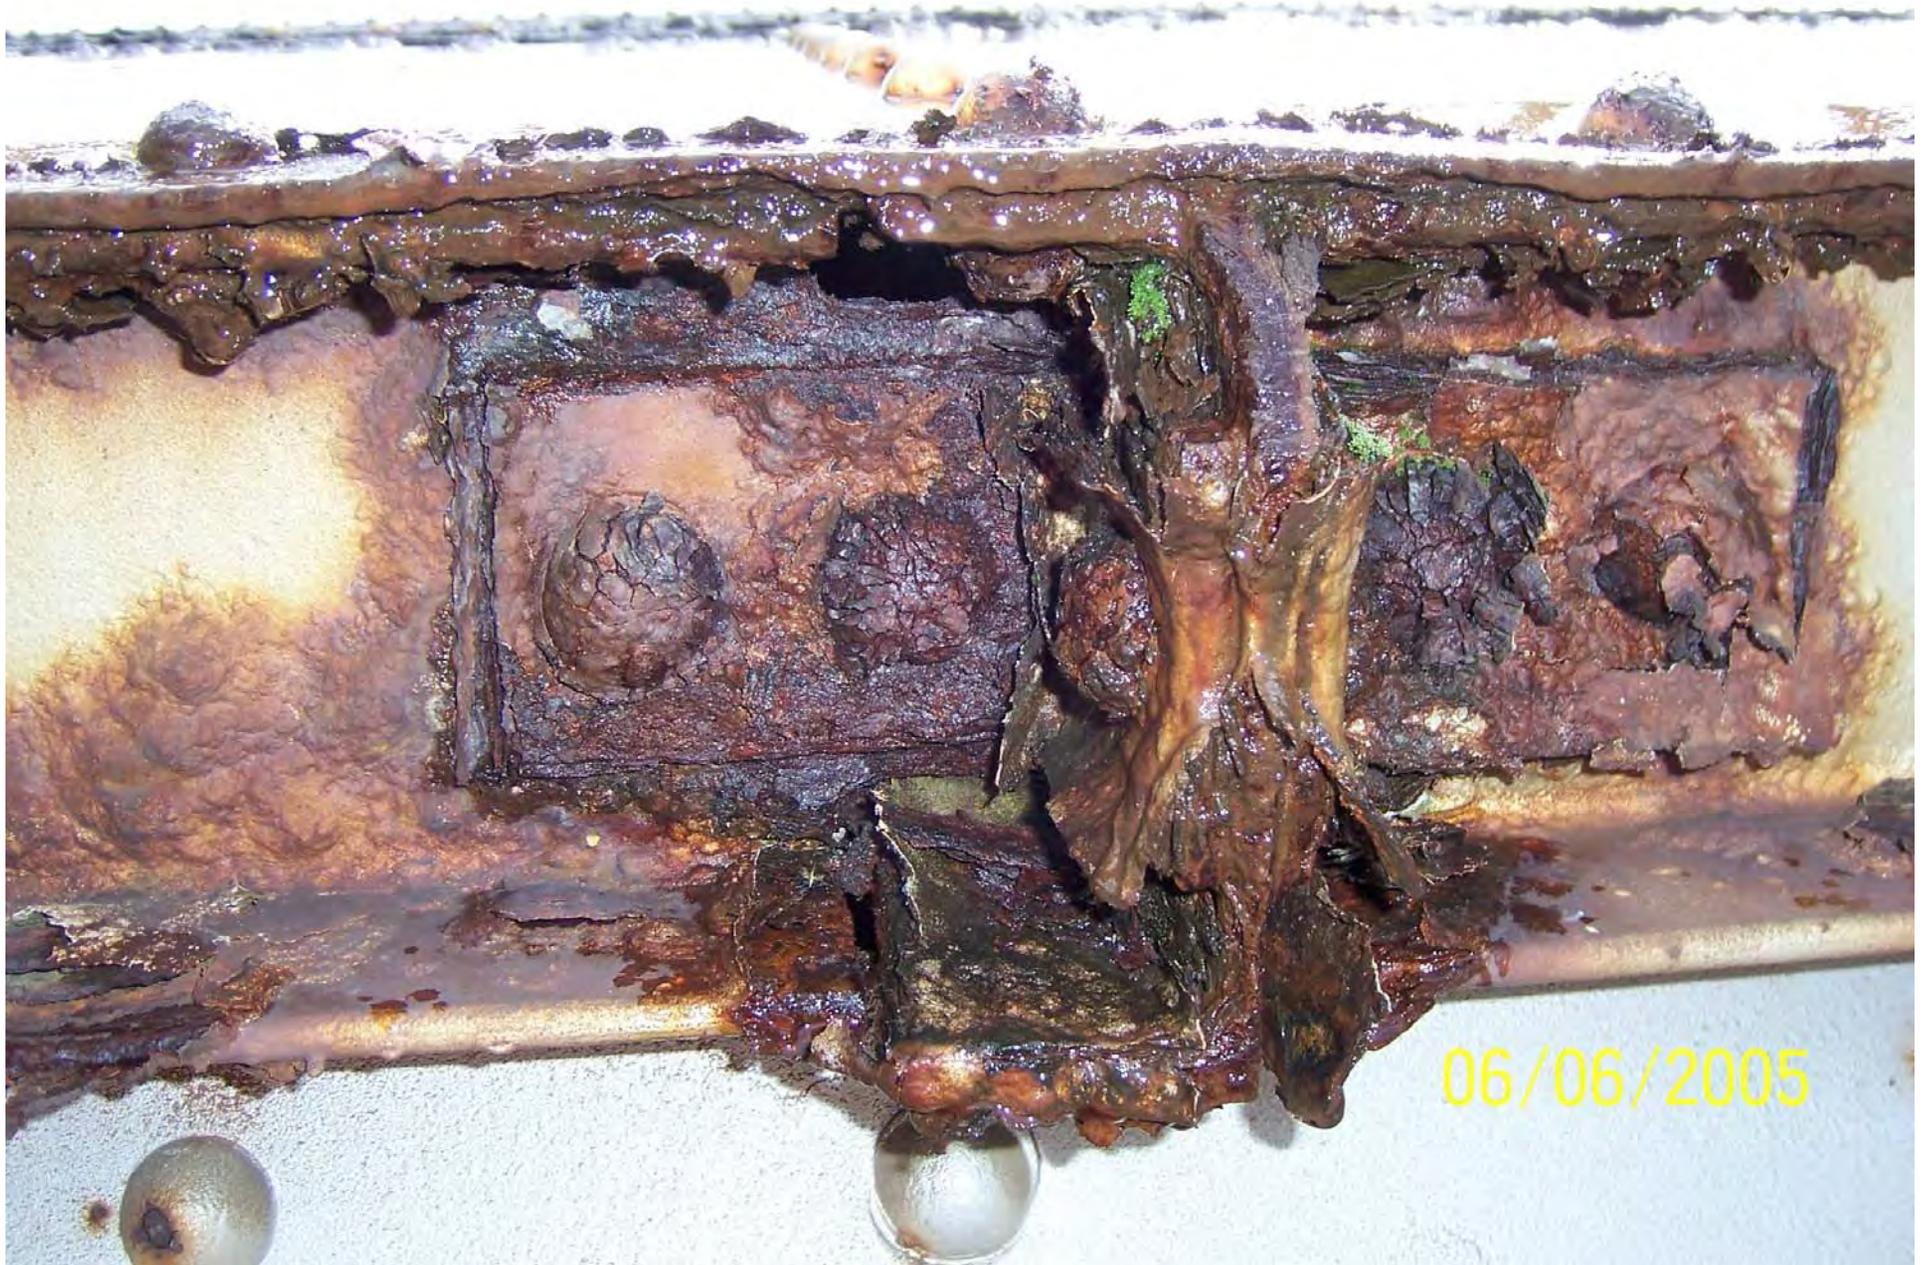
Rivet heads
deteriorated

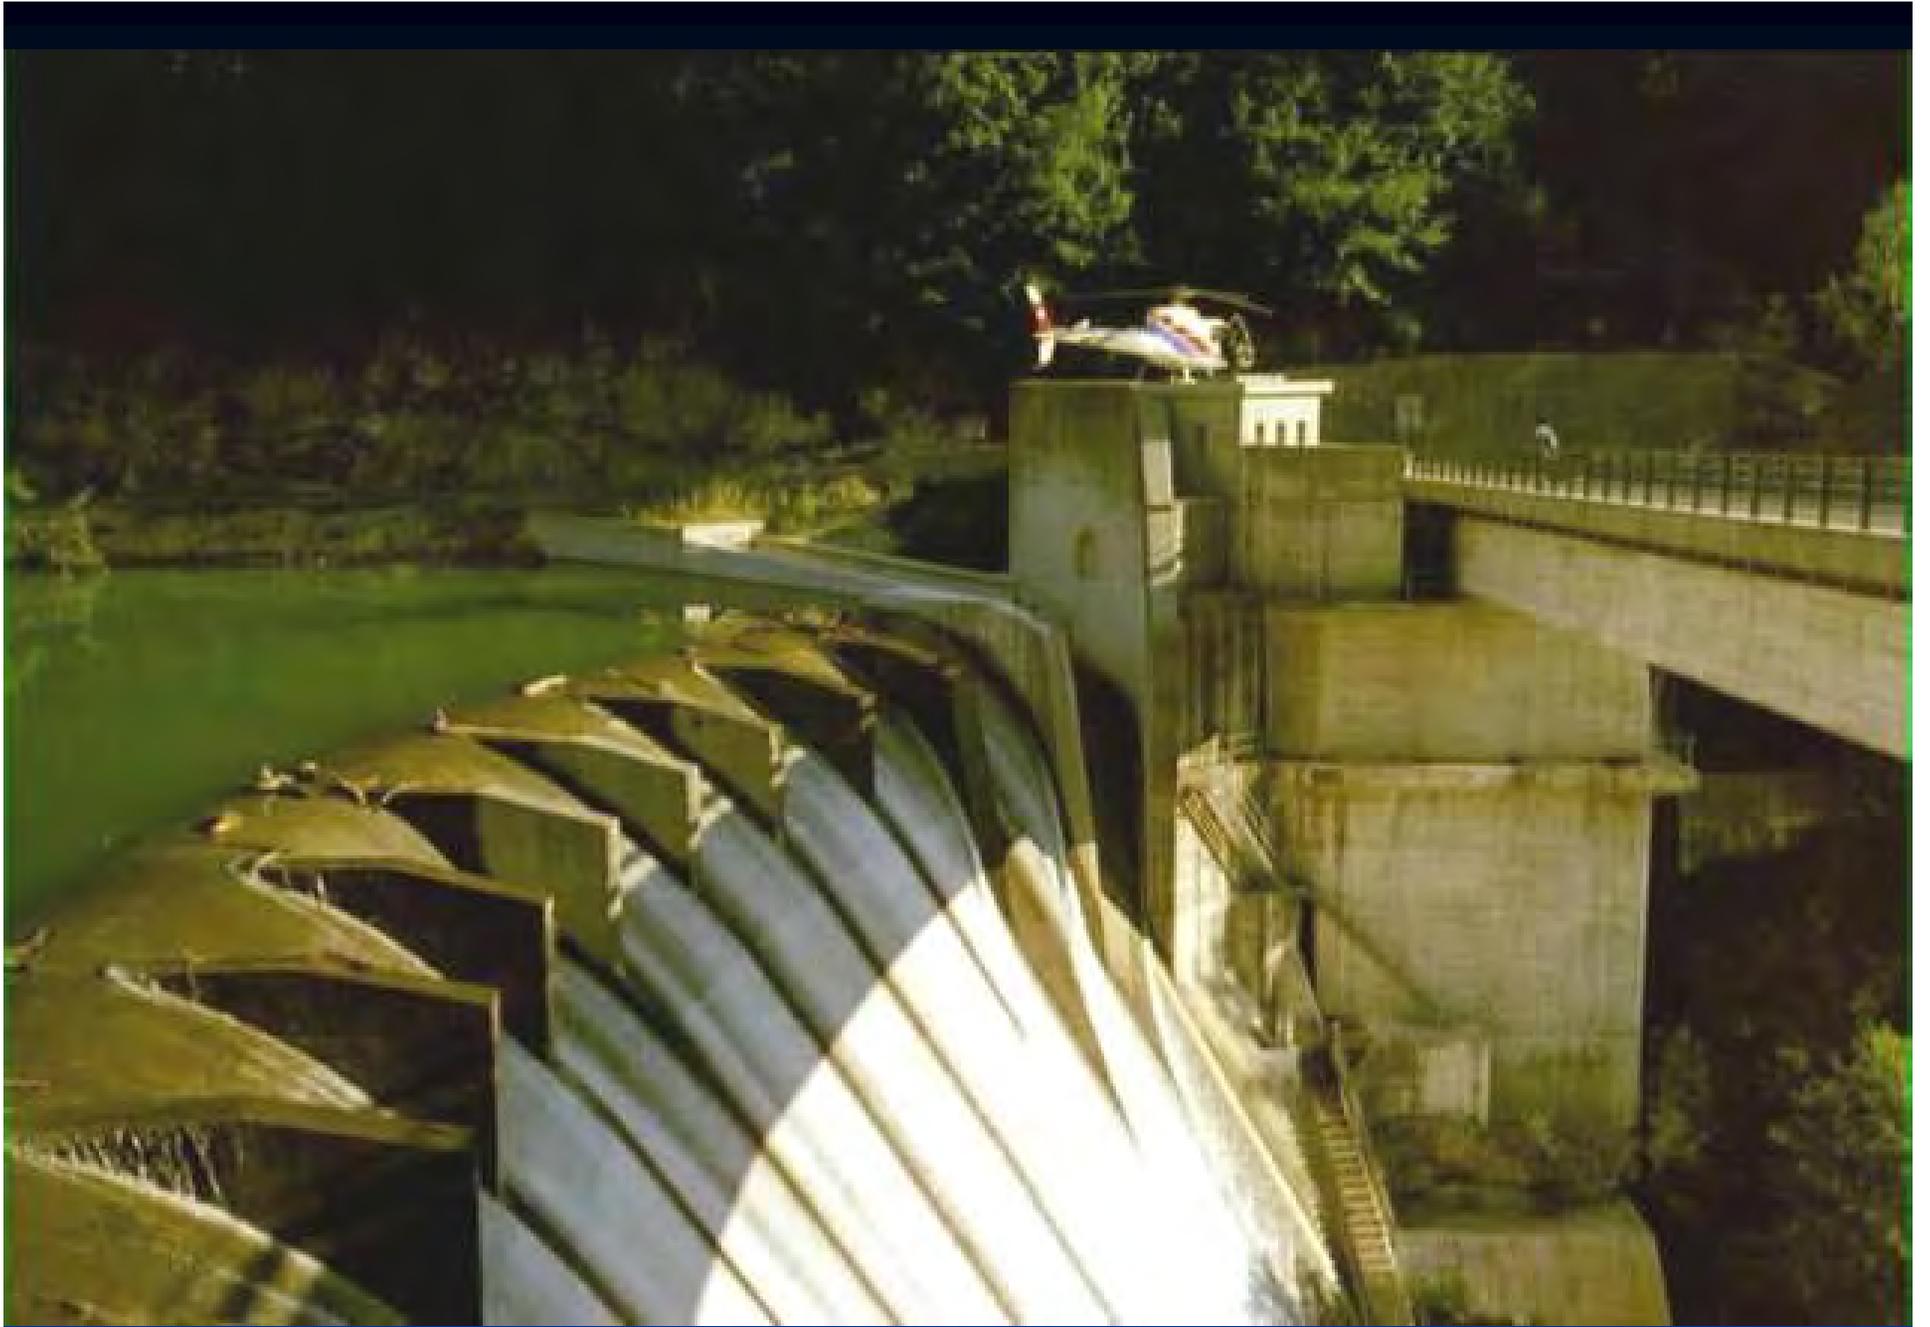
- The spillway at Palagnedra Dam was completely blocked with debris.
- Water spilled over the main concrete dam and through a low spot upstream on the right bank.
- 50,000 cu meters of glacial moraine material was washed out from the downstream side of a 40 m high diaphragm wall upstream on the right side of the reservoir nearly causing failure of the wall.

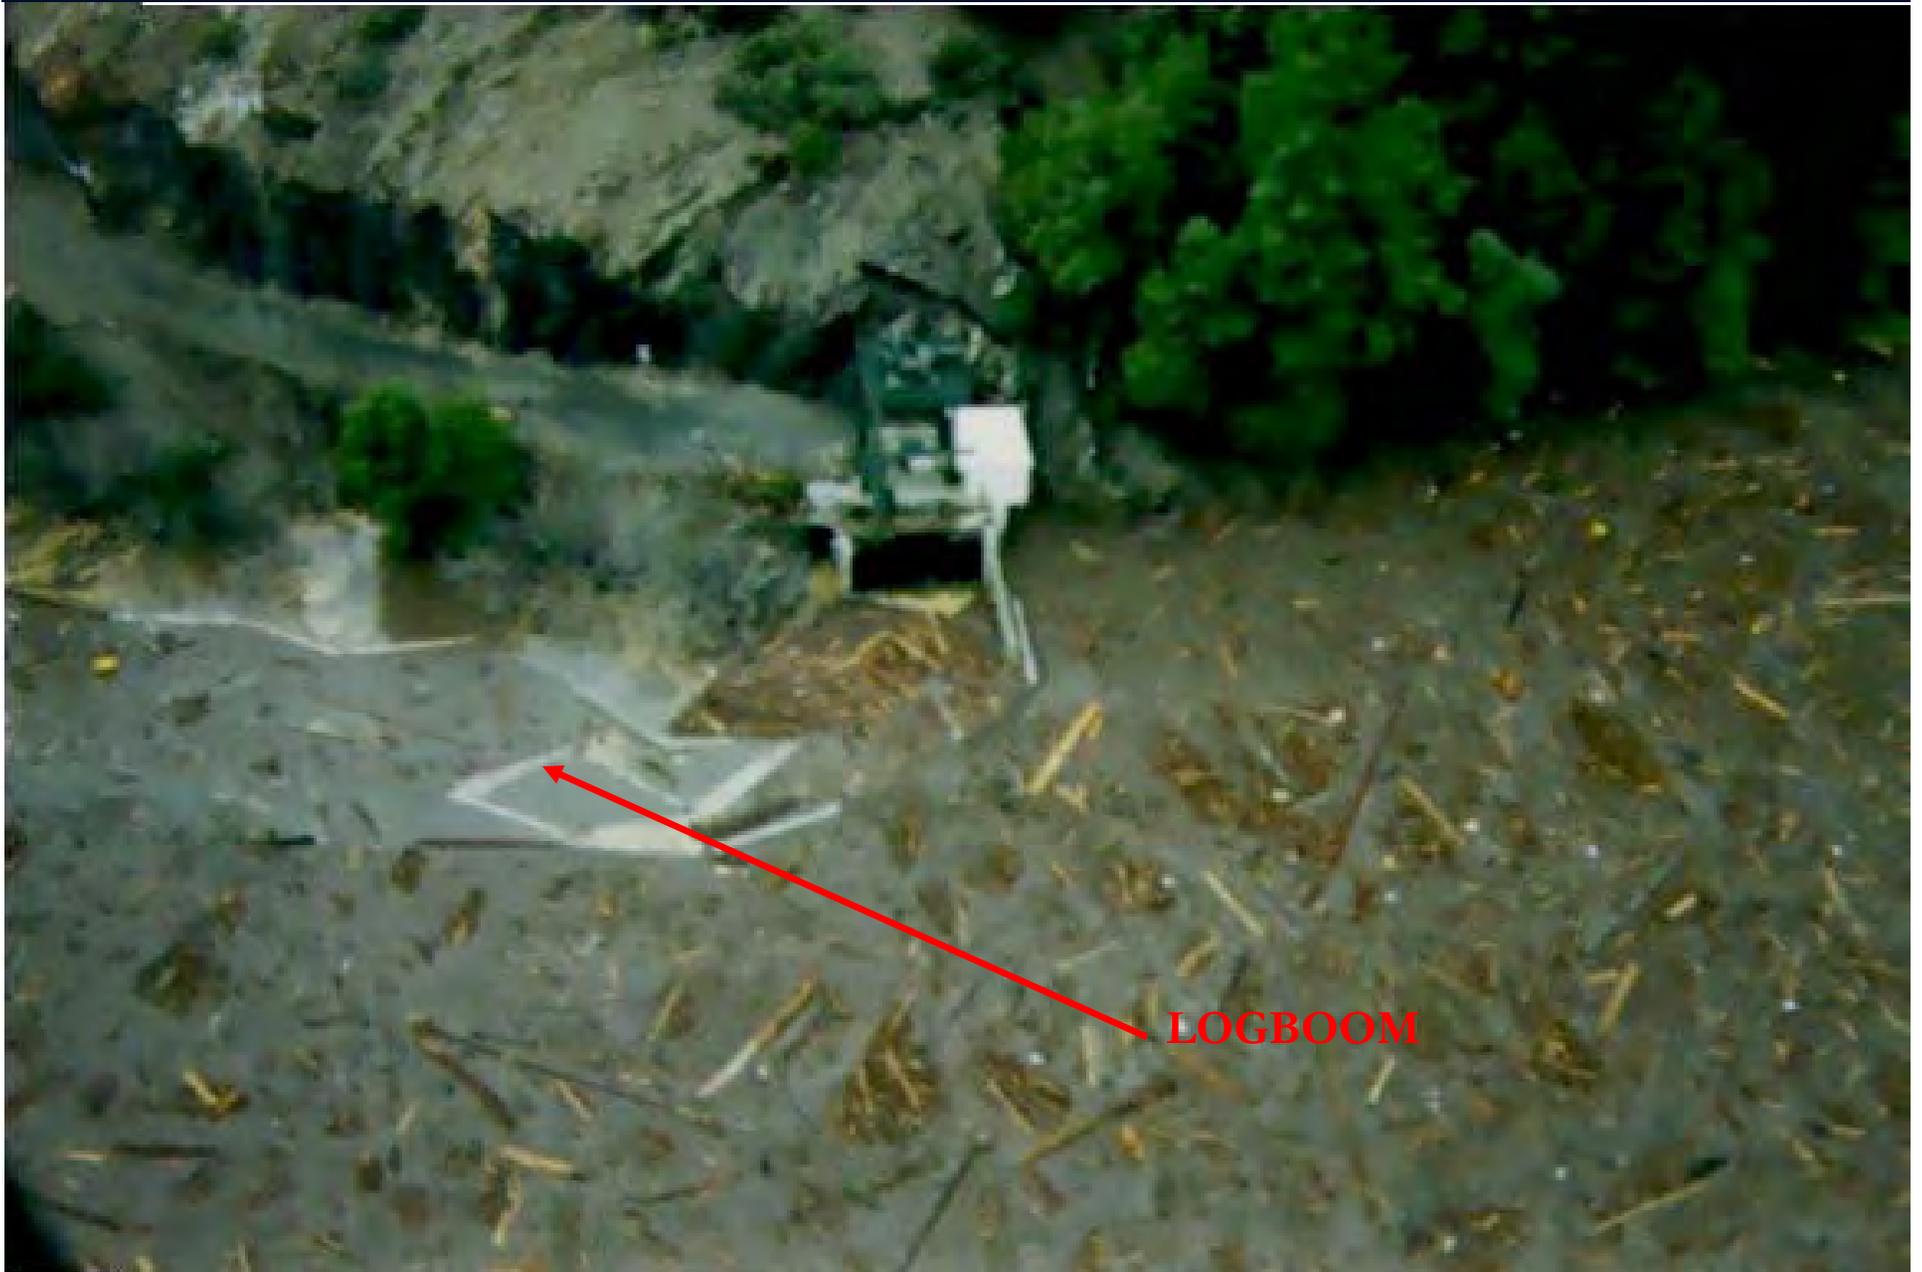
- Logbooms may not be adequately strong to withstand large rafts of debris
 - Forces on anchorage is very large
 - Connections are often weak link
- Failure of a logboom may make things worse by allowing debris to knit together rather than passing singly over dam

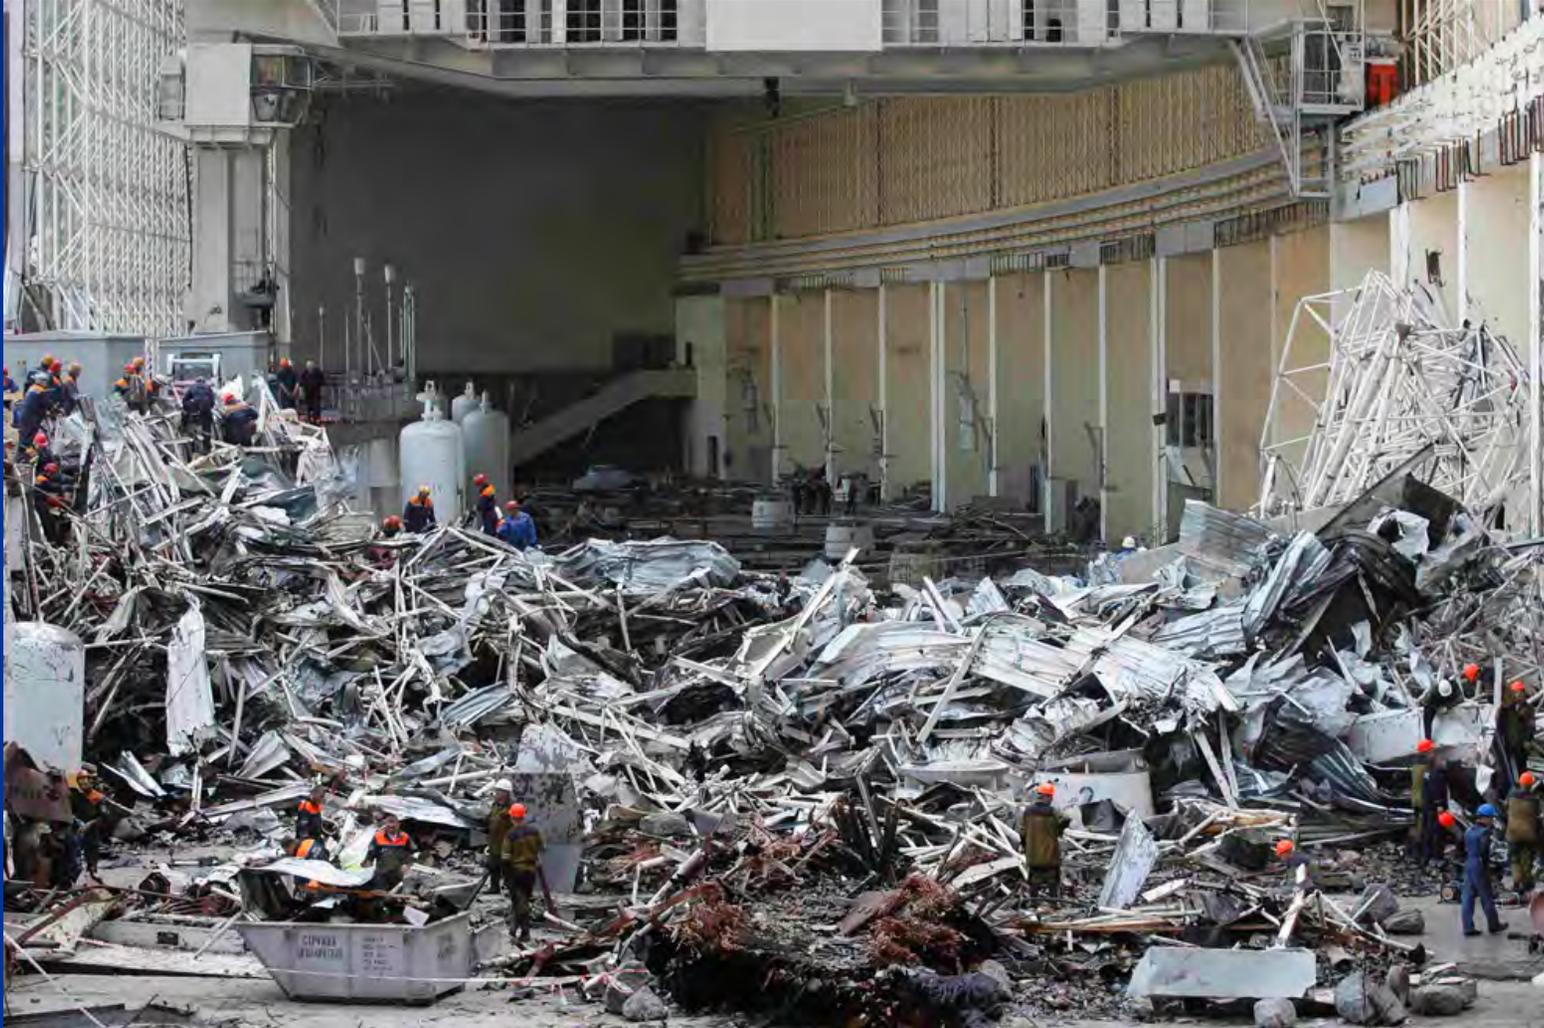
Sayano-Shushenskaya

- Dam Type: Gravity Arch
- Dam Height: 242 meters / 794 ft
- Reservoir Capacity: 31.3 km³ / 25.4M ac-ft
- Spillway Capacity: 12,800 m³/s / 455K cfs
- Powerhouse Capacity: 3,500 m³/s / 124K cfs
- Flood of Record: 24,300 m³/s

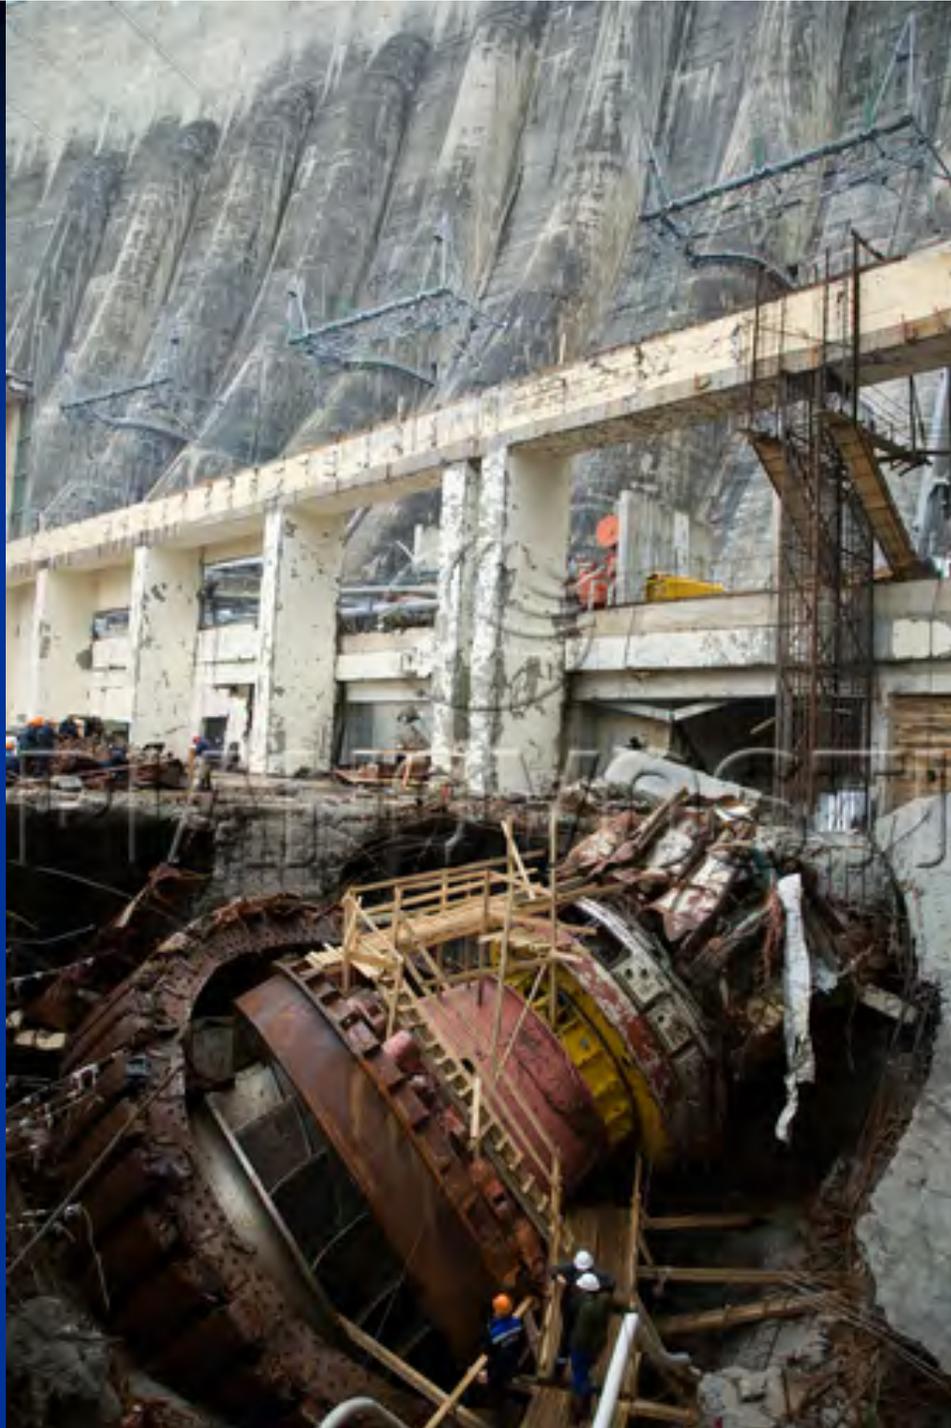
- 5) In load following mode Unit 2 transitions through the rough operating region on several occasions
- 6) The fatigue failure of the head cover bolts reaches a critical state
- 7) The turbine head cover tears loose ejecting the turbine through the generator

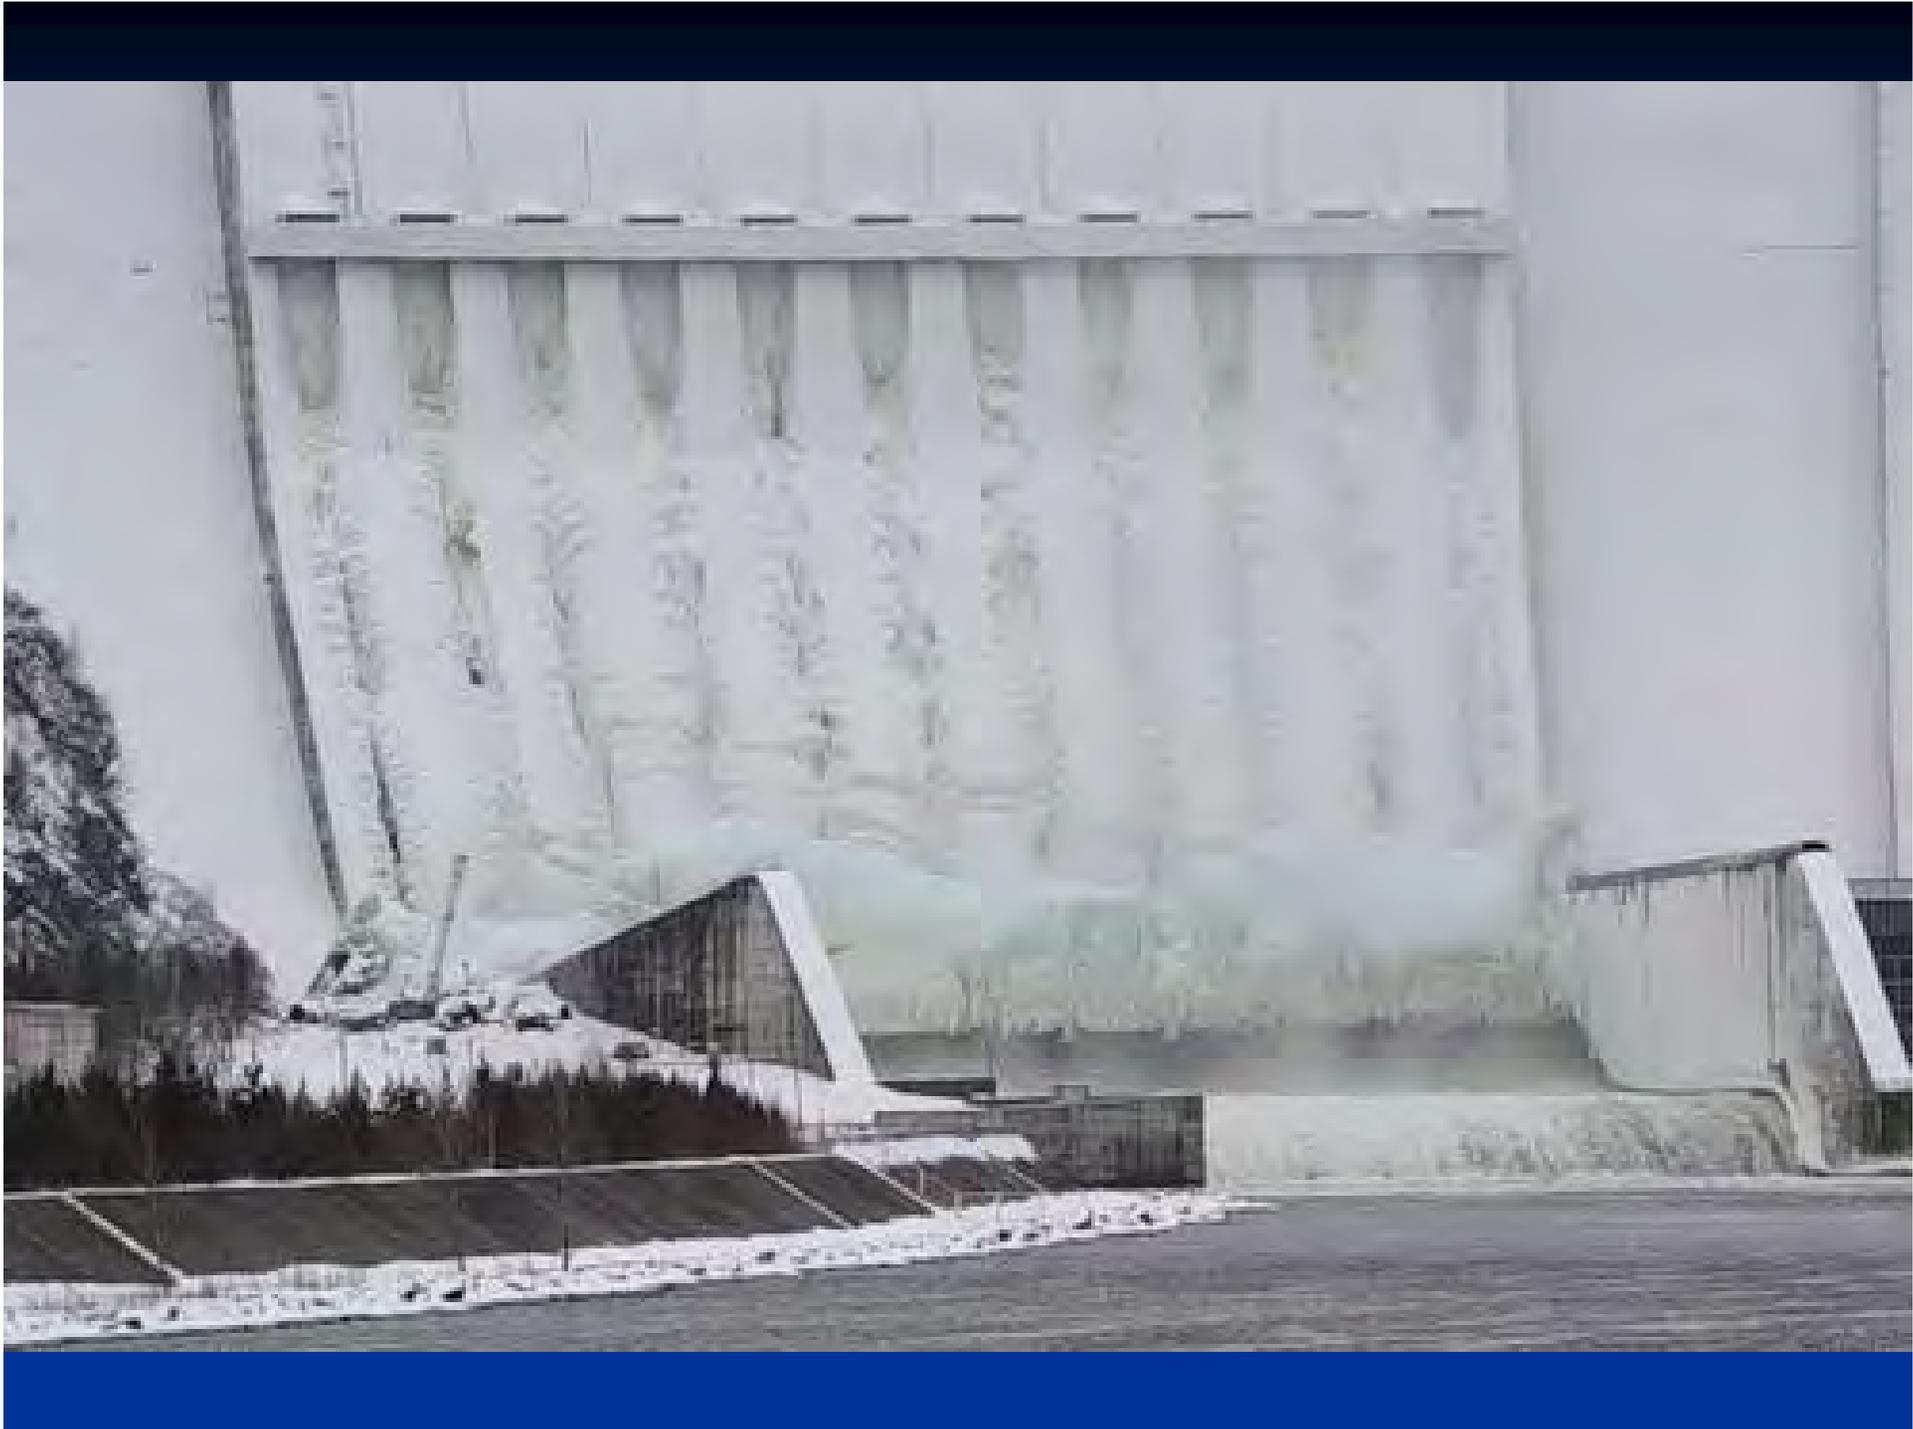
- 12) Damage to the powerhouse results in the majority of inflow passing through the spillway for an extended period
- 13) Operation through the winter results in icing over the spillway and collapse of a crane used to access the stilling basin for repair

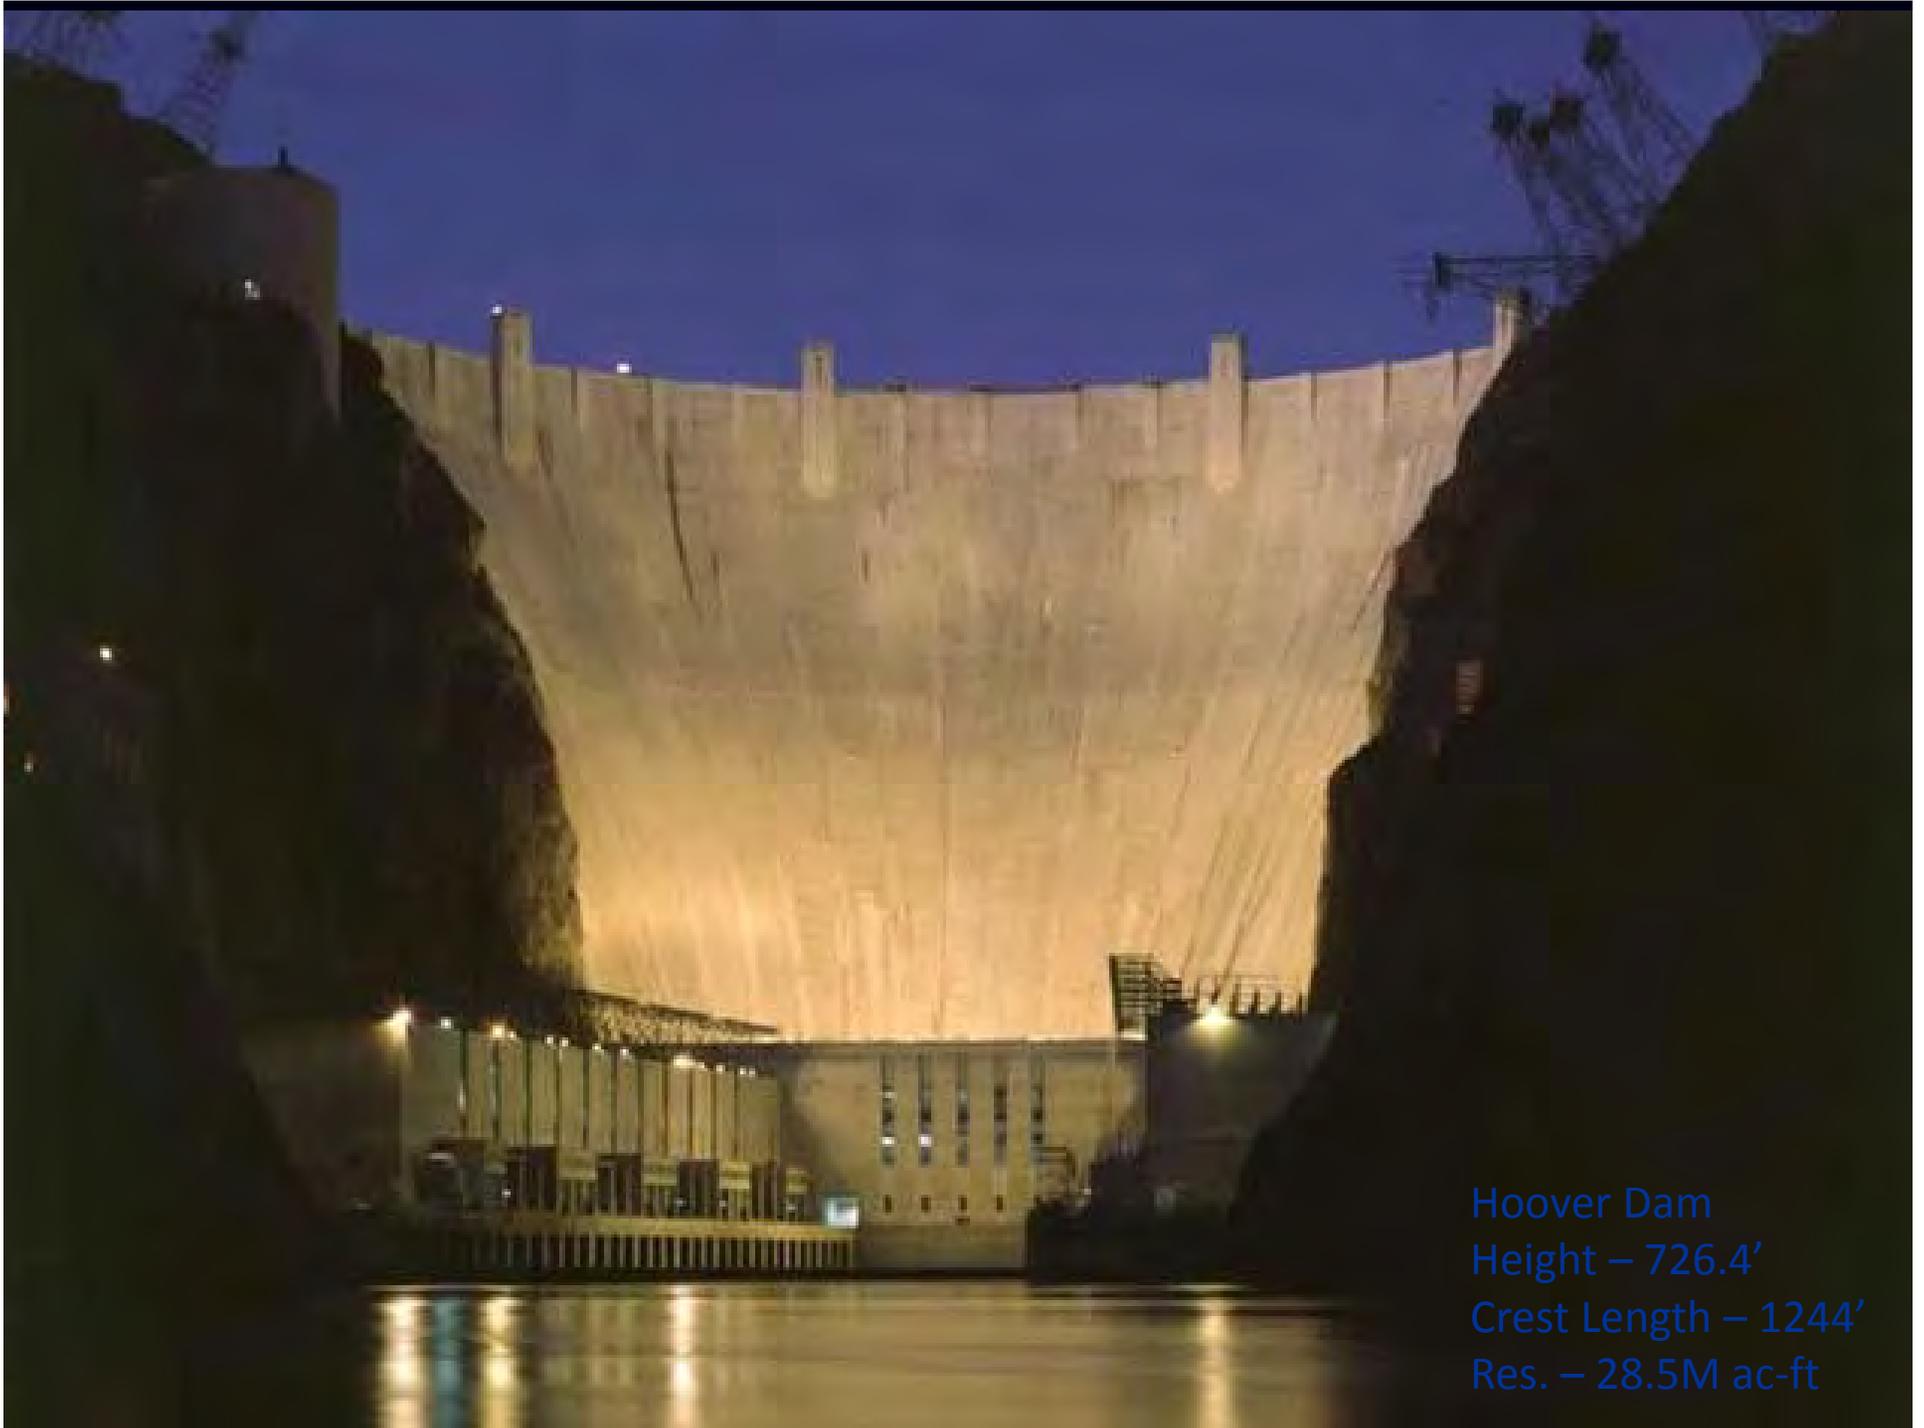
Hoover Dam
Height – 726.4'
Crest Length – 1244'
Res. – 28.5M ac-ft

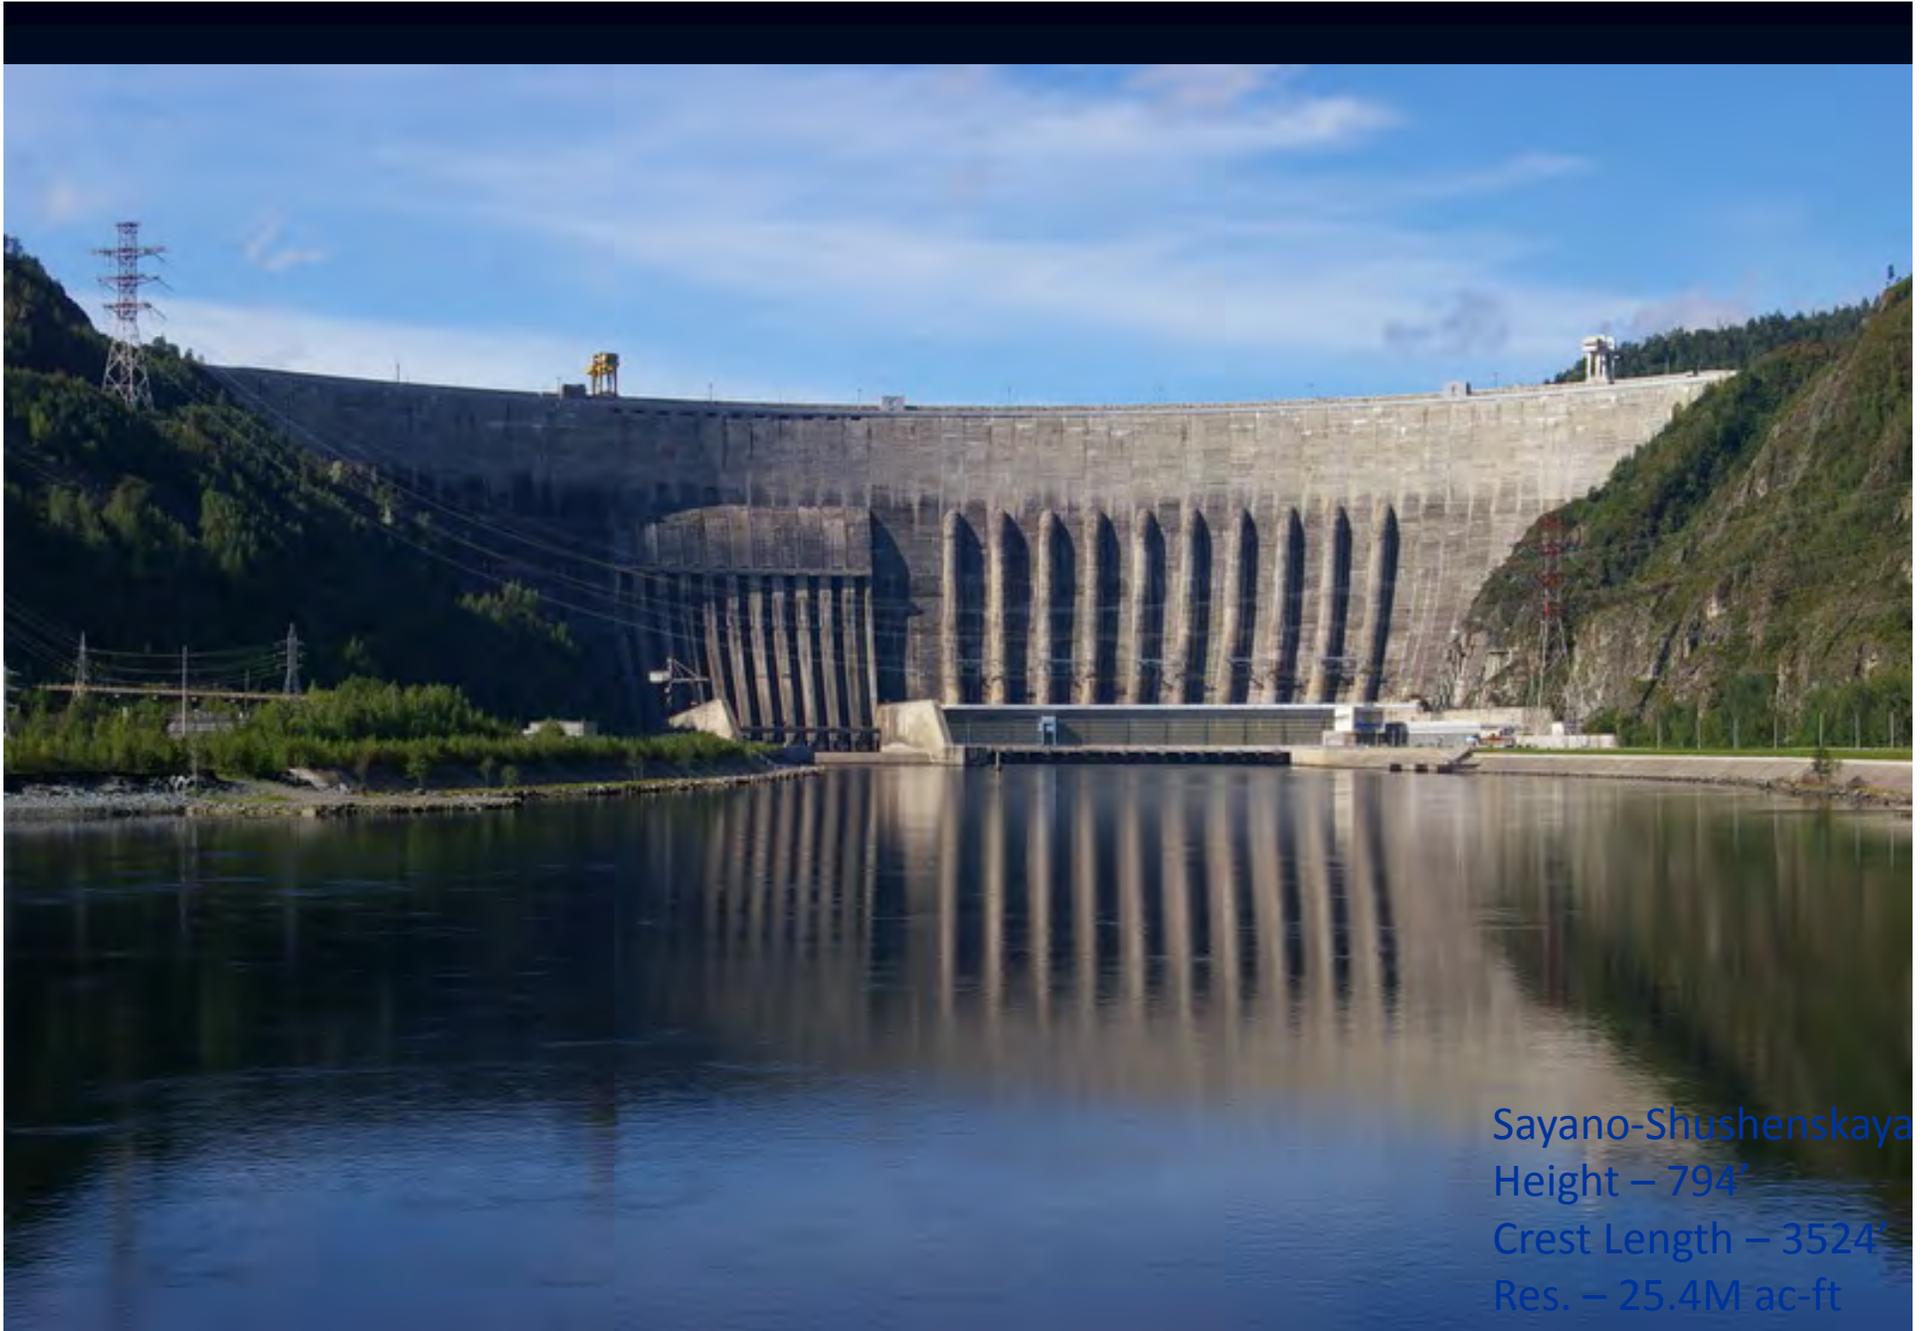
Sayano-Shushenskaya
Height – 794'
Crest Length – 3524'
Res. – 25.4M ac-ft
