Senior Leaders Dam Safety Seminar

FERC Dam Safety Program

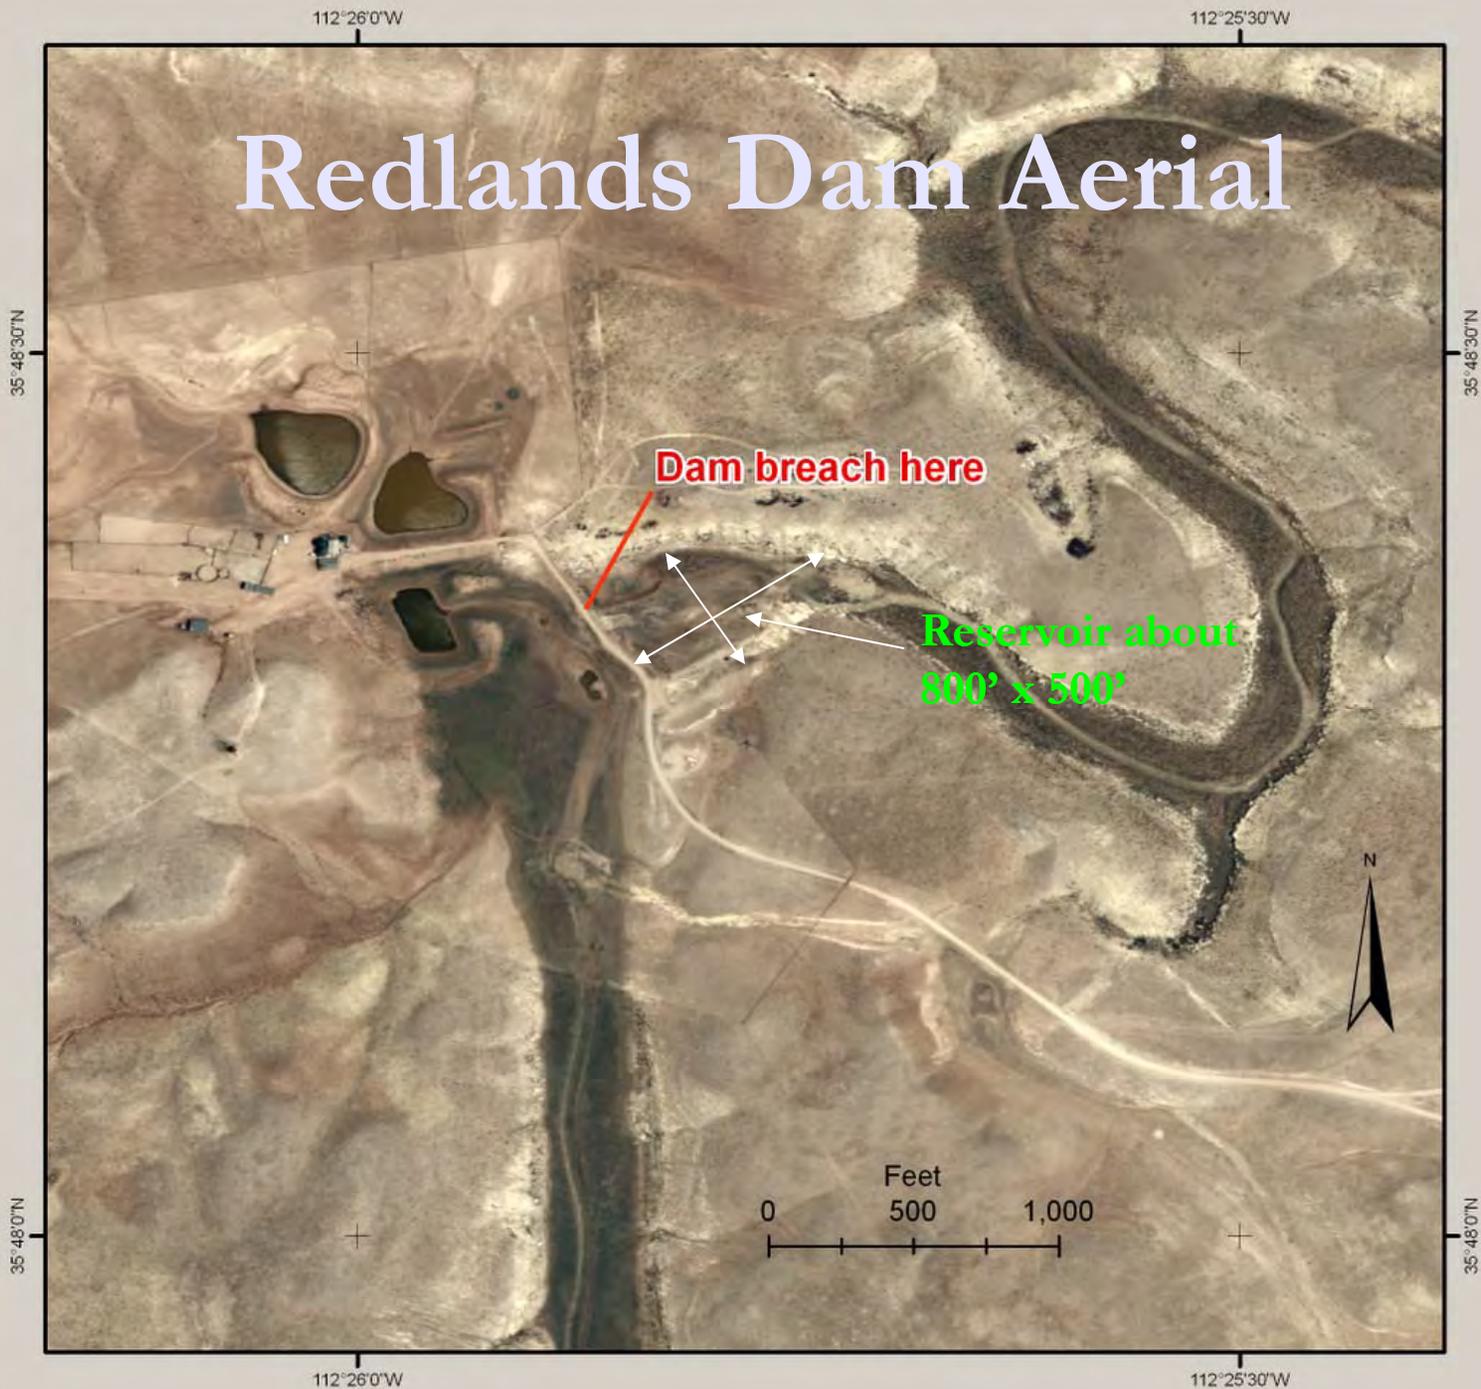
Redlands Dam Aerial

- Redlands Dam was a ranch stock pond.
- It was too small to be listed on the National Inventory of Dams
- The flooding for the most part was the result of extreme rains that caused even the Colorado River hydrograph to spike

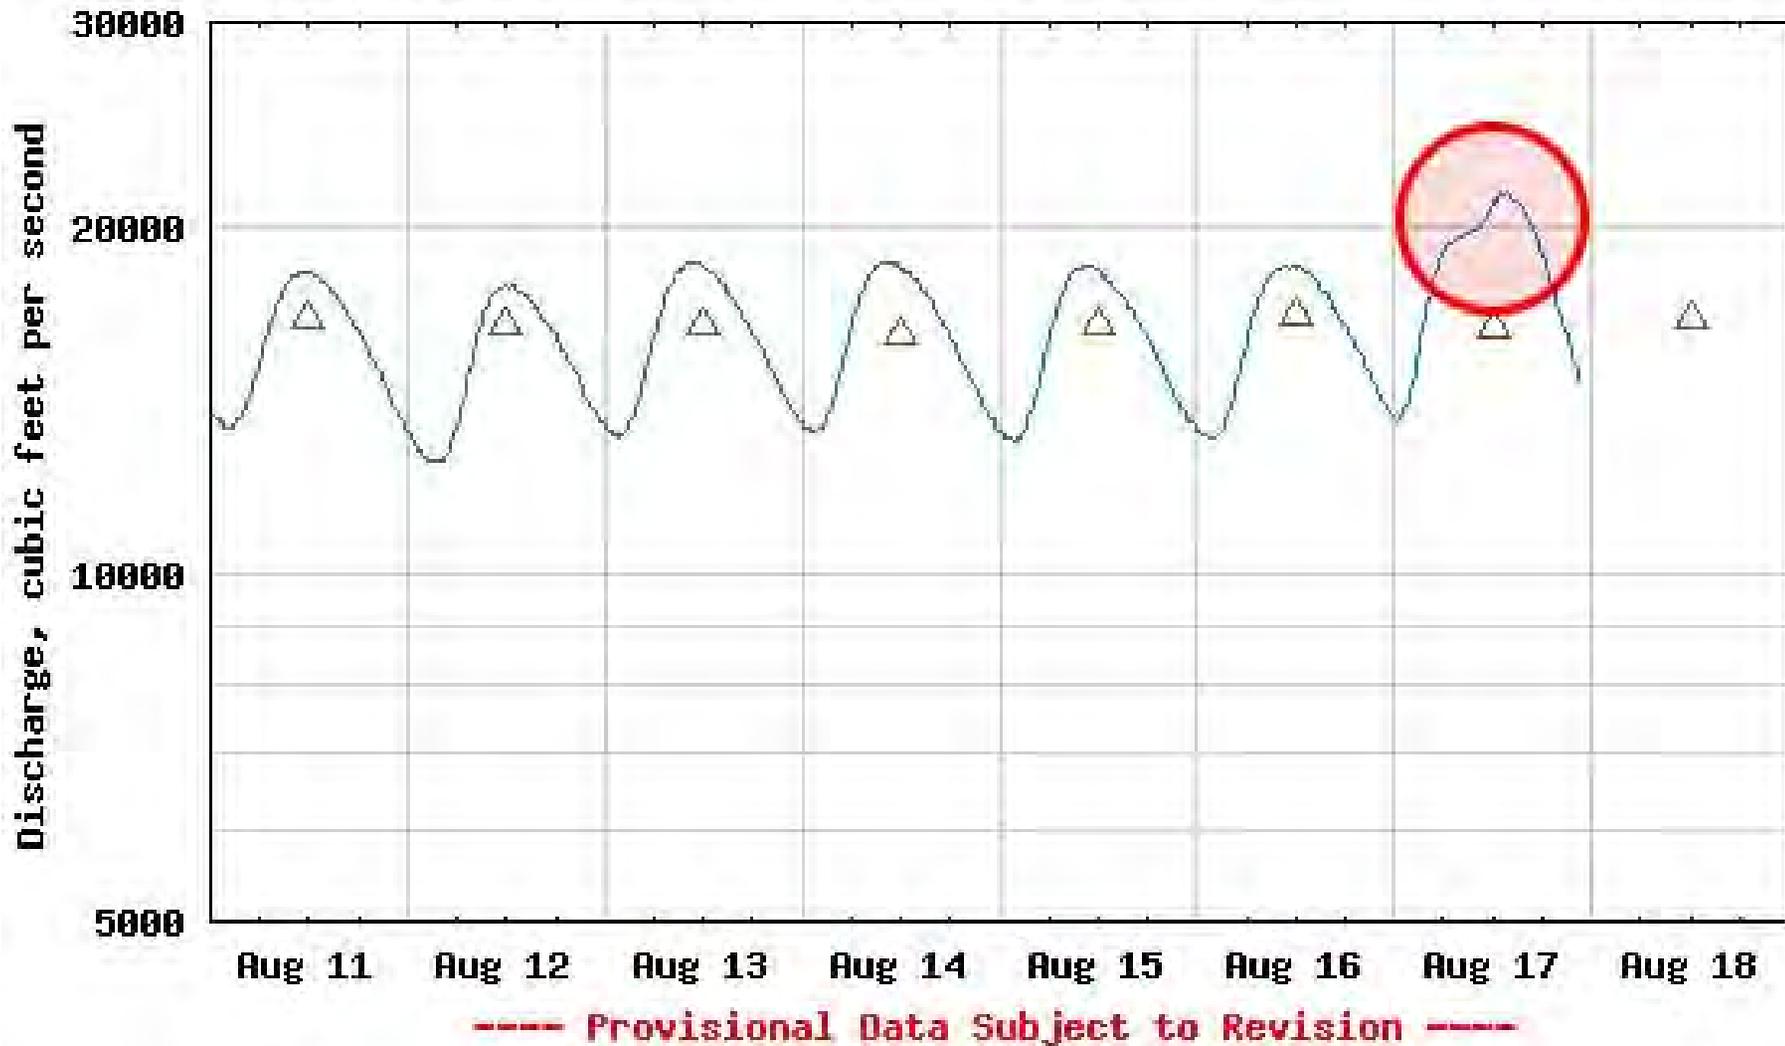
USGS 09404200 COLORADO RIVER ABOVE DIAMOND CREEK NR PEACH SPRING

The Diamond Creek Gage is at mile 226 on the Colorado River. Havasu Creek dumps into the Colorado at mile 157. The Redlands Dam is at least 55 miles up Havasu/Cataract Creek. That is more than 120 miles that the water would have to travel in just 8 hours (15 miles an hour). However, the flash flooding was reported in the Havasu campground between 1 AM and 3 AM Sunday. So, the dam break didn't cause the jump in the Diamond Creek gage on Sunday afternoon. It was the large area of heavy rain that fell between the Redlands Dam and Supai Village.
