**Denali Avoidance Alternative –
Visual Impact Assessment**

**Affected Visual Environment, Impacts, and Mitigation Measures
at Key Observation Points**

Figure E.1-1
Alaska LNG Project
Denali Avoidance Alternative
 Key Observation Pt: KOP K, L, M,
 2018-8, 2018-9, 2018-10, 2018-11,
 2018-13, and 2018-14

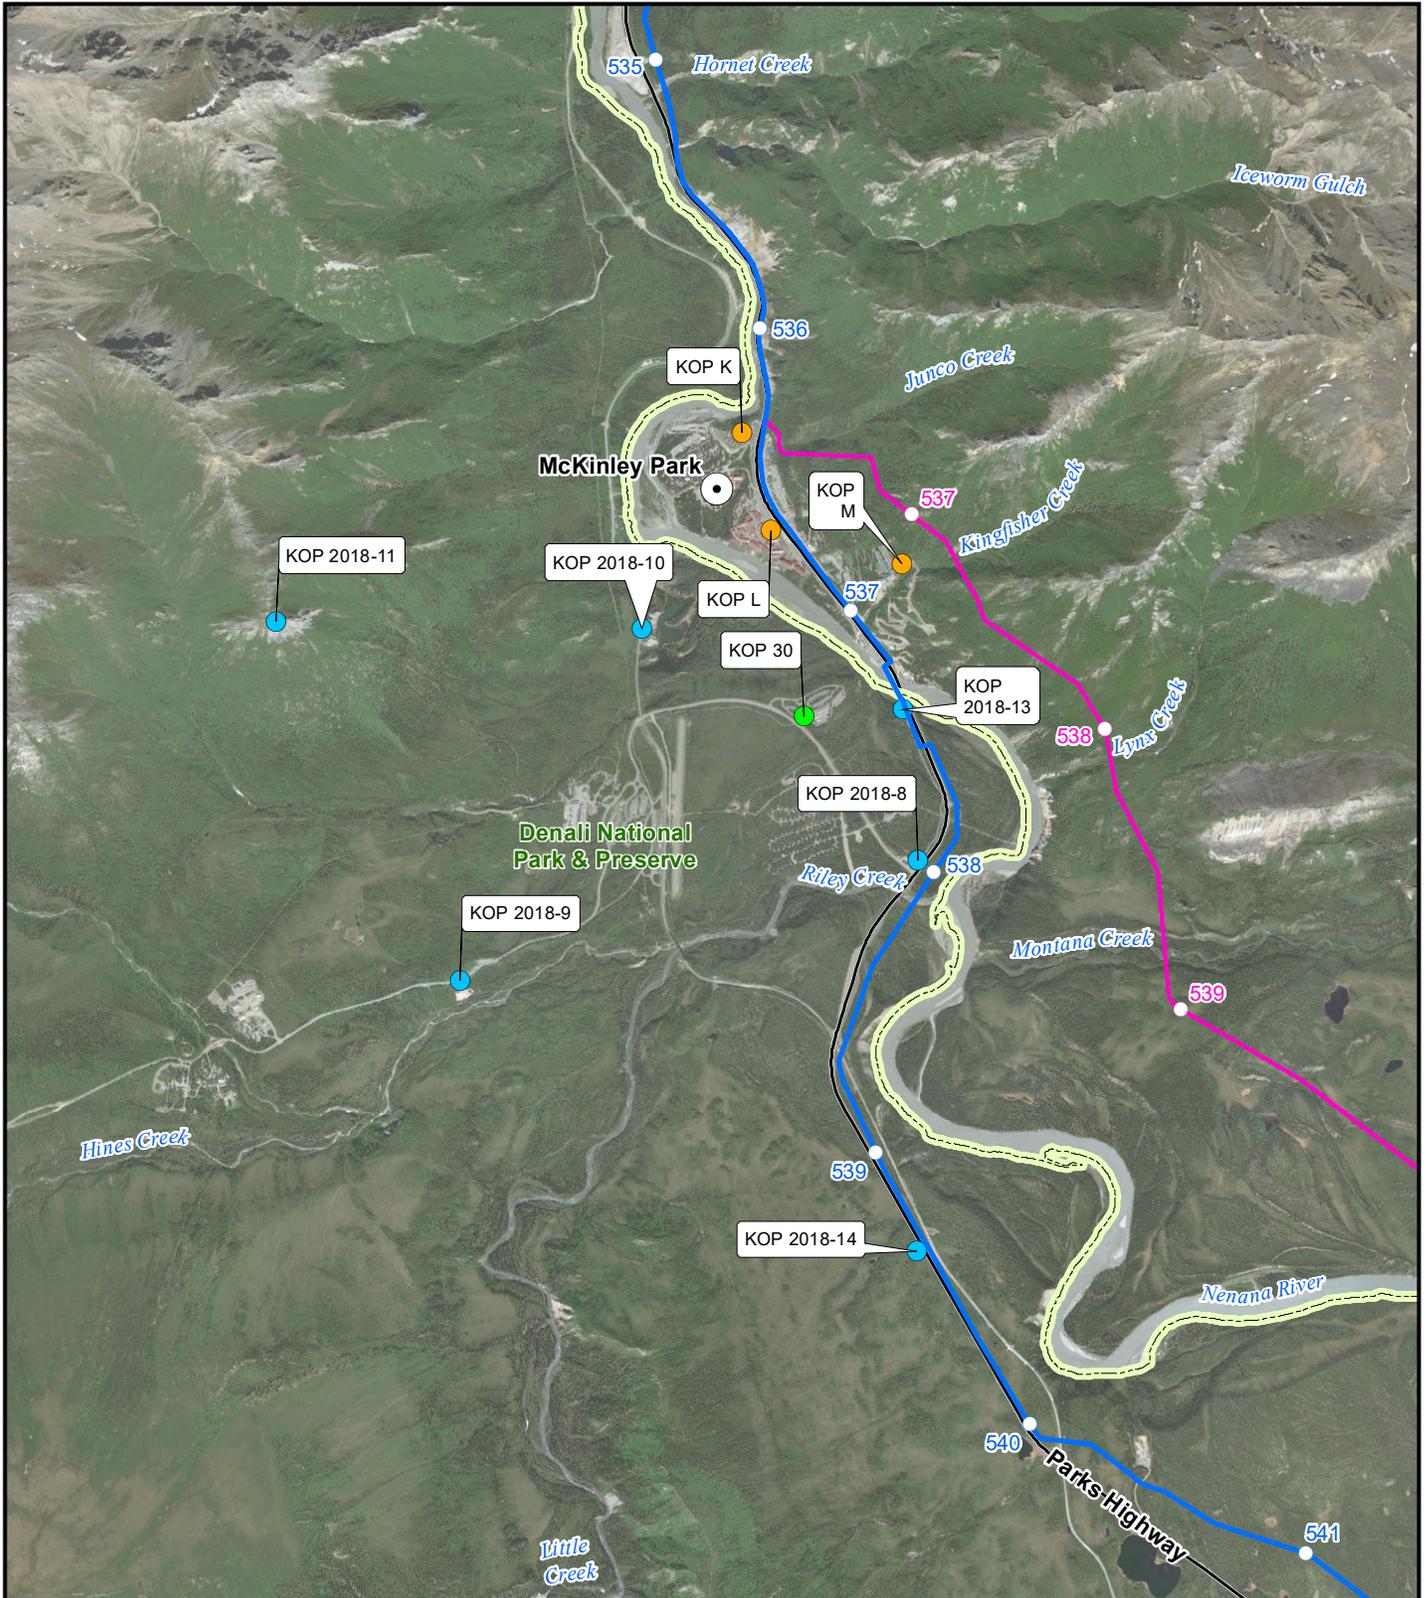
- Key Observation Point 2015
- Key Observation Point 2016
- Key Observation Point 2018
- Place of Interest
- Denali Avoidance Alternative Milepost
- Alaska LNG Proposed Mainline Milepost
- Alaska LNG Proposed Mainline Pipeline
- Denali Avoidance Alternative
- Park/Refuge Boundary

Figure E.1-1	KOP K, L, M, 2018-8, 2018-9, 2018-10, 2018-11, 2018-13, 2018-14.....	E-11
Figure E.1-2	KOP 2018-12	E-12

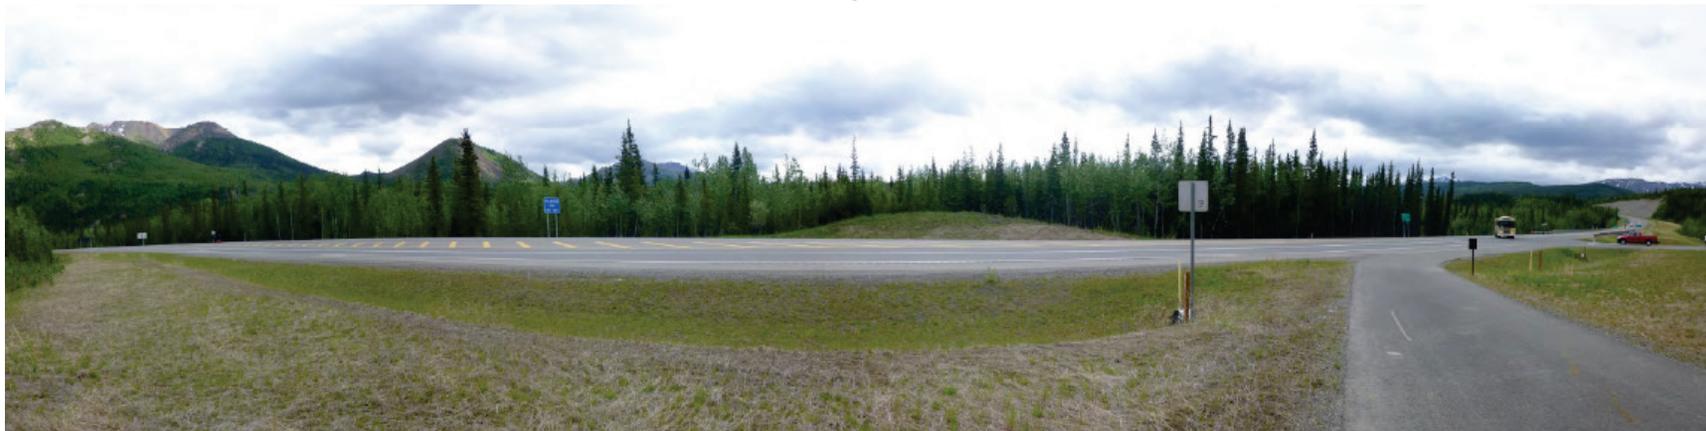
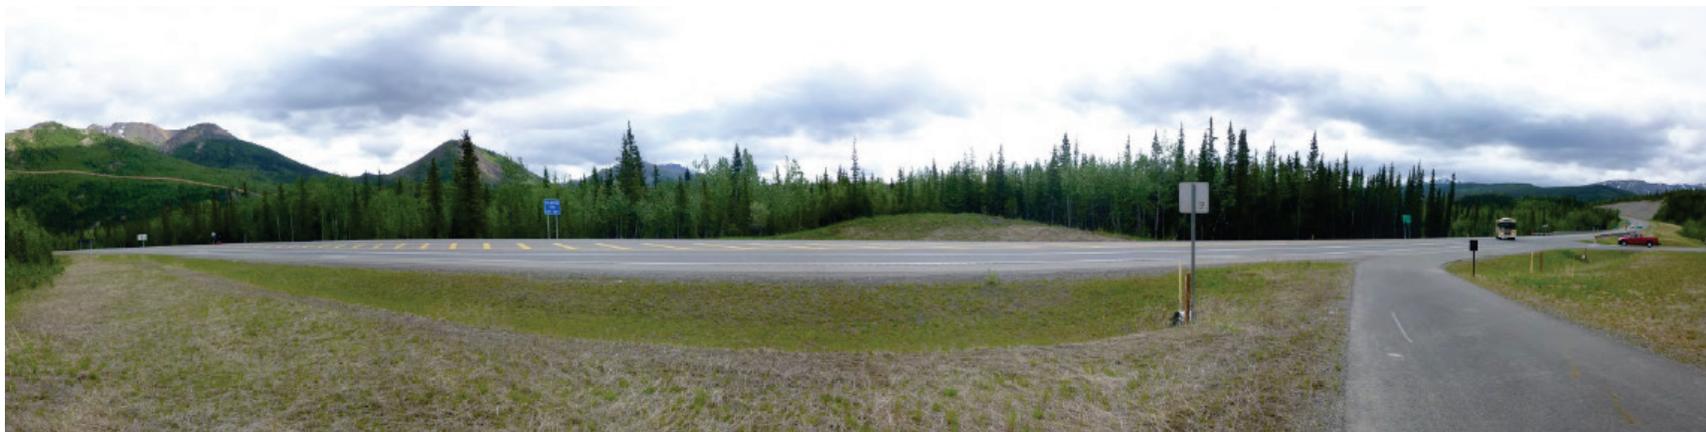
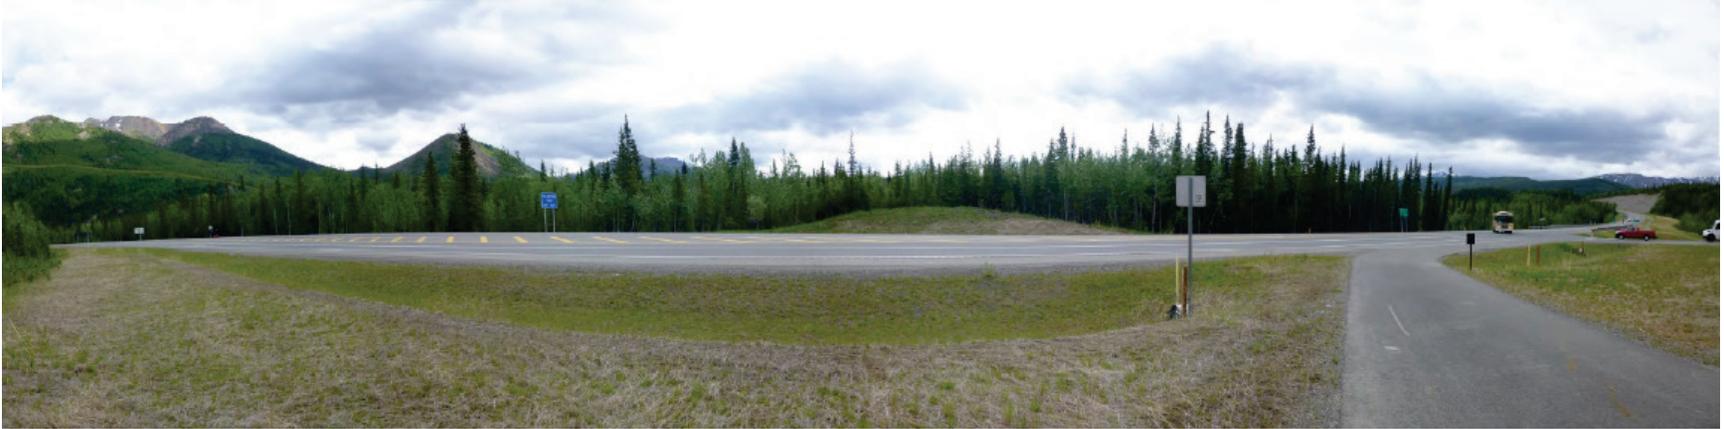
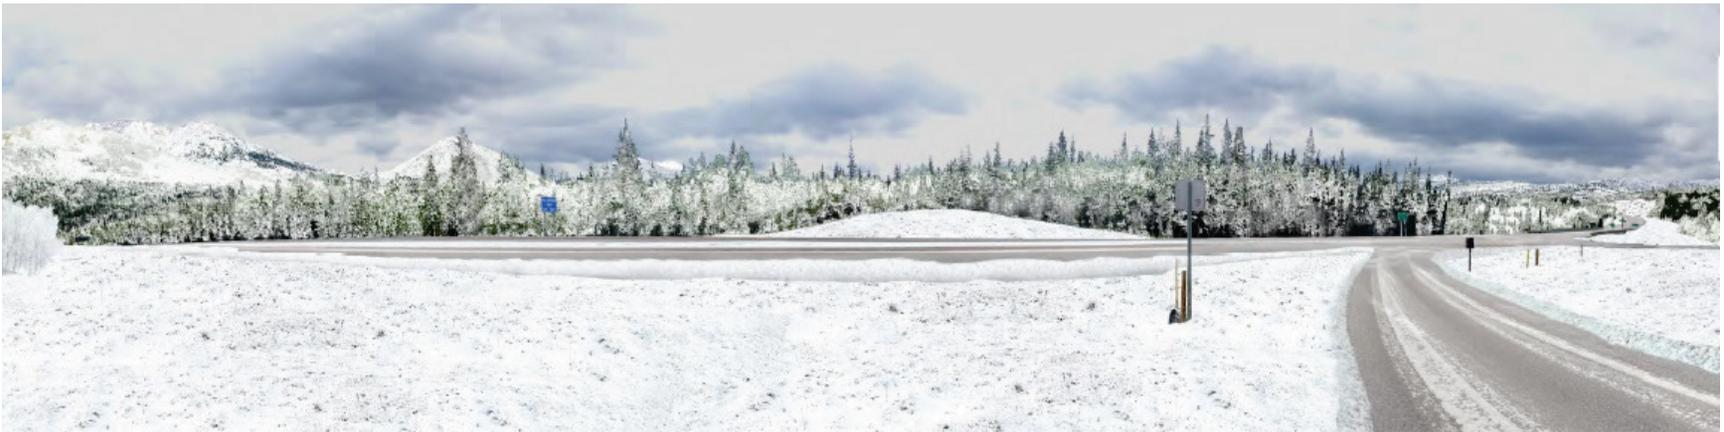
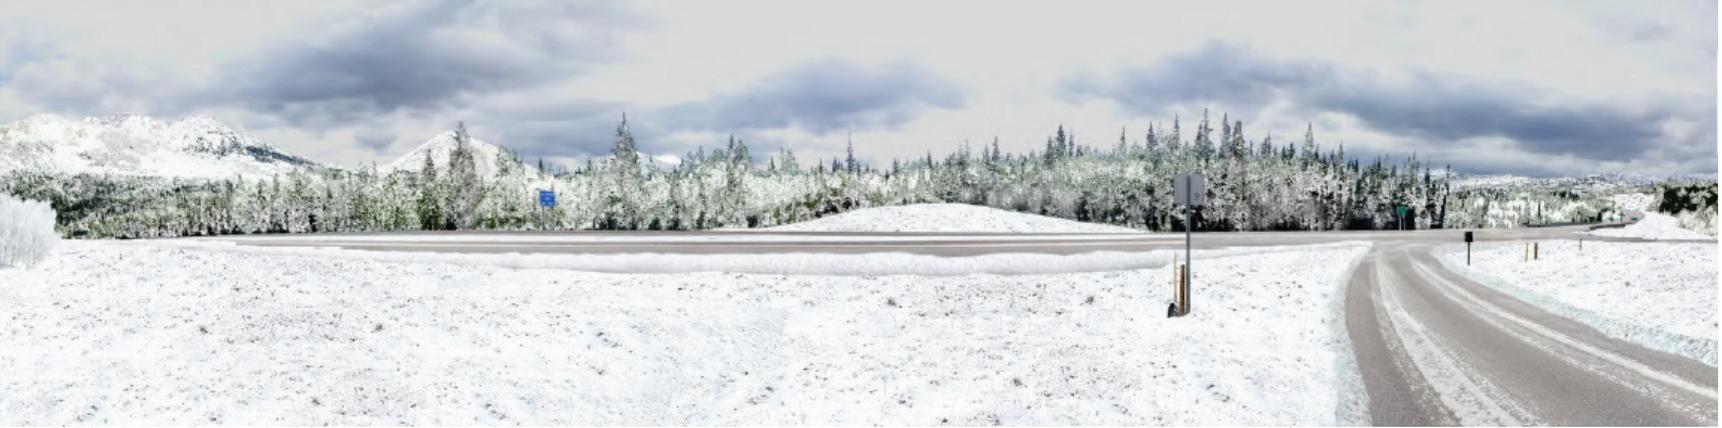
Figure E.1.2-1: KOP 2018-8: Intersection of George Parks Highway and the DNPP Park Road; View of the Denali Avoidance Alternative to the East

a. Existing Conditions

b. After Construction

c. After Reclamation

d. Existing Winter Conditions

e. Winter Conditions After Construction

Table E.1.1-1 summarizes the scenic quality, view importance, and scenic inventory ratings for each KOP within the DNPP. To evaluate visual impacts, AGDC prepared visual simulations for each KOP in the DNPP. Table E.1.1-2 summarizes the BLM visual resource inventory class, contrast rating, and impacts for the three KOPs near the DNPP. Appendix E-1c provides existing condition images along with the simulations.

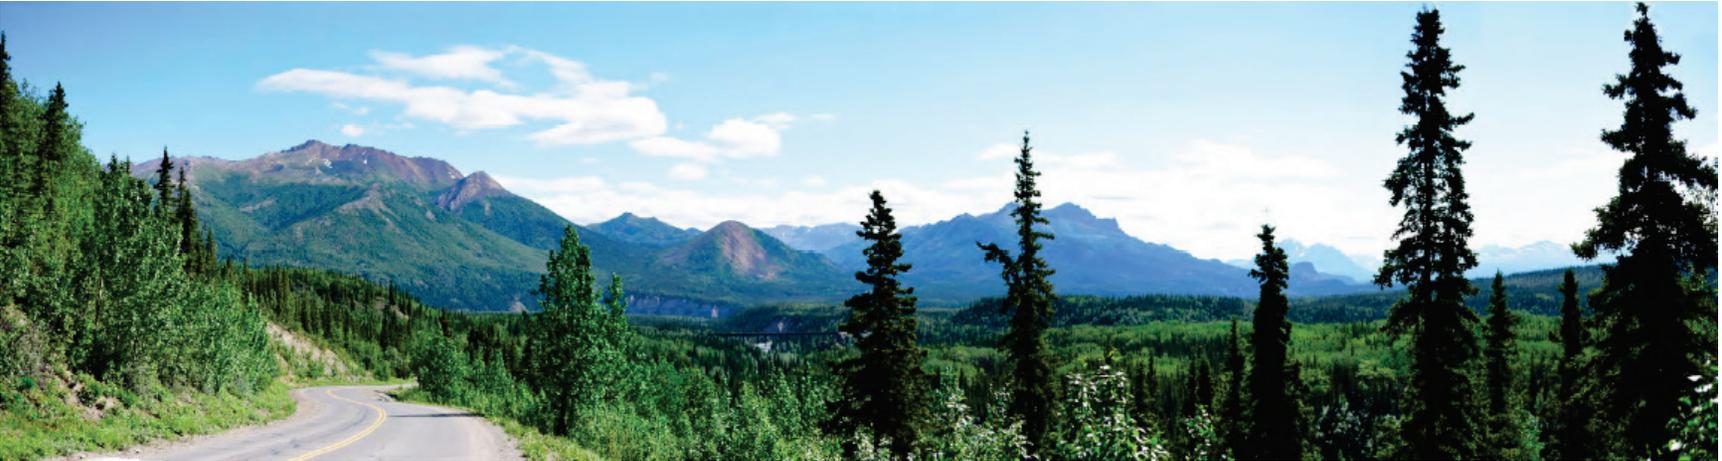
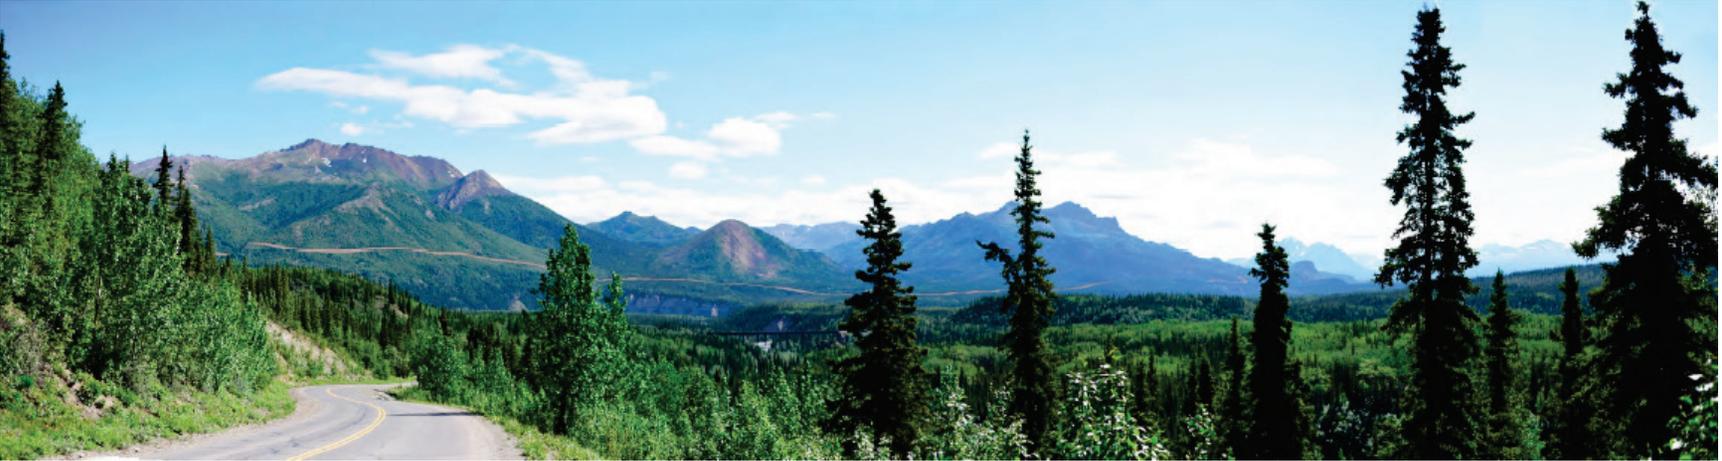
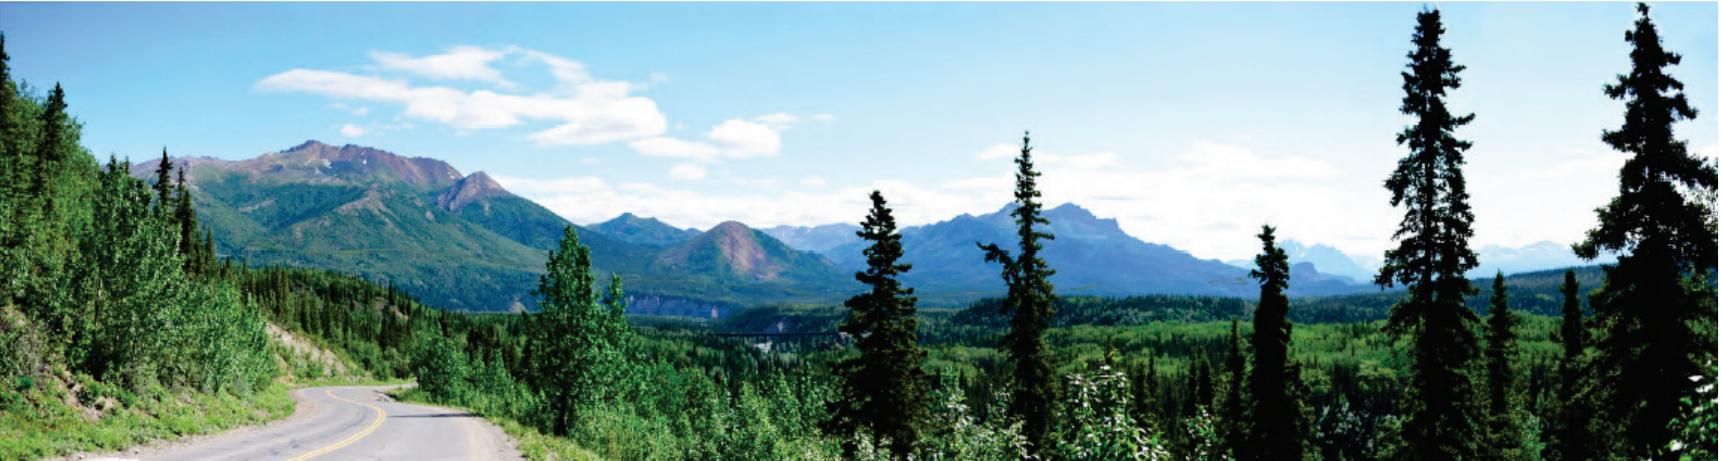
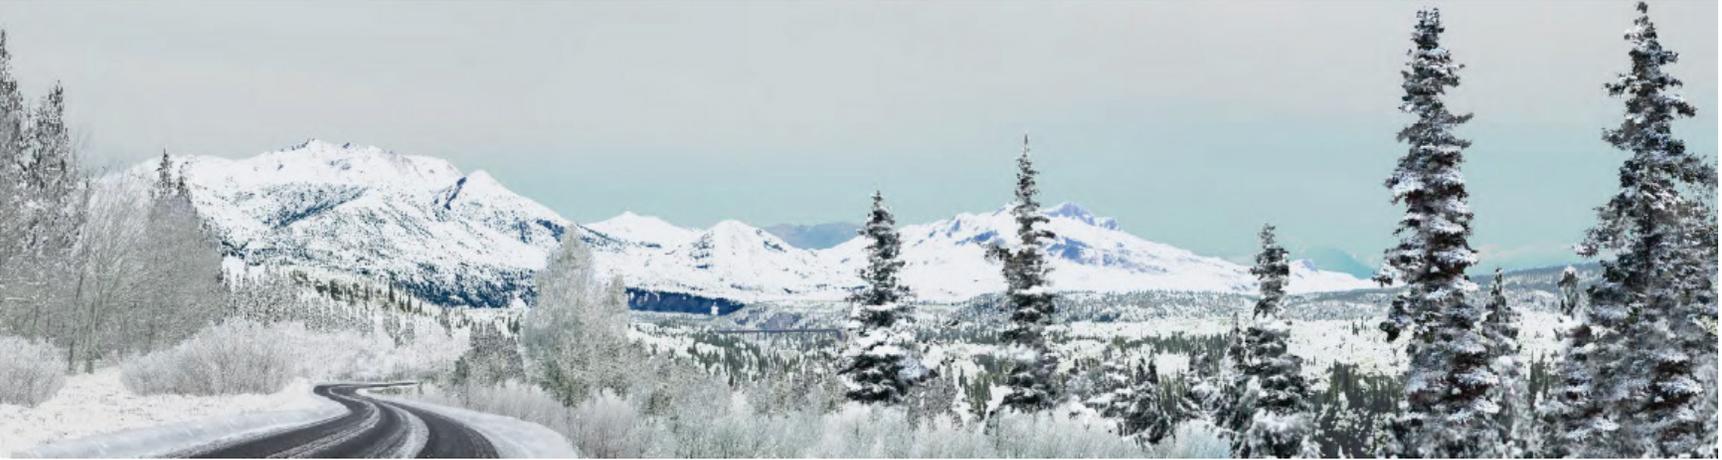
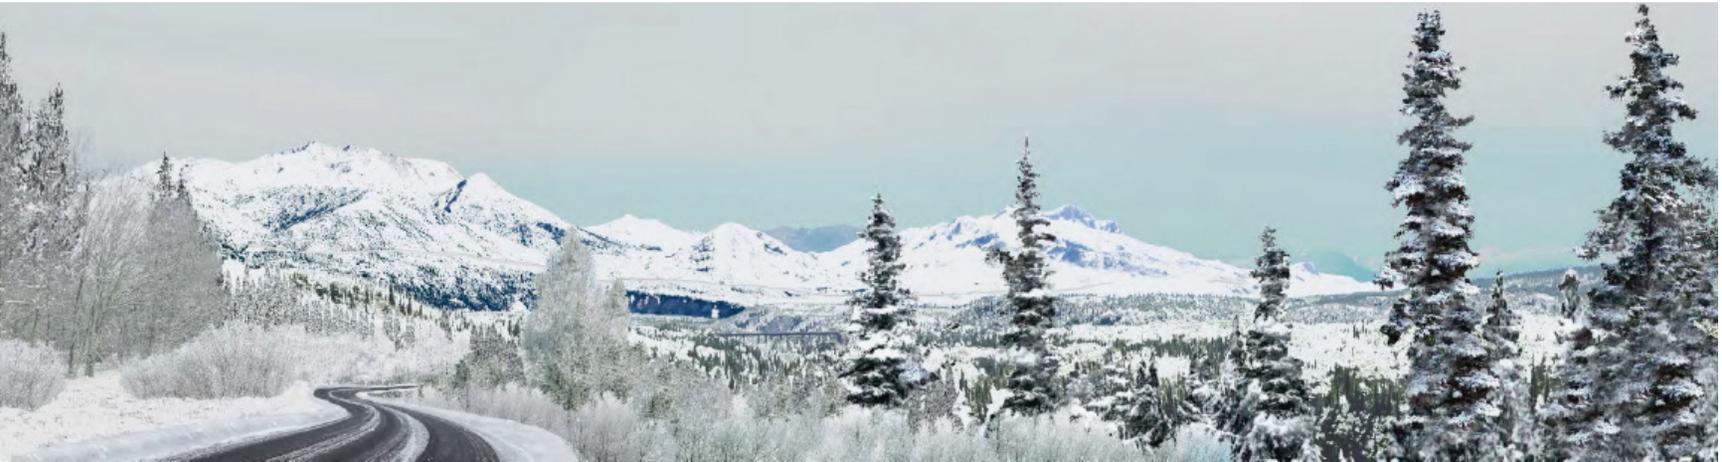
Figure E.1.3-1: KOP 2018-9: Government Hill; View of the Denali Avoidance Alternative to the East and Southeast

a. Existing Conditions

b. After Construction

c. After Reclamation

d. Existing Winter Conditions

e. Winter Conditions After Construction

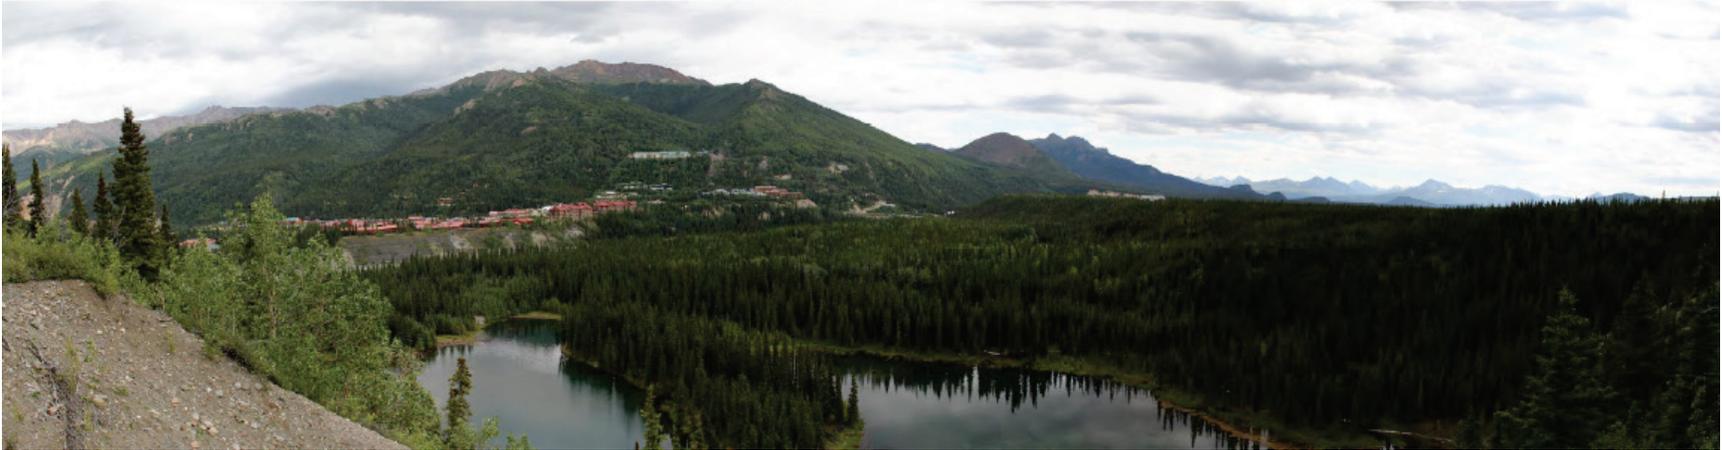
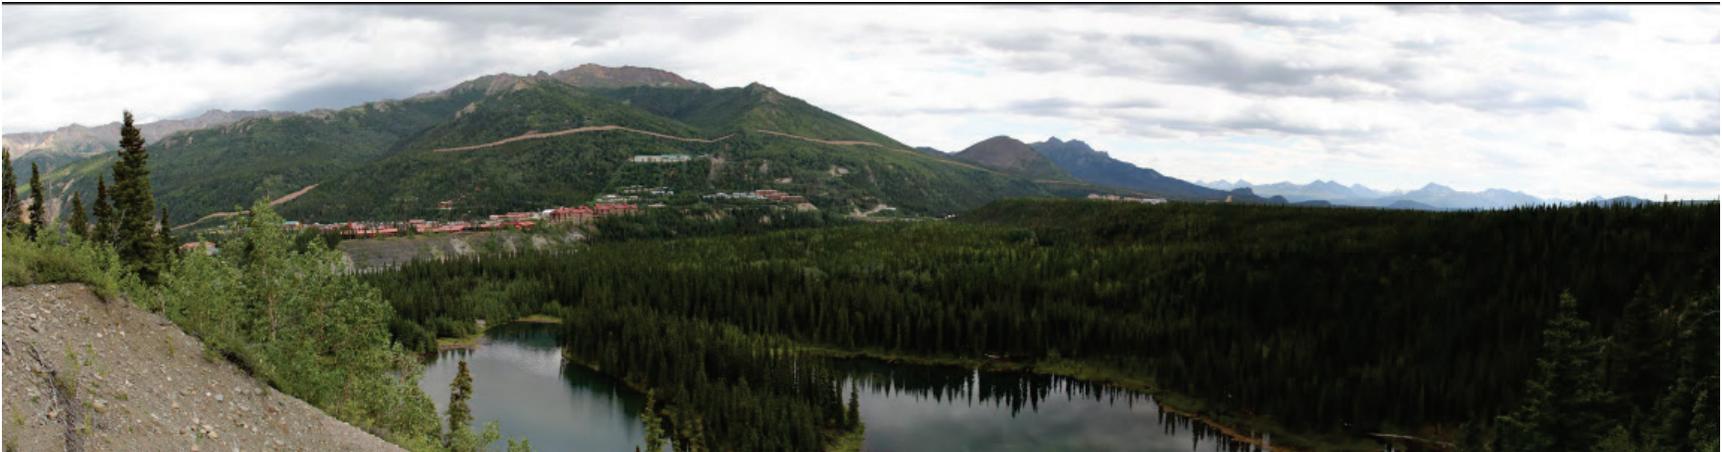
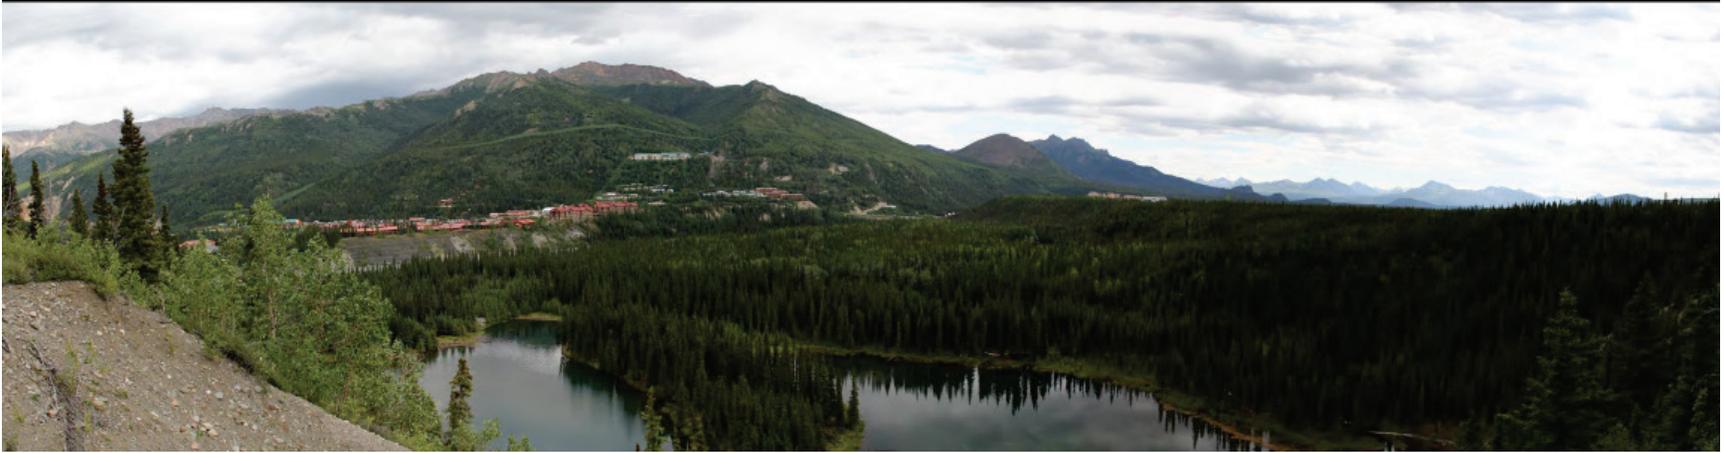
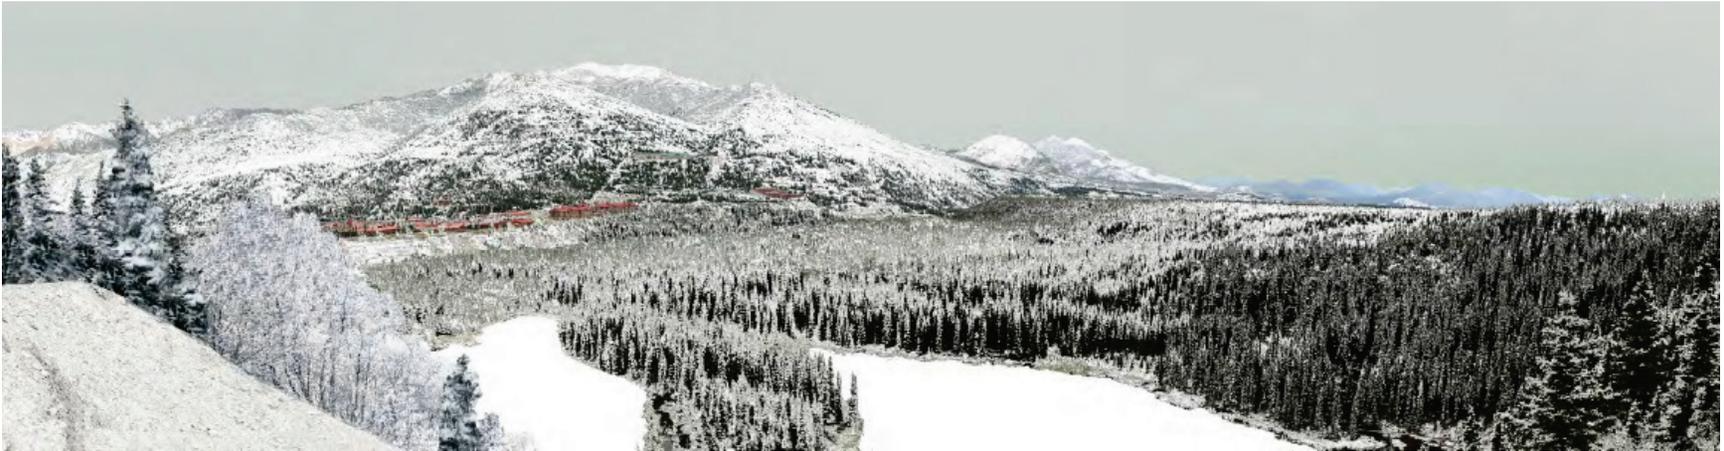
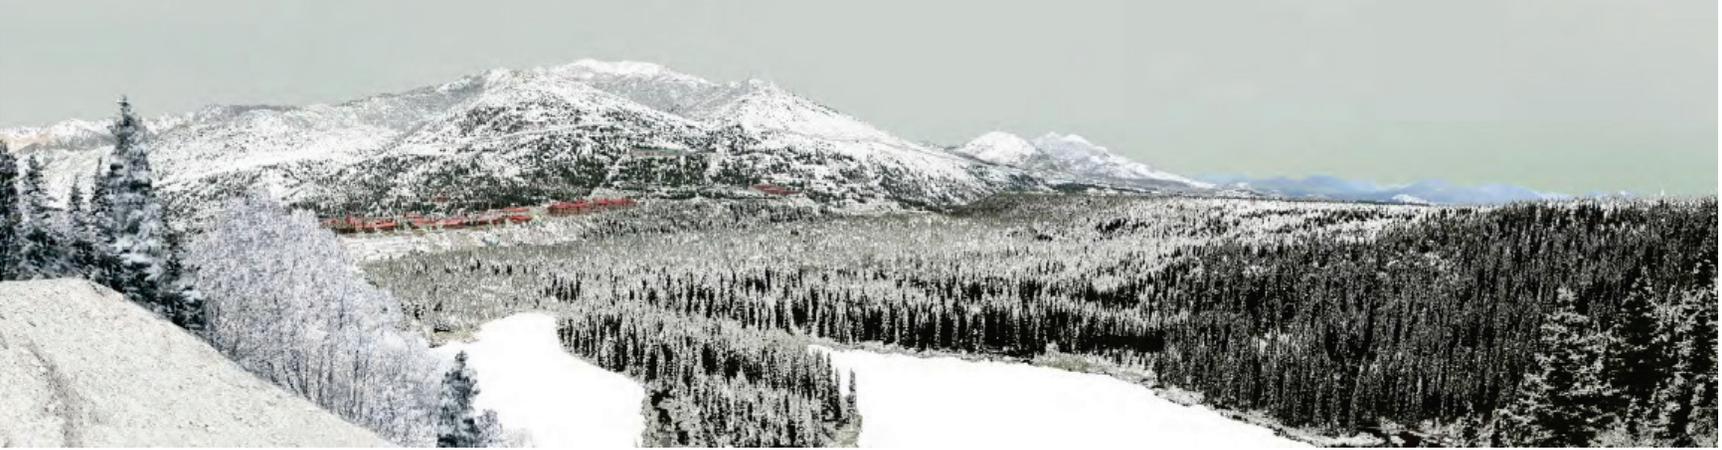
Figure E.1.4-1: KOP 2018-10: Railroad Above Horseshoe Lake; View of the Denali Avoidance Alternative to the East

a. Existing Conditions

b. After Construction

c. After Reclamation

d. Existing Winter Conditions

e. Winter Conditions After Construction

^d Due to the inability to access the Alaska Railroad right-of-way, the NPS selected a proxy location near, but not at, the coordinates listed in table E.1-1. This proxy location was used to determine scenic quality and capture photos used to demonstrate existing conditions and simulate potential visual impacts.

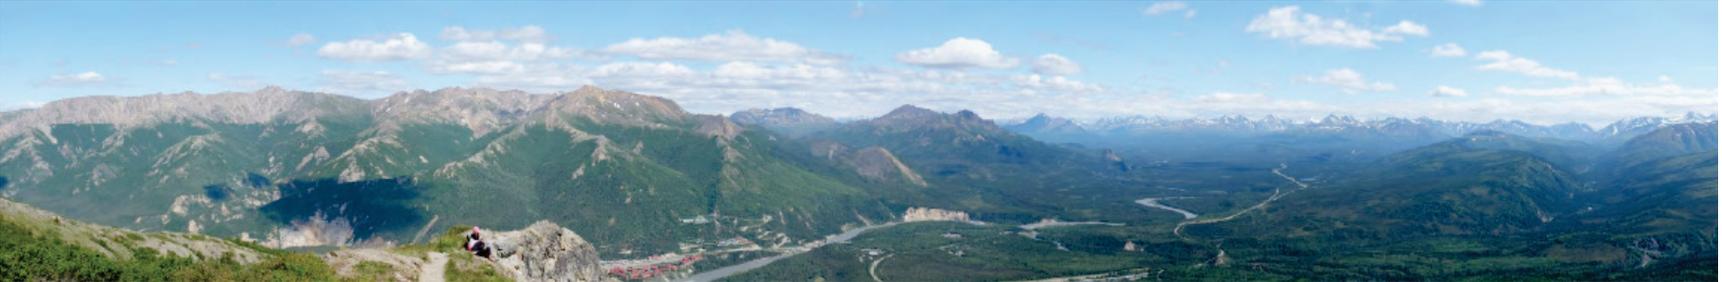
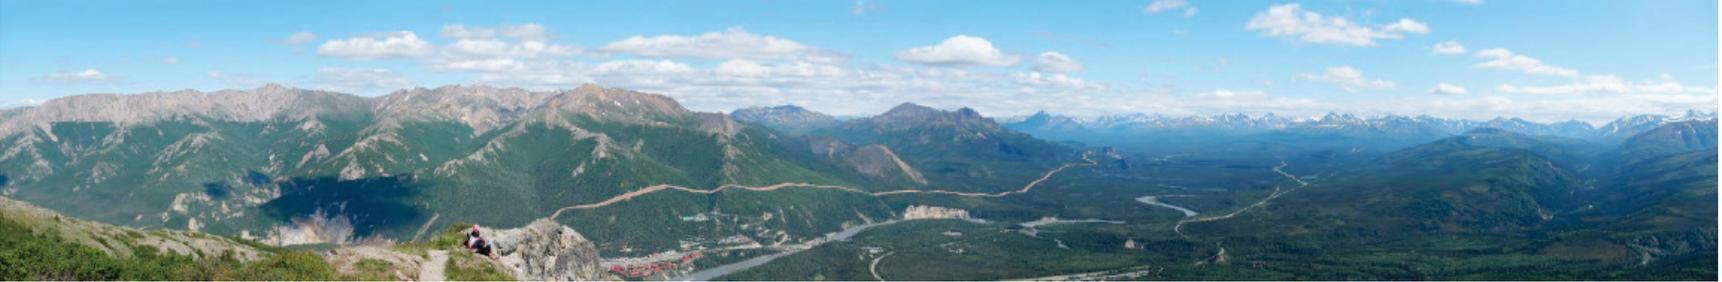
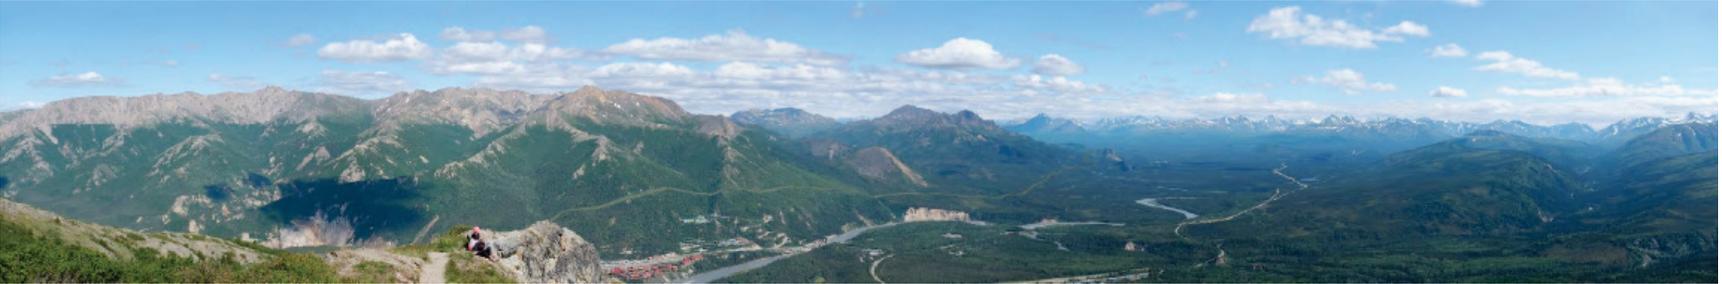
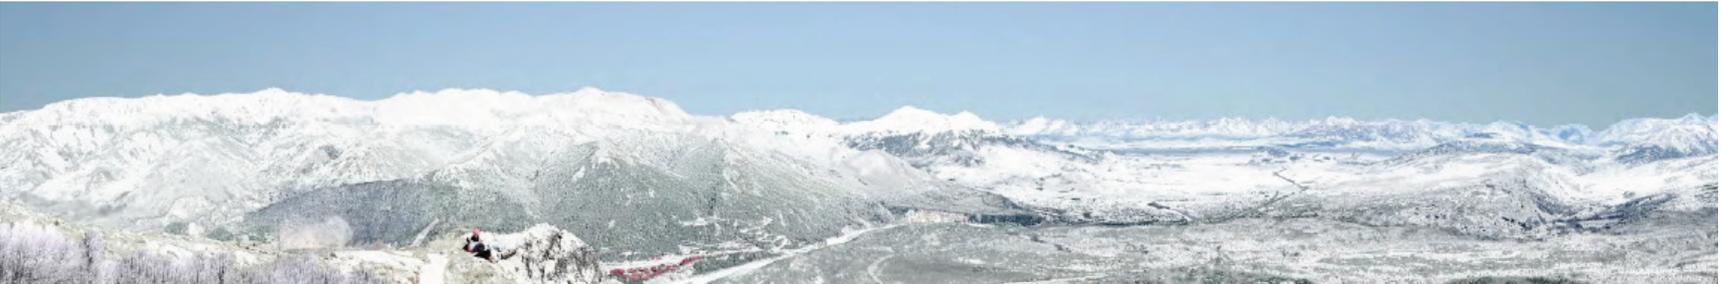
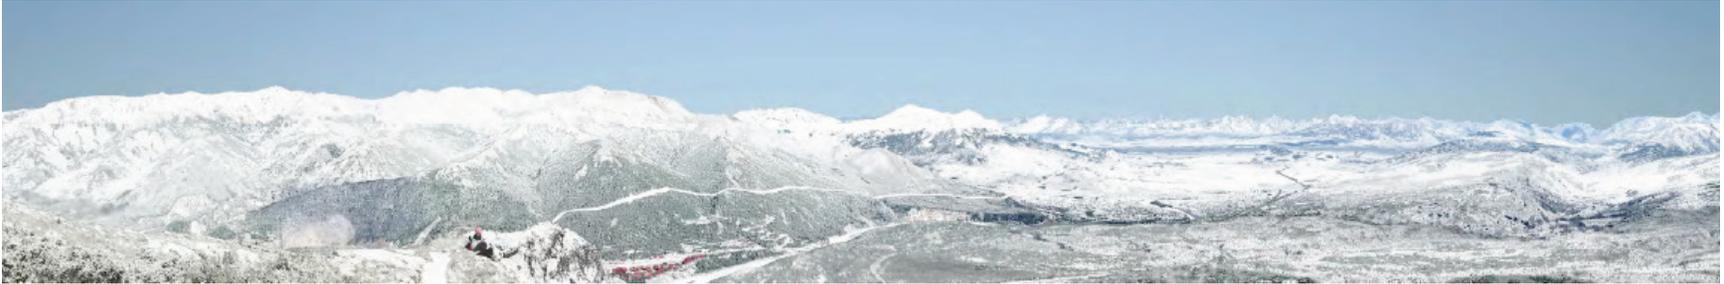
Figure E.1.5-1: KOP 2018-11: Mt. Healy Overlook Trail Summit; View of the Denali Avoidance Alternative to the East, Southeast, and South

a. Existing Conditions

b. After Construction

c. After Reclamation

d. Existing Winter Conditions

e. Winter Conditions After Construction
