**Denali Avoidance Alternative –
Visual Impact Assessment**

**Affected Visual Environment, Impacts, and Mitigation Measures
at Key Observation Points**

Figure E.1-1
Alaska LNG Project
Denali Avoidance Alternative
 Key Observation Pt: KOP K, L, M,
 2018-8, 2018-9, 2018-10, 2018-11,
 2018-13, and 2018-14

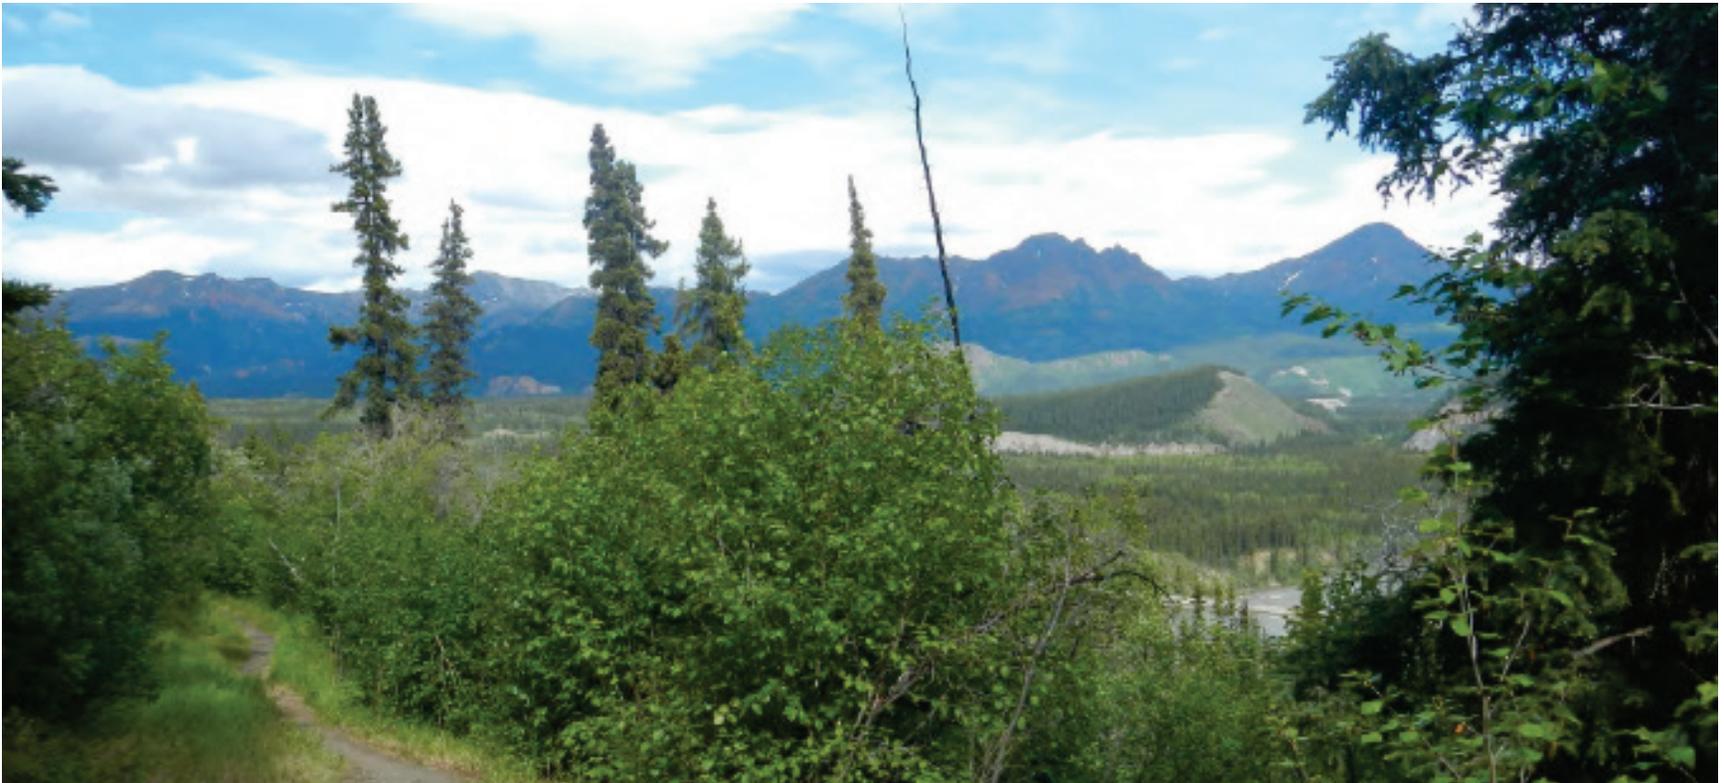
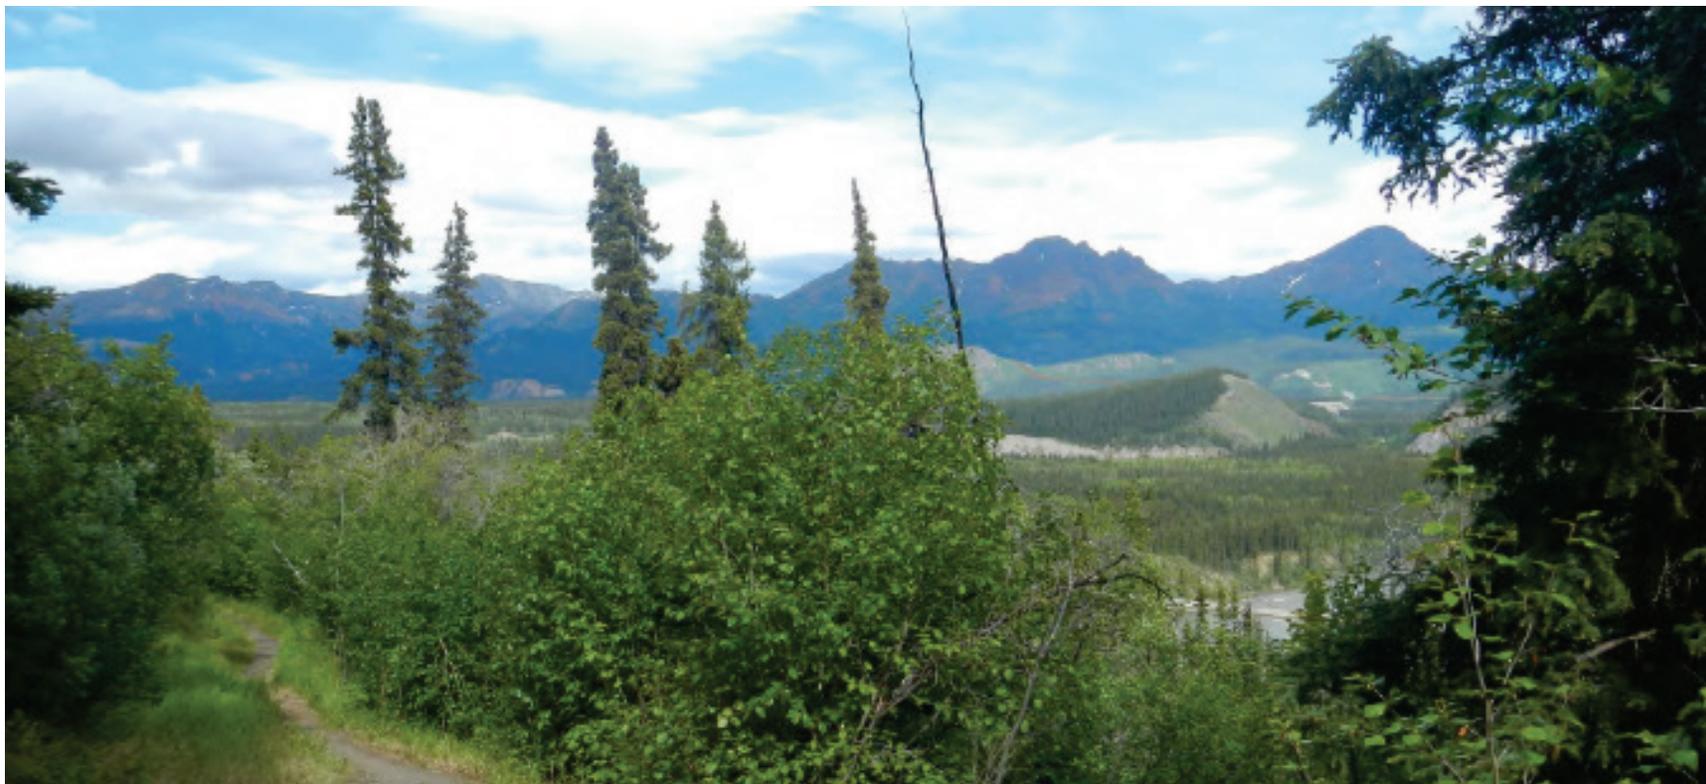
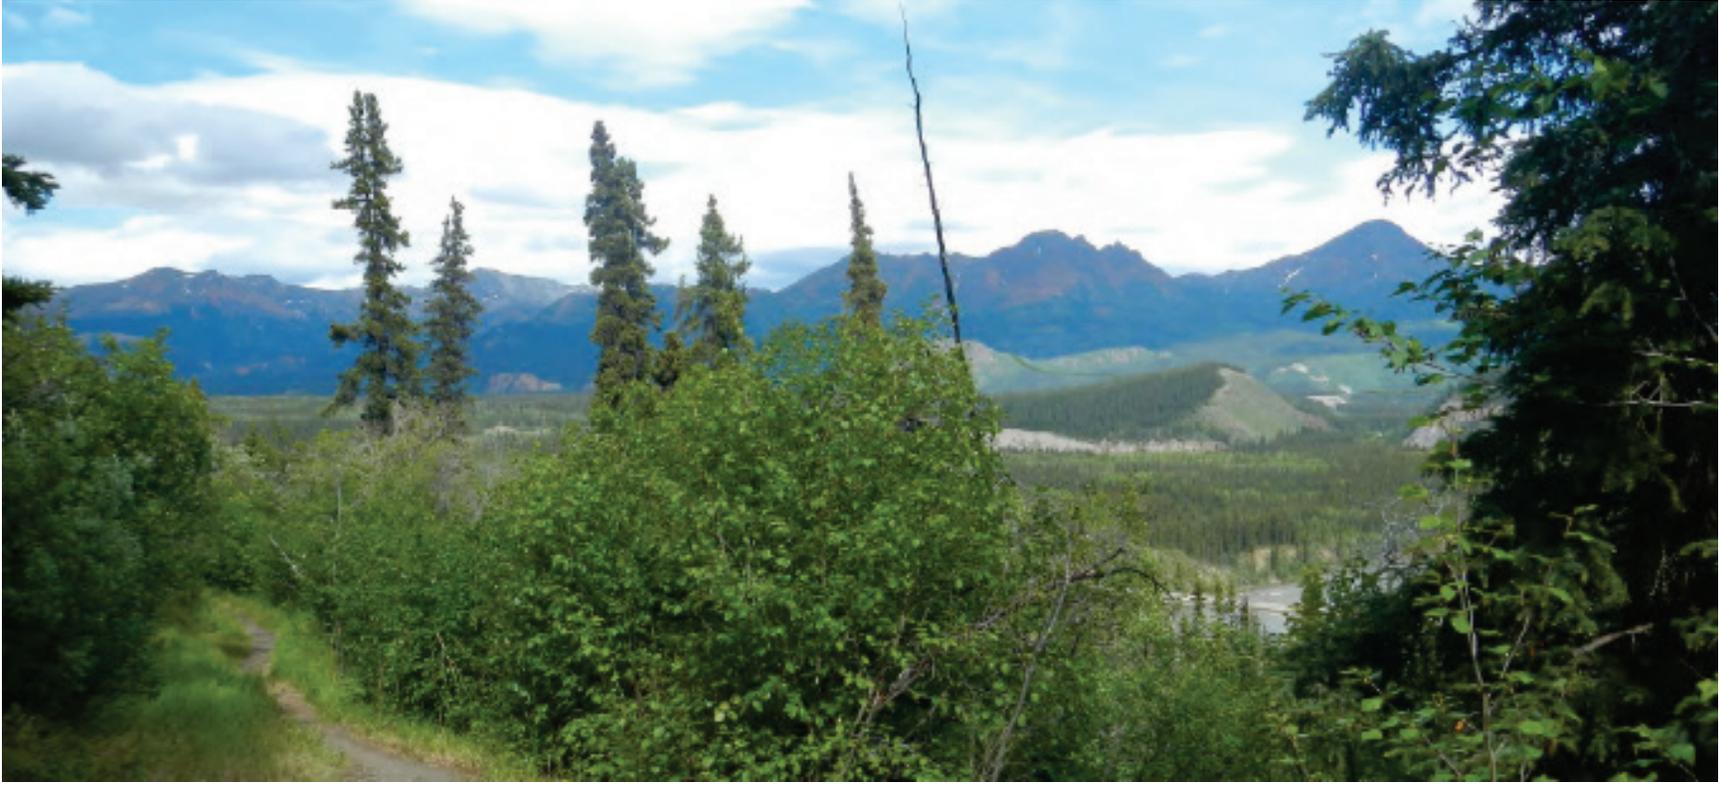
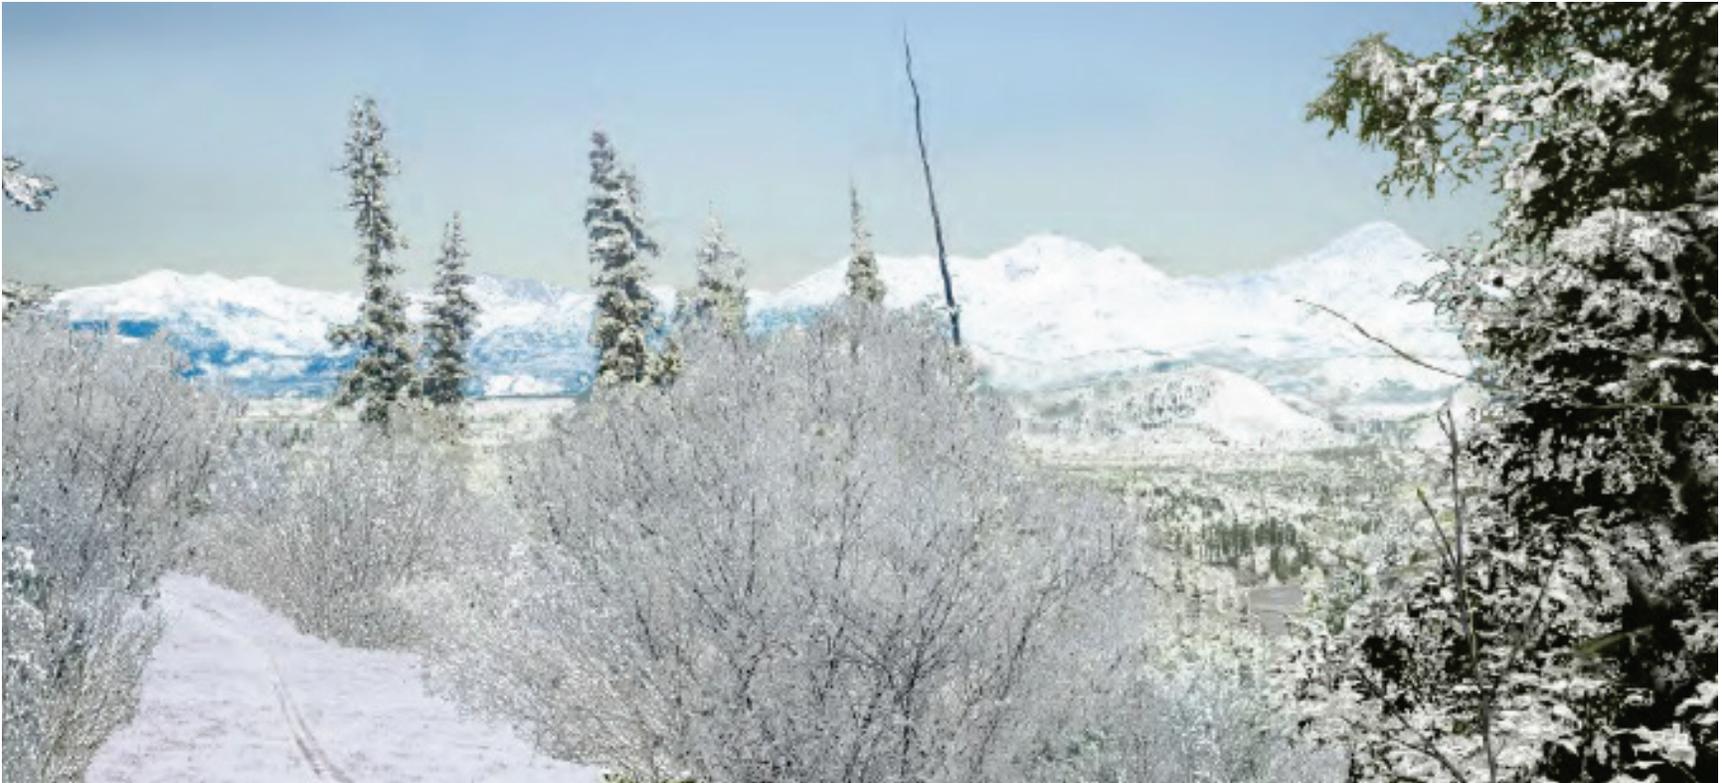
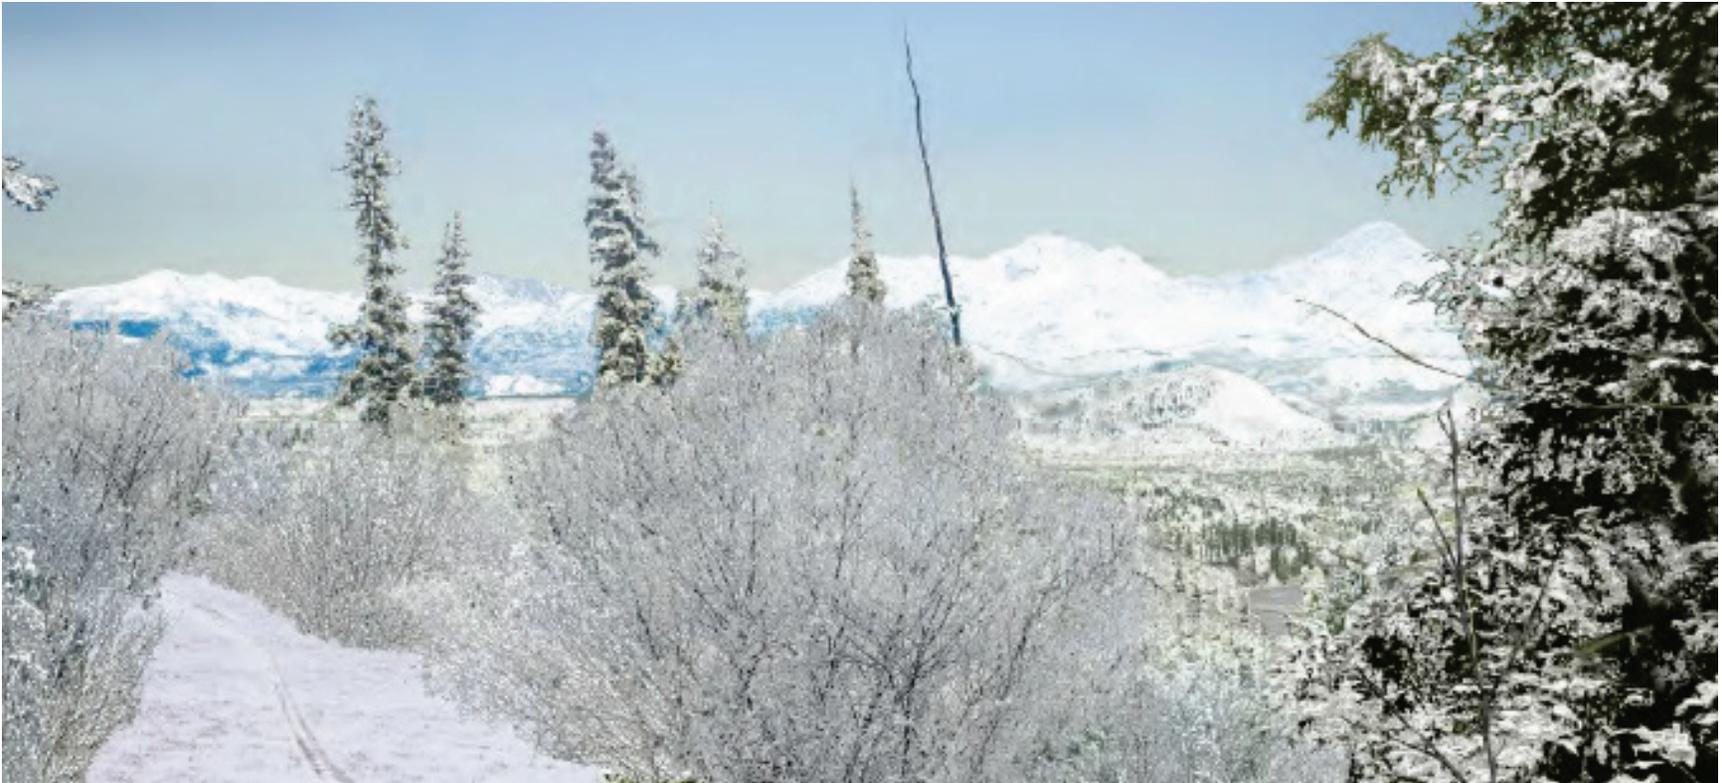
Figure E.1.6-1: KOP 2018-12: Triple Lakes Trail; View of the Denali Avoidance Alternative to the Northeast

a. Existing Conditions

b. After Construction

c. After Reclamation

d. Existing Winter Conditions

e. Winter Conditions After Construction

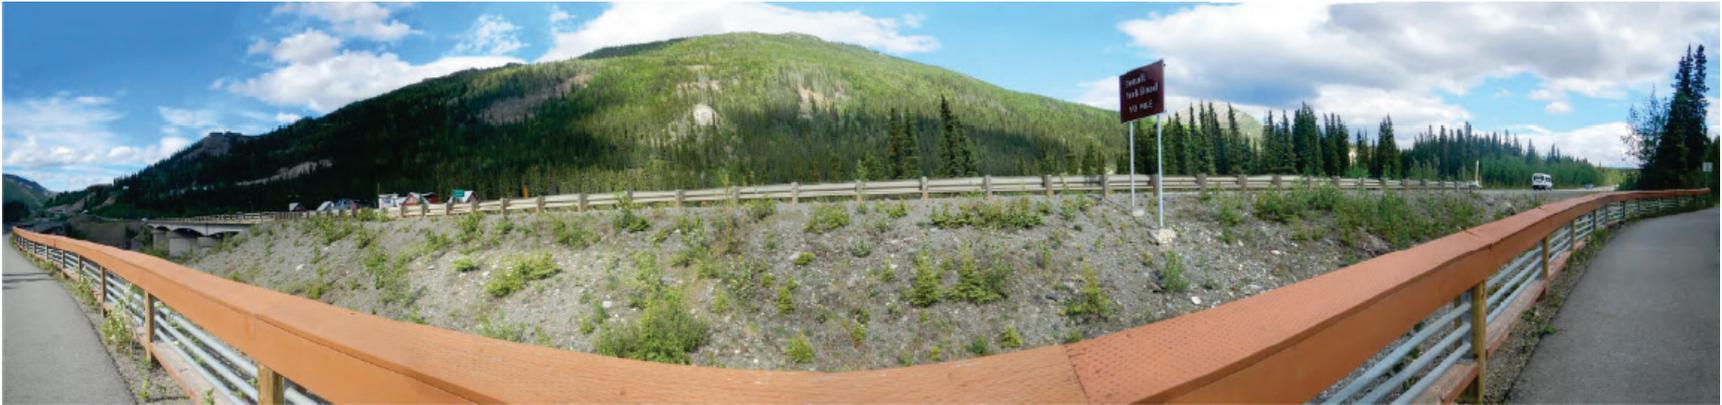
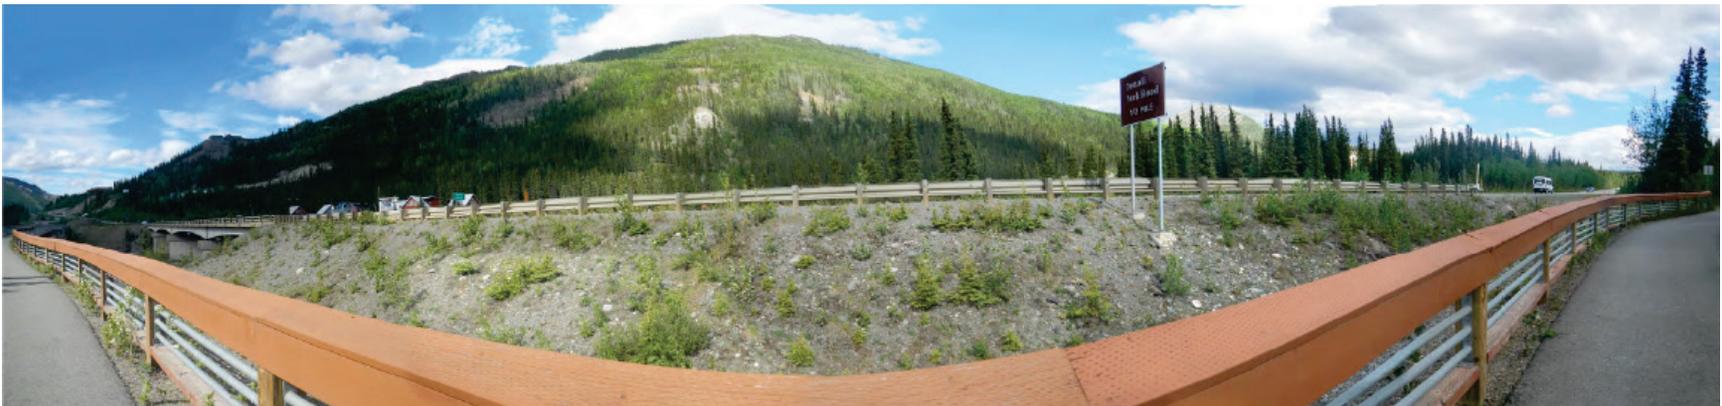
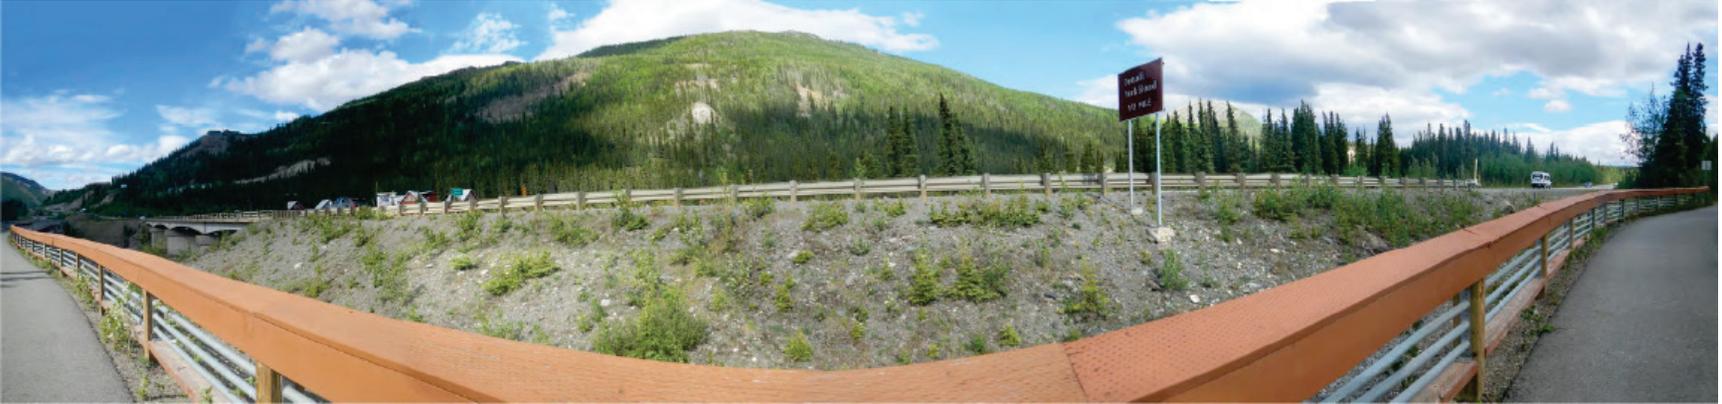
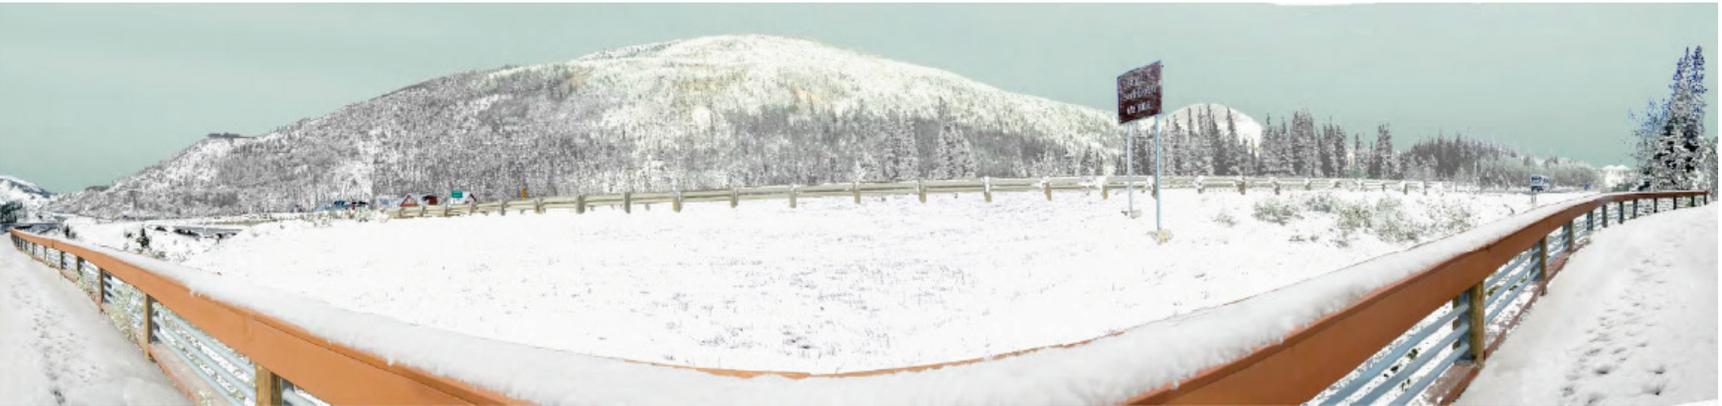
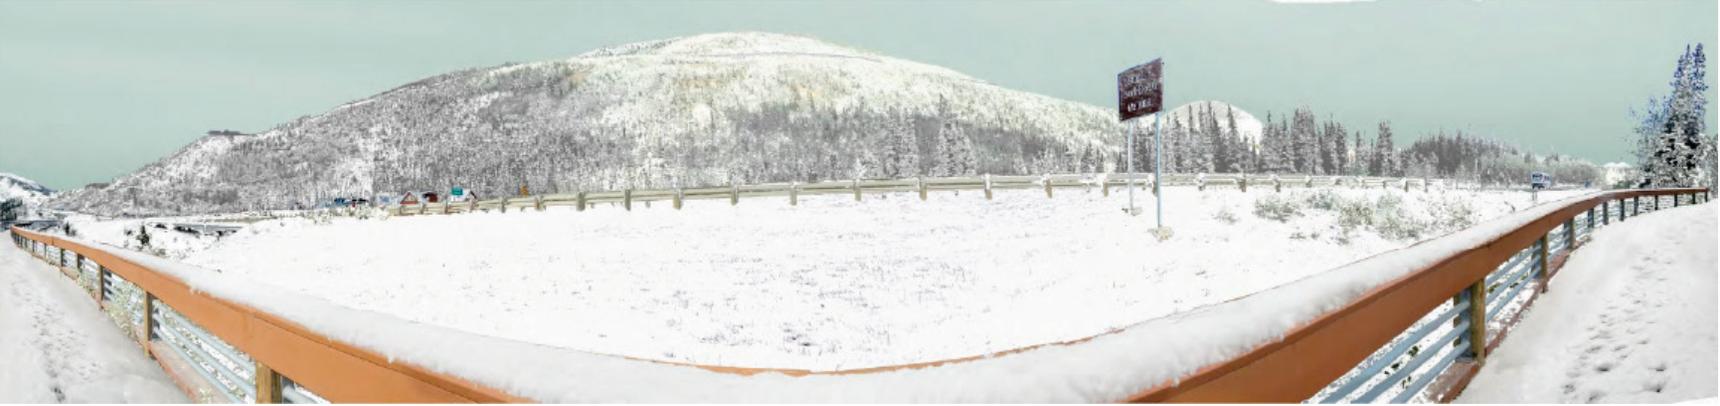
Figure E.1.7-1: KOP 2018-13: Nenana River Pedestrian Bridge; View of the Denali Avoidance Alternative to the South

a. Existing Conditions

b. After Construction

c. After Reclamation

d. Existing Winter Conditions

e. Winter Conditions After Construction

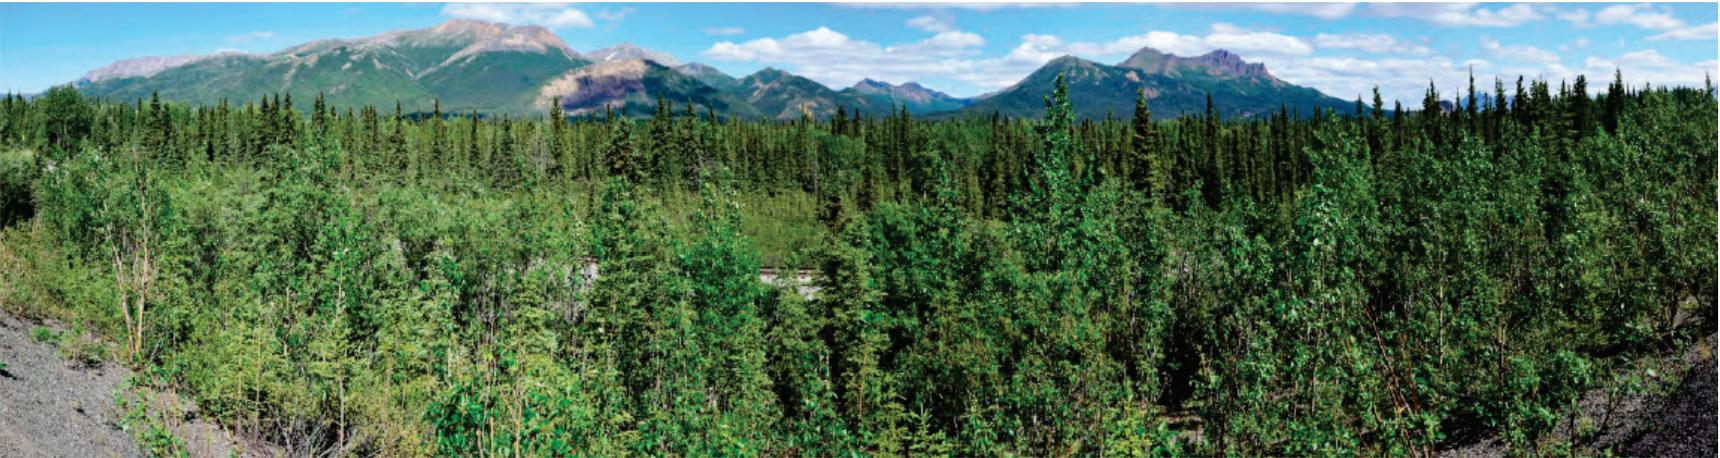
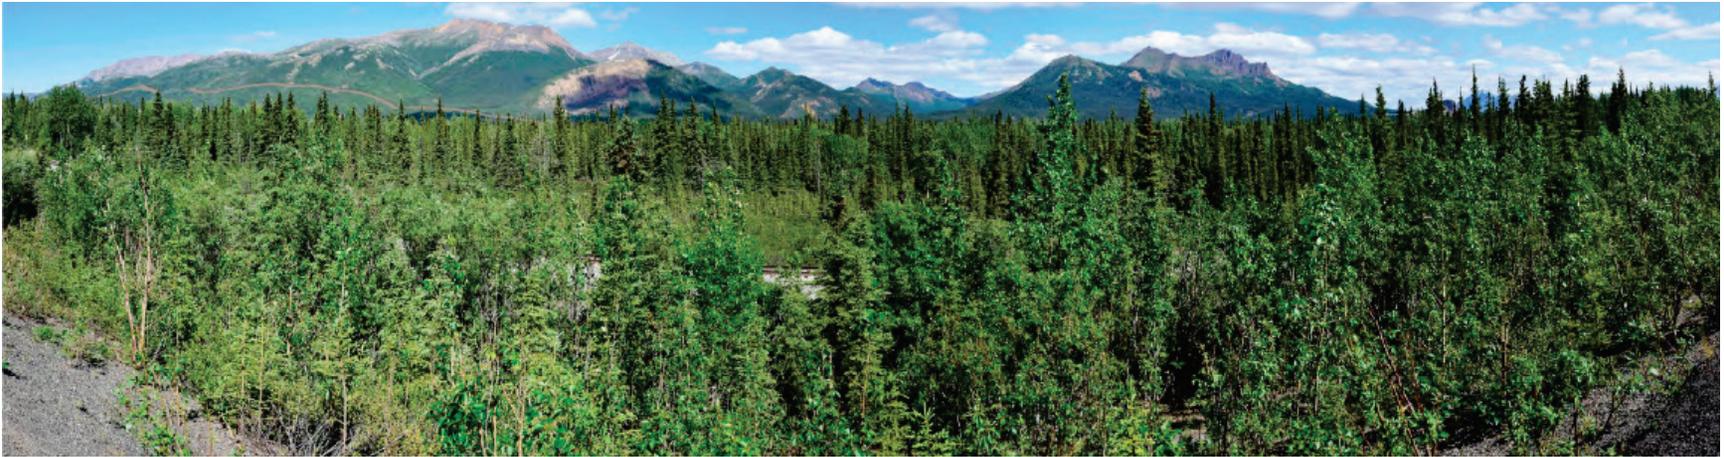
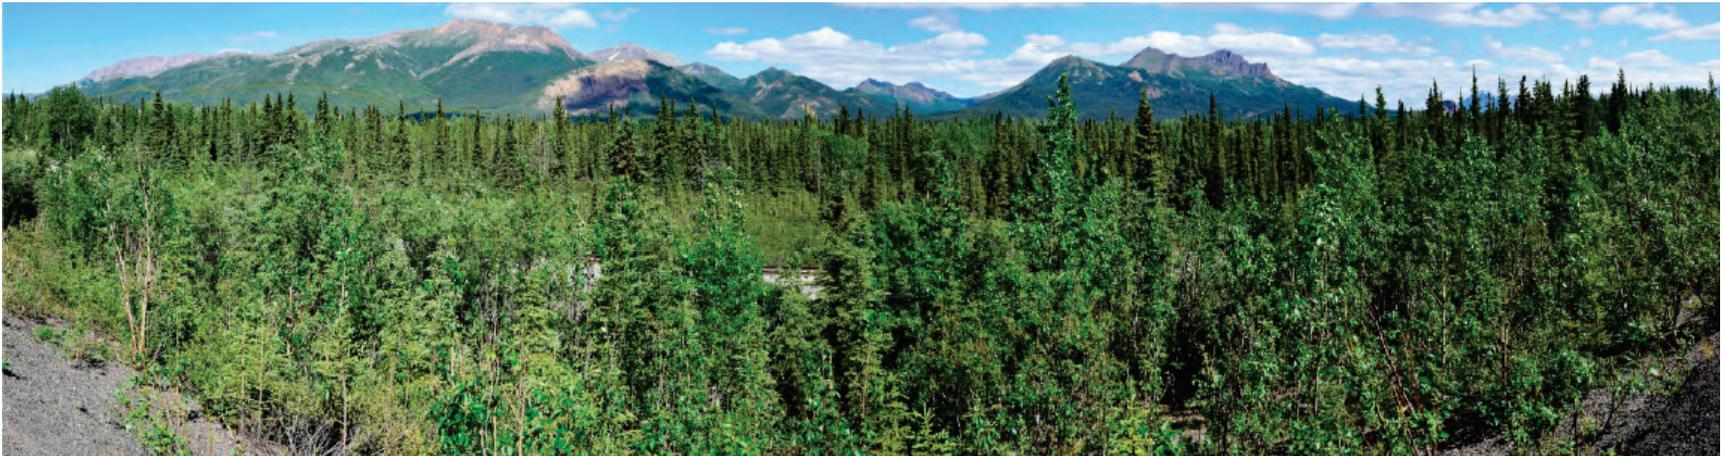
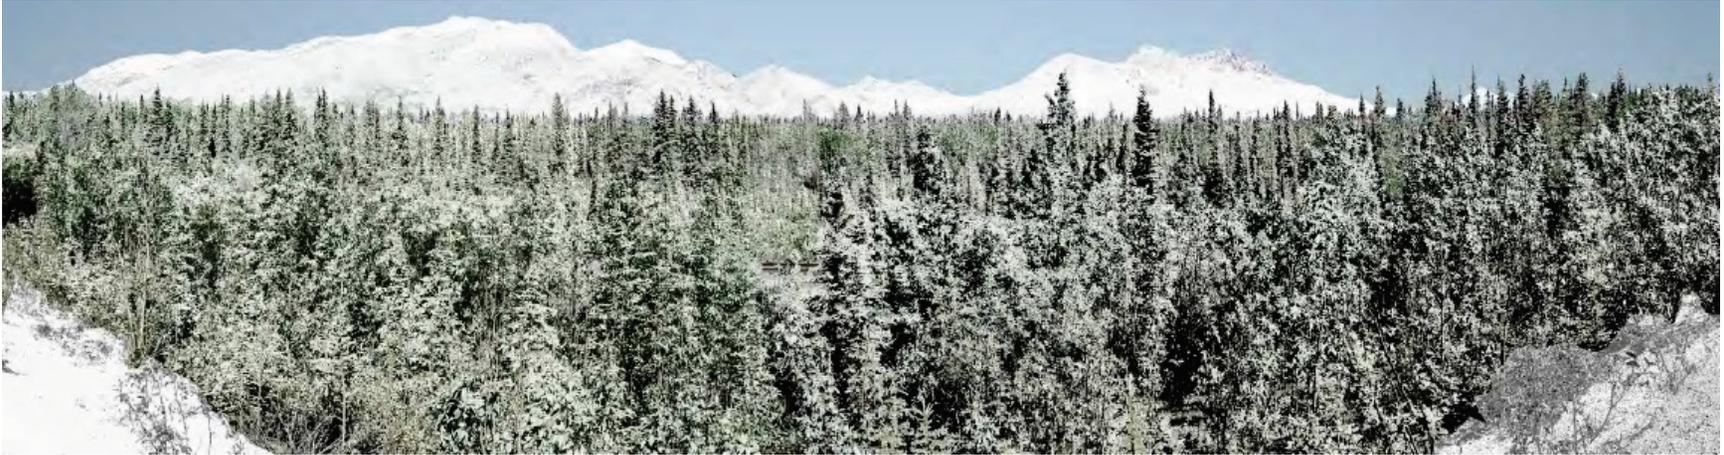
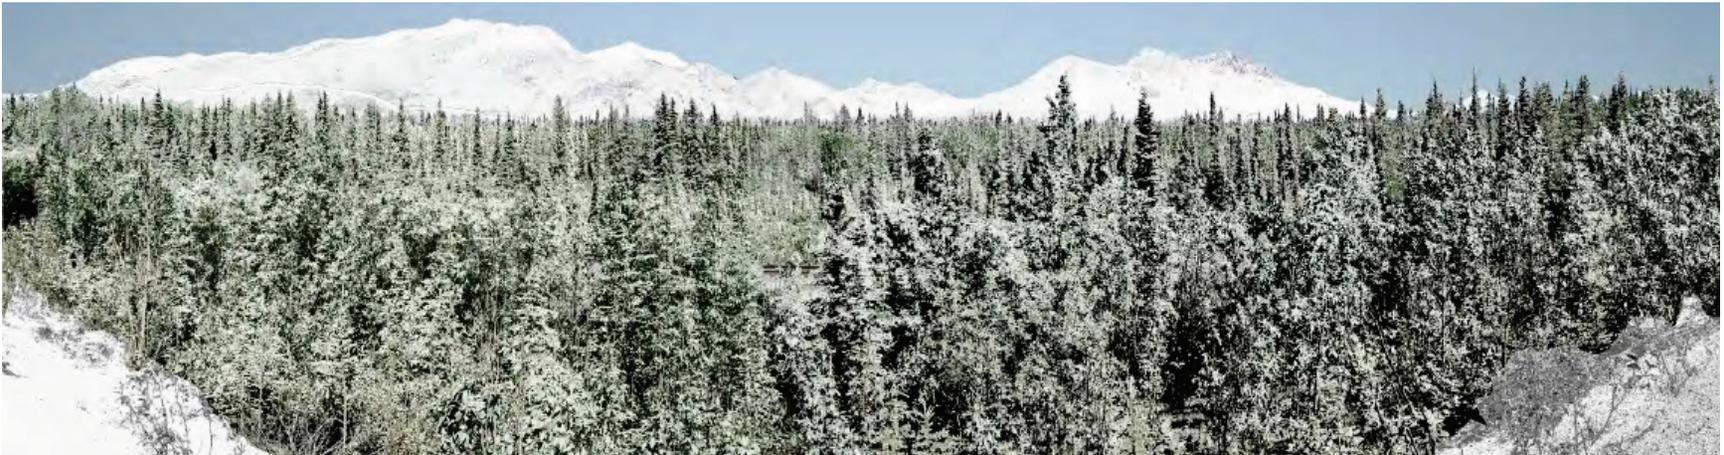
Figure E.1.8-1: KOP 2018-14: George Parks Highway MP 236; View of the Denali Avoidance Alternative to the East

a. Existing Conditions

b. After Construction

c. After Reclamation

d. Existing Winter Conditions

e. Winter Conditions After Construction

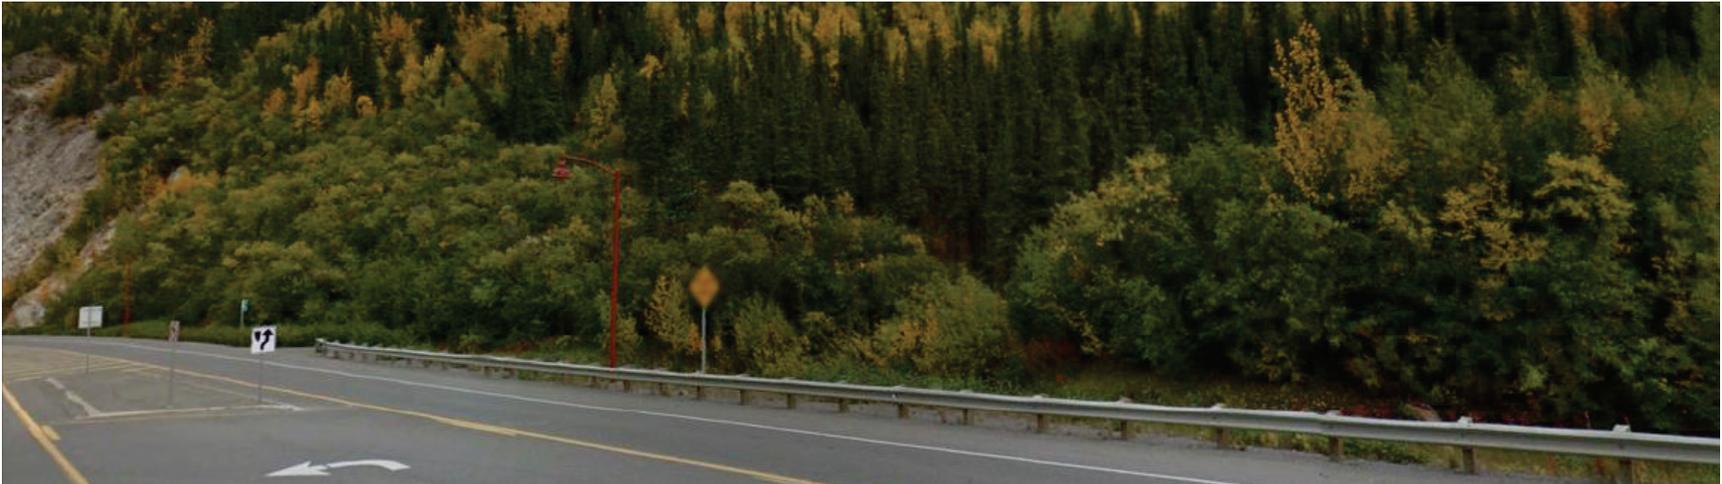
a. Existing Conditions

Figure E.1.9-1: KOP K: McKinley Chalet Resort; View of the Denali Avoidance Alternative to the East
