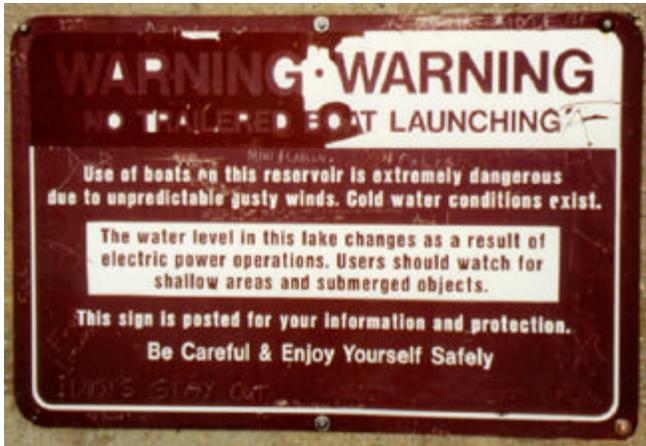
BS-23

Warning No Trailered Boat Launching...

Sign has faded and been vandalized. Warning text is well grouped and stated, but disrepair detracts from effectiveness.

Replace or repair, and assess need for more frequent maintenance or anti-vandalism measures.

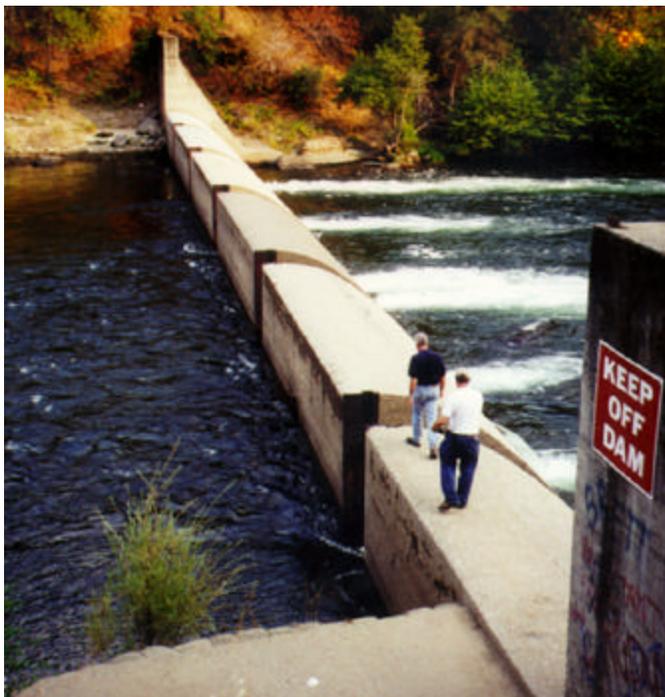
BS-24

Keep Off Dam

Coloring, position, and text are good. Sign ineffective as only measure. Worn dirt area indicates possible frequent use of banking.

Assess need for additional measures including signs that are visible from all approaches to the dam, fencing, increased monitoring of area, or addition of penalty/law text on sign, if appropriate.
