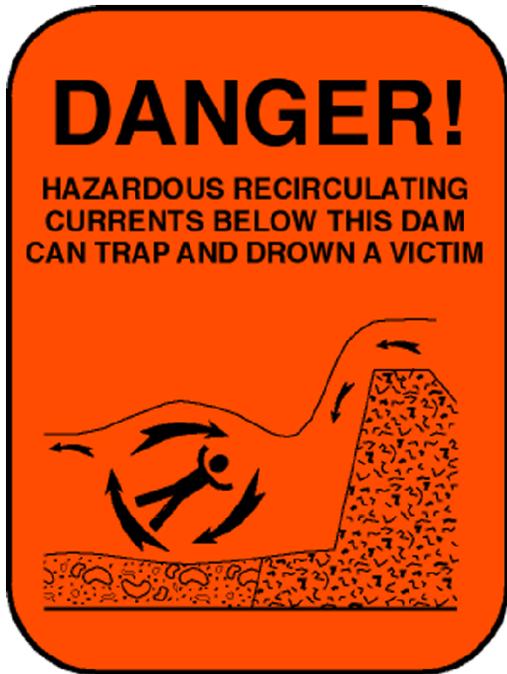
SI-21

Danger Hazardous
Recirculating Currents Below
This Dam Can Trap And Drown
a Victim

This sign was developed by the Minnesota Department of Natural Resources (MN DNR) for low head dams. It identifies non-obvious currents that may occur. The sign has been used commonly in Minnesota and other states, increasing public recognition through standardization of the warning. Well designed specialty graphic increases effectiveness. (Used with permission: Copyright, 2001 Minnesota Department of Natural Resources. Contact MN DNR Boating Safety Section (651) 296-3336 for permission to use.)

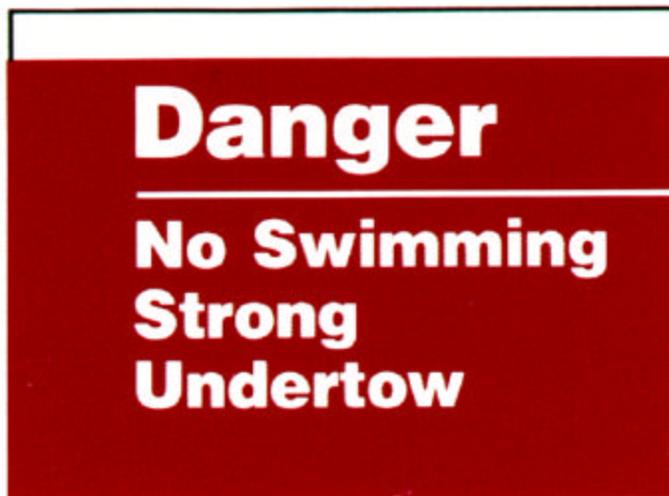
SI-22

Danger No Swimming
Strong Undertow

Subsurface currents are not obvious to viewers and should be identified. Uses USACE spacing, font, coloration, and capitalization in design.
