## APPENDIX S

**Visual Resources**

## **APPENDIX S: VISUAL RESOURCES**

# APPENDIX S-2a: AFFECTED ENVIRONMENT, IMPACTS, AND MITIGATION MEASURES AT KEY OBSERVATION POINTS

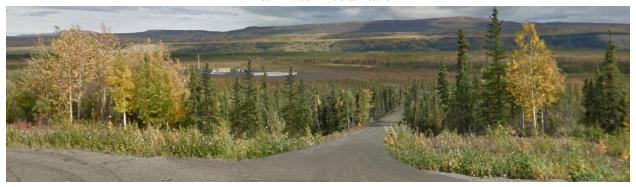
Figure S-2-16: KOP 2018-1: Healey Compressor Station

c. After Reclamation

Due to the high use of the Parks Highway, the Project would be visible to a large number of travelers, although the average viewer would see this view for a brief period (see figure S-2-16c). Condensation plumes from the compressor station could also be visible under certain atmospheric conditions (see section S-2.1.1.1) in an area where no such plumes exist. Overall contrast would be moderate to strong, and visual impacts during operation would be moderate.

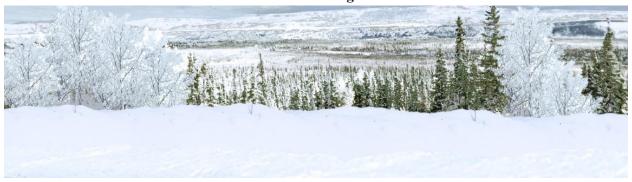
d. Winter Existing Conditions

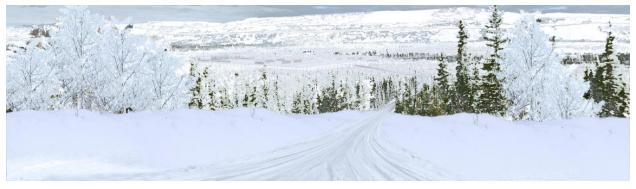
e. Winter Conditions After Construction

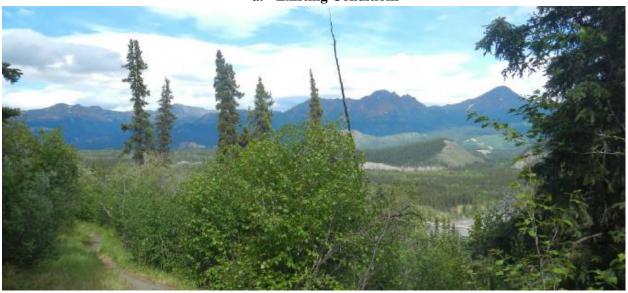
Figure S-2-27: KOP 2018-12: Triple Lakes Trail

### a. Existing Conditions

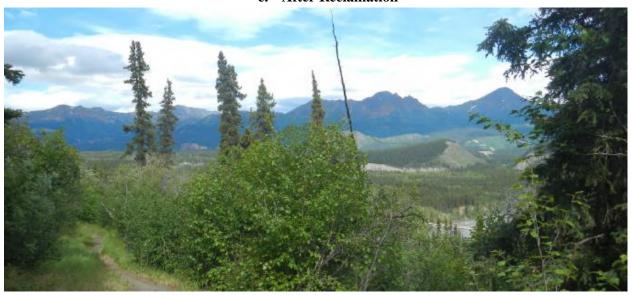
### c. After Reclamation

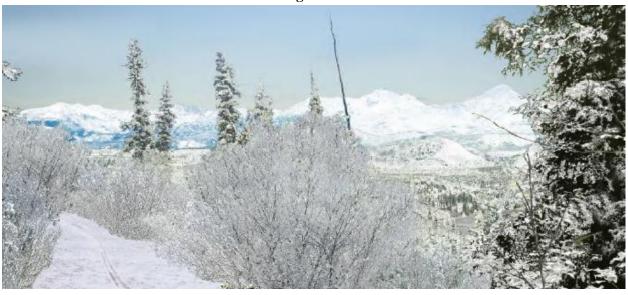
d. Existing Winter Conditions

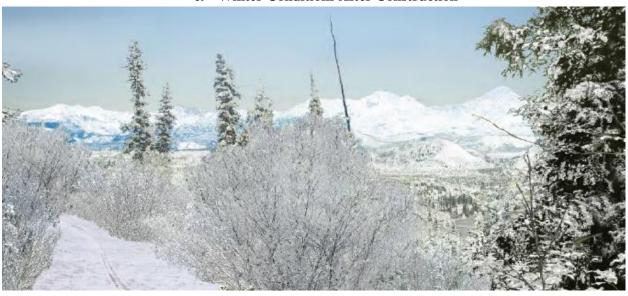
### e. Winter Conditions After Construction
