APPENDIX S

Visual Resources

APPENDIX S: Visual Resources

**Affected Environment, Impacts, and Mitigation Measures
at Key Observation Points**

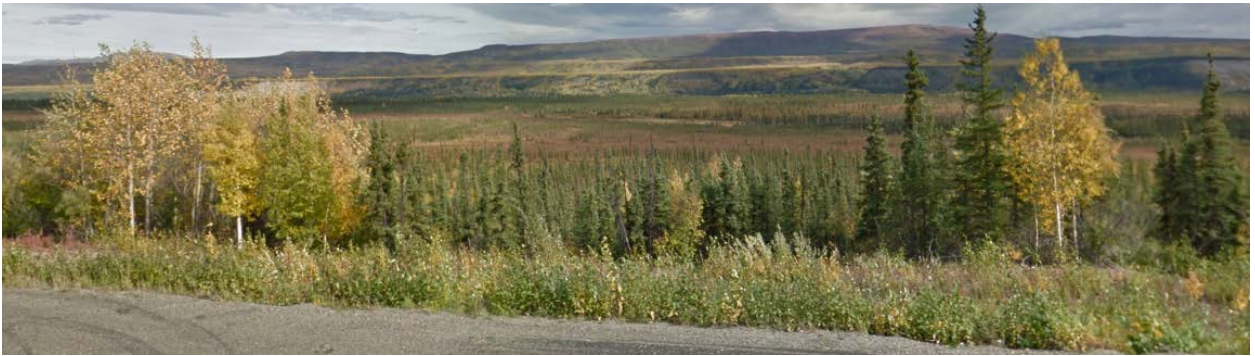
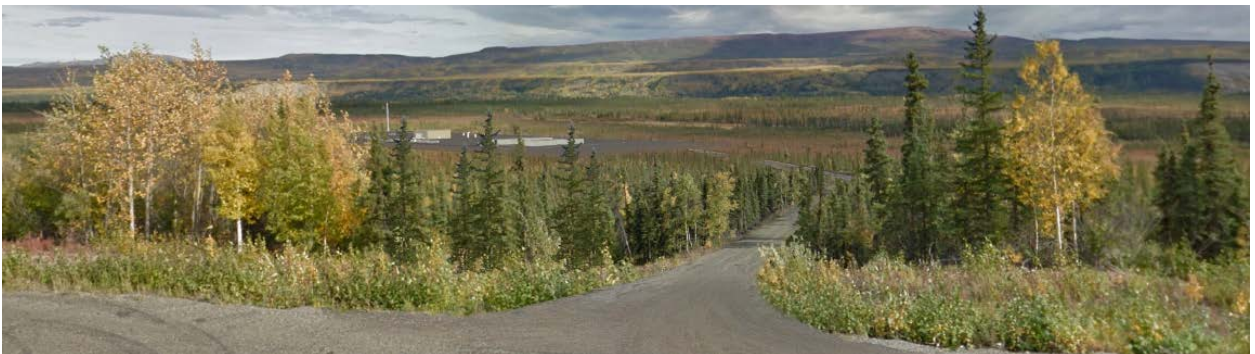
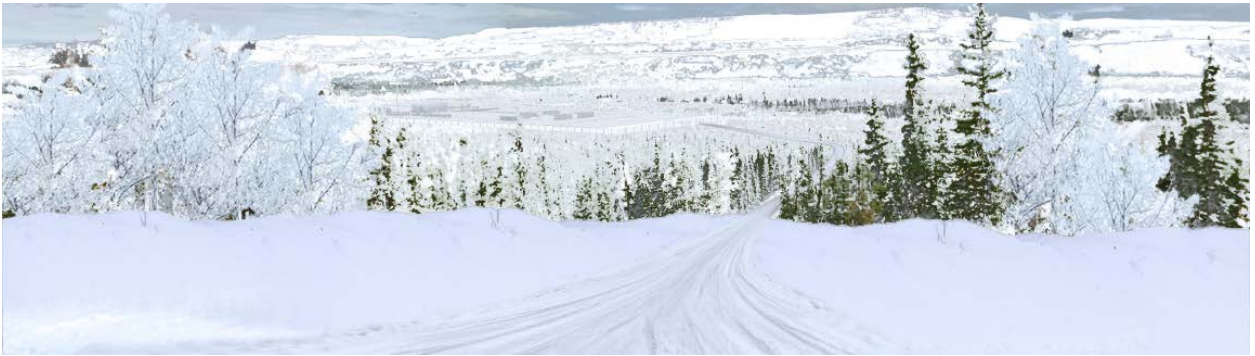
Figure S-2-20: KOP 2018-1: Healey Compressor Station

a. Existing Conditions

c. After Reclamation

e. Winter Conditions After Construction

Due to the high use of the Parks Highway, the Project would be visible to a large number of travelers, although the average viewer would see this view for a brief period (see figure S-2-20c). Condensation plumes from the compressor station could also be visible under certain atmospheric conditions (see section S-2.1.1.1) in an area where no such plumes exist. Overall contrast would be moderate to strong, and visual impacts during operation would be moderate.

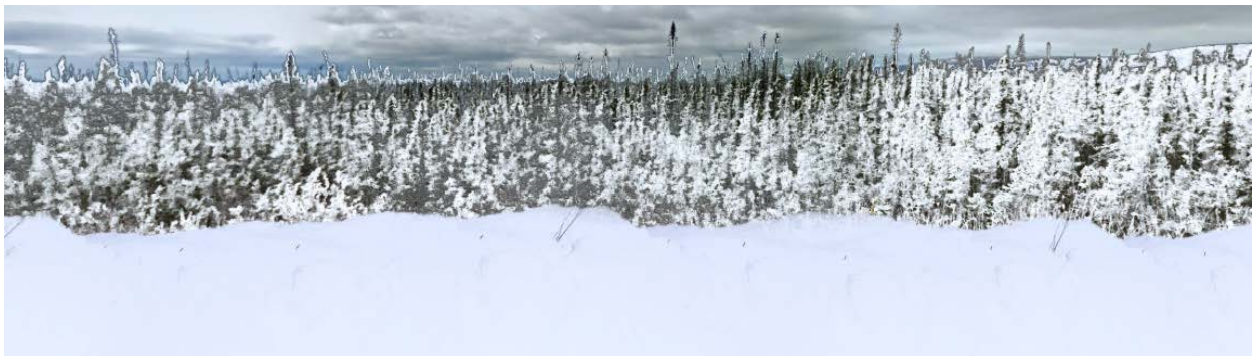
Figure S-2-21: KOP 2018-2: Ray River Compressor Station

a. Existing Conditions

c. After Reclamation

d. Existing Winter Conditions

g. Night Conditions After Construction, Summer

Due to the high use of the Parks Highway, the compressor station would be visible to a large number of travelers, although the average viewer would see this view for a brief period (see figures S-2-21c, S-2-21f, and S-2-21g). Condensation plumes from the compressor station could also be visible under certain atmospheric conditions (see section S-2.1.1.1) in an area where no such plumes exist. Overall, contrast would be moderate to strong and visual impacts during operation would be moderate.
